# AQUETONG ROAD/ WINDY BUSH ROAD

## Road Safety Audit

October 2007

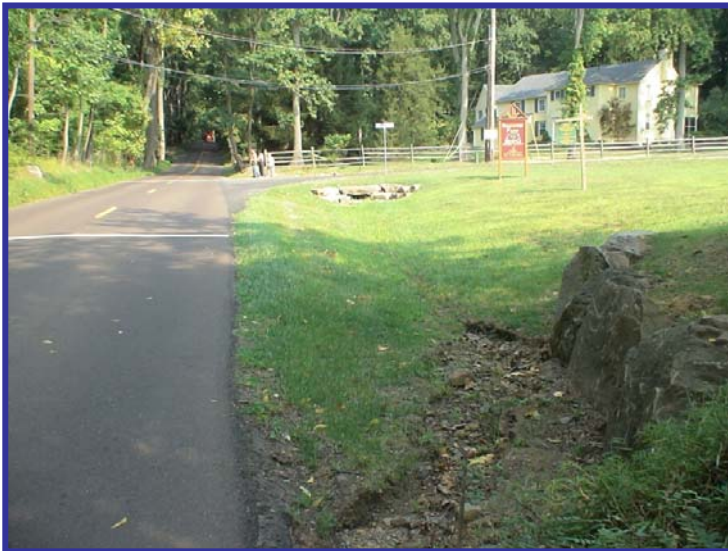
Edge of pavement drop off and drain at Rockwood Path

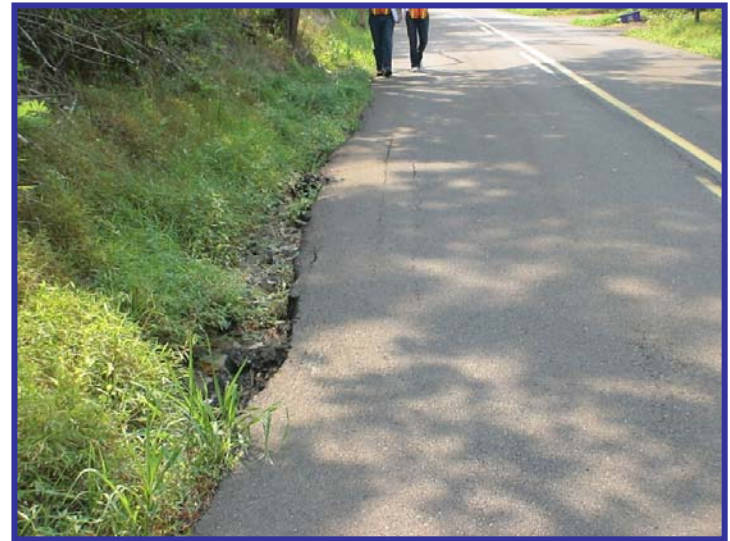
Edge of pavement drop off and deterioration on Aquetong Road west of Cover Bridge Road

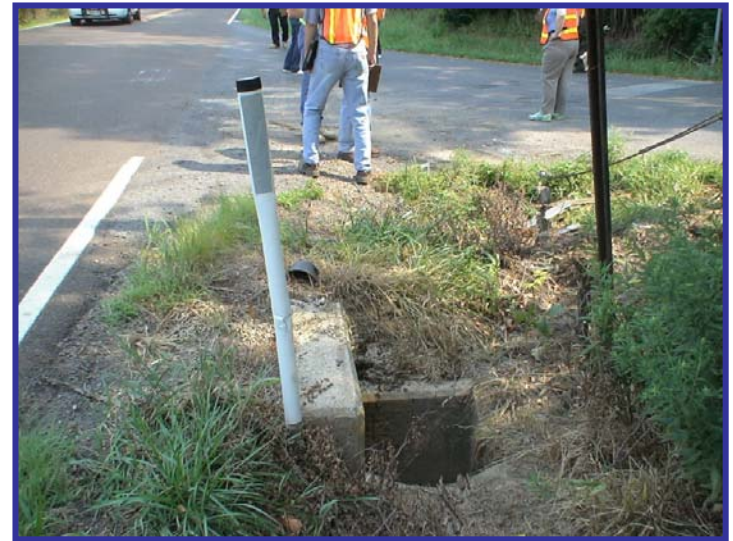
Inlet at the intersection of Old Windy Bush Road and Windy Bush Road

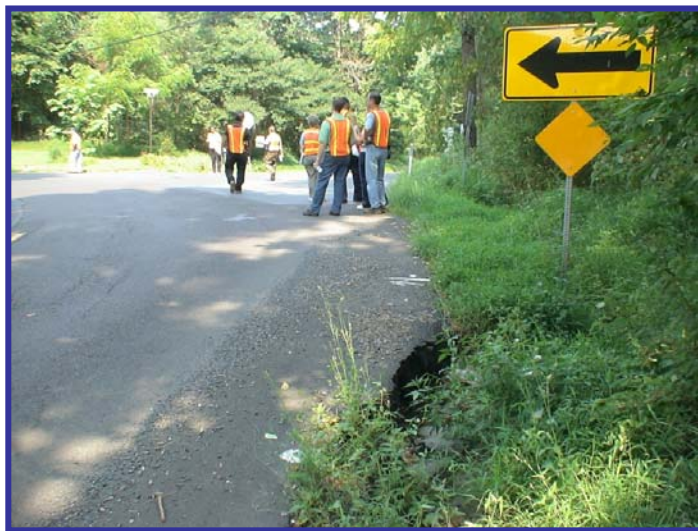
Edge of pavement drop off and deterioration on Aquetong Road east of Sugan Road

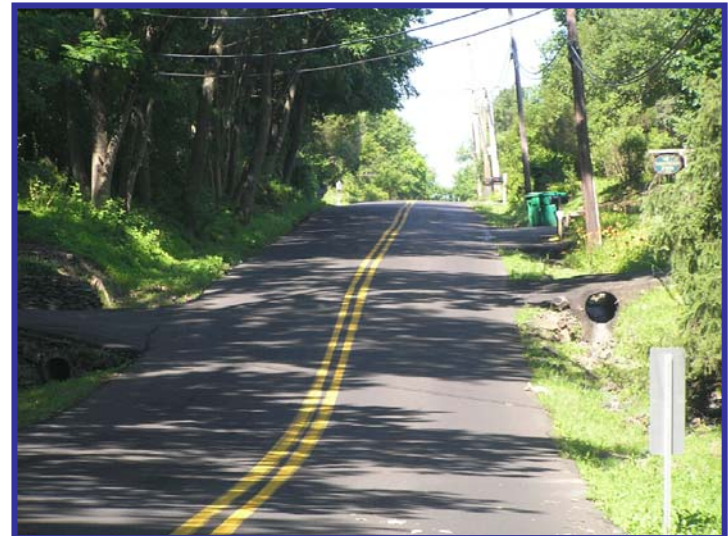
Oversized drain pipe at private property driveway on Aquetong Road west of Sugan Road

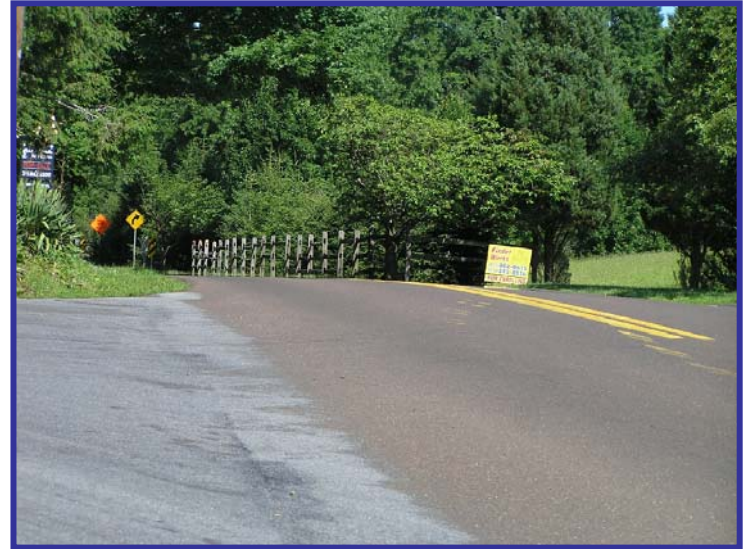
Vegetation at the intersection of Aquetong Road and Cover Bridge Road limits sight distance looking west

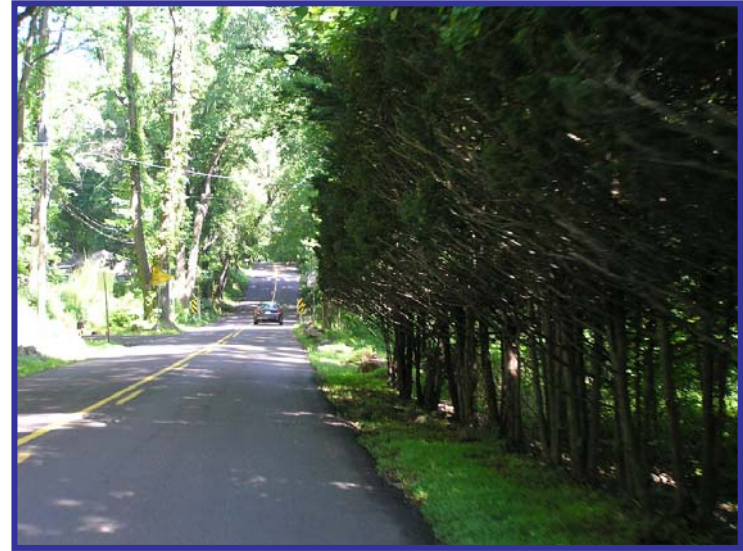
Trees on Aquetong Road in the clear zone

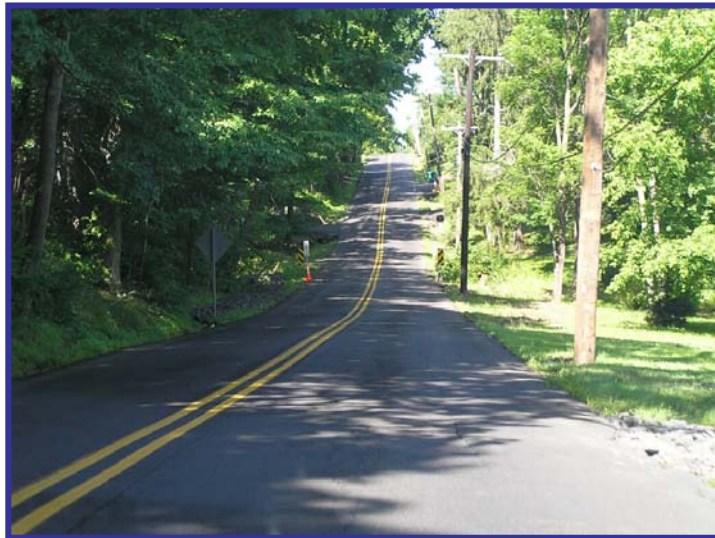
Utility poles in the clear zone on Aquetong Road east of Sugan Road

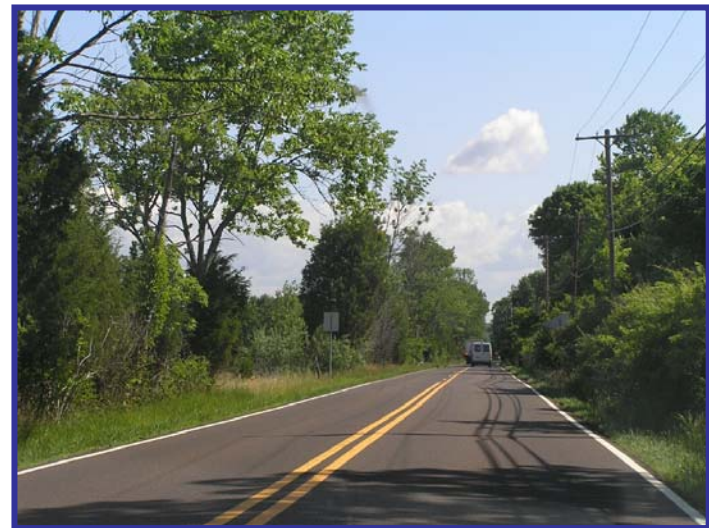
Narrow pavement of Windy Bush Road east of Sugan Road

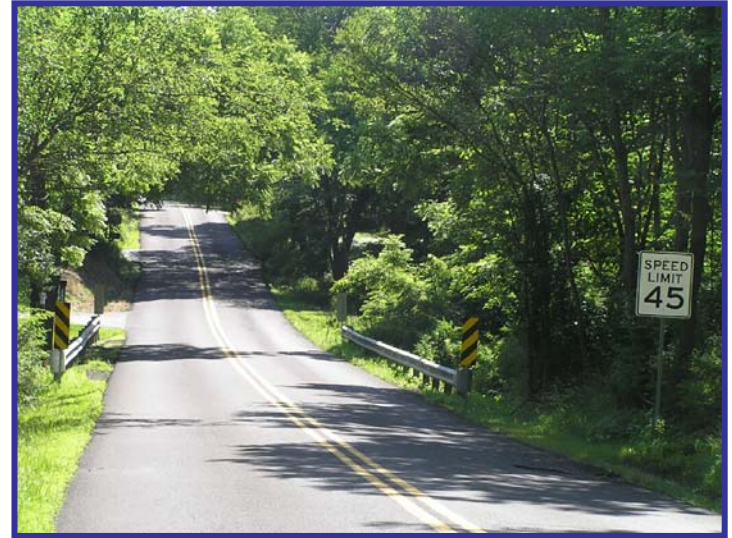
Narrow pavement of Aquetong Road west of Sugan Road, chevron signage at guide rail

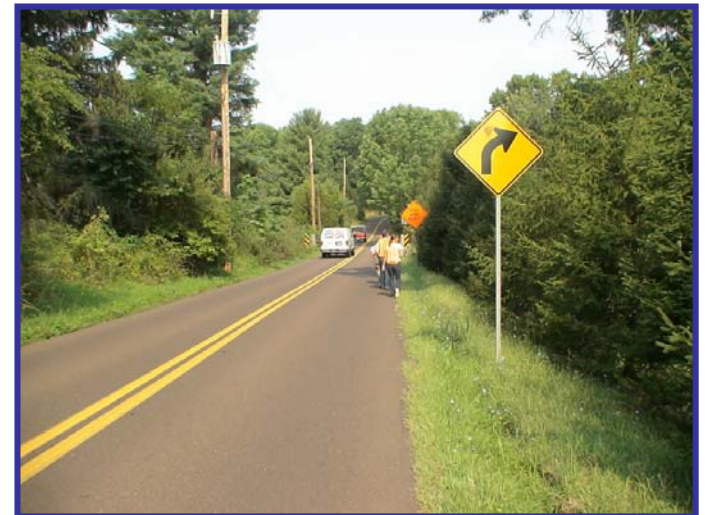
Narrow pavement of Aquetong Road with no pedestrian amenities

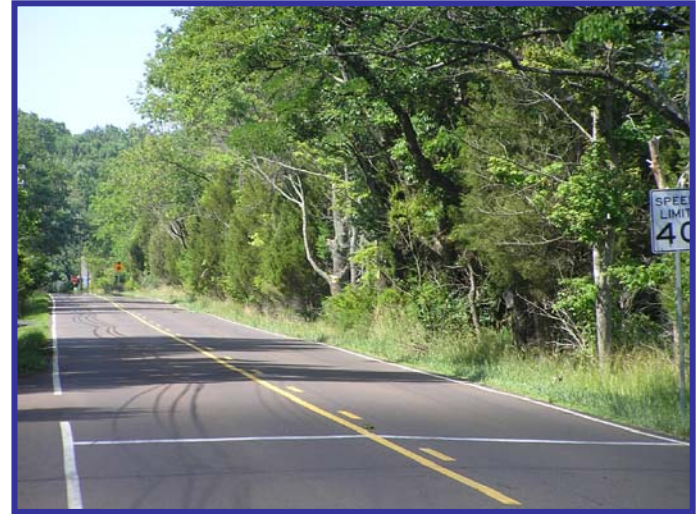
Windy Bush Road looking south at Cornwell Drive – passing zone, narrow shoulders

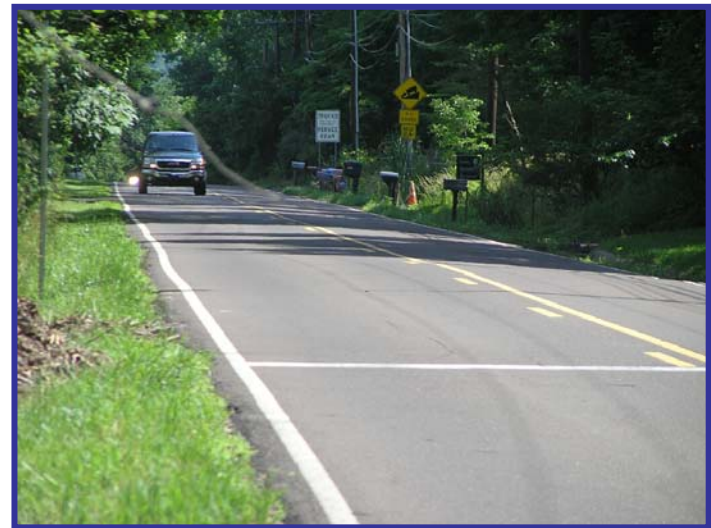
Windy Bush Road looking north at Cornwell Drive – passing zone, narrow shoulders

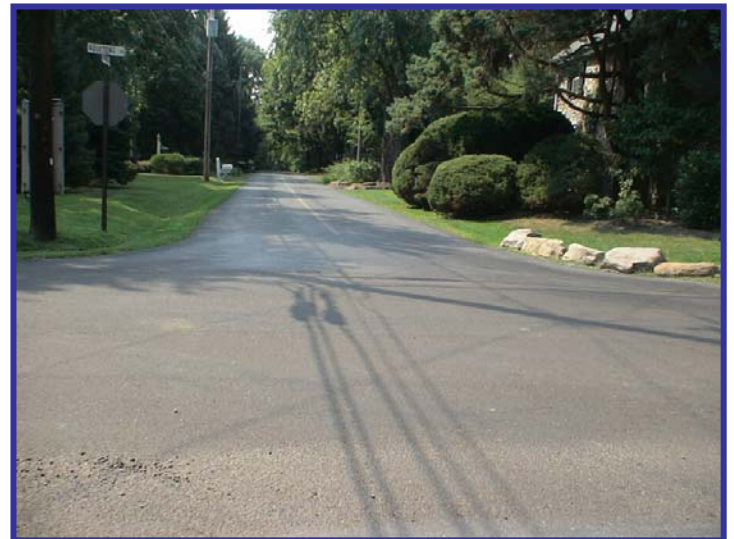
Rocks at corner of Aquetong and Old Windy Bush Roads in the clear zone

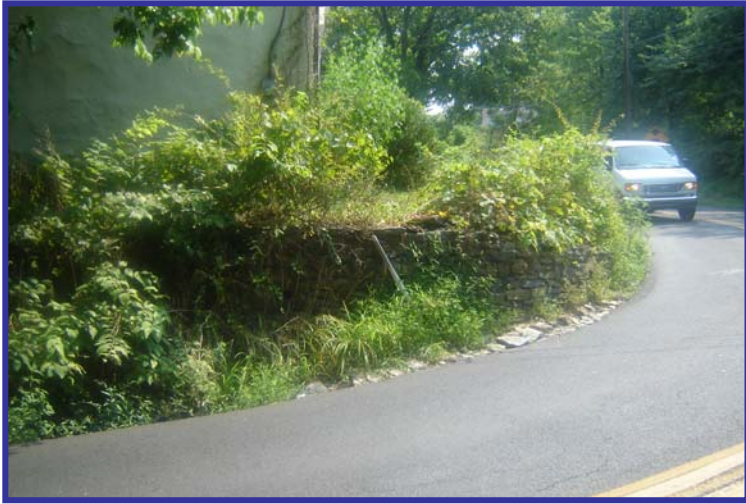
Rock wall on the curve on Aquetong Road east of Suga Road

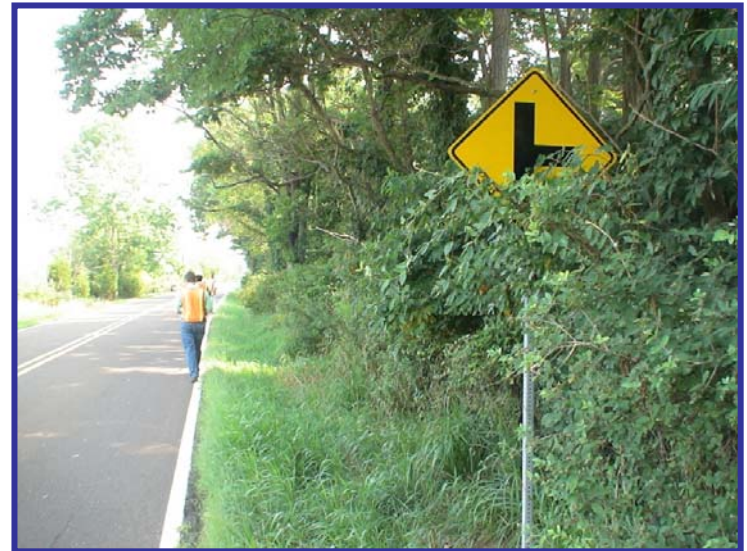
Sign partially hidden by tree branches along Windy Bush Road

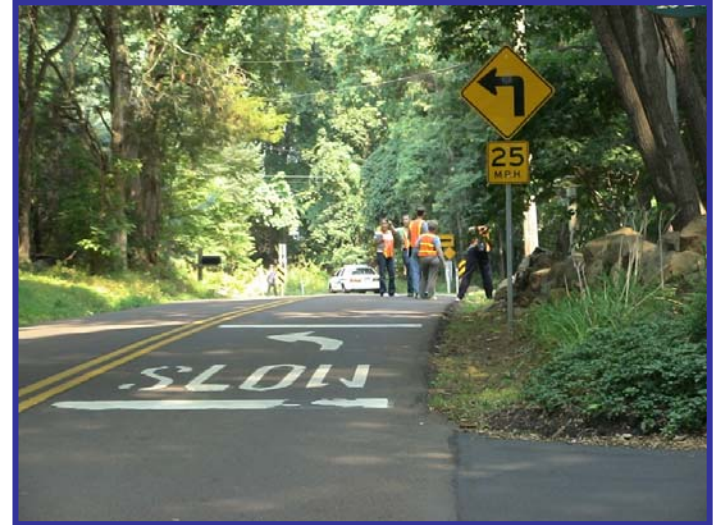
Deteriorating pavement marking on Aquetong Road

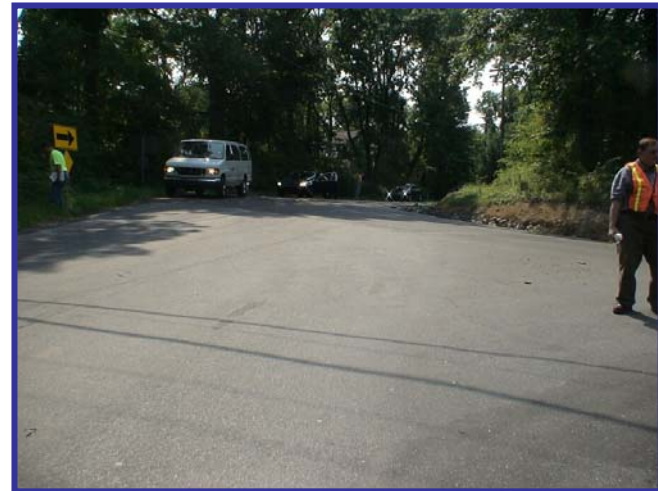
Aquetong Road/Sugan Road intersection Showing no pavement markings

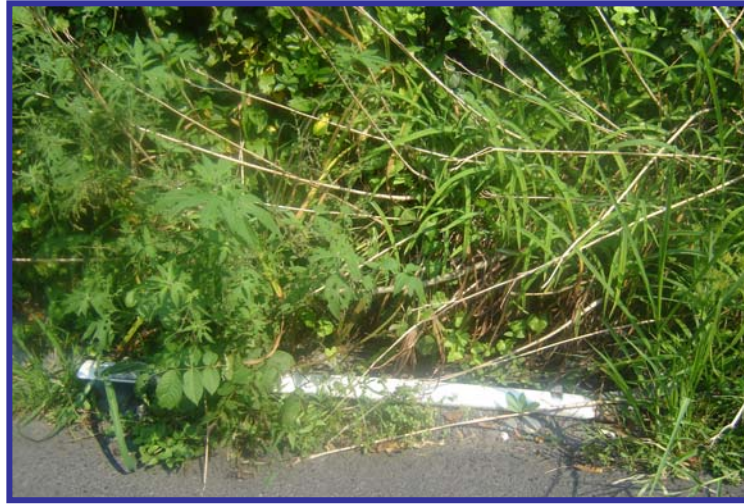
Delineator pole in the ditch on Aquetong Road east of Sugan Road

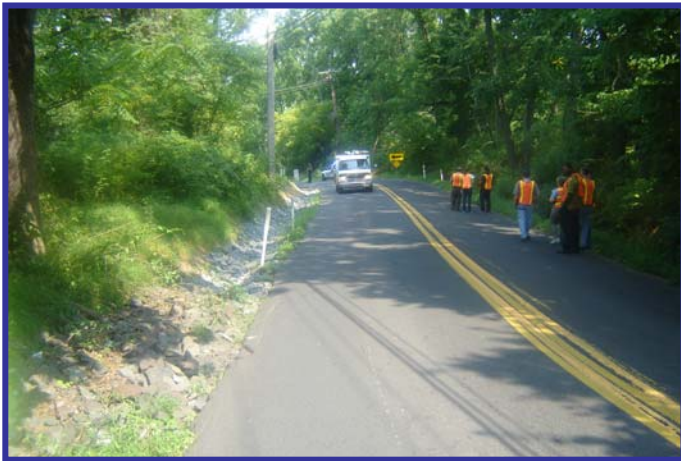
Deteriorating delineator pole on Aquetong Road east of Sugan Road

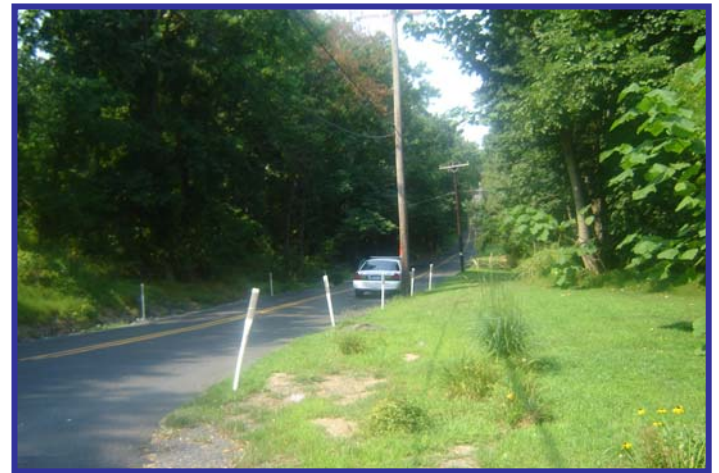
Leaning delineator pole on Aquetong Road west of Sugan Road
