Delaware Valley
Regional Planning
Commission

JUNE 2007

CONESTOGA ROAD

Road Safety Audit

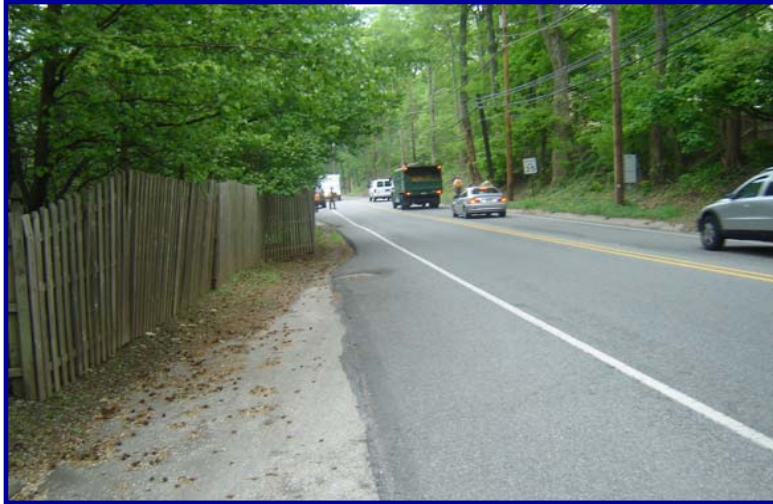
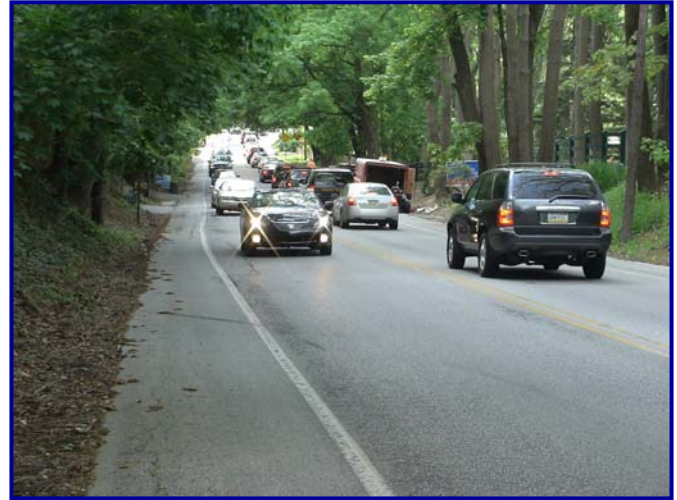
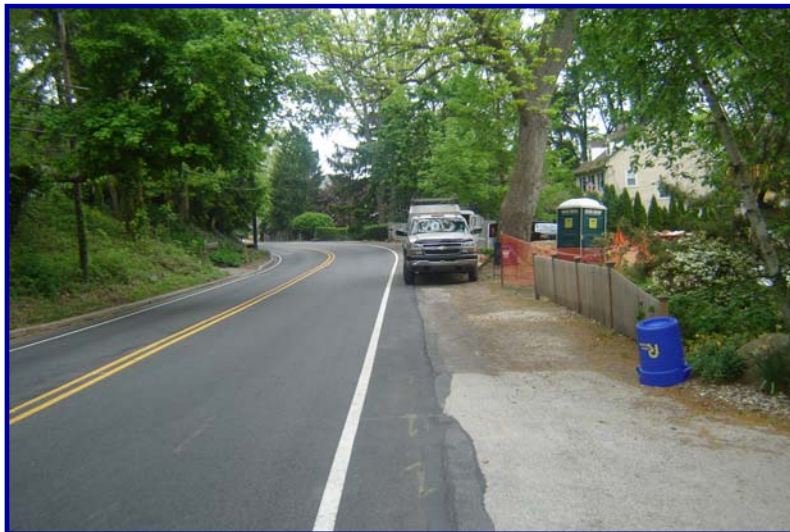
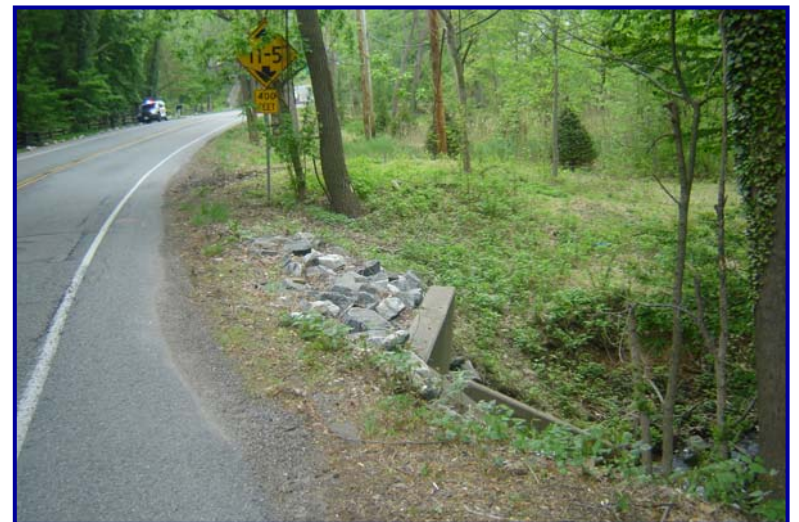
SHOULDERS

ISSUES	RECOMMENDATIONS	LEVEL OF EFFORT REQUIRED	POTENTIAL SAFETY BENEFITS
<p>Shoulders</p> <ul style="list-style-type: none"> ○ Inconsistency shoulder widths ○ Edge lines not clearly delineated ○ Shoulder drop offs are prevalent through out the corridor 	<ul style="list-style-type: none"> ○ Provide consistent painted shoulder width with pavement throughout the corridor and curb the road. 	<p>Medium</p>	<p>High</p>
<p>Utilities</p> <ul style="list-style-type: none"> ○ Utility poles in some locations are too close to the roadway 	<ul style="list-style-type: none"> ○ Coordinate with utility company on relocating the affected poles or make them more visible to the motorists by providing some type of delineation as appropriate 	<p>Medium</p>	<p>High</p>
<p>Drainage</p> <ul style="list-style-type: none"> ○ Inlets top units present a hazard to all road users. Inlet blunt curb ends are unprotected and numerous inlet top units are not flush with pavement gutter line. Some inlet grates are also rotted. ○ Grates/Inlets are clogged 	<ul style="list-style-type: none"> ○ Replace inlet top units and address untreated inlet blunt curb ends. Install inlet top units flush with roadway gutter line. ○ Unclog drainage grates/inlets 	<p>Medium</p> <p>Low</p>	<p>High</p> <p>High</p>

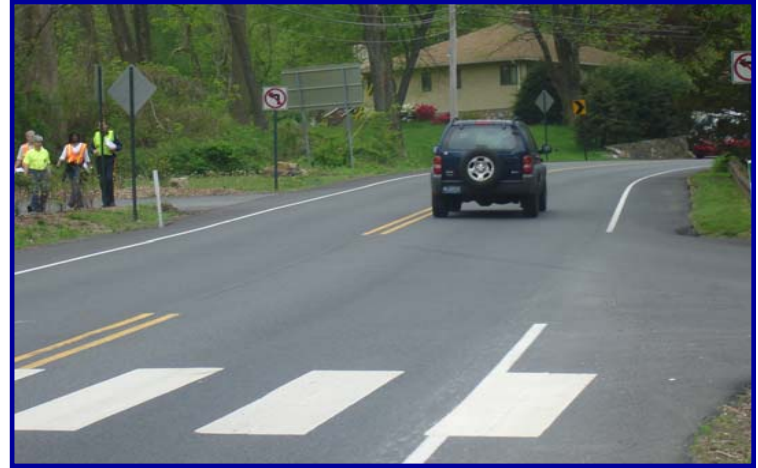
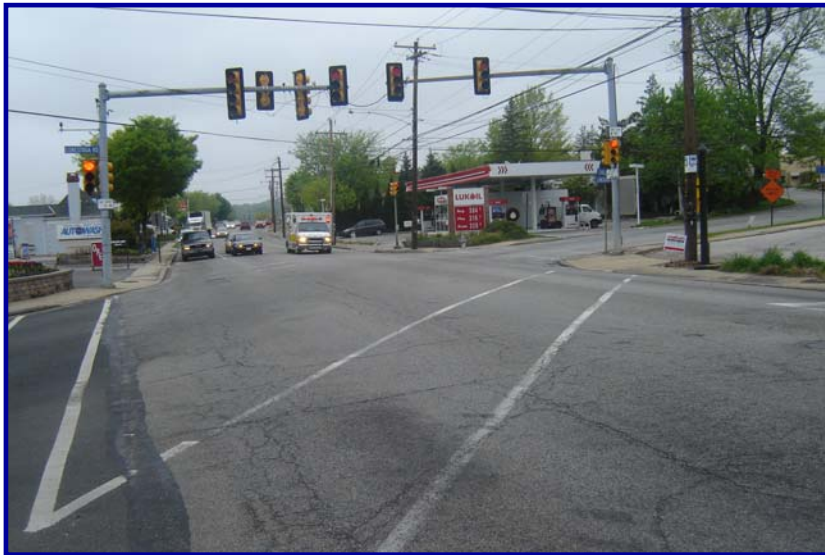
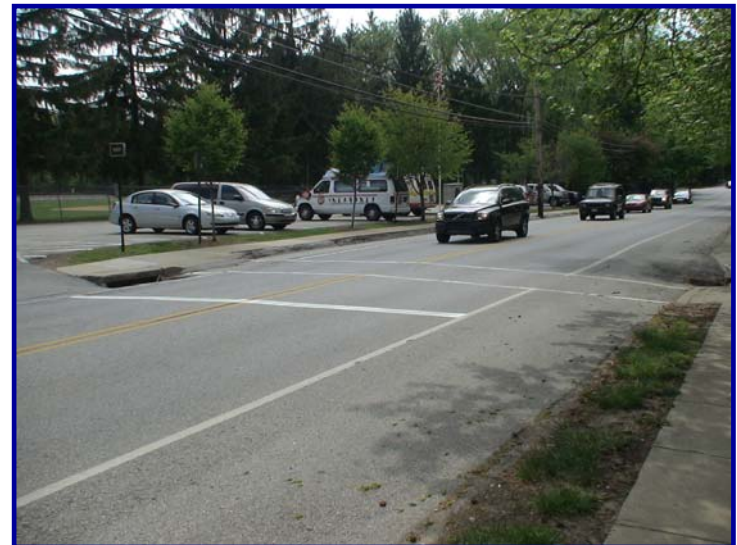
CROSSWALKS

<p>Crosswalks</p> <ul style="list-style-type: none"> ○ Faded and hardly visible ○ Inconsistent style of crosswalk ○ Missing crosswalk ahead signs and yield to pedestrian signs in crosswalk ○ Long crosswalks due to skewed intersections 	<ul style="list-style-type: none"> ○ Re-stripe crosswalks along the corridor ○ Install same crosswalk style at all locations ○ Install signs as appropriate ○ Reduce the skew to as close as 90 degrees ○ Utilize bulb-outs to shorten crossing distance and increase the visibility of pedestrians visibility at key locations 	<p>Low</p> <p>Low</p> <p>Low</p> <p>Medium</p> <p>Medium</p>	<p>High</p> <p>High</p> <p>High</p> <p>Medium</p> <p>High</p>

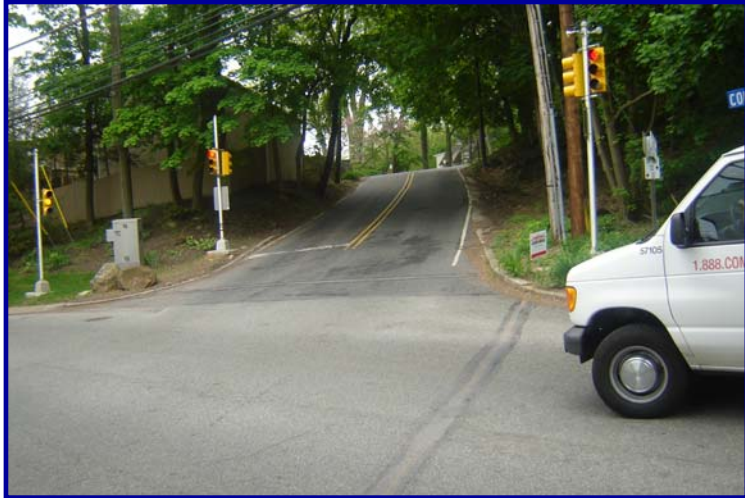
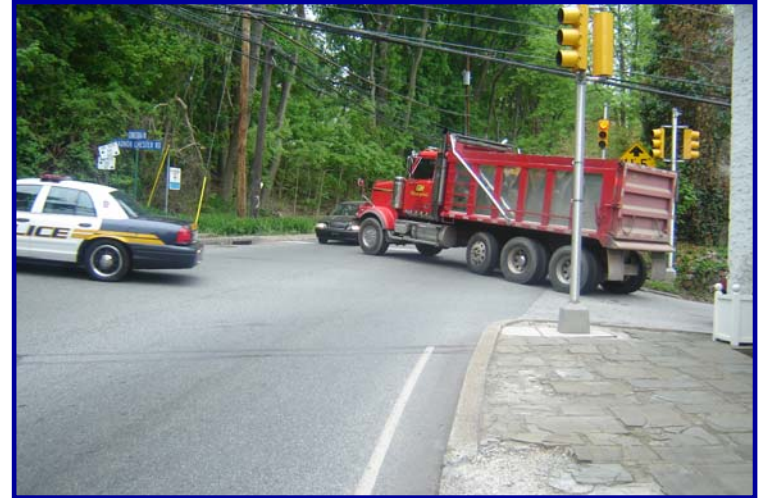
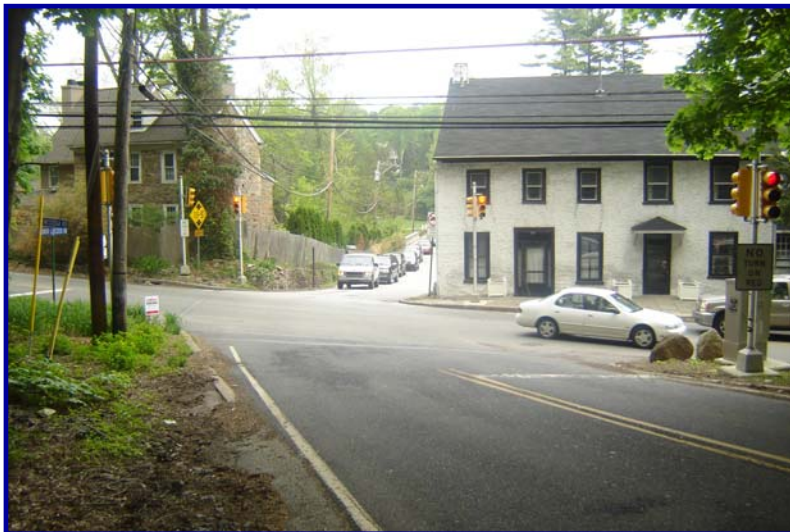
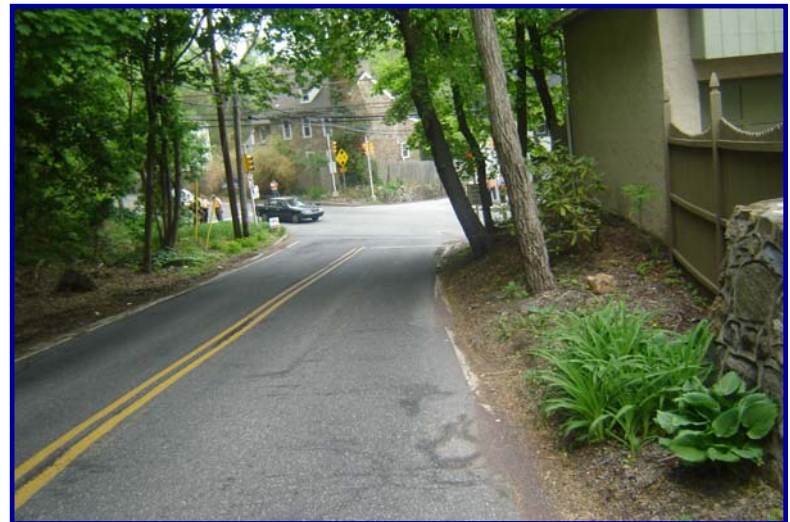
RADNOR CHESTER ROAD

ISSUES	RECOMMENDATIONS	LEVEL OF EFFORT REQUIRED	POTENTIAL SAFETY BENEFITS
<p>Radnor Chester Road Intersection</p> <ul style="list-style-type: none"> ○ Rear end crash problem for Conestoga Road eastbound ○ Signals are mounted on poles which results in problems seeing them ○ Stop bars are faded ○ Intersection is a safety issue for bicyclists 	<ul style="list-style-type: none"> ○ Re-design and add left turn lane eastbound ○ Due to limitation with widening intersection, reconfigure intersection and use Newtown Rd for jughandle for eastbound left turn movement ○ Mount signals on mast arms to make more visible ○ Re-paint stop bars 	<p>High</p> <p>Medium</p> <p>Low</p> <p>Low</p>	<p>High</p> <p>High</p> <p>High</p> <p>High</p>
<p>Between Radnor Chester Road and Sproul Road</p> <ul style="list-style-type: none"> ○ Need access management in front of gas station and store 	<ul style="list-style-type: none"> ○ Define access and egress points for these businesses 	<p>Medium</p>	<p>High</p>

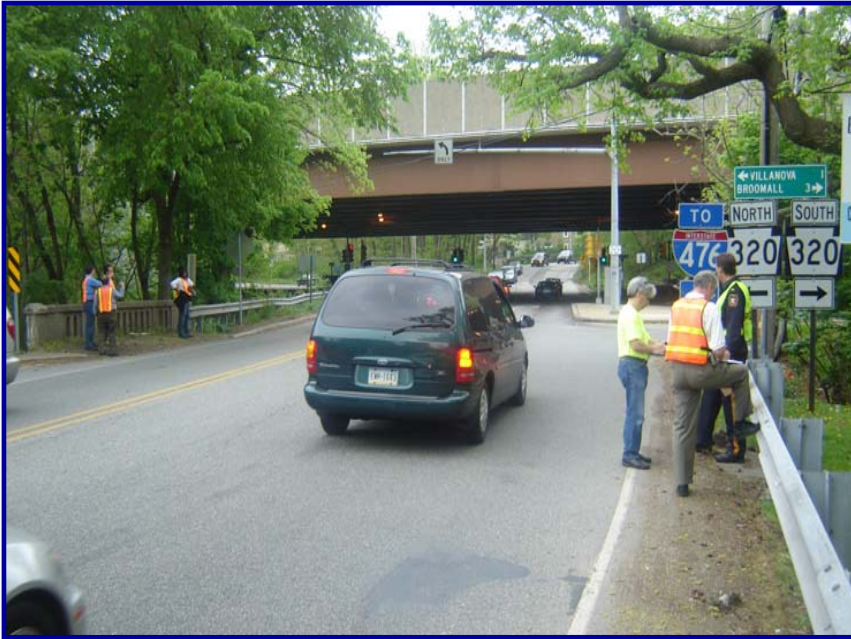
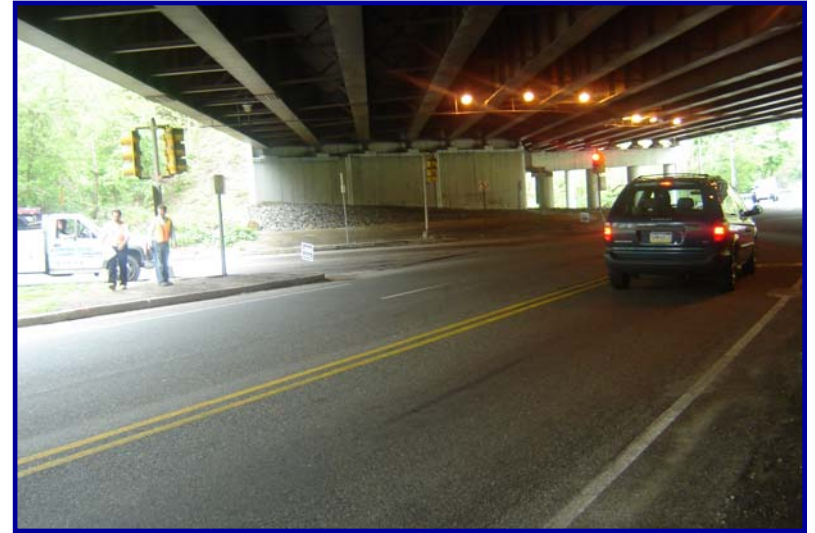
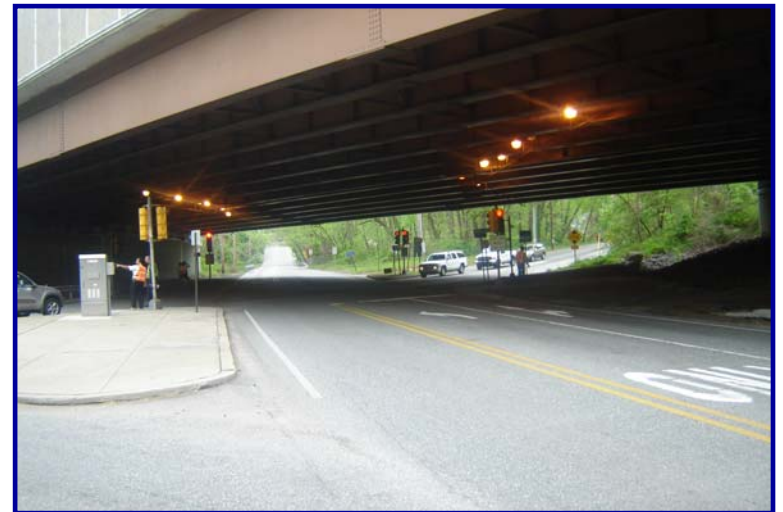
SPROUL ROAD

ISSUES	RECOMMENDATIONS	LEVEL OF EFFORT REQUIRED	POTENTIAL SAFETY BENEFITS
<p><i>Sproul Road Intersection (continued)</i></p> <ul style="list-style-type: none"> ○ Motorists are driving over W-beam guide rail on northbound Sproul Road ○ “Slippery when Wet” signs are redundant ○ There are no bicycle or pedestrian amenities (pedestrians are discouraged) 	<ul style="list-style-type: none"> ○ Add a dedicated left turn lane to the southbound approach of Sproul Road ○ Add a dedicated left turn lane on Conestoga Road westbound for southbound Sproul Rd ○ W-beam guide rail on northbound Sproul Road, turn down, truncate and use end post treatment ○ Remove “Slippery when Wet” signs ○ Consider providing pedestrian and bicyclist amenities at this intersection 	<p>Low</p> <p>Low</p> <p>Medium</p> <p>Low</p> <p>Medium</p>	<p>Medium</p> <p>Medium</p> <p>High</p> <p>Low</p> <p>High</p>
<p><i>Spring Mill Road Intersection</i></p> <ul style="list-style-type: none"> ○ Broken sign post near Radnor Avenue ○ There is no crosswalk across Spring Mill Road. ○ Intersection is skewed and very wide 	<ul style="list-style-type: none"> ○ Replace broken sign post ○ Install crosswalk at Spring Mill Road. ○ Realign Spring Mill Road to meet Conestoga Road at a right angle 	<p>Low</p> <p>Low</p> <p>Medium</p>	<p>Medium</p> <p>High</p> <p>High</p>

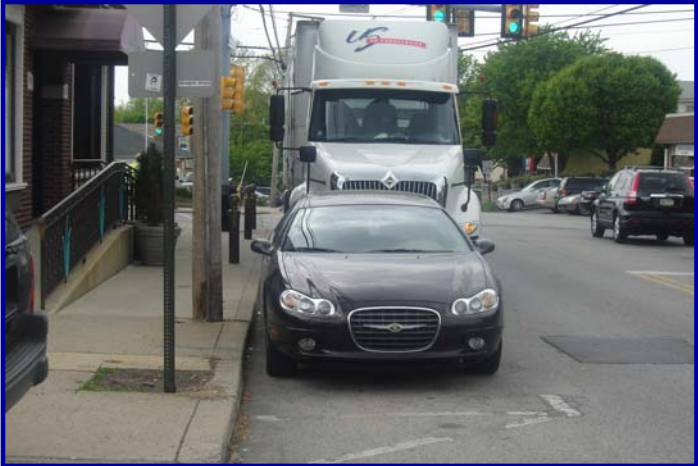
GARRETT AVENUE / WILLIAMS ROAD VICINITY

Utility pole placed in narrow sidewalk

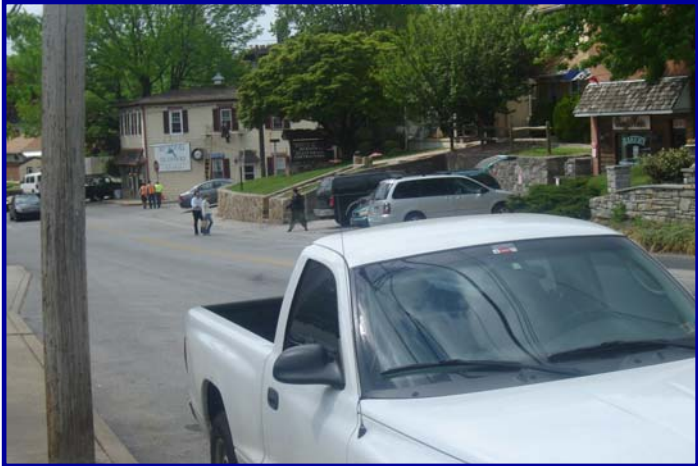
Pedestrian activity
