Delaware Valley
Regional Planning
Commission

DECEMBER 2008

PA 10

Road Safety Audit

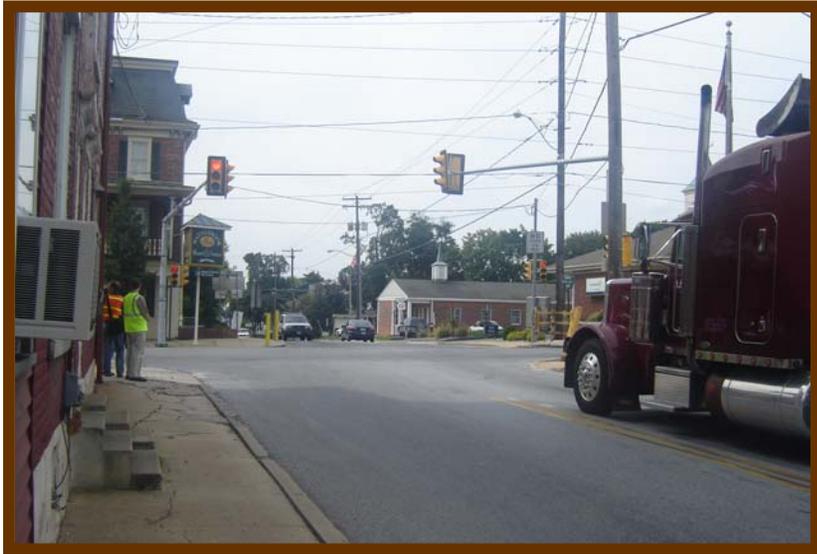
Evident of drainage problems on eastside of PA 10, south of Water Street

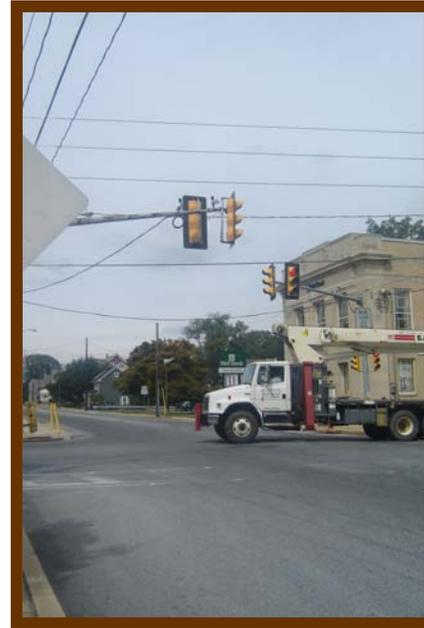
Sidewalk on PA 10 in poor condition north of the US 322 intersection

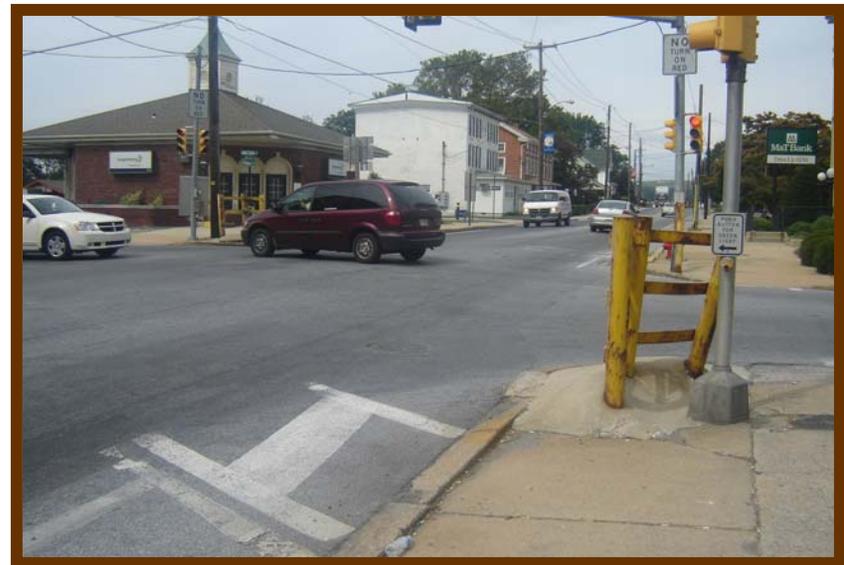
Pavement markings are faded at the US 322/PA 10 intersection

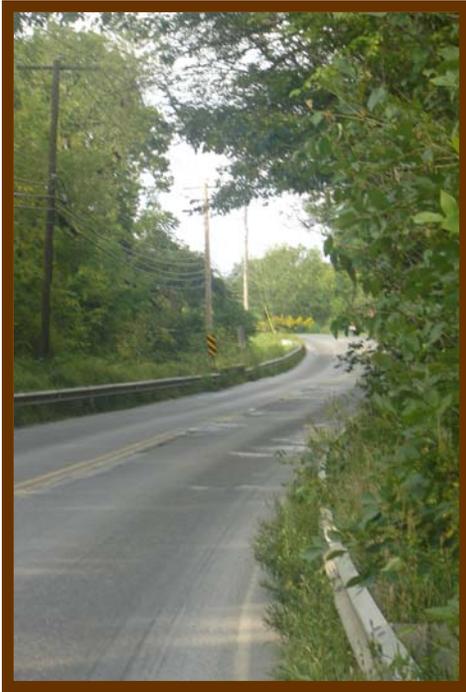
South of the PA 10/Cambridge Road intersection, shoulders are narrow and pavement markings are faded

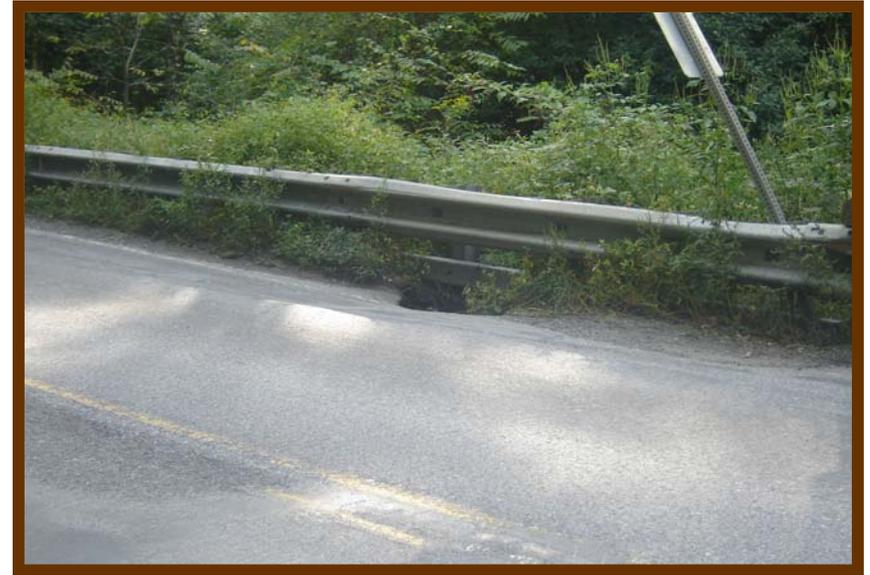
Narrow bridge south of the PA 10/Cambridge Road intersection, wheel ruts on the bridge. Pavement is worn

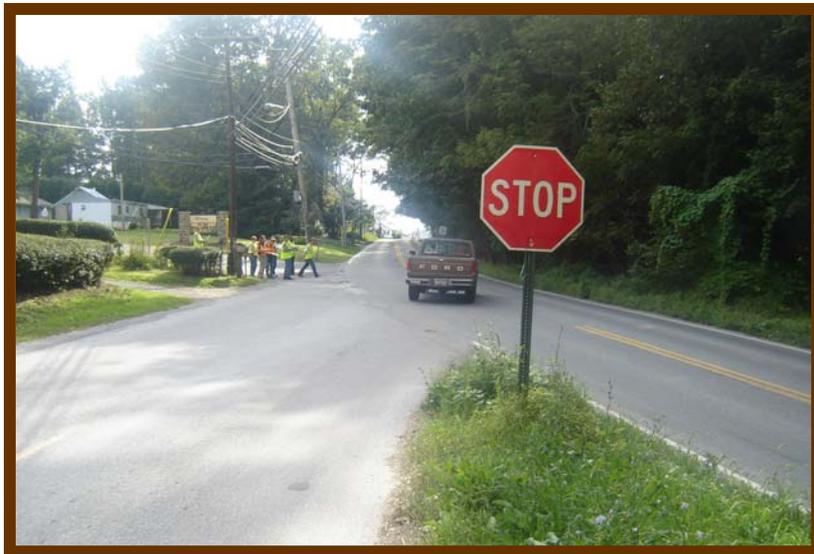
Poor pavement condition at the south leg of the Hill Road intersection with PA 10

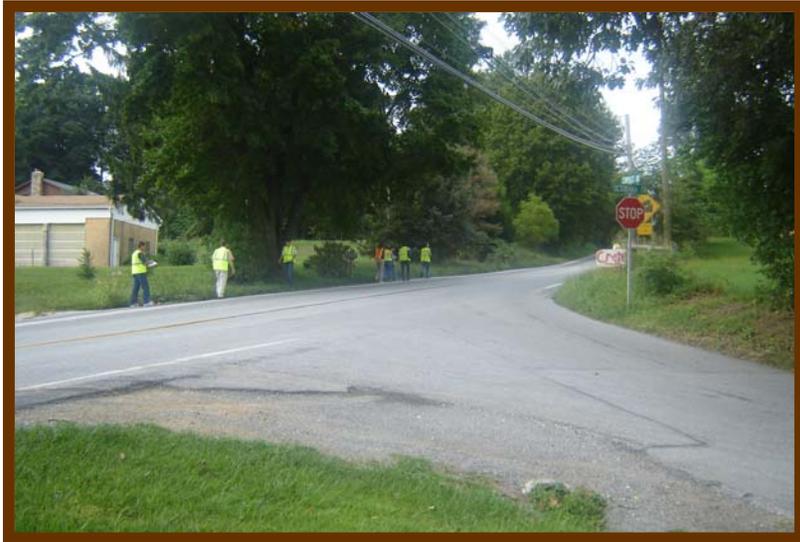
Compromised sight distance for Beacon Light
Road traffic at PA 10 to the north

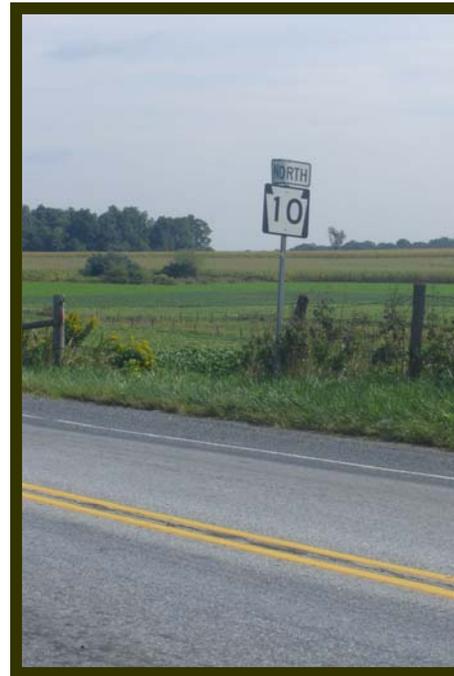
Tight turning radii at the intersection of PA 10/PA 896

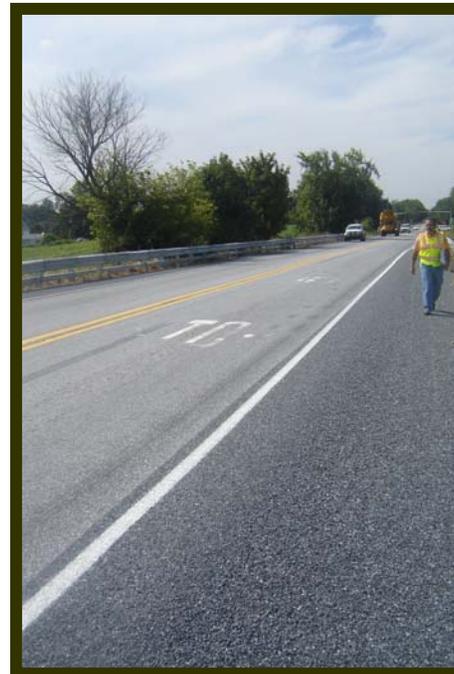
The guide rail has improper end treatment and is not properly secured along northbound PA 10, north of the PA 896 intersection

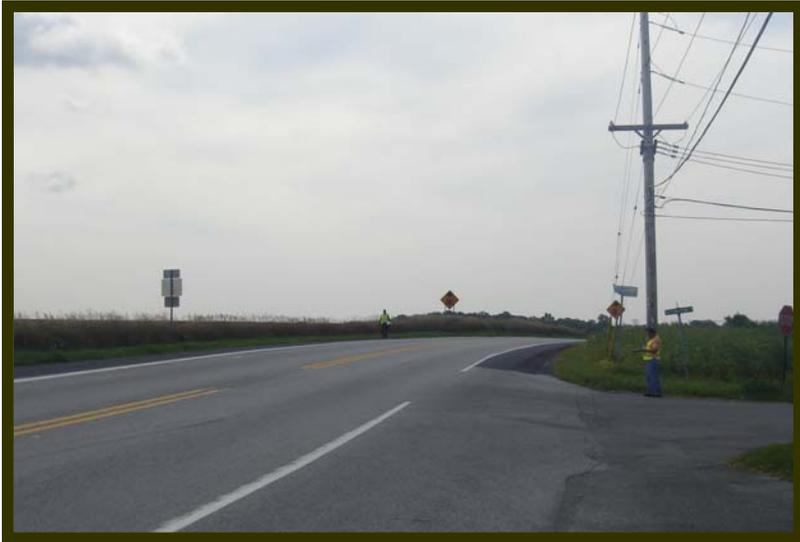
Faded "Stop Ahead" pavement marking approaching PA 896 intersection southbound

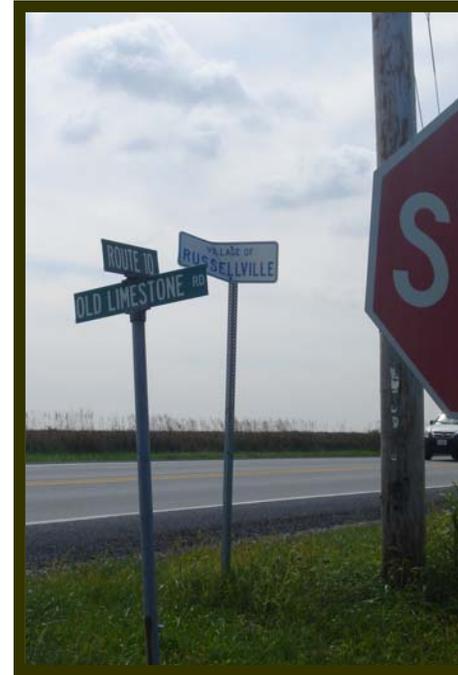
Old Limestone Road slopes away from the PA 10 intersection. Inadequate sight distance from Old Limestone Road looking south at PA 10

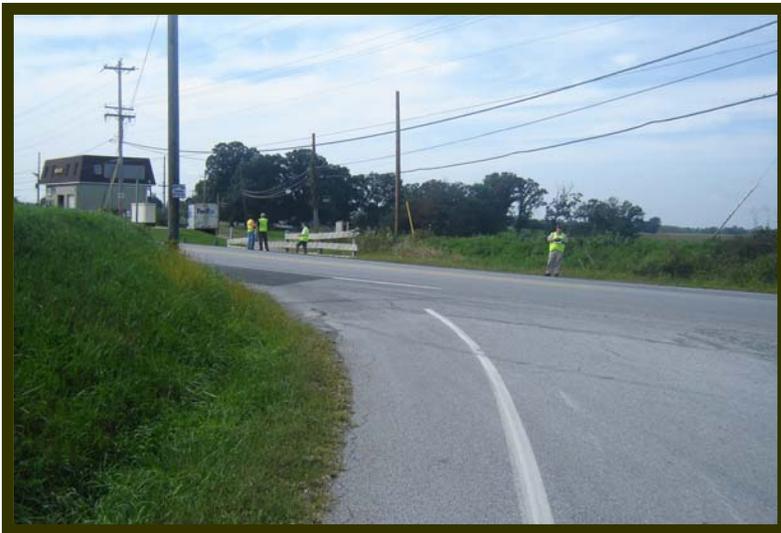
Damaged signs at the Old Limestone Road intersection

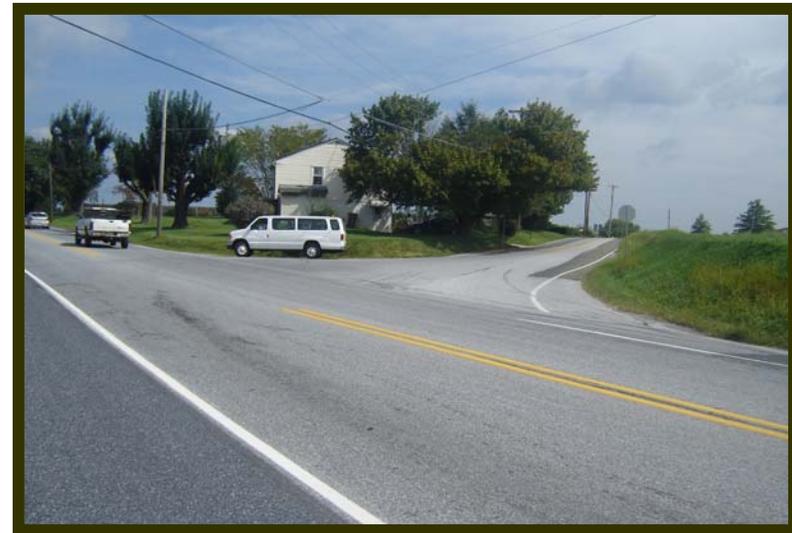
Old, damaged barrier blocking the previous Old Limestone Road alignment is located in the clear zone

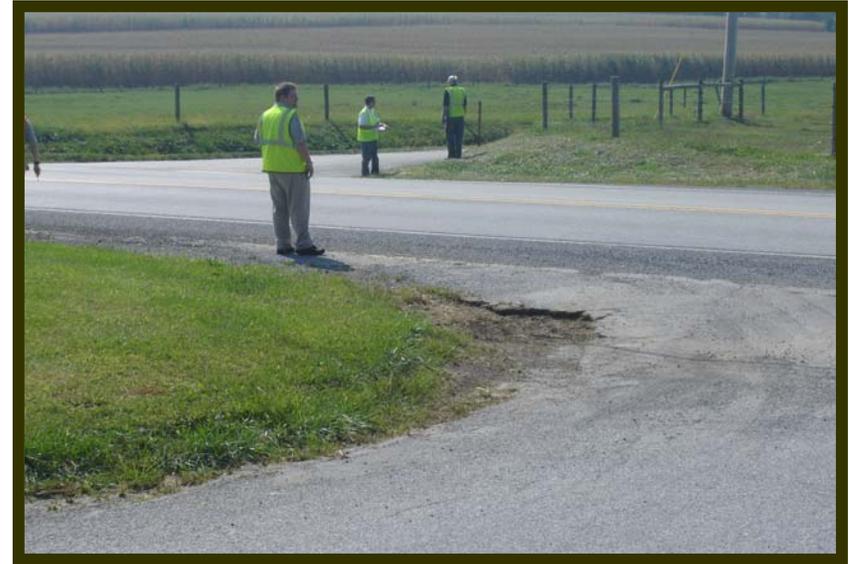
Tight intersection radii at High Point Road makes it difficult for turns at the intersection

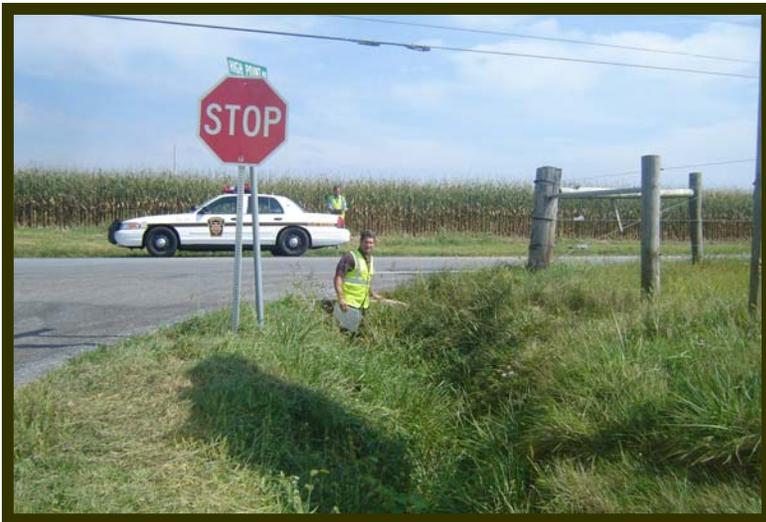
Offset intersections of High Point and Troop Roads with PA 10; water pooling on the corner of Troop Road deteriorating pavement edge causing drop off

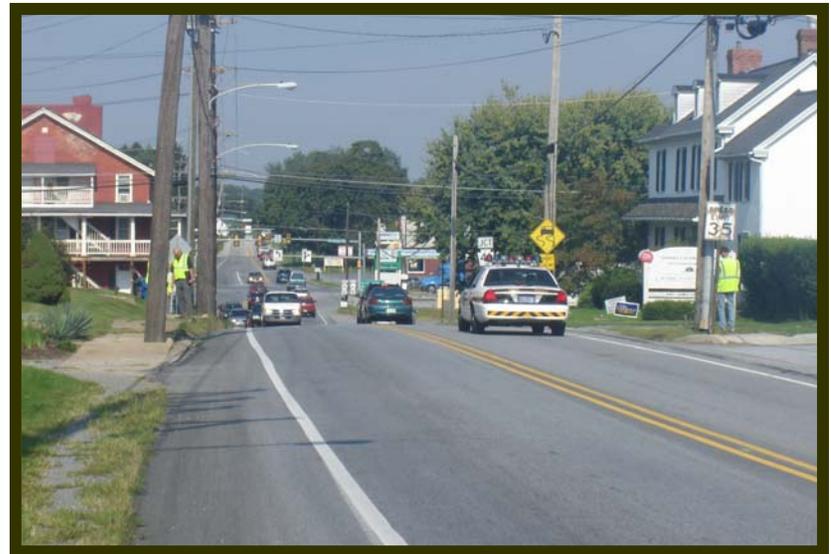
Skewed alignment of Church Road at PA 10. "Stop" sign is too low and covered in the trees.

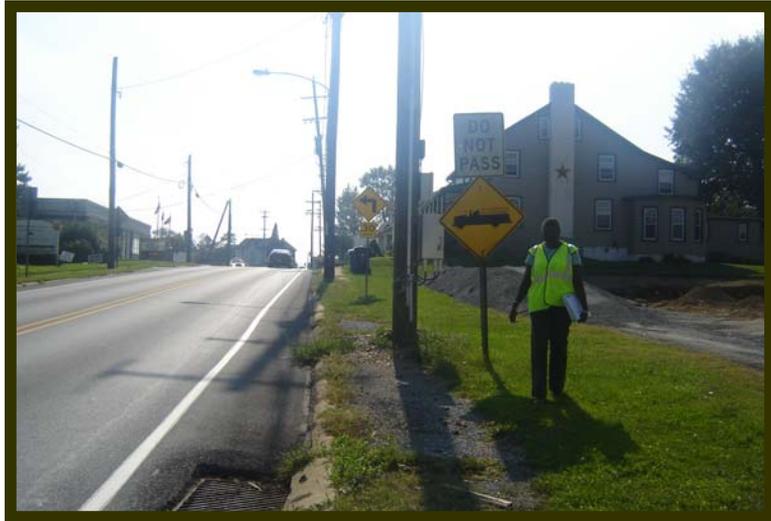
Sidewalks in poor condition approaching PA 41 northbound

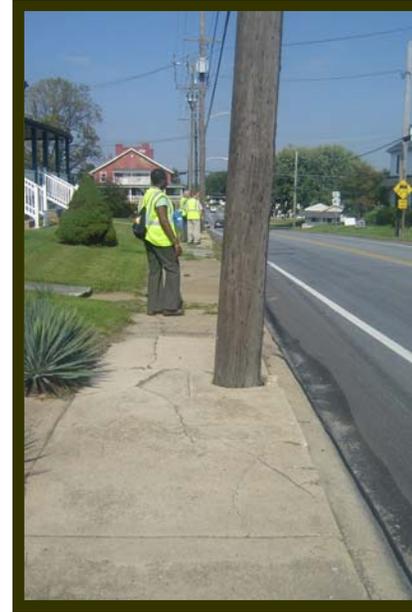
Sidewalks in poor condition on PA 10 in Cochranville. The “fire station” and the “curve signs are mounted too low

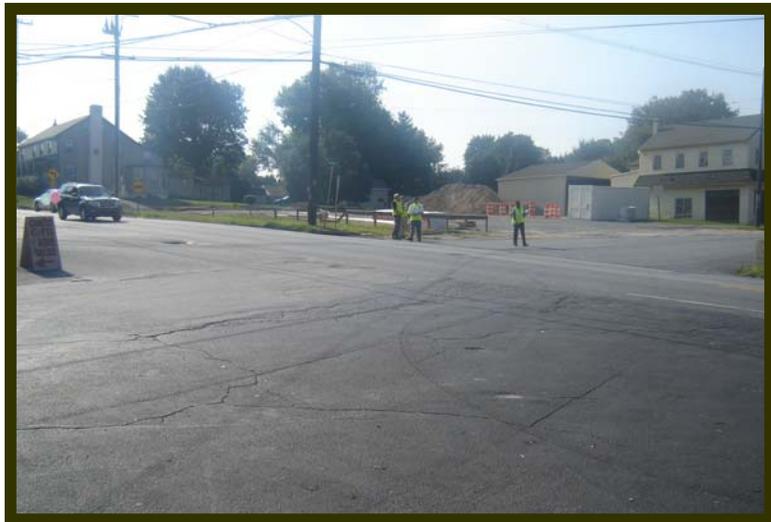
Sidewalk in poor condition with huge drop to street.

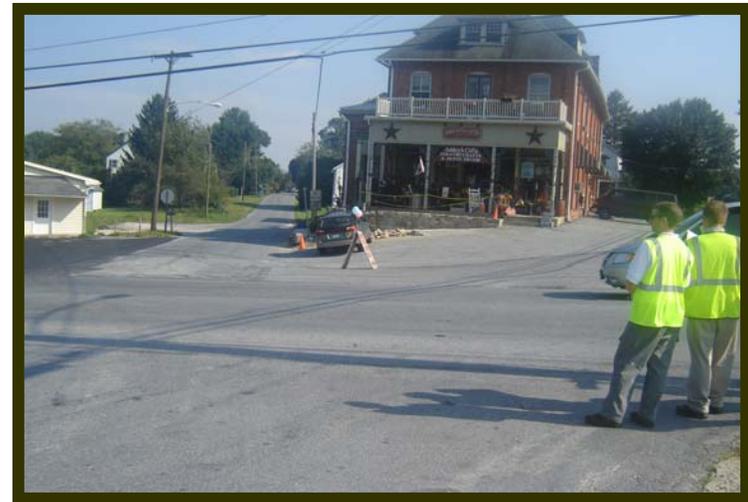
No access management at shops

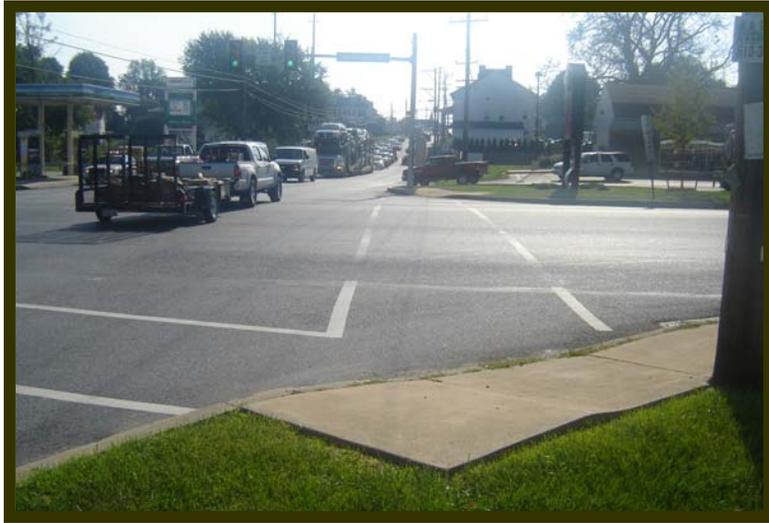
No access management at shops. Stop signs at Daleville and Cochran Roads are missing or in the wrong position

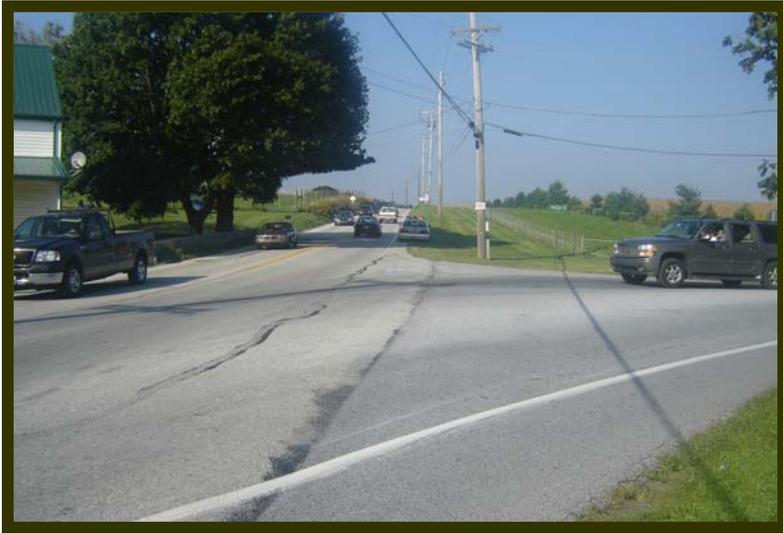
Truck making a left turn on to PA10 northbound from eastbound PA 41

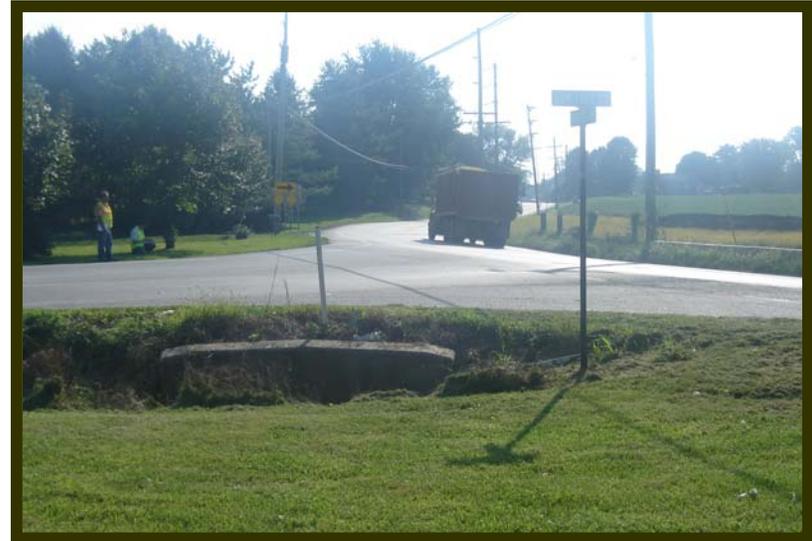
The skewed intersection of Gum Tree Road/PA 10. This intersection is on a curve. Stop bar is missing

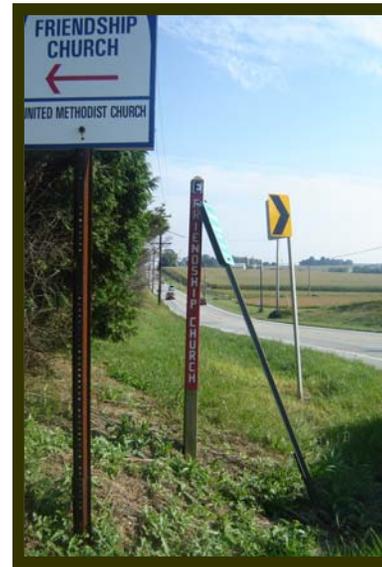
Traffic was observed speeding southbound around the curve north of Friendship Church Road
