# LEVITTOWN PARKWAY

ROAD SAFETY AUDIT

DECEMBER 2010

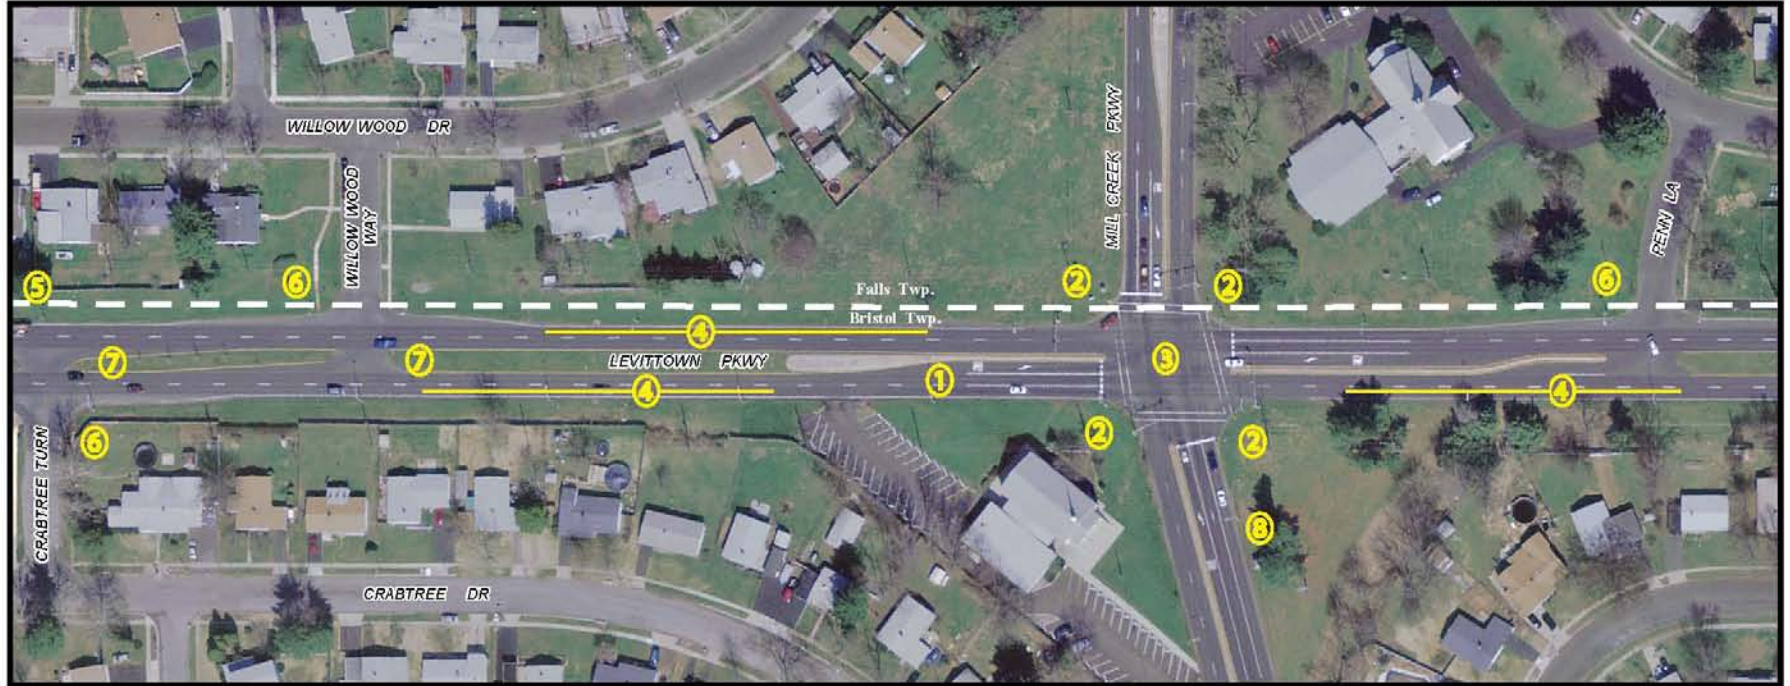
Figure 1: Panel 1 (Mill Creek Parkway to Crabtree Turn)

Site-Specific Issue	Potential Strategy	Level of Effort	Estimated Safety Benefit
<b>Panel 1 (Mill Creek Parkway to Crabtree Turn)</b>			
1. Evidence of pavement rutting along the Parkway southbound;	1. Repair damaged pavement during scheduled maintenance;	Low	Medium

2. Dual-stripe crosswalks are in place at the Mill Creek Parkway intersection but pedestrian heads are missing;	2. Upgrade crosswalk to continental, provide pedestrian signal heads with countdown timers;	Low	Medium

5. Damaged drainage inlet along Parkway northbound at mid-block, near northern edge of aerial photo;	5. Repair drainage inlet and ensure it is a bicycle-safe design;	Medium/High	Medium

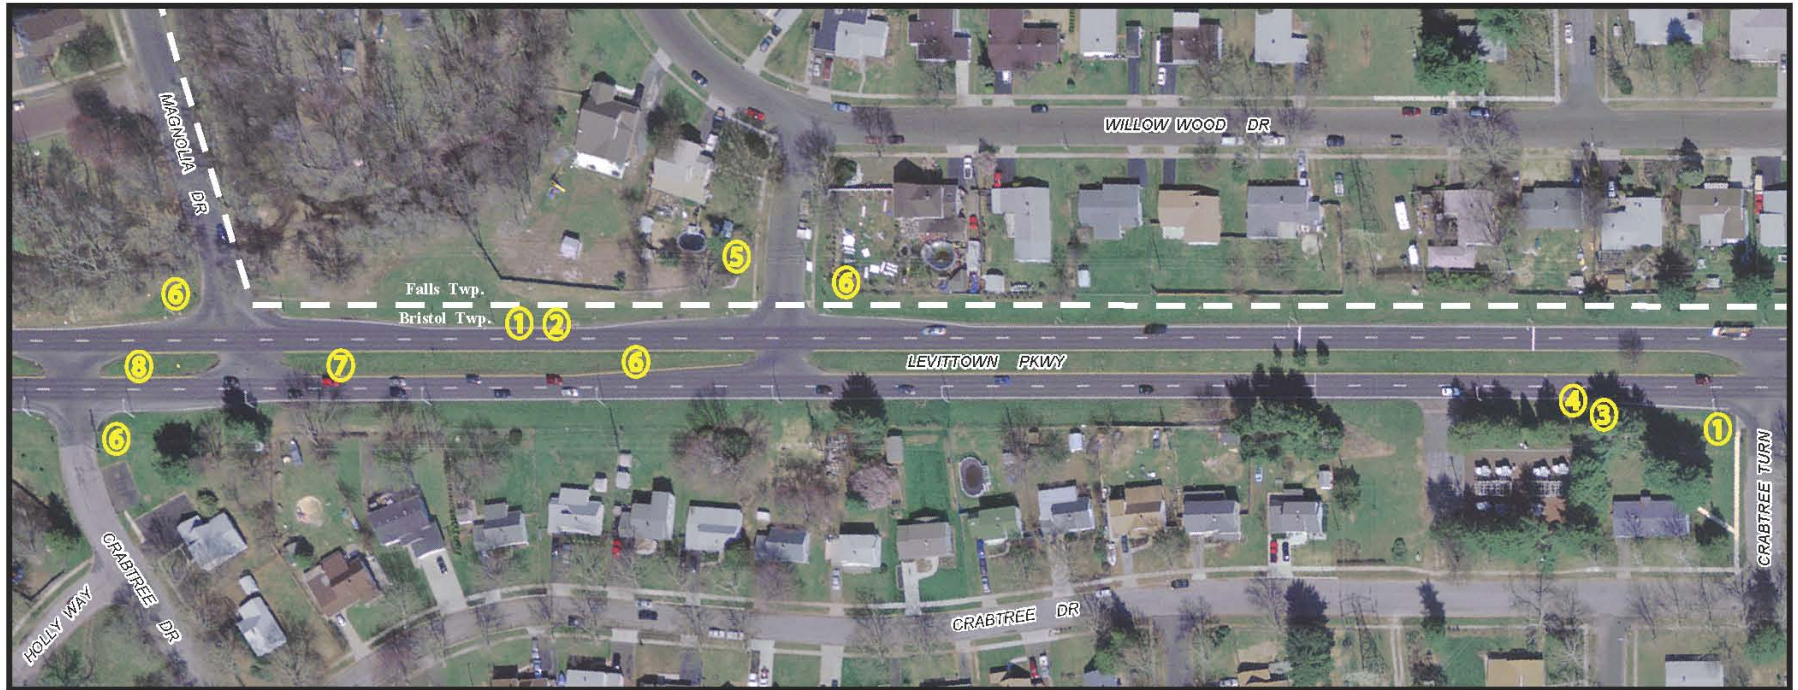
Figure 2: Panel 2 (Crabtree Turn to Crabtree Drive)

Site-Specific Issue	Potential Strategy	Level of Effort	Estimated Safety Benefit
<b>Panel 2 (Crabtree Turn to Crabtree Drive)</b>			
1. Drainage issues – evidence of standing water near Crabtree Turn; dilapidated drain box between Willow Wood Turn and Magnolia Drive;	1. Address the drainage issues during scheduled maintenance, replace damaged drainage inlet using bicycle-friendly design;	Medium/High	High

2. Evidence of a pedestrian trail between Willow Wood Turn and Magnolia Drive;	2. As per the corridor-wide recommendation, add pedestrian accommodation between side streets along the Parkway section of the corridor;	Medium	Medium

7. Turning from Magnolia Drive to the Parkway southbound there are tire tracks in the grass median suggesting improper use as an accel lane. Also, vehicles turning left from the Parkway onto Magnolia Drive are also leaving the paved surface and damaging the grass median;	7. Provide dedicated accel lane for southbound traffic existing Magnolia Drive, consider a redesign of the median to better accommodate turns;	High	High

9. Observed speed is seemingly inconsistent with context (topography, curve and hill). <i>Not shown on map</i>	9. Narrow to one lane in each direction through hill/curve section (between Magnolia Dr. and Holly Turn, and maybe further); consider road diet from New Falls Road south to slow traffic to and from the hill.	Medium	High

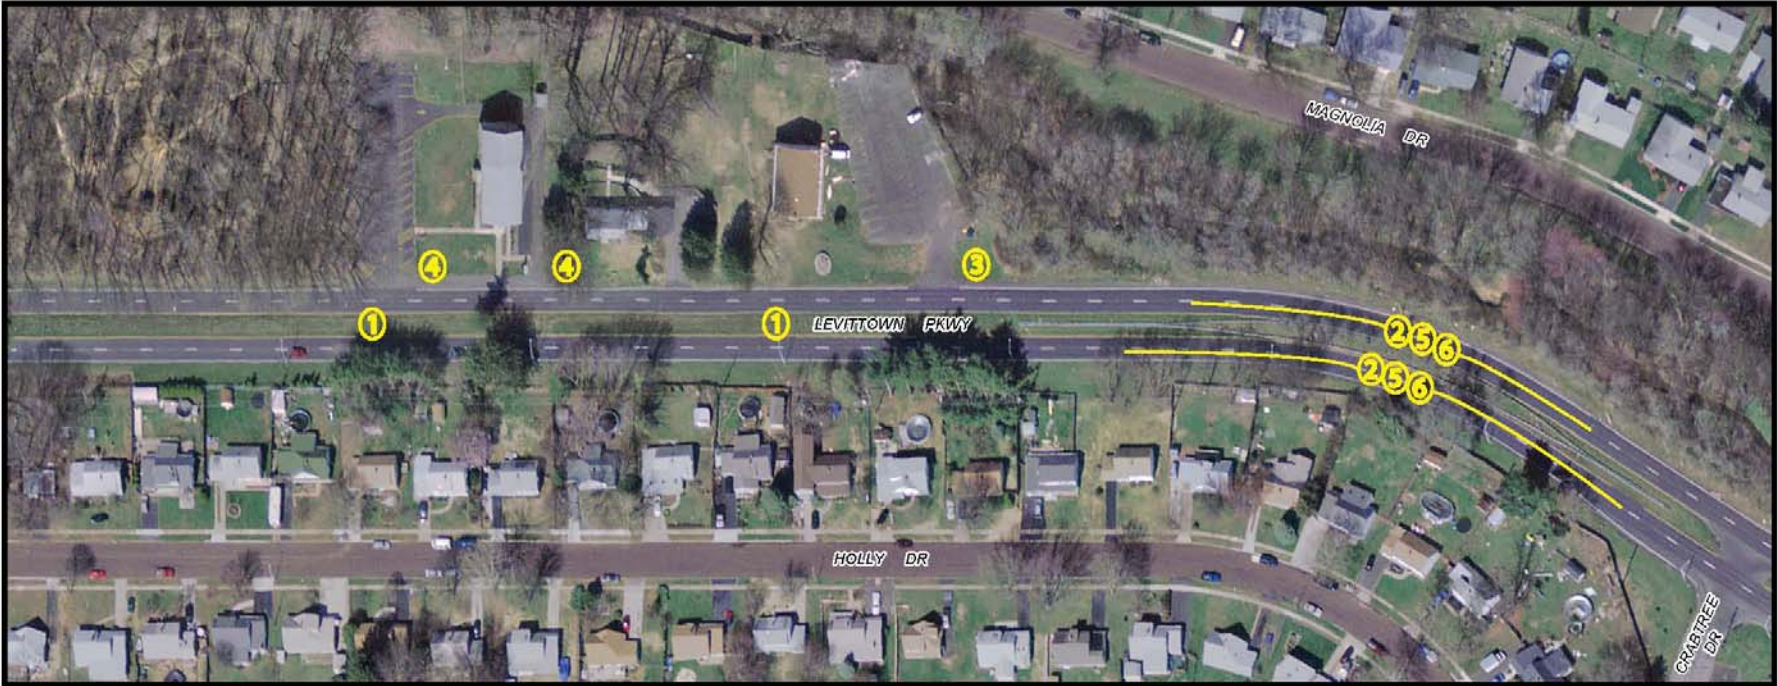
Table 3: Panel 3 (Crabtree Drive up through the hill and curve)

Site-Specific Issue	Potential Strategy	Level of Effort	Estimated Safety Benefit
<b>Panel 3 (Crabtree Drive up through the hill and curve)</b>			
1. Considerable slopes within median create a non-recoverable crash area;	1. Extend guide rail in median to reduce cross-over crashes;	Medium	High

2. Tire traction compromises through the horizontal and vertical curve areas combined with seemingly high speeds make this area crash prone—this is supported by crash data;	2. Install high-friction pavement treatment on curve and measure the superelevation of the curve and redesign if necessary, install transverse and edge-line rumble strips to slow traffic through the curve, install optical speed bars to further slow and warn drivers of topography hazards;	Medium	High

7. Observed speed is seemingly inconsistent with context (topography, curve, and hill). <i>Not shown on map.</i>	7. Narrow to one lane in each direction through hill/curve section (between Magnolia Dr. and Holly Turn, and maybe further); consider road diet from New Falls Road south to slow traffic to and from the hill.	Medium	High

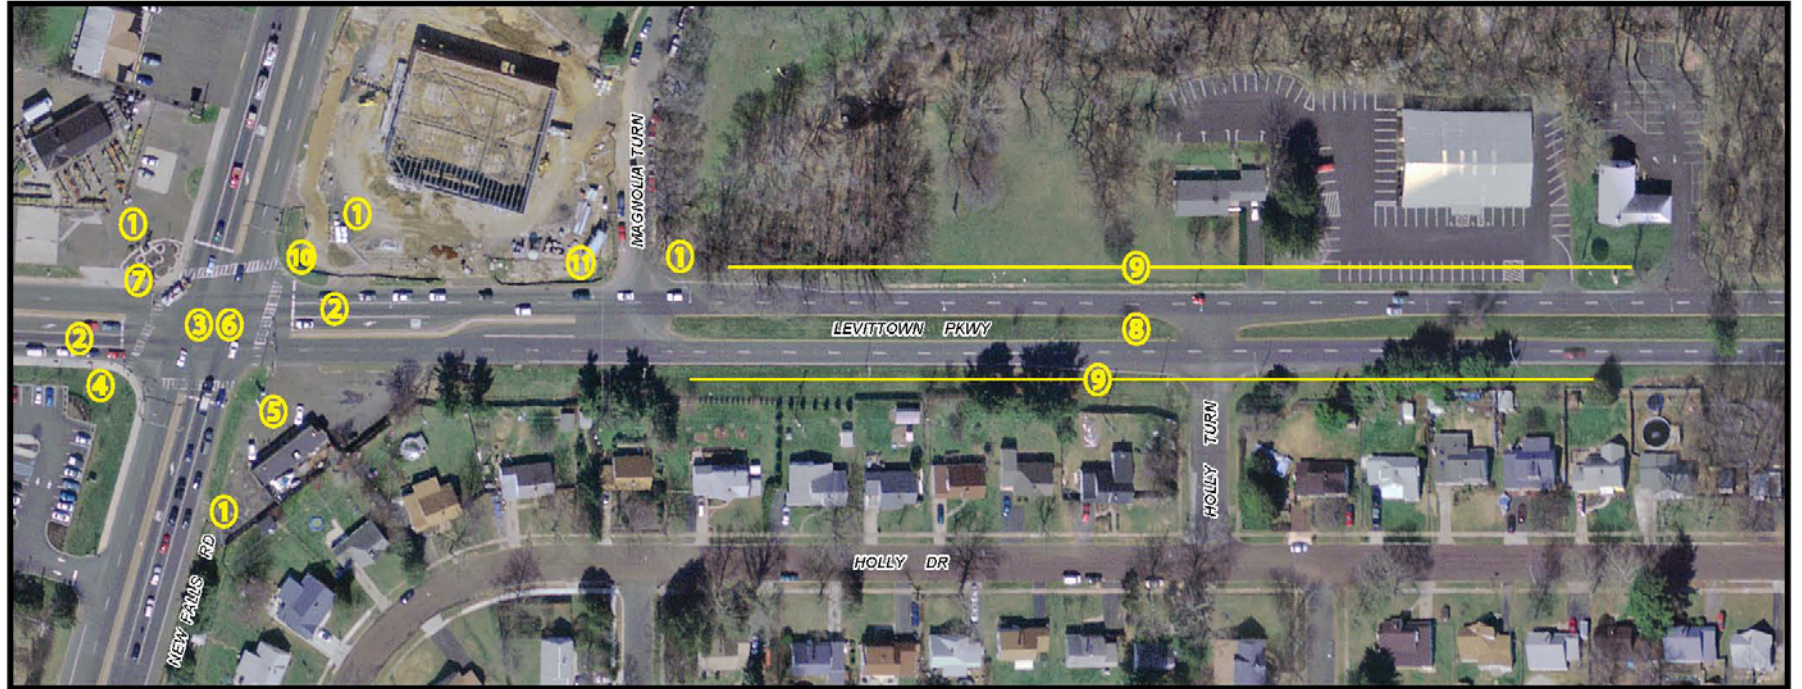
Figure 4: Panel 4 (top of hill through to New Falls Road)

Site-Specific Issue	Potential Strategy	Level of Effort	Estimated Safety Benefit
<b>Panel 4 (top of hill through to New Falls Road)</b>			
1. Duplicative business access points at the intersection of the Parkway and New Falls Road;	1. Work with property owners on a modified access plan that accommodates patrons without complicating access from the Parkway;	Medium	High

2. Major pavement rutting at the intersection;	2. Repair pavement issues during scheduled maintenance;	Low	Medium
3. Intersection geometry is wide and slightly skewed possibly contributing to hit fixed object crashes;	3. Install “elephant tracks” pavement markings through intersection to guide left turns;	Low	High

4. The yellow phase on Levittown Parkway is short and there is no delay for opposing traffic providing inadequate time for pedestrians to cross;	4. Evaluate the signal timing at New Falls Road and modify to appropriate crossing time for pedestrians; consider extra time for pedestrians due to the wide crossing;	Medium	High

6. Mixed signal head types create visual clutter and may be confusing to motorists;	6. Evaluate need for upgraded signal heads;	Medium	Medium
7. Damaged drainage inlet box on the northeast corner;	7. Repair drainage inlet, upgrade to bicyclist-friendly design;	Medium/High	High

9. Sidewalk is missing along the Parkway both northbound and southbound, and there is evidence of a goat path;	9. Provide sidewalk, and make this section a priority in a corridor-wide pedestrian improvement plan;	High	High

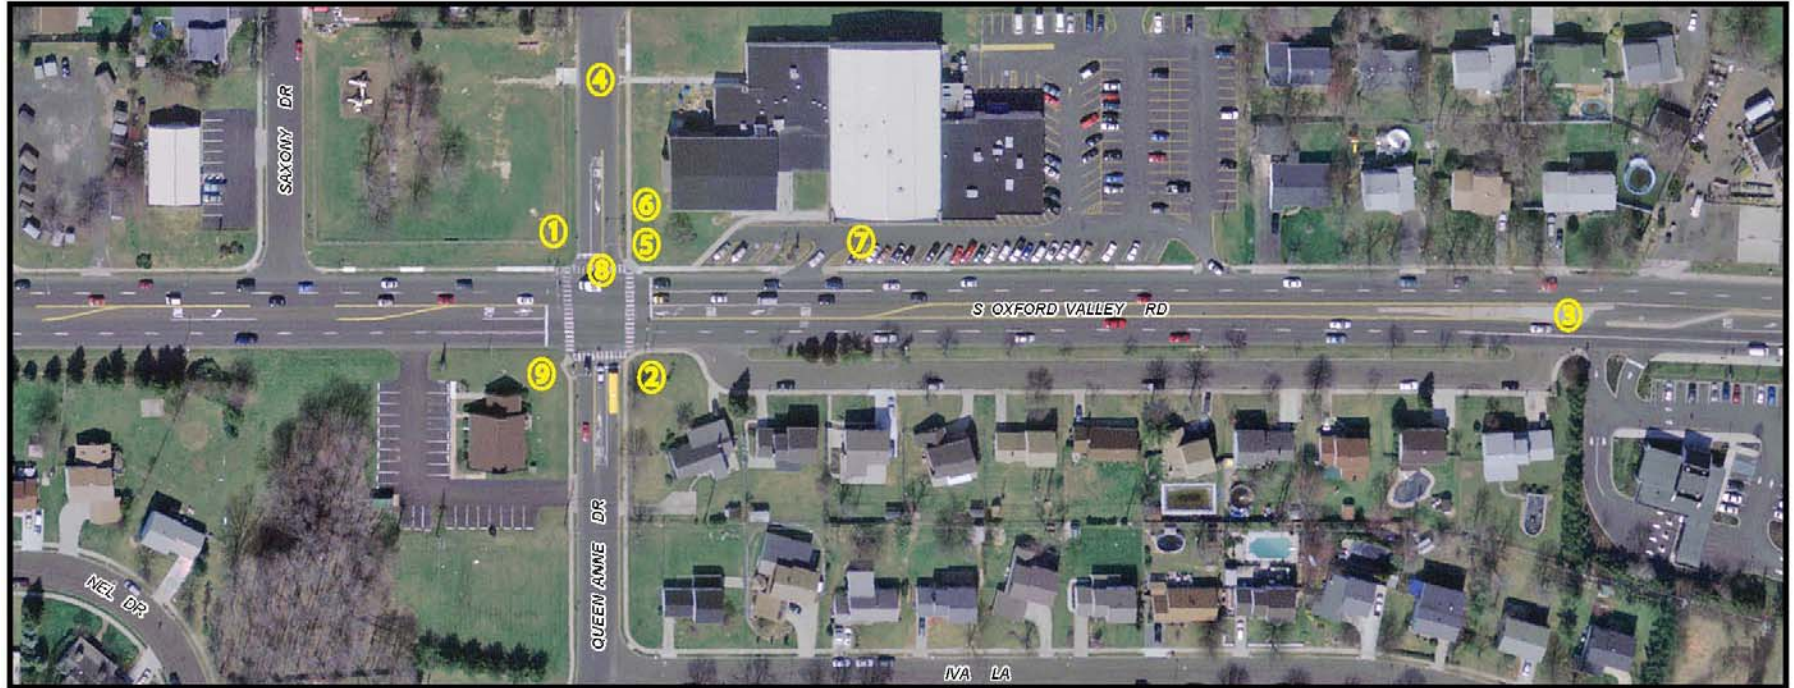
Figure 5: Panel 5 (New Falls Road through Queen Anne Drive)

Site-Specific Issue	Potential Strategy	Level of Effort	Estimated Safety Benefit
<b>Panel 5 (New Falls Road through Queen Anne Drive)</b>			
1. A drainage problem was identified along the north side of Queen Anne Drive;	1. Address drainage problem during scheduled maintenance;	Low	Medium

2. Missing pedestrian signal opposite YMCA along southbound South Oxford Valley;	2. Add missing pedestrian signal head;	Medium	Medium
3. Bank access via left-turn lane from South Oxford Valley Road northbound is poorly aligned and presents opportunities for conflicts with drivers exiting the residential frontage road along southbound South Oxford Valley Road;	3. Extend northern end of the median divider south to better channel vehicles into the bank access thus prohibiting misuse and reducing the potential for conflicts. Consider closing the median altogether at this location; this will provide added storage for vehicles turning left at New Falls Road;	Medium	Medium

7. Several left-turn conflicts were noted in the data analysis due to motorists making illegal lefts out of the YMCA lot;	7. Increase the deflection of the right-turn-only channel to prevent drivers from leaving the YMCA lot and making an illegal left turn, and add a “No Left Turn” sign for vehicles exiting the YMCA;	Medium	High

9. Pedestrian signal heads are missing for crossing Queen Anne Drive along the west side of the intersection.	9. Add missing pedestrian signal heads.	Medium	Medium

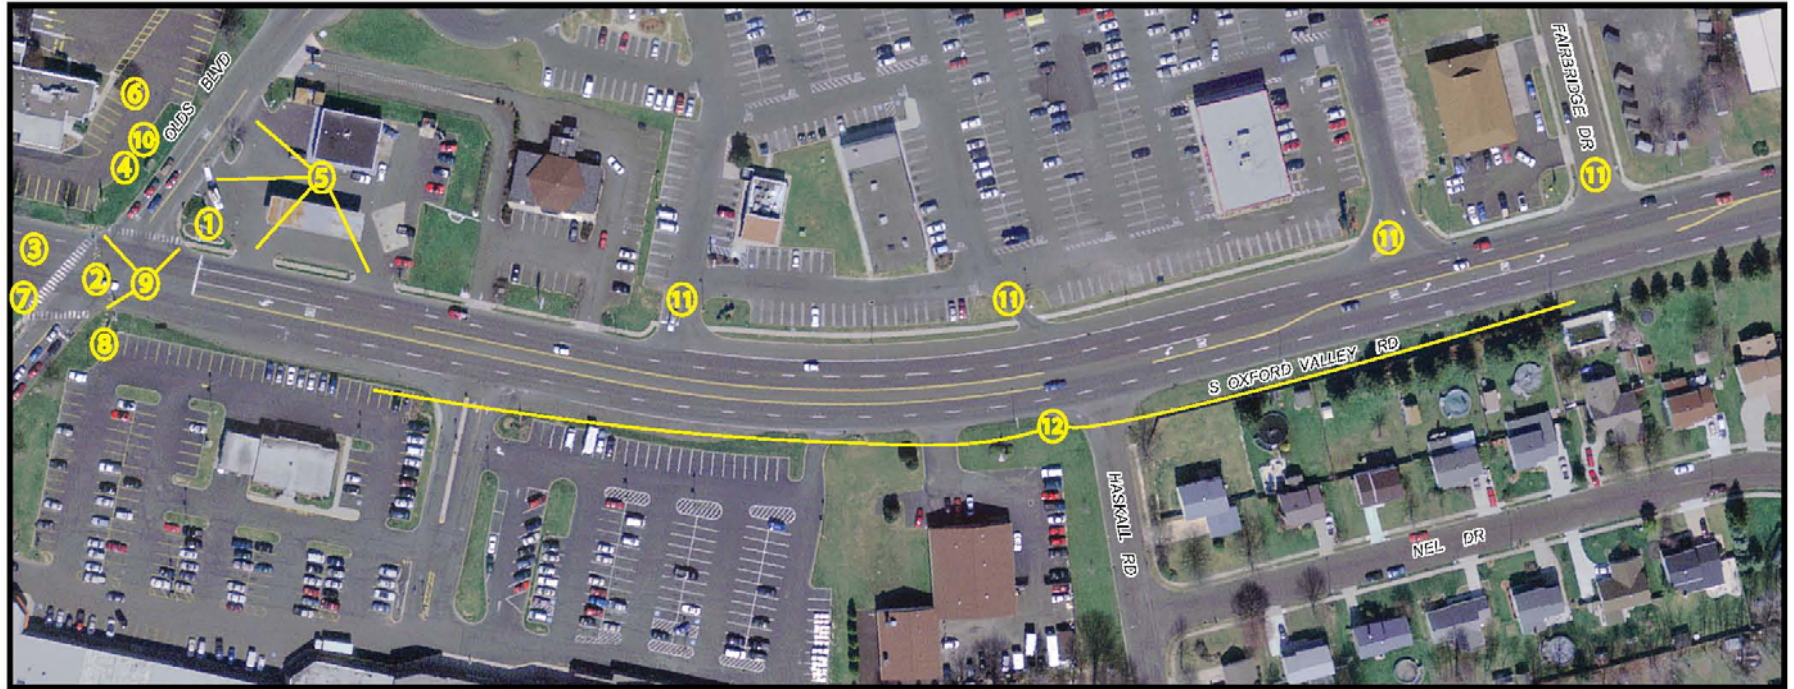
Figure 6: Panel 6 (Fairbridge Drive to Olds Boulevard)

Site-Specific Issue	Potential Strategy	Level of Effort	Estimated Safety Benefit
<b>Panel 6 (Fairbridge Drive to Olds Boulevard)</b>			
1. Turning radius going right on Olds Boulevard from South Oxford Valley Road northbound is very tight, especially for trucks, as evidenced by the adjacent signal head that has been hit multiple times. Missing pedestrian actuation on the northeast corner;	1. Evaluate the right-turn radius and adjust to accommodate larger vehicles---possibly cutting back the island at the corner of the gas station property. Add missing actuation to pedestrian signal;	Medium	Medium

4. No sidewalk along Olds Boulevard where bus stop is located;	4. Install missing sidewalk piece to connect to bus stop;	Medium	Medium
5. Duplicative access points for gas station create unnecessary additional conflict point;	5. Consolidate access points and internalize where possible;	Medium	Medium

6. Discontinuous sidewalk near Wachovia bank doesn't connect with frontage;	6. Add missing sidewalk connection;	Medium	Medium
7. Broken inlet grate on the northwest corner of Olds Boulevard and South Oxford Valley Road intersection;	7. Repair damaged drainage inlet and upgrade to bicyclist-friendly design;	Medium/High	Medium

9. ADA ramps are missing from intersection;	9. Add ADA ramps where needed;	Medium	Medium
10. Bus stop on North Olds Boulevard blocks the right through-lane;	10. Evaluate feasibility of a bus pull off at this location.	Low	Medium

11. Missing pedestrian crosswalks over driveways along South Oxford Valley Road northbound;	11. Add continental crosswalks at every opportunity;	Low	High

12. Missing pedestrian accommodations along all of South Oxford Valley Road southbound.	12. Install sidewalks and crosswalks along entire section.	High	High

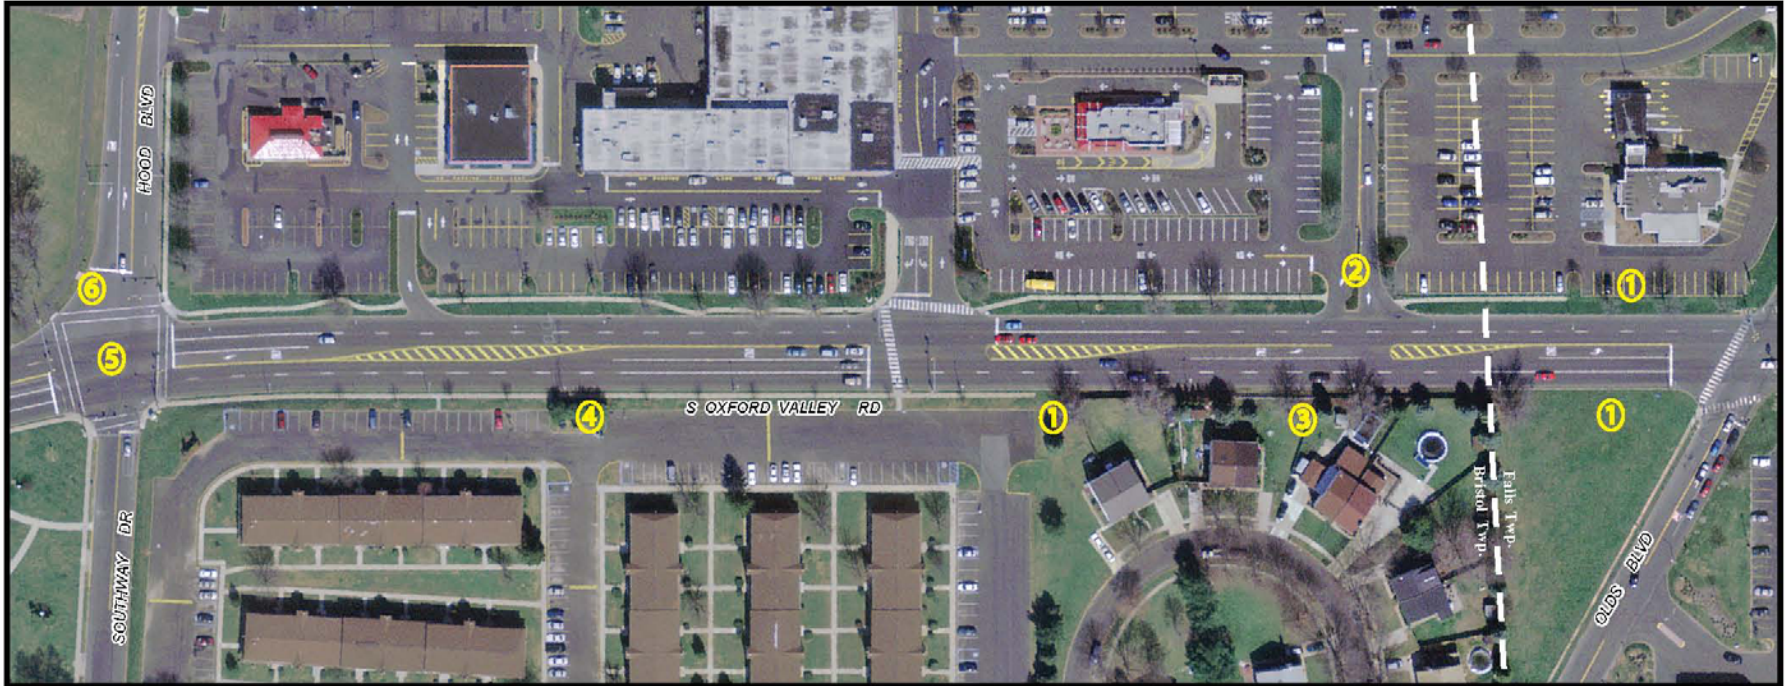
Figure 7: Panel 7 (Olds Boulevard through Southway Drive/Hood Boulevard)

1. Gaps in sidewalk along northbound side of South Oxford Valley Road and no sidewalk along southbound side just north of the Olds Boulevard intersection;	1. Replace missing sidewalk along both sides of South Oxford Valley Road;	Medium	Medium

3. Backwards/unwarranted guide rail along southbound South Oxford Valley opposite the shopping center access (painted green);	3. Remove unnecessary guide rail if deemed a safety hazard;	Low	Medium
