Putting the Equity Through Access Map Toolkit to Work in Lower Bucks County

Background

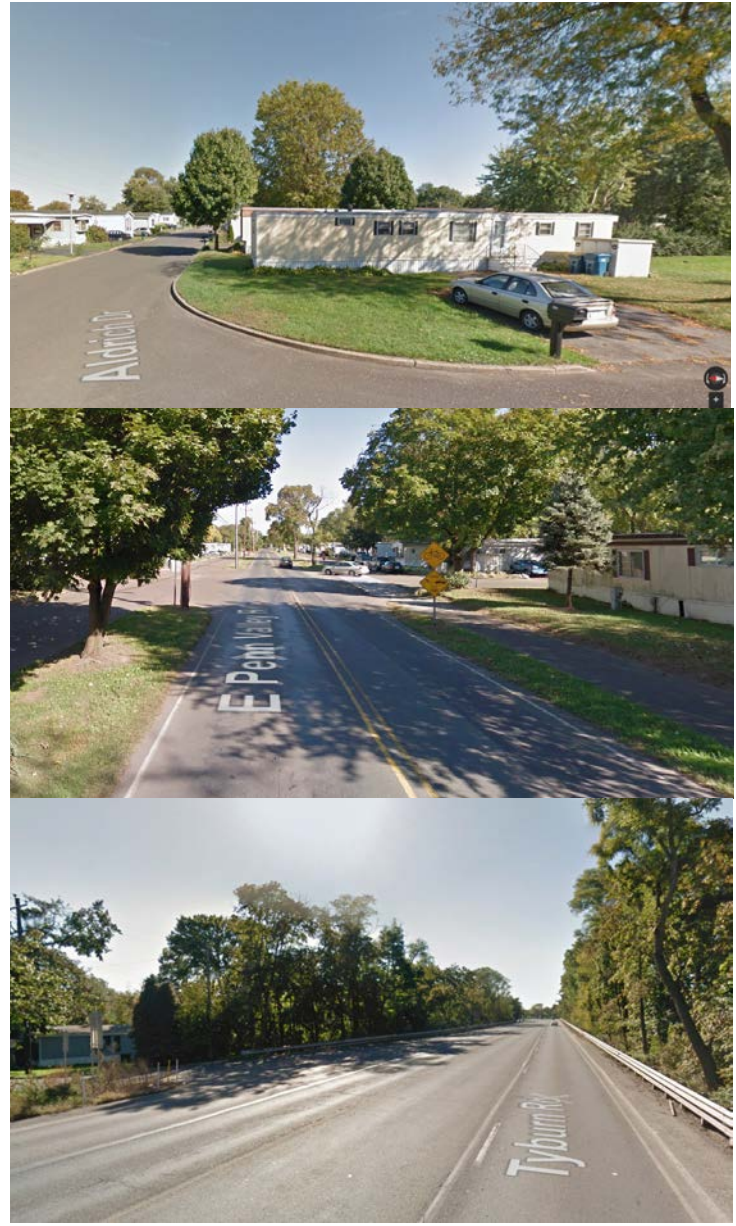
Top: Few of the streets within Pennwood Crossing feature sidewalks.

Middle: The south side of Penn Valley Road features a two-mile shared path.

Bottom: Tyburn Road, which runs along the north side of Pennwood Crossing, is wide, fast moving, and has narrow shoulders unsuitable for walking.

Using Google Street View, one can see that Pennwood Crossing is largely made up of mobile homes, contains few sidewalks, and has very little accessible commercial activity besides a Wawa near the corner of Penn Valley Road and Old Bristol Pike.

One of the few high-quality bicycle/pedestrian features in the area is along the south side of Penn Valley Road, a nearly two-mile bike trail that connects Pennwood Crossing to New Falls Road, as well as to a loop that goes around Falls Township Lake.

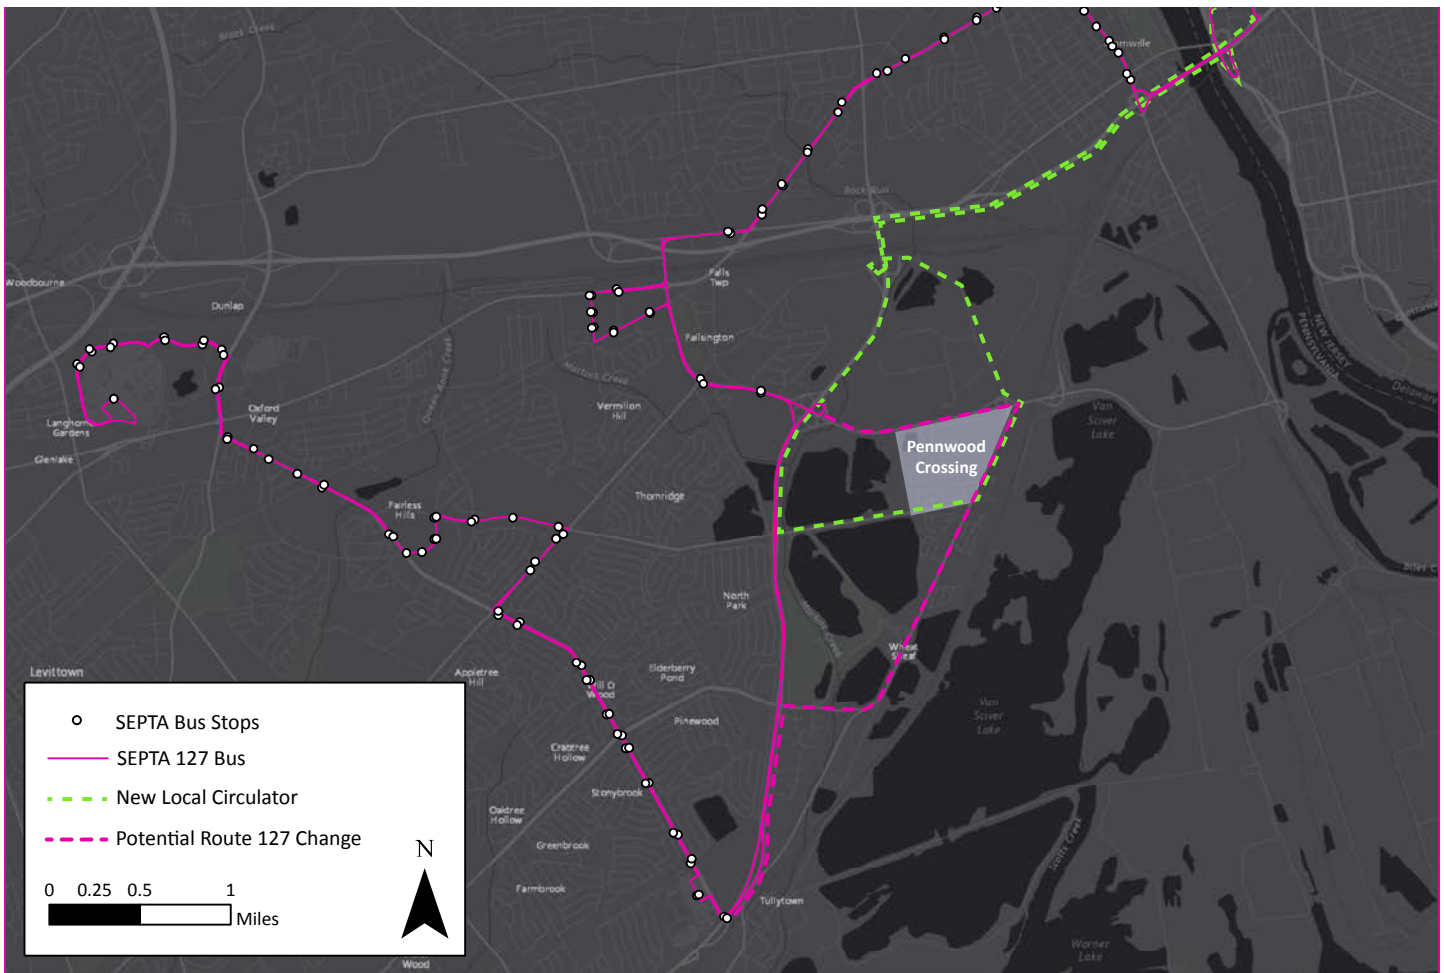
Figure 7. SEPTA Route 127 Solutions

One possible solution for improving transit access to Pennwood Crossing would be to reroute the SEPTA 127 bus. The route currently bypasses the area using Bristol Pike—a stretch in which it does not make a stop for over 3.2 miles between Tullytown Regional Rail Station and Tyburn Road east of the Bristol Pike interchange. One possible reroute of the bus would have the bus take Bristol Pike north to Mill Creek Road and then north along Old Bristol Pike. The route would head west at Tyburn Road, resuming its regular route (see Figure 7). This route would provide service to three previously unserved block groups with high vulnerable population ranks, linking them with direct access to shopping centers, health care, senior and disabled activity centers, and Regional Rail access.

Another possibility for providing improved transit access to Pennwood Crossing residents and workers would be to develop a circulator bus route with the help of the local Transportation Management Association (TMA) or other partners. The route shown in blue shows a possible route that provides access between the Trenton Transit Center and Pennwood Crossing, with potential stops at the many employers in the industrial park along Newbold Road. The Z-Line shuttle, provided by Mercer County TMA, is a similar local service that's been successful in providing last-mile job access to the Amazon Distribution Center in Robbinsville, New Jersey.
