**DELAWARE VALLEY REGIONAL
PLANNING COMMISSION**

Making Butler Pike Pedestrian Friendly

July 2001

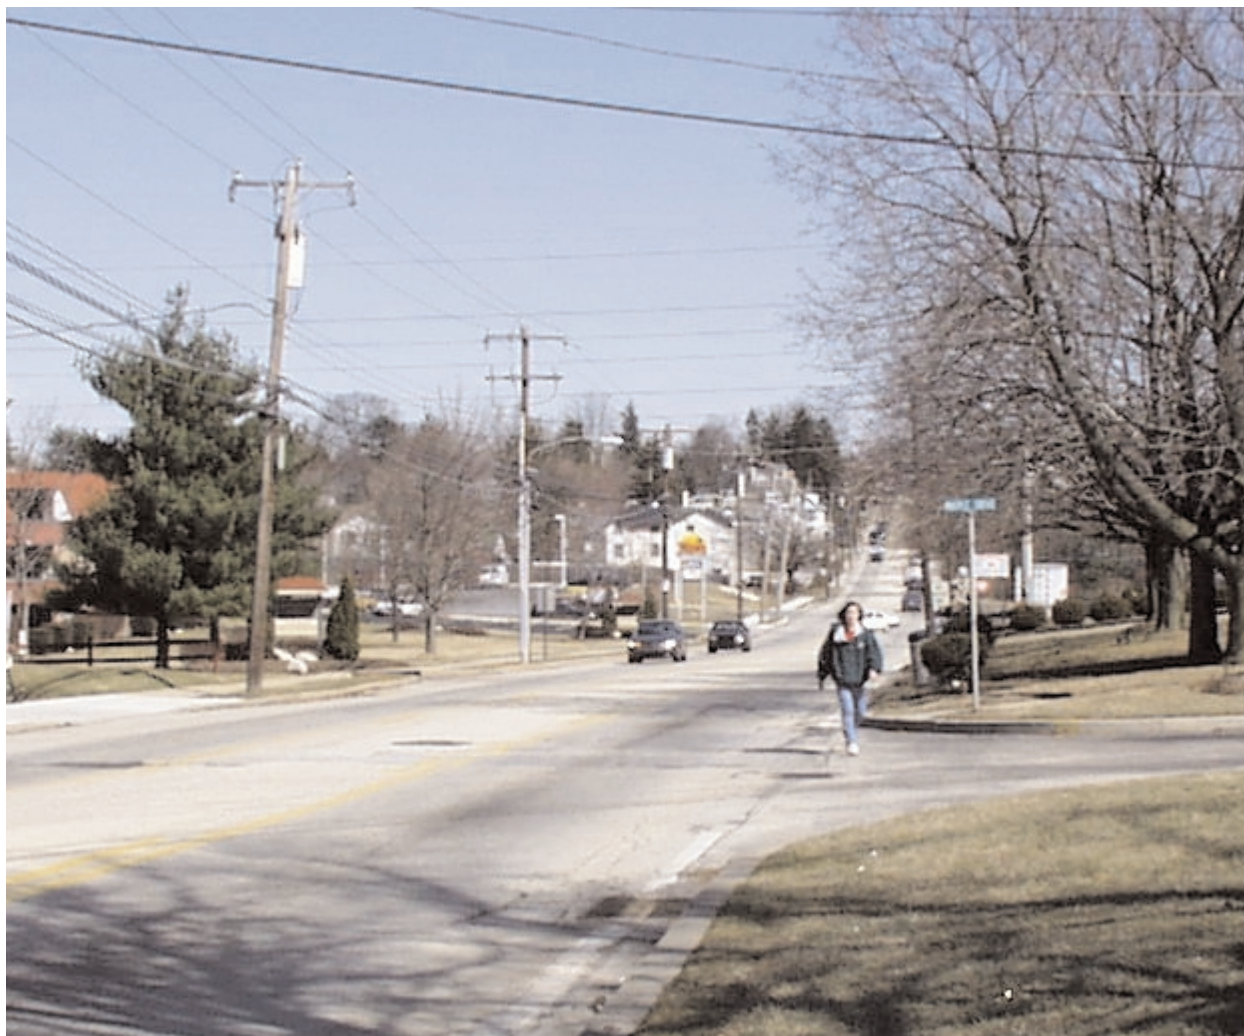
Above: A pedestrian is forced to walk in the road due to lack of sidewalks along Butler Pike (March 2001)

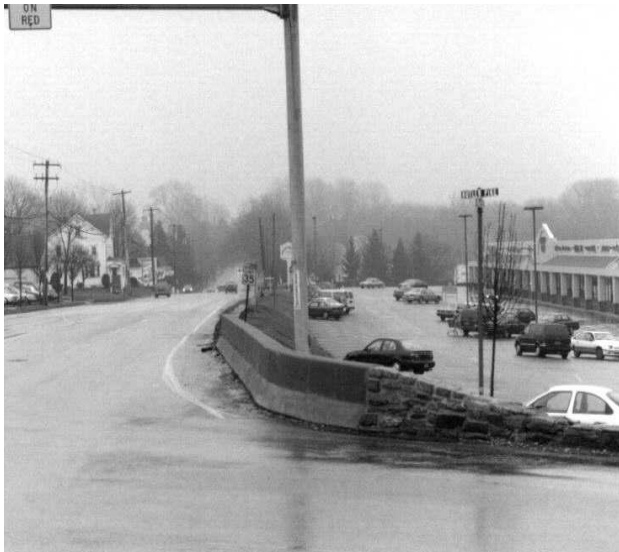
Above: Southeast corner of Ridge and Butler Pike, a wall prohibits safe access to shopping center for pedestrians. (November 2000)

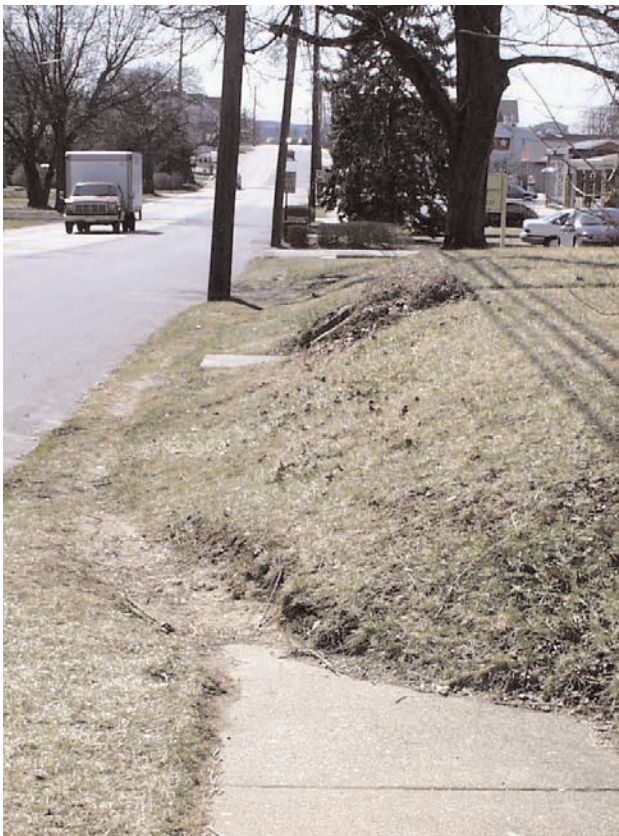
Above: Worn dirt and gravel paths indicate a desire for sidewalks. (March 2001)

Much of the study area is lacking in sidewalks, despite worn dirt and gravel paths that indicate a desire for sidewalks. Expansive, grassy areas up to the curb are found along Butler Pike. In other spots without sidewalks, the shoulder of the road, or extended parking lots (in front of commercial and retail uses) serve as a hazardous walkway for pedestrians. Currently, there are approximately 700 linear feet of sidewalks sporadically placed within the study area. In a portion of the study corridor, walls located on the edge of the road force pedestrians to walk in the roadway.

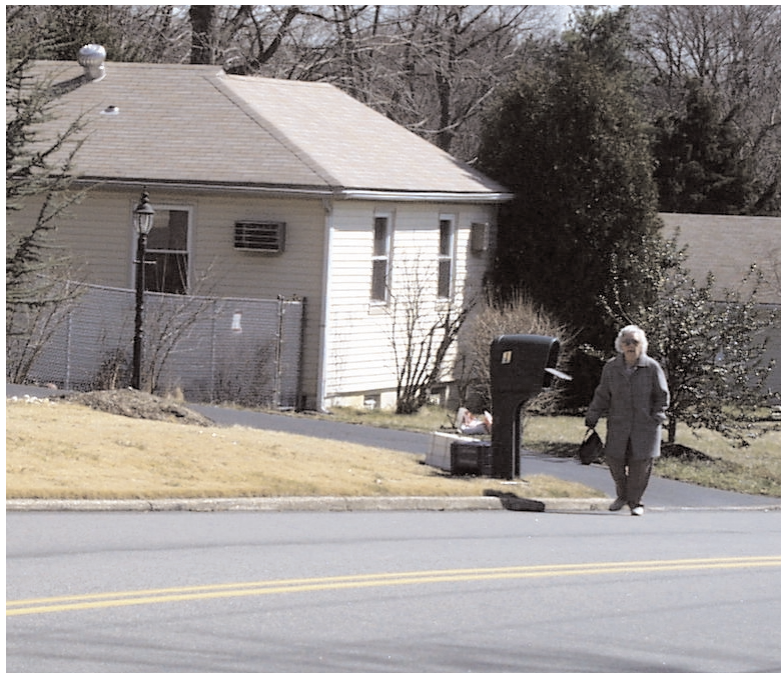
Above: A senior citizen uses the side of the road, which has no shoulder, as a walkway due to lack of sidewalks. (March 2001)

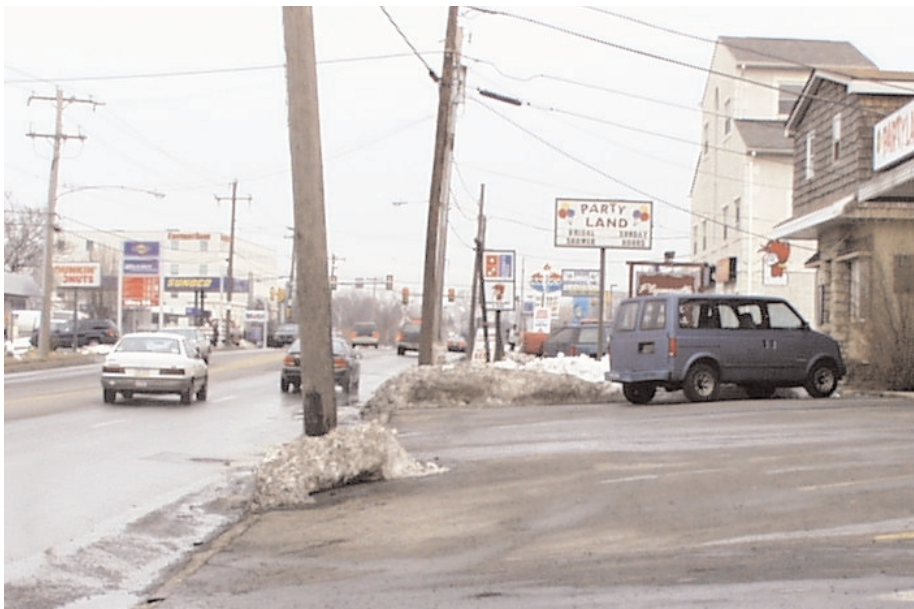
Left: A typical commercial area along Ridge Pike, near the intersection with Butler Pike. A congested corridor of commercial driveways and parking lots. Used as walkways, this creates dangerous conditions for pedestrians. (February 2001)

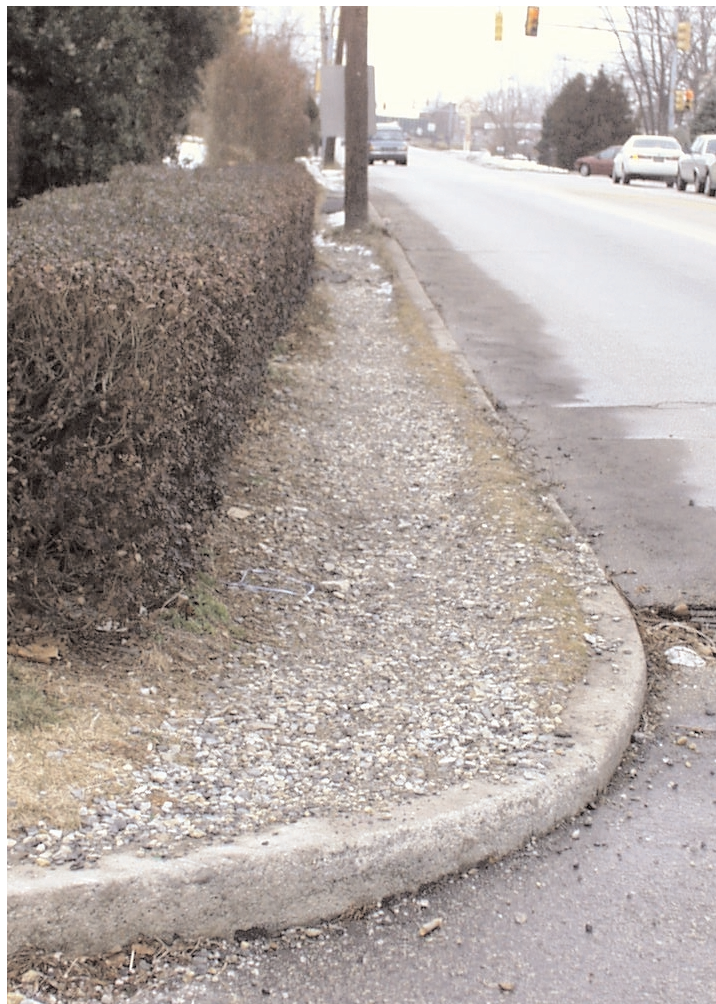
Left: An example of gravel sidewalks, clearly indicating a desire for a sidewalk along Butler Pike. Note the close distance of the walkway to the roadway creating dangerous conditions for pedestrians. (January 2001)

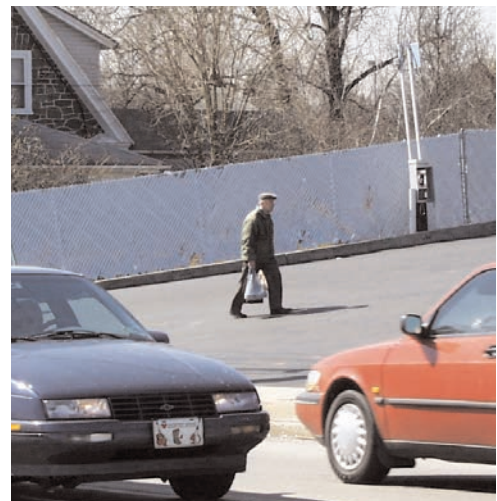
Below: A senior citizen uses the pavement of a gas station to walk along Butler Pike. (March 2001)

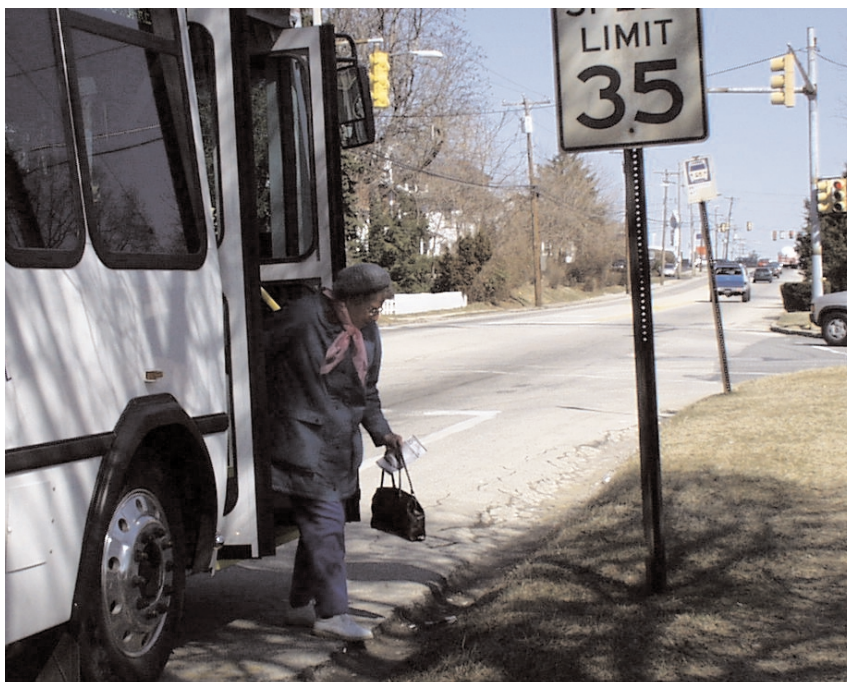
Above: A senior citizen exiting the SEPTA bus is greeted by a grassy curb. (March 2001)

- Provide bigger, clearer bus stops.
- Install benches, shelters, and other furniture.
- Establish peak hour commuter shuttles from the apartment complexes to the Conshohocken and Spring Mill train stations.

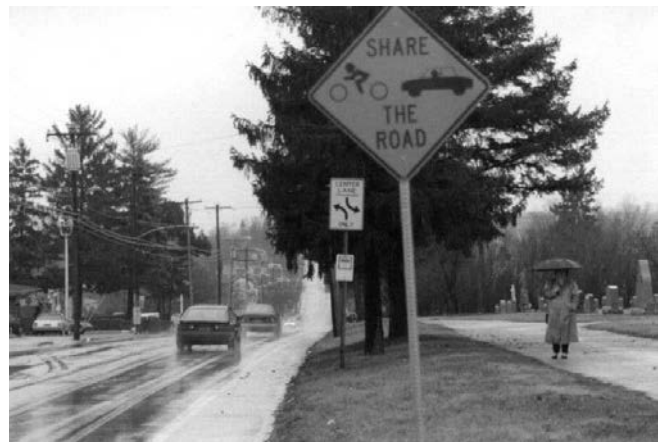
Above: A pedestrian uses the roadway in St. Matthews Cemetery as a walkway to wait for the SEPTA bus.

1. Install crosswalks on all sides of intersection
2. Modify crosswalk design to increase visibility
3. Install pedestrian signal heads
4. Work with cemetery to install sidewalks, or grant easement for pedestrian use of aisles
5. Install wheelchair-accessible bus shelters on Butler Pike
6. Install ADA curb ramps
7. Install bus shelters with street furniture
8. Reconfigure crossing on south side of intersection to go directly across the road

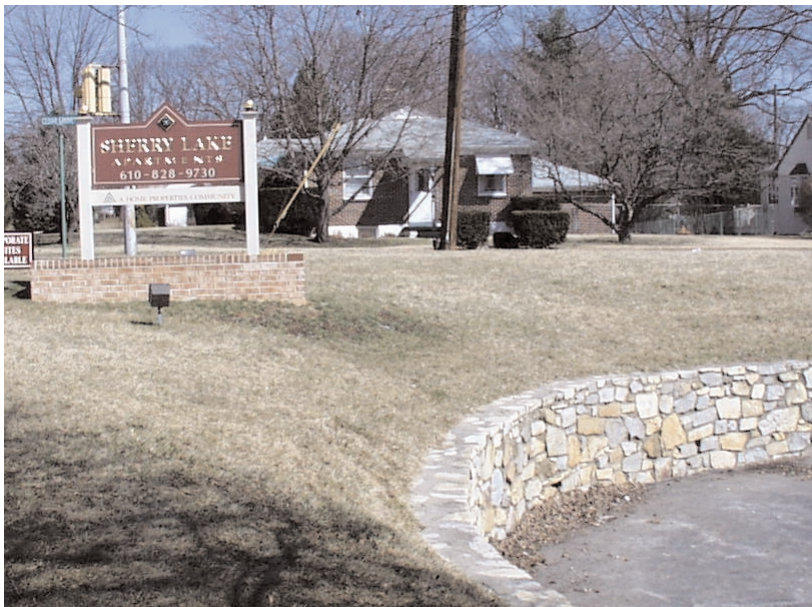
Left: The steep embankment on the southeast corner of the Butler Pike and Keys Street/ Cedar Grove Road, prohibits pedestrians of Sherry Lake Apartments. Pedestrians must go around the barrier. (March 2001)

1. Install sidewalks on along Butler Pike
2. Install crosswalks
3. Install pedestrian signal heads
4. Install bus shelters and street furniture
5. Install stairway from Sherry Lakes parking lot to south corner of intersection

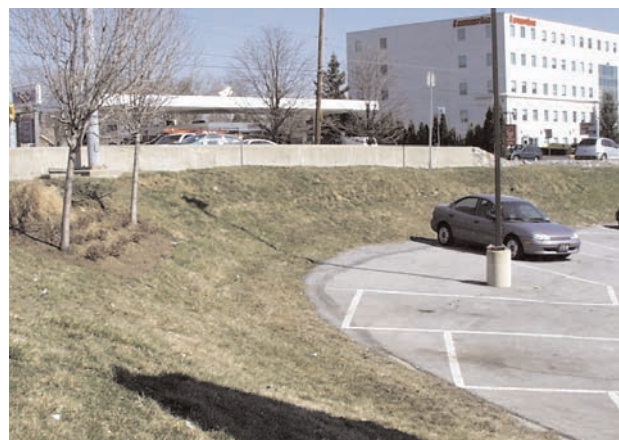
Above: The concrete barrier at the southeast corner of Butler Pike and Ridge Pike prohibits pedestrians. Shoppers must go around the barrier. (March 2001)

This intersection is devoid of even the most basic accommodation of pedestrian movement. Indeed, pedestrians cannot be received on the southeast corner; a stone and concrete wall will greet them. Likewise, on the opposite corner, a gasoline station chose to terminate the sidewalks at its property line. Unrestricted turning movements make this intersection even more hazardous to cross. Elsewhere in the vicinity of this intersection, poorly channelized commercial entrances make walking unpleasant. Despite the preponderance of pedestrian productions and attractions in the area, pedestrians are made to feel as if they don't belong here.

1. Install crosswalks
2. Install pedestrian signals with pushbutton access that allow an actuated pedestrian phase
3. Work with property owners to make accommodations for pedestrians
4. Redesign commercial areas to improve safety and aesthetics for pedestrians, as part of an access management program
5. Install bus shelters and street furniture
6. Remove concrete wall on the southeast corner and construct staircase to elevate the pedestrian to the intersection and allow safer access to the Whitemarsh Shopping Center
7. Add trees and vegetation to the intersection to visually narrow the road, thus slowing down cars and creating a safer environment for the pedestrian.

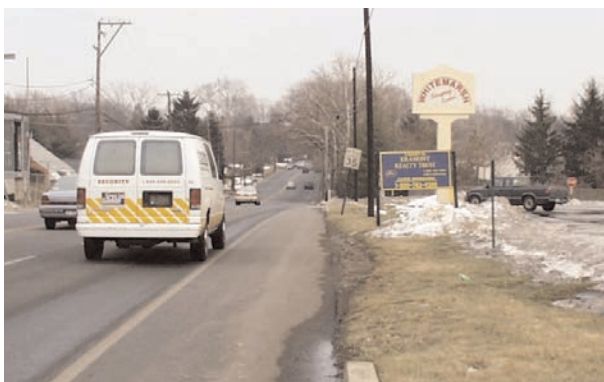
Left: Lack of sidewalks along Ridge Pike, near the intersection of Butler Pike, creates a deterrent to pedestrians in front of a major retail center. (February 2001)

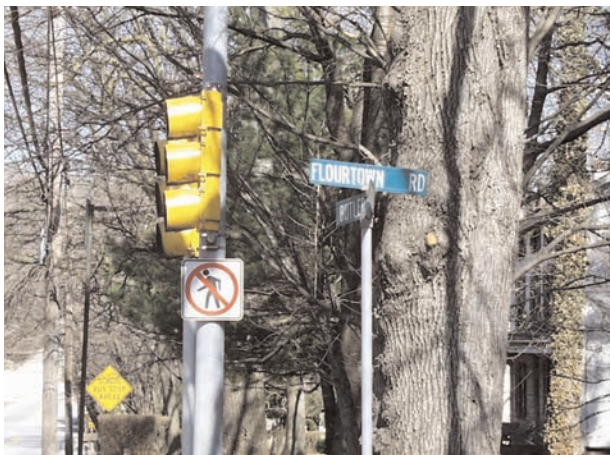
Above: The corner of Flourtown Road and Butler Pike has ‘no pedestrian’ signs on every corner, despite another sign in the background announcing a school bus stop ahead. (March 2001)

As stated earlier, the intersections located in this area of the corridor offer no pedestrian facilities. There are no walkways, crosswalks, or any other pedestrian infrastructure located at these intersections. Furthermore, there are no shoulders at either intersection to facilitate any sort of walkway. The private residences in the area have lawns that lead right to the edge of the road, many with wooden fences or other protective shrubbery. In fact, pedestrians are prohibited from the intersections by the posting of 'no pedestrian signs' at both intersections.

1. Work with private residences to construct standard sidewalks with ADA curb ramps at each corner.
2. Install crosswalks
3. Install pedestrian signal heads with pushbutton access
4. Dismantle no crossing zones and accompanying signs

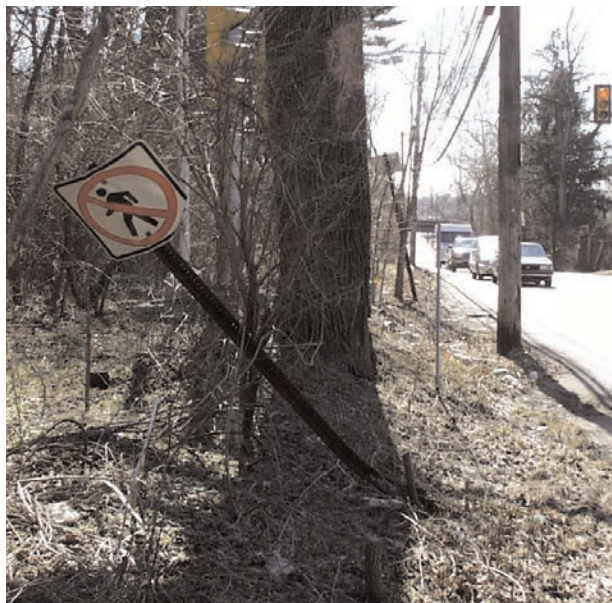
Above: A damaged 'no crossing' sign at the intersection of Butler Pike and Plymouth Road. (March 2001)
