TABLE OF CONTENTS

EXECUTIVE SUMMARY

Phase III of a continuing project to assess and increase non-motorized access to transit stations examined six stations (three in New Jersey and three in Pennsylvania). Three Burlington County RiverLINE stations were studied (Beverly/Edgewater Park, Burlington Town Center, and Riverton) as a follow-up to a 2002 DVRPC report assessing Transit Village potential for these stations and others. Three SEPTA rail stations were studied (Cynwyd, Eastwick, and Oreland) based on their having a high observed proportion of commuters from within one mile using station parking facilities.

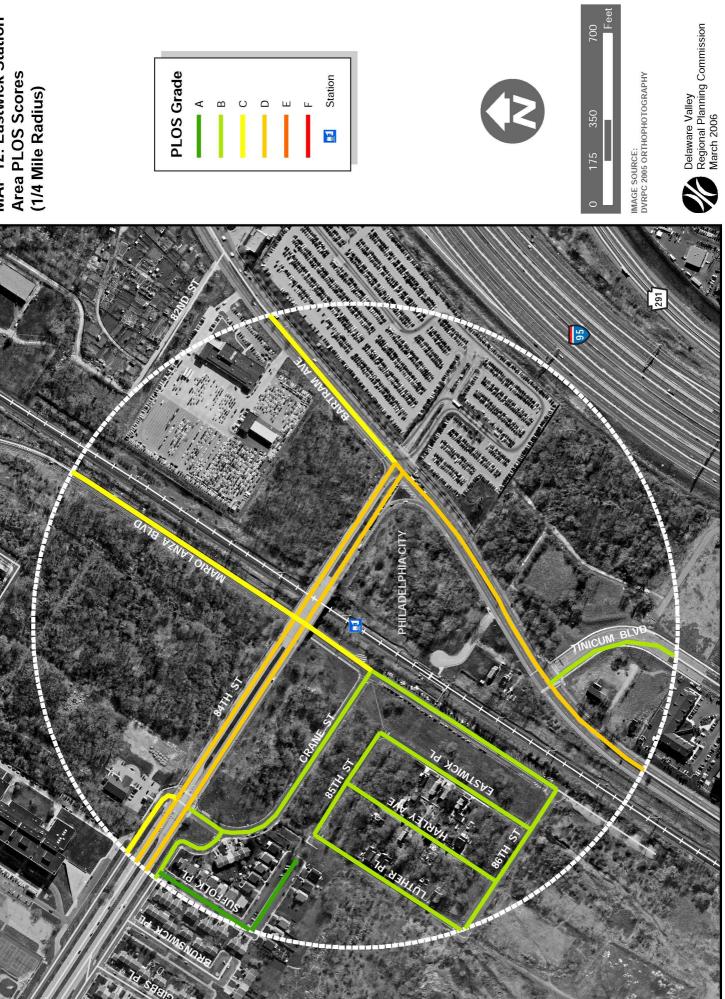
MAP 12: Eastwick Station Area PLOS Scores (1/4 Mile Radius)

Table 14 below contains the PLOS scores calculated for road segments within one quarter mile of Eastwick station. Road segments are arranged alphabetically for ease of reference.

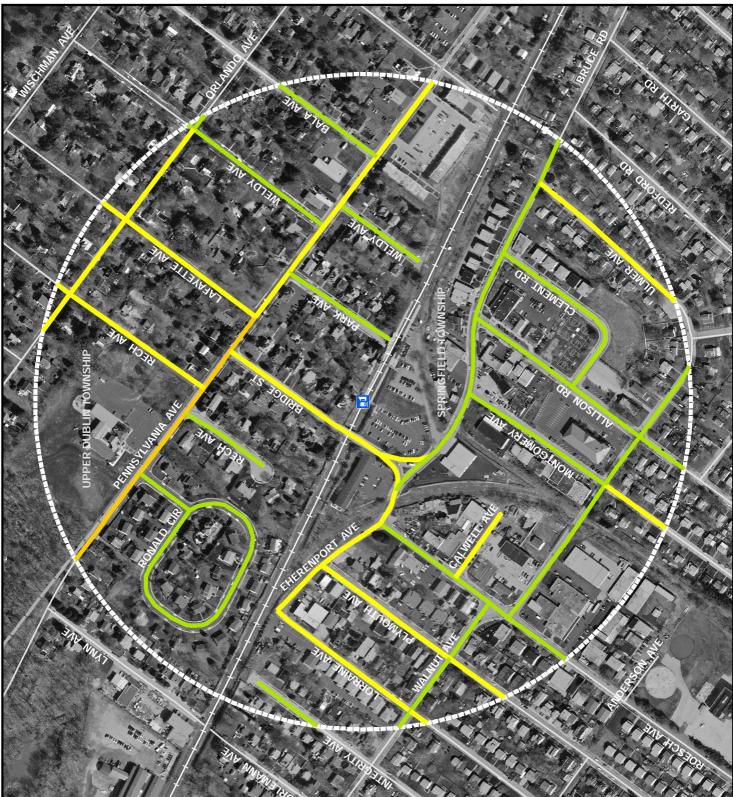
Table 18 below contains the BLOS scores calculated for road segments within one mile of Oreland station. Road segments are arranged alphabetically for ease of reference.

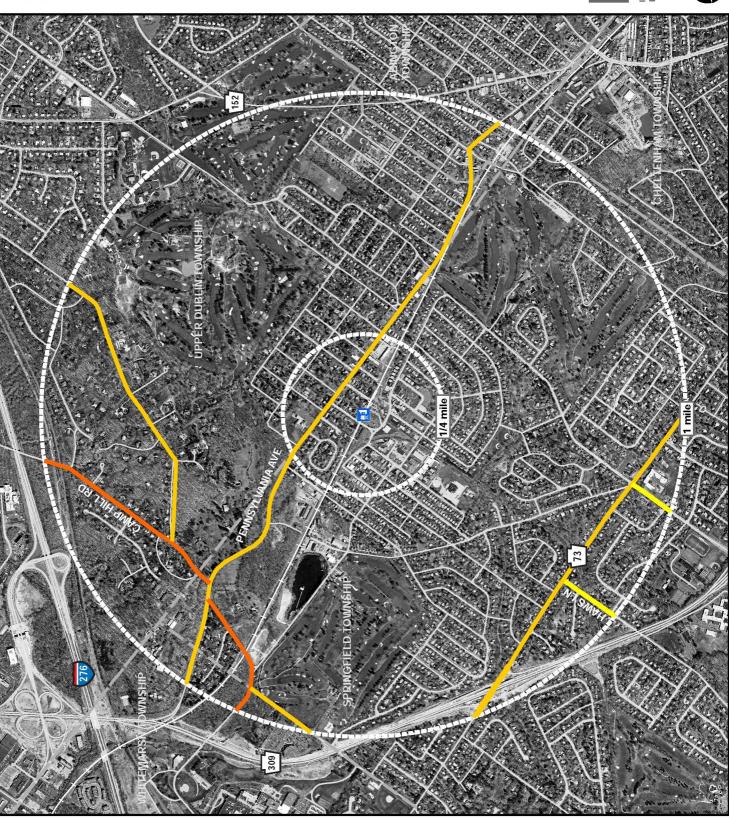
From the south, the station site is accessible from Bruce Road / Eherenport Avenue. Segments of Bruce Road typically have relatively high PLOS scores due to fairly consistent sidewalks and a low posted speed limit (25-mph). However, the intersection of Bridge Avenue, Bruce Road, and Eherenport Avenue (to the immediate west of the station) is hazardous for pedestrians, featuring no crosswalks. This may make station access uncomfortable even from the Station Square apartments located opposite the station on Bridge Street. The complexity of this intersection is aggravated from a pedestrian standpoint by a lack of sidewalks and poor pavement condition where an abandoned rail right-of-way crosses Eherenport Avenue (just to the west of the intersection).

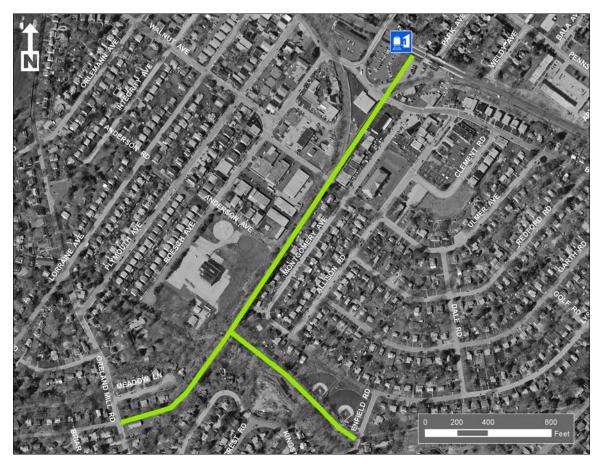
Conceptual alignment of a multipurpose trail that would connect Oreland Station (on the north) with Oreland Mill Road (on the south), with a branch providing access to an existing recreation area. Much of the trail would follow an abandoned rail right-of-way, providing comfortable bicycle/pedestrian station access from residences to the south of the station.

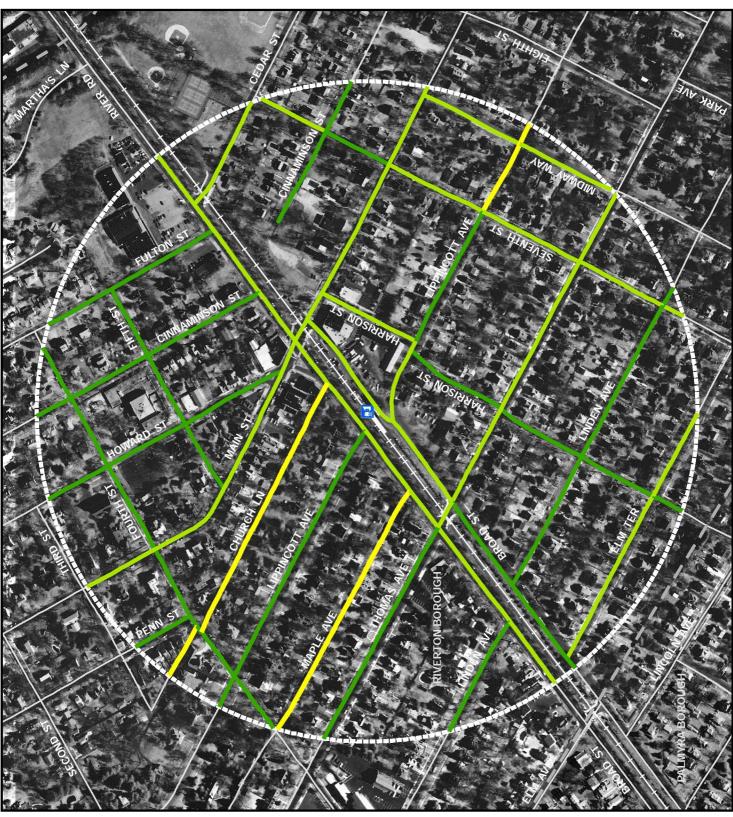
Table 21 below contains the BLOS scores calculated for road segments within one mile of the Riverton station. Road segments are arranged alphabetically for ease of reference.

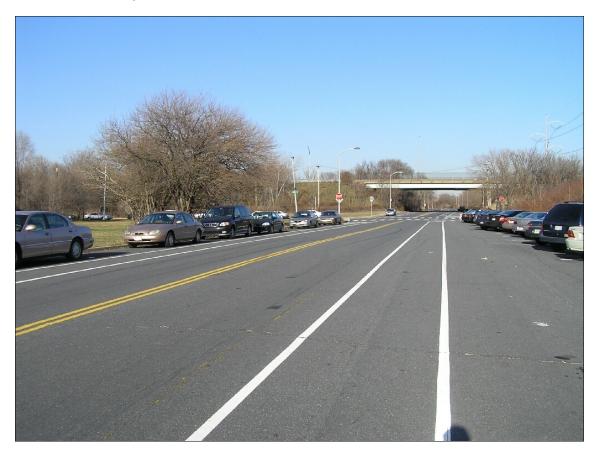
Mario Lanza Boulevard to the north of Eastwick Station. Factors yielding the highest possible BLOS score include 5-foot bicycle lanes in both directions and a high average width of dedicated on-street parking/shoulder areas, which will typically allow cars to avoid obstructing the bicycle lanes.

There are a number of study area road segments with the highest possible BLOS score (0.00; LOS 'A'). In most cases, these scores reflect a combination of particularly wide shoulders, dedicated bicycle lanes, or both. The photo below depicts one of these road segments: Mario Lanza Boulevard adjacent to the Eastwick R1 station.

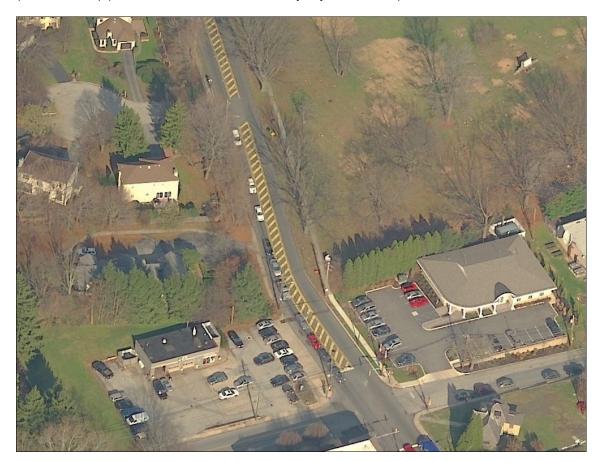
Belmont Avenue north of City Ave (east of Cynwyd Station). The relatively poor BLOS score relates to the lack of shoulders, narrow lanes (typically less than 10 feet in width), and a comparatively high proportion of truck traffic (11%). (*Image source*: Microsoft/Pictometry; http://local.live.com).

The lowest BLOS score was associated with the portion of Belmont Avenue north of City Avenue (6.90; LOS 'F') (located within one mile of the Cynwyd R6 station).

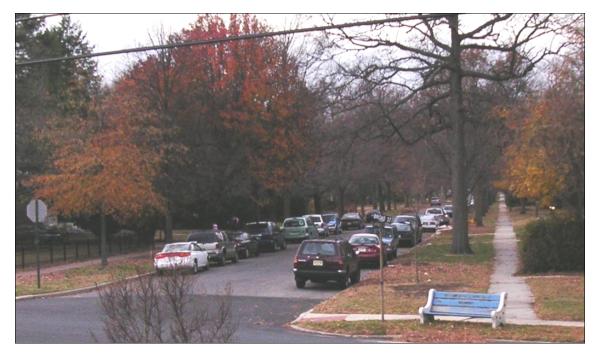
Lippincott Avenue north of Broad Street. Factors yielding a desirable pedestrian environment include consistent sidewalks (roughly 4.75 feet avg. width), an unusually generous green buffer between the sidewalk and roadway (14.5 feet), frequent street trees (spaced 40 feet on center), and a high proportion of occupied on-street parking (estimated at 40% for the length of the block) which provides an additional physical barrier from moving cars.

The phase III road segment with the highest PLOS score was Lippincott Avenue (north of Broad Street) in the immediate vicinity of Riverton Station, which had a score of 0.82 (LOS 'A').

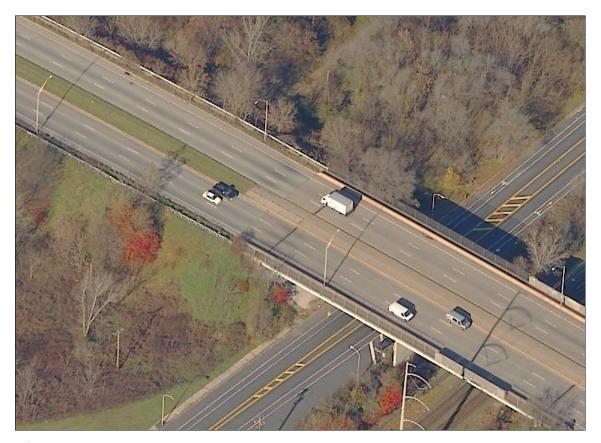
84th Street north of Bartrum Avenue. Factors influencing a negative score are a lack of any continuous sidewalk and high estimated vehicular volumes. (*Image source*: Microsoft/Pictometry; http://local.live.com).

The lowest PLOS score was associated with the inner lanes of 84th Street in the vicinity of Eastwick Station (4.02; LOS 'D').

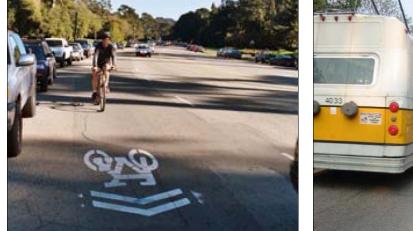
Example of a 'sharrow' in San Francisco

Several portions of this report reference the possibility of employing shared lane pavement markings (or shared lane arrows) as an alternative to dedicated bicycle lanes. The purpose of these 'sharrows' is to direct cyclists away from parked cars (and potential door openings) while promoting awareness among drivers of cyclists' right to use the road. Below are two examples of shared-lane pavement markings taken from a 2004 report of the San Francisco Department of Parking & Traffic.
