ACCESS MANAGEMENT

Along Pennsylvania Highways

State Road/US 1
Case Study Corridor

Delaware Valley Regional Planning Commission

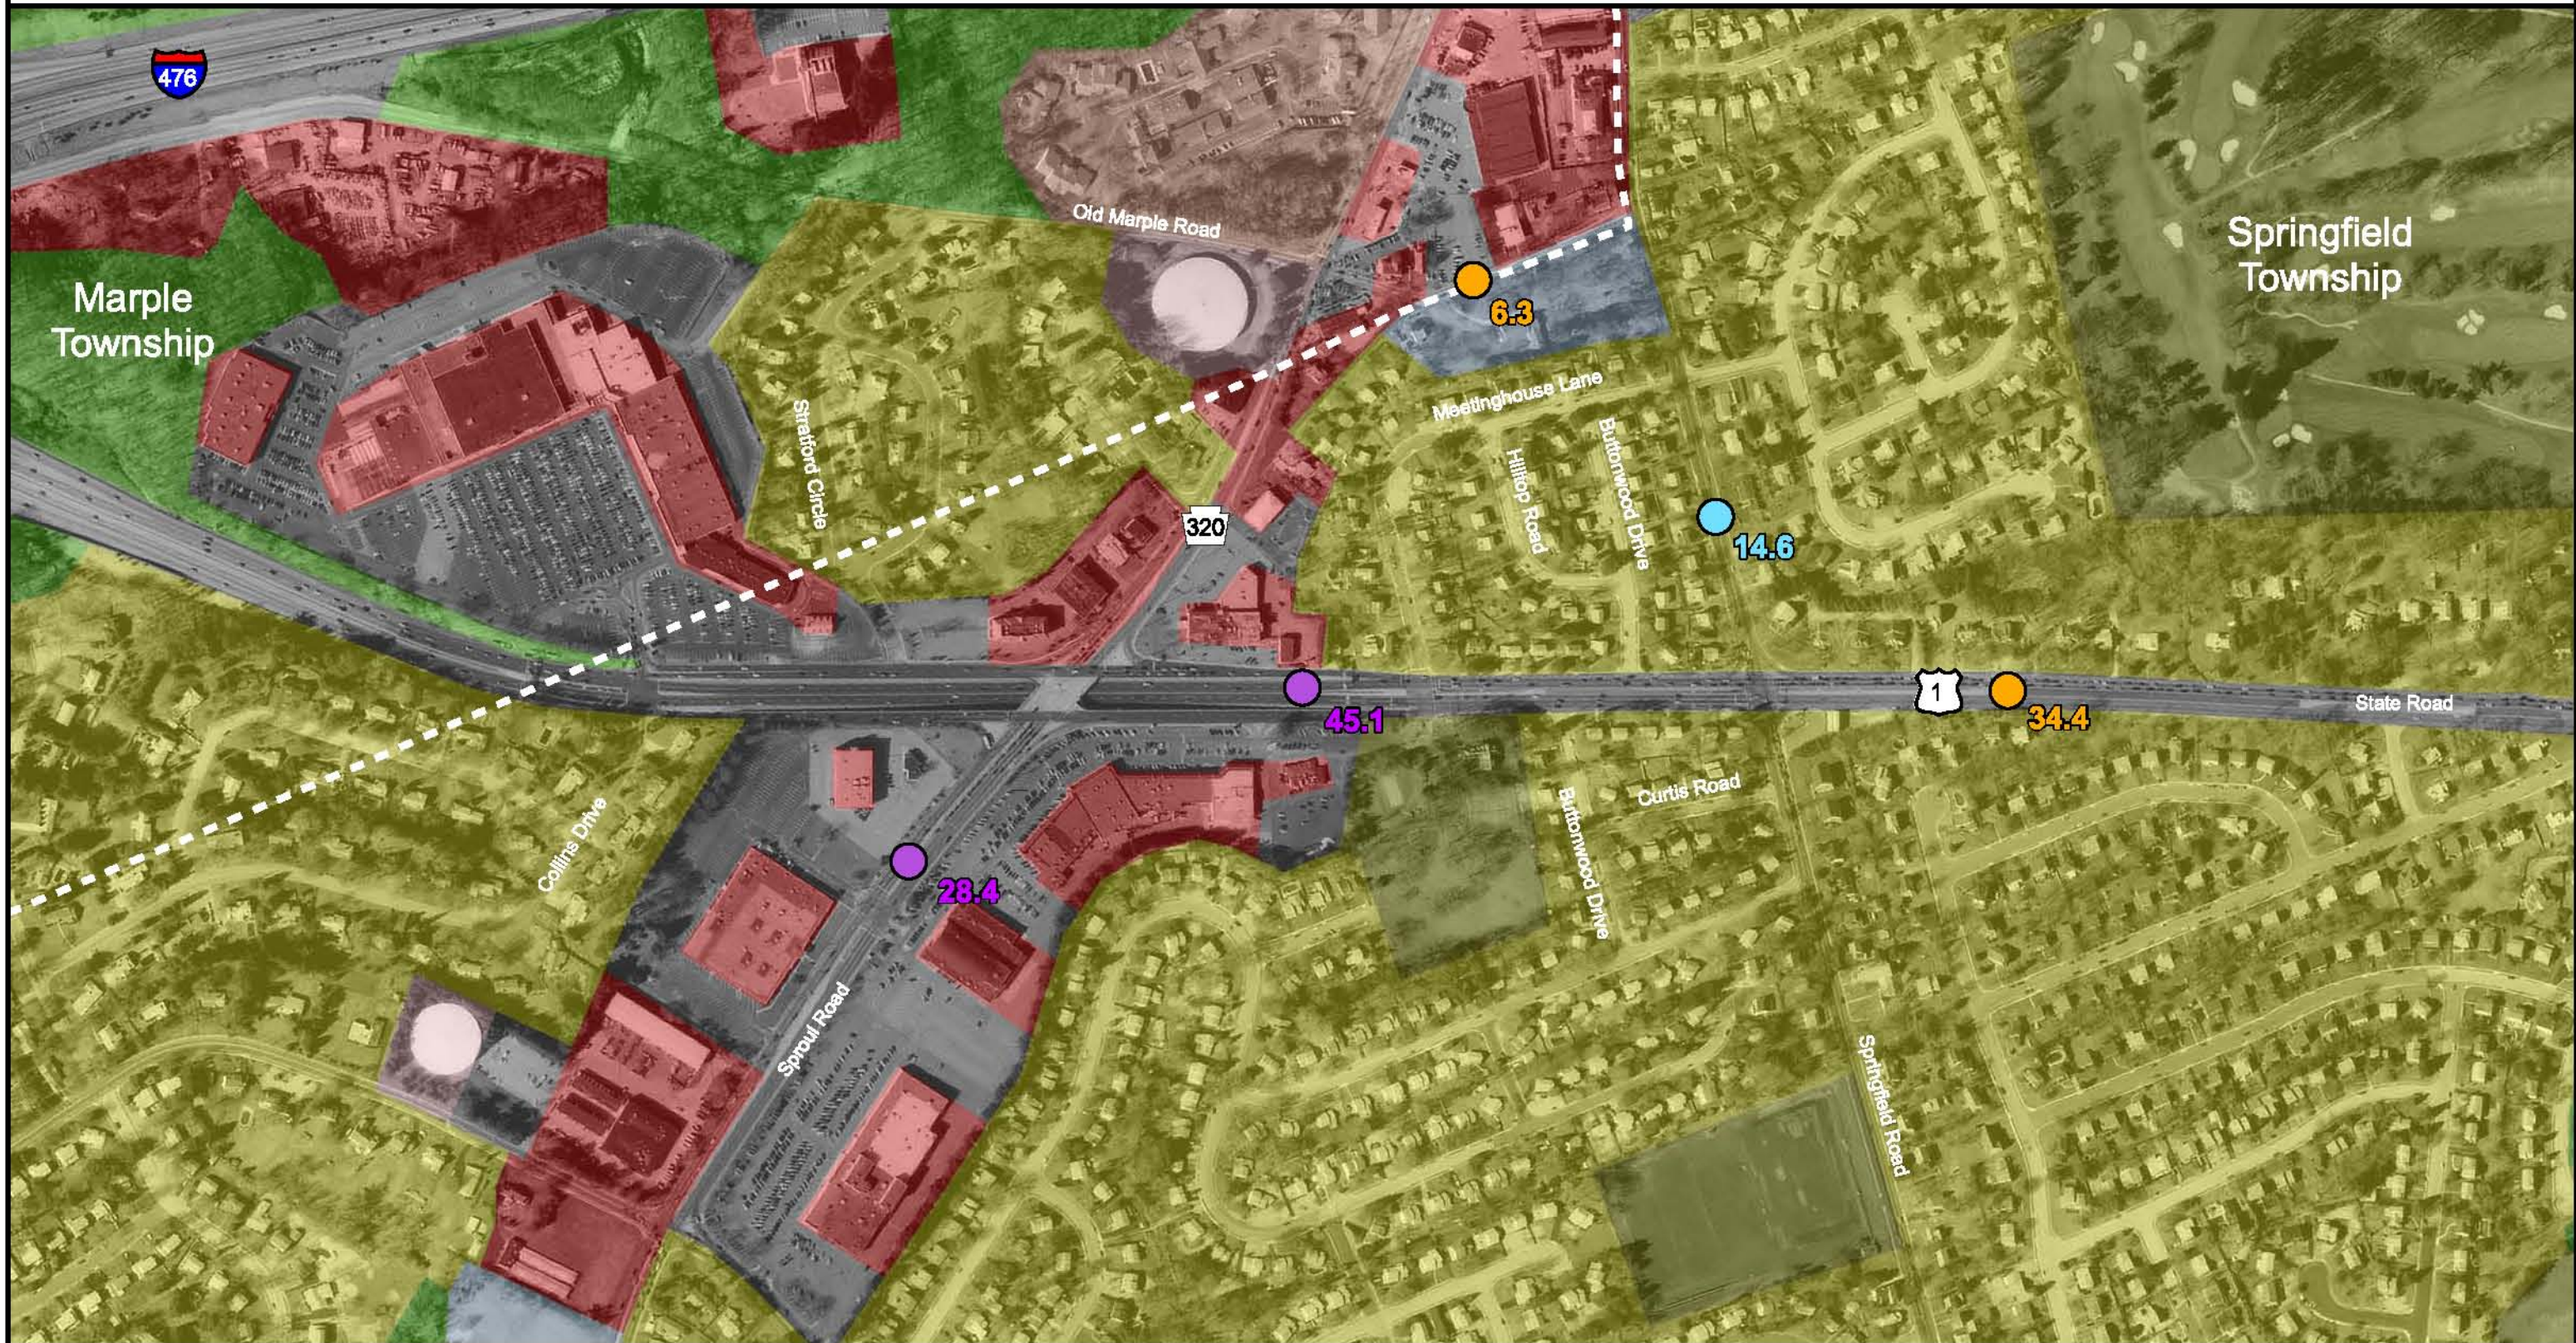
Figure 3: Traffic Volumes & Land Use

The posted speed for State Road – US 1 within the study corridor varies from 45 MPH to 55 MPH. The Annual Average Daily Traffic (AADT) volume on State Road – US 1 within the study corridor is 45,100 vehicles. North of Springfield Road, daily traffic levels approximate 34,400 vehicles (see Figure 3). Daily traffic levels on cross streets or nearby highways in the study corridor are also shown on Figure 3.

Land use within the corridor is also illustrated on Figure 3. North \ west of the study highway segment, commercial development dominates from the Marple Crossroads Shopping Center to Meetinghouse Lane, and a residential neighborhood (single family detached) occupies the land from Meetinghouse Lane to Springfield Road, on the north \ east. On the south \ west portion of the corridor, a neighborhood of single family detached homes (served by Collins Drive) lies adjacent to commercial development. A shopping center also occupies the south \ east quadrant, extending to Meadowgreen Park Entrance, with a residential neighborhood between it and Springfield Road.

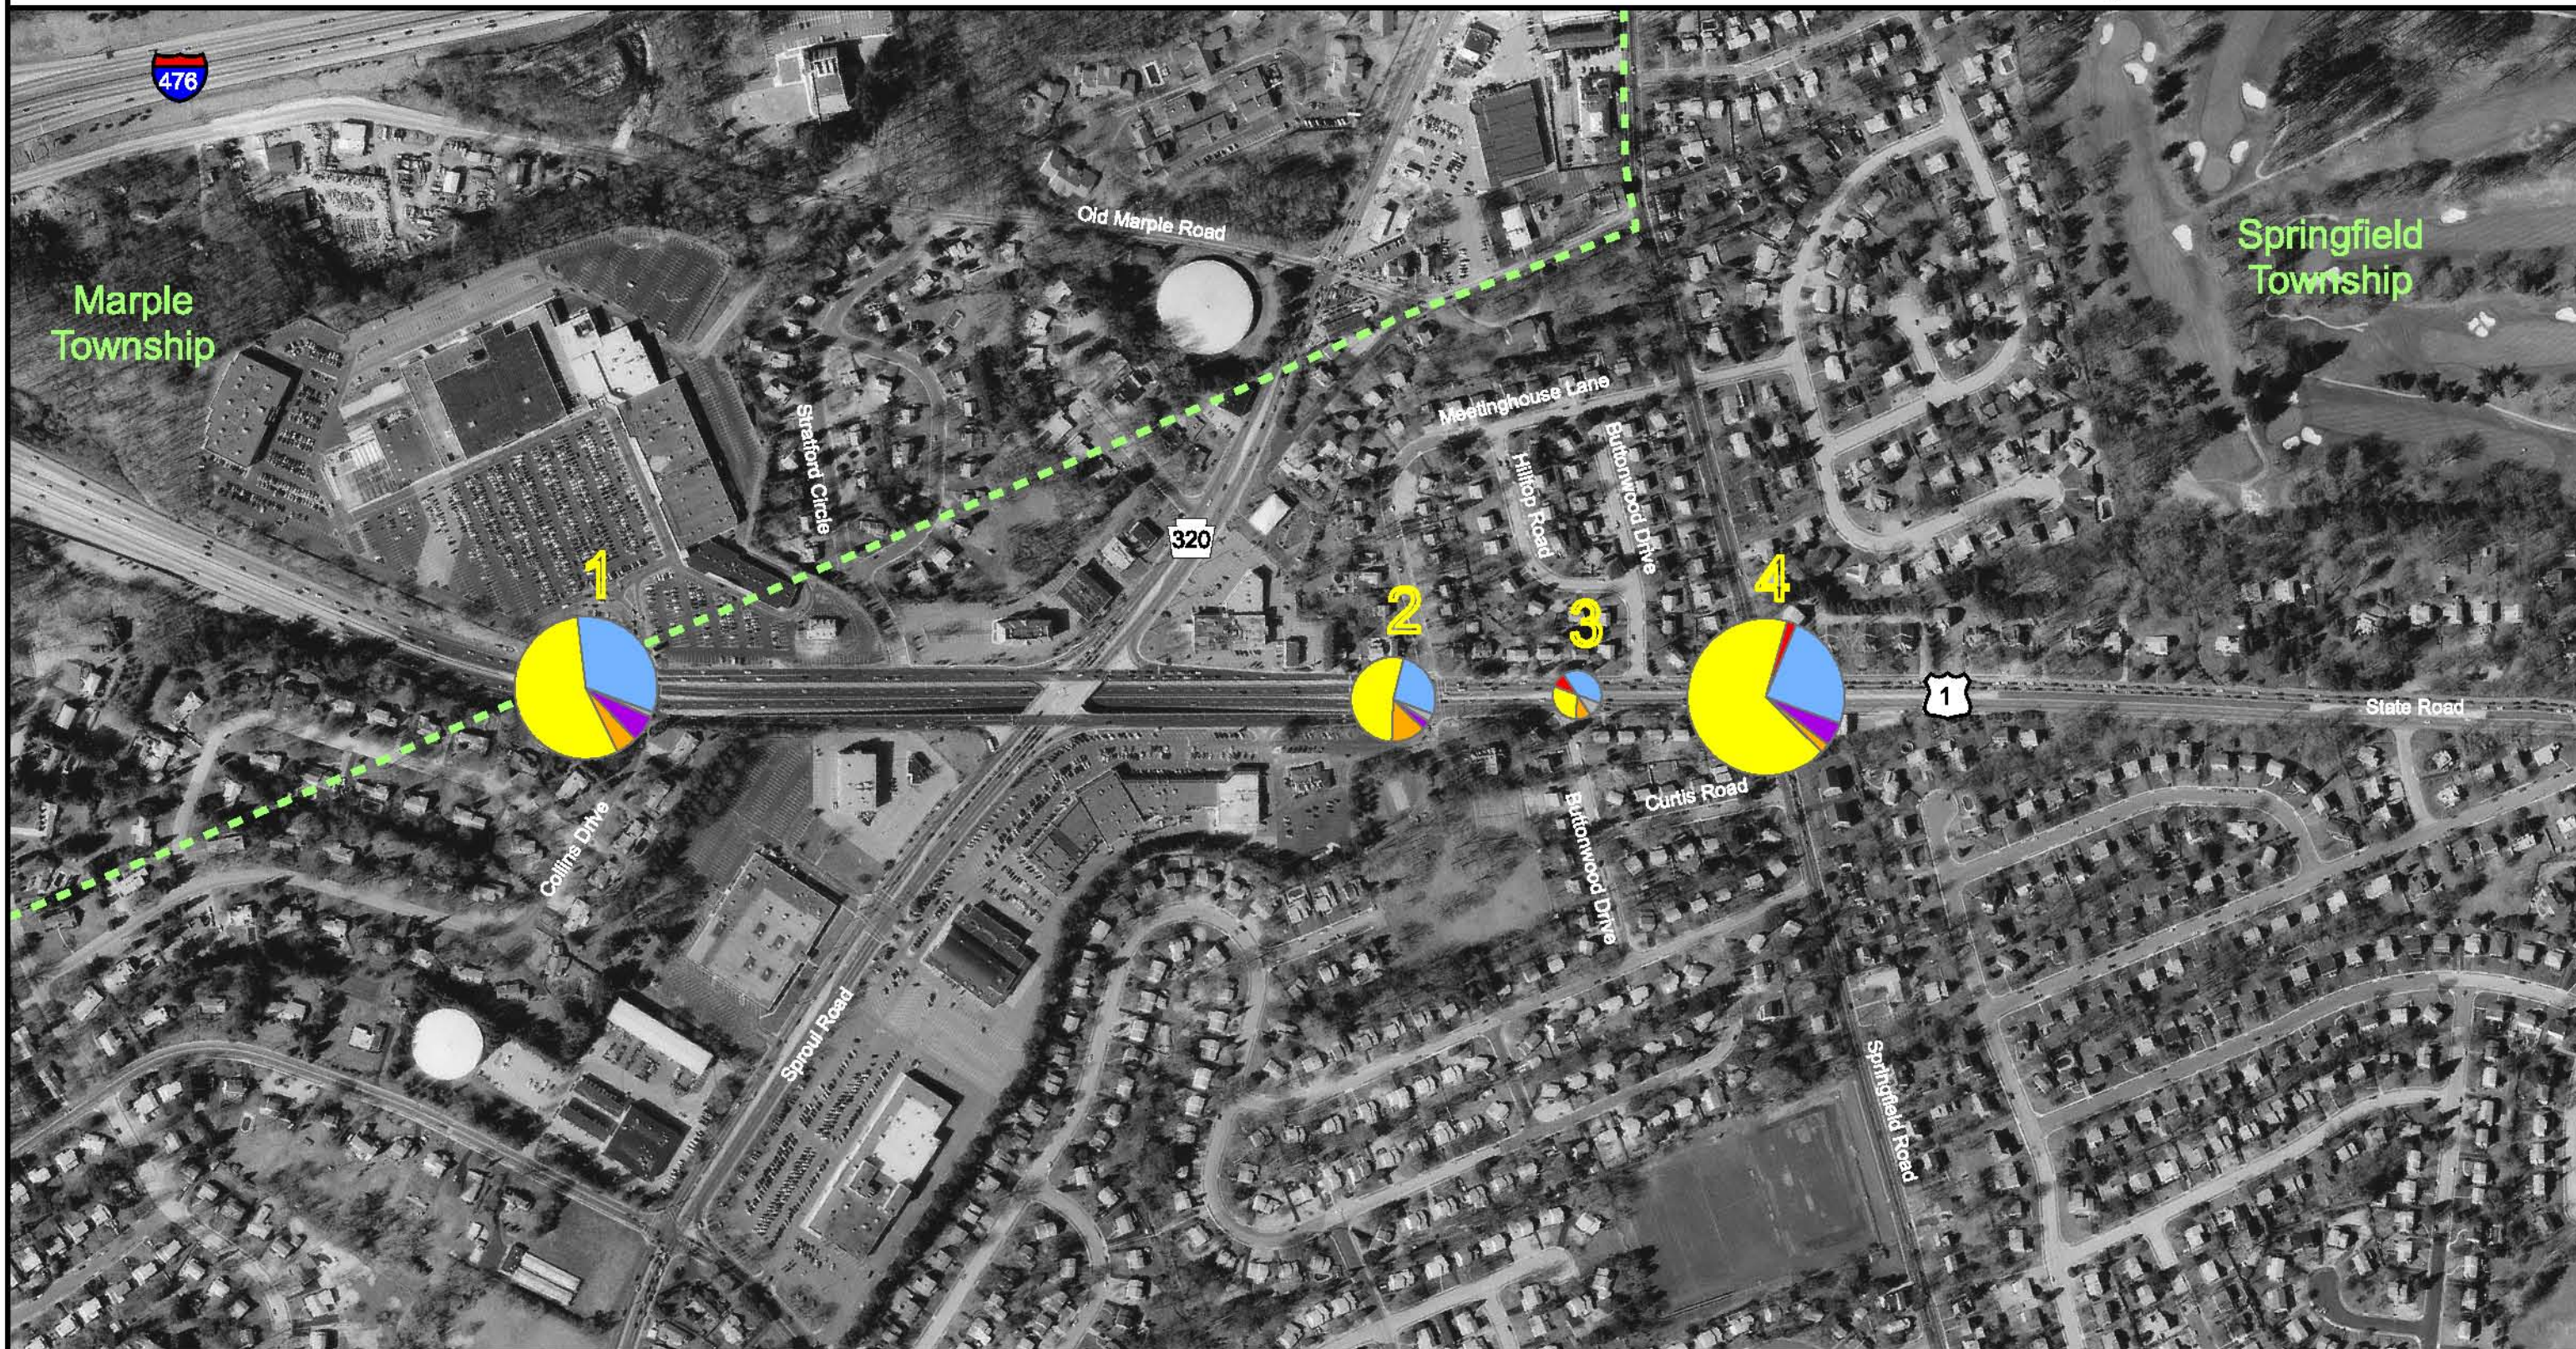
Figure 4: Traffic Accident Patterns

The pie charts in Figure 4 provide a comparison of the types of accidents that occurred at each analyzed location. The size of the pie chart is reflective of the number of accidents occurring at the intersection. As shown, the highest number of accidents occur at the Springfield Road intersection, followed by Collins Drive, Meetinghouse Lane and Buttonwood Drive. All locations (with the exception of Buttonwood Drive) show a majority of angle accidents (yellow) and a substantial number of rear-end accidents (blue). The remaining composition varies between sites.

Table 2 corresponds to the pie charts in Figure 4 and enumerates the type of each accident.

The posting of “NO TURNS” signs and skip mark lines (between the SB main line through movement and the frontage road through movement) should help reduce the occurrence of the illegal (and hazardous) right turn from the SB main line to the Marple Shopping Center. The changing of the “yield” controlled movement from Marple Shopping Center to US 1 S.B. to a signal controlled, no turn on red movement should reduce or eliminate the occurrence of accidents wherein dangerous speed differentials are identified as contributing factors. The replacement of missing signal permit signs and demarcation of islands with tubular markers should reduce “confusion” and “island \ median” related accidents. Implementation of these improvements should help reduce the “angle”, “rear end”, and “hit fixed object” accidents detailed in the traffic safety section of this report (Table 2 and Figure 4).

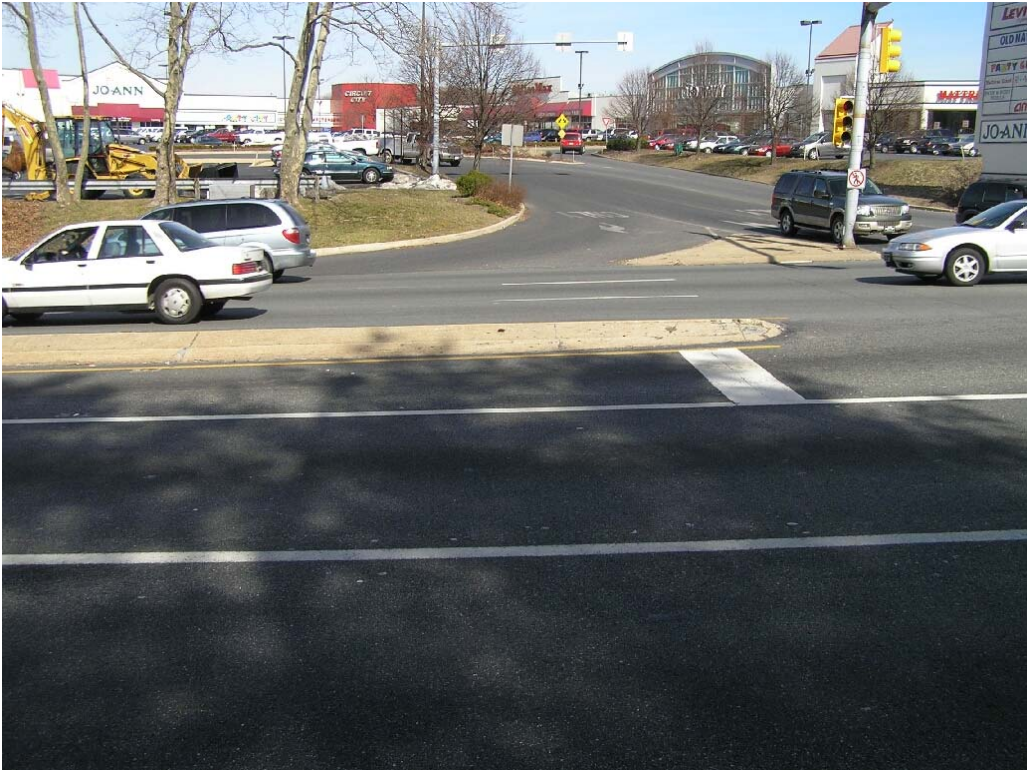
Marple Shopping Center EB, existing right turn lane “yield” movement proposed to be made a “signal controlled, NO TURN ON RED” movement

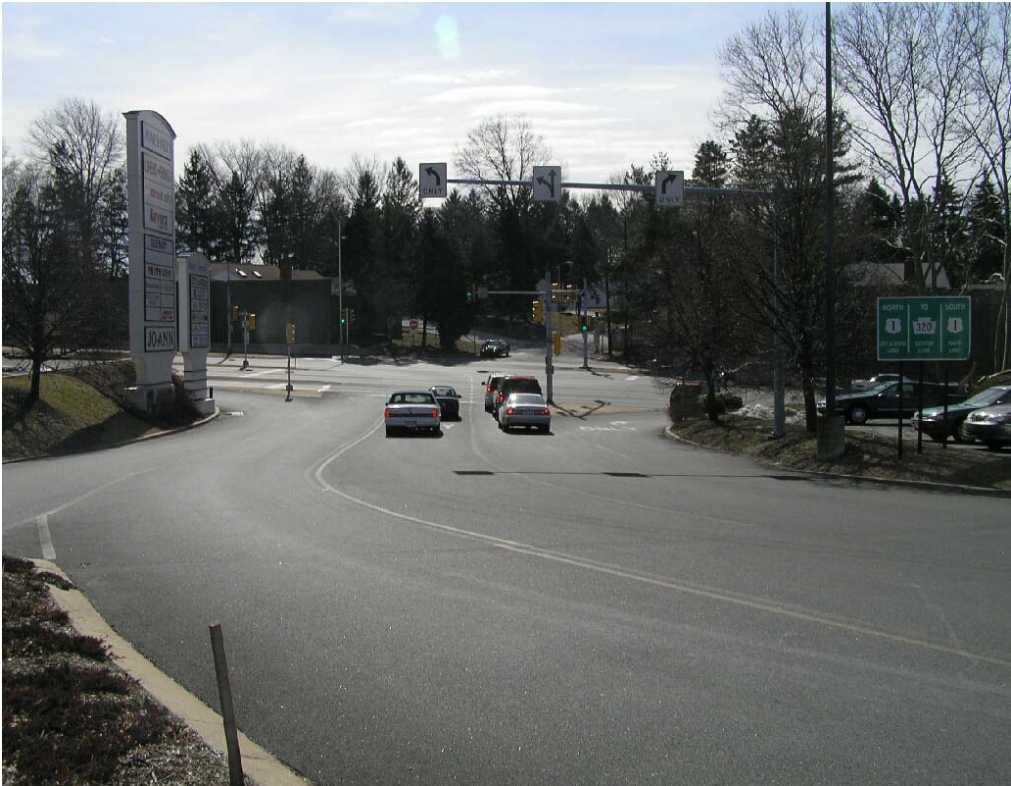
Marple Shopping Center Drive EB at US 1

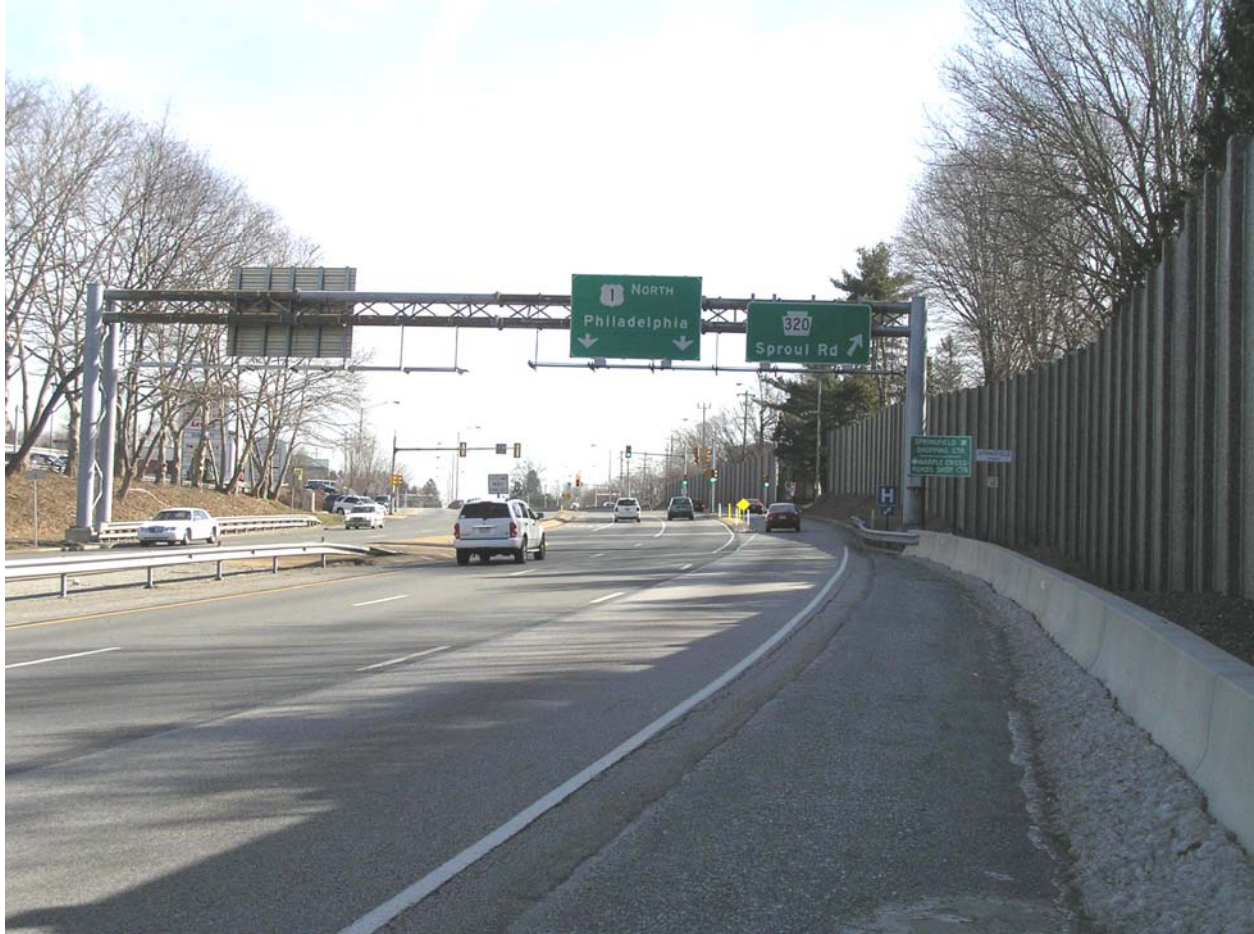
US 1 NB approaching Collins Drive with proposed demarcation of traffic island

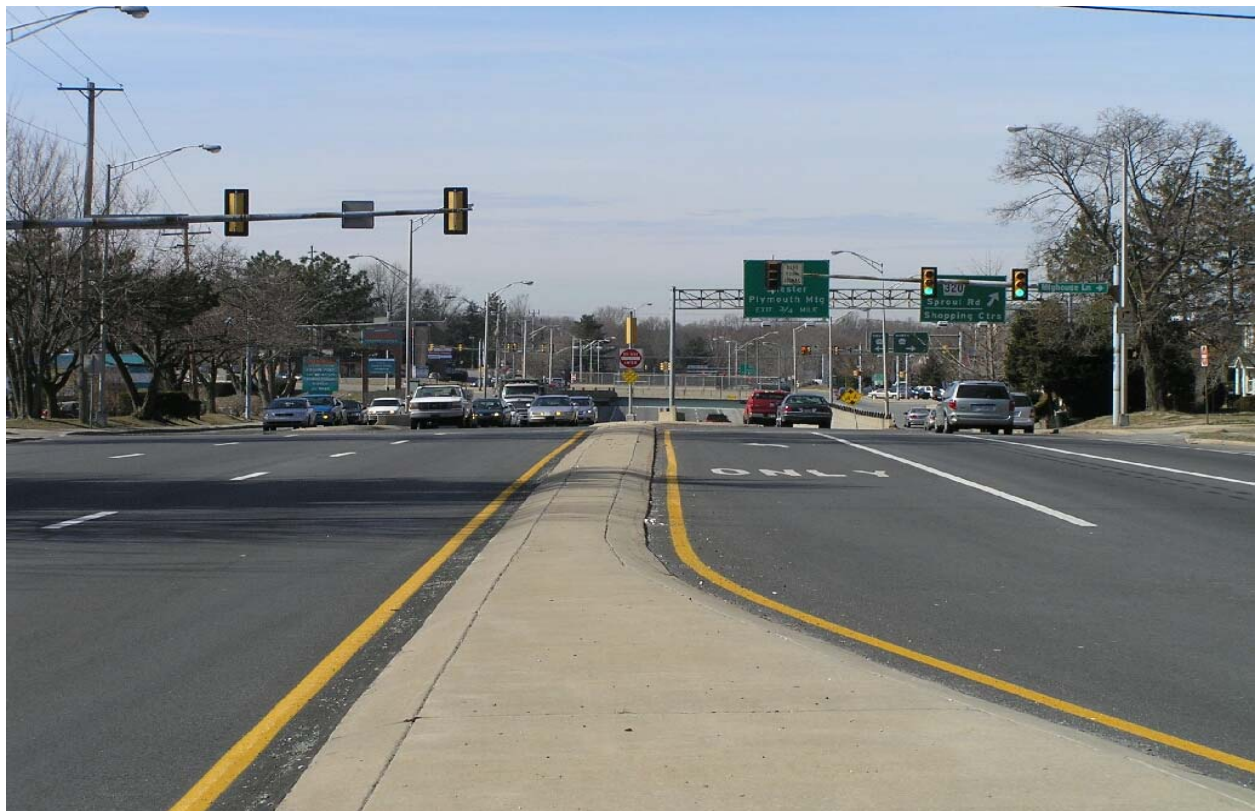
US 1 looking SB at Meadowgreen Park Entrance \ Meetinghouse Lane

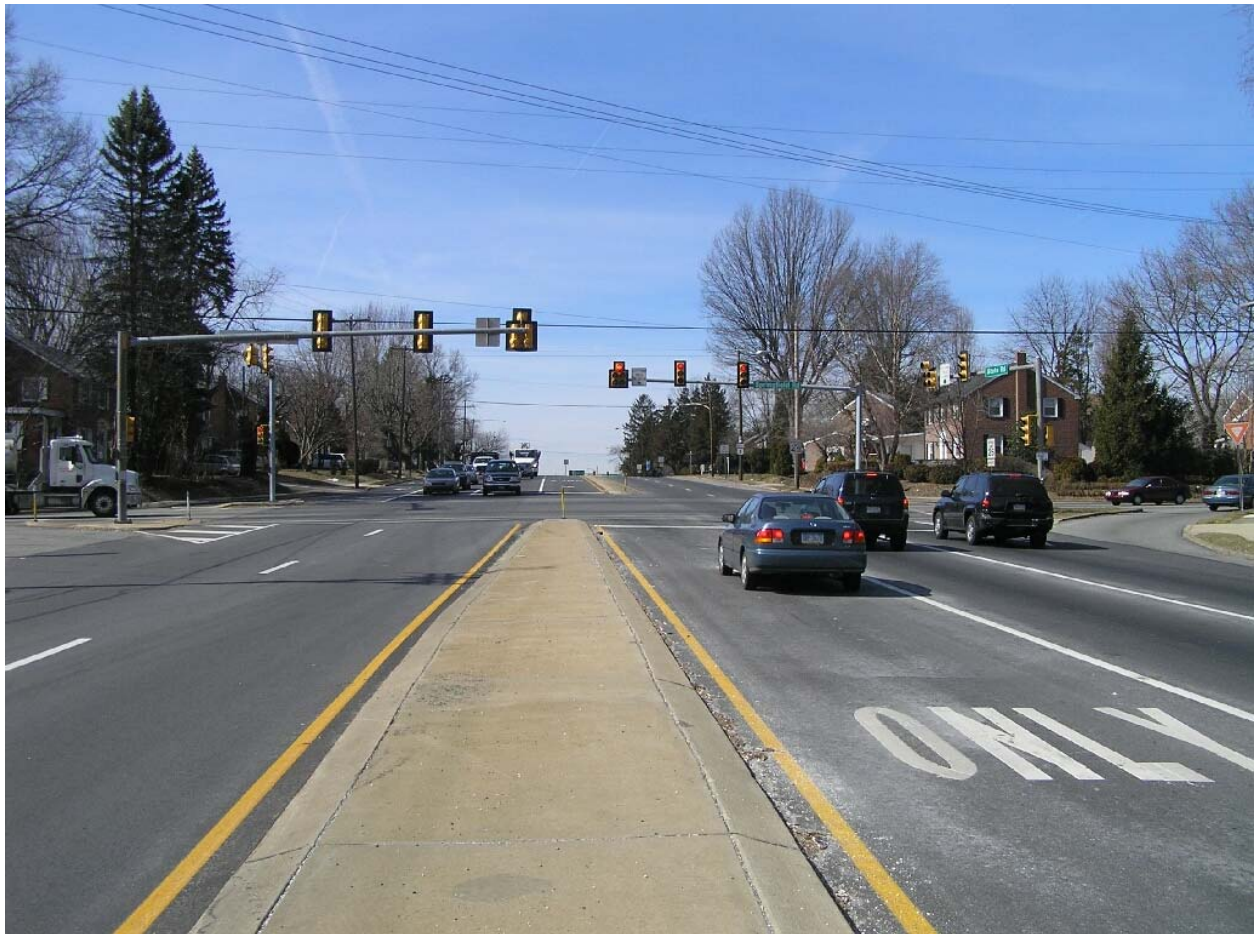
US 1 looking SB at Springfield Road

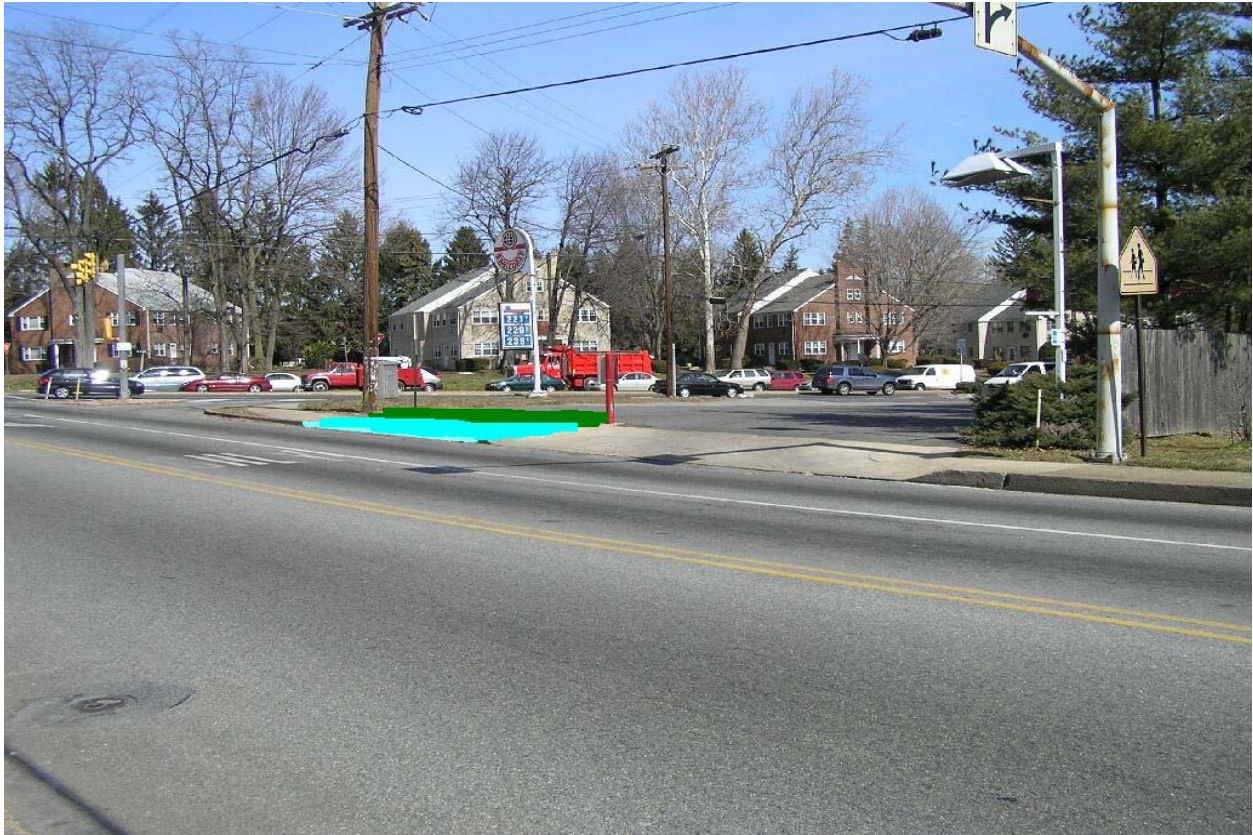
Springfield Road WB at US 1 – Gas Station entrance proposed for closure

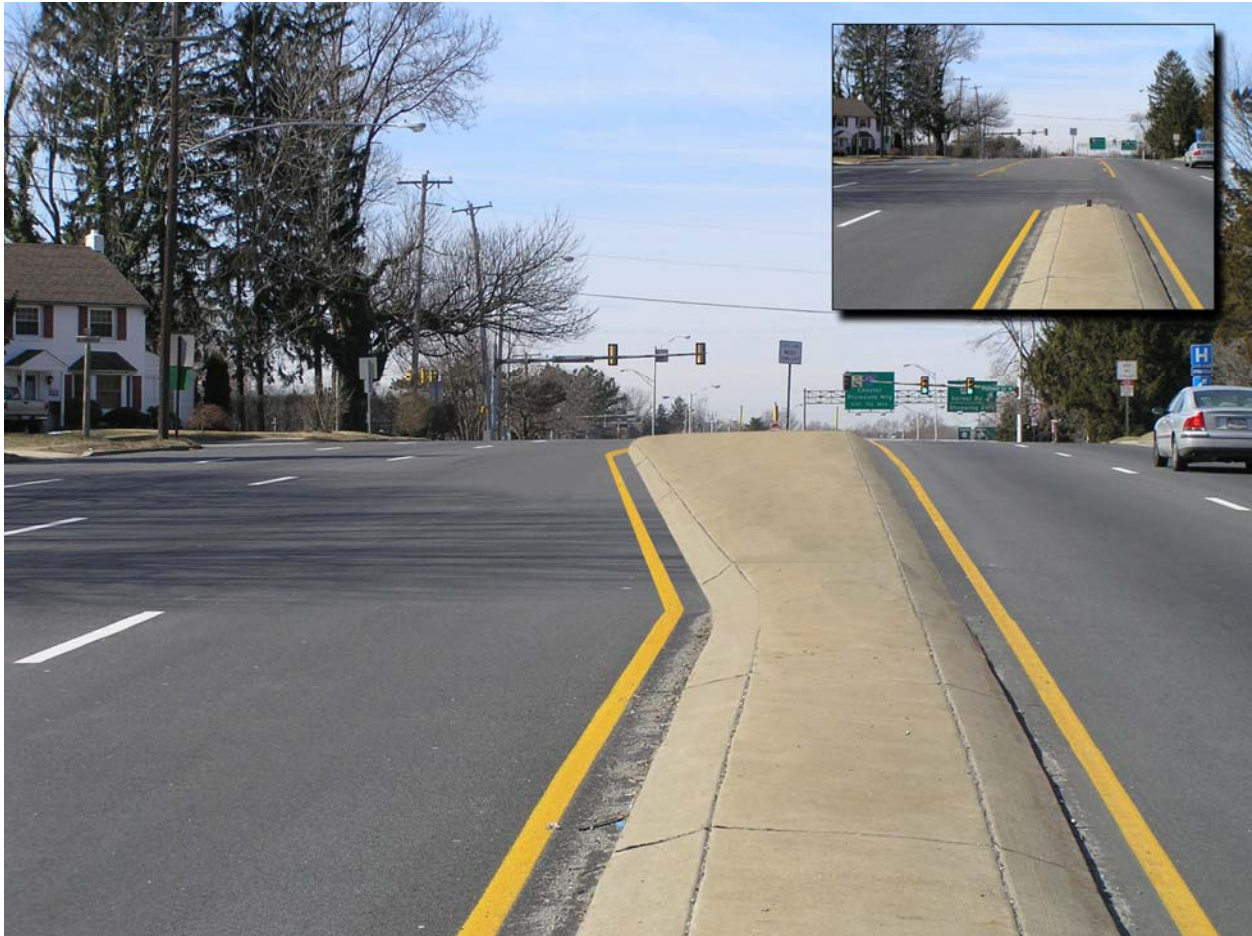
US 1 looking SB at Buttonwood Drive proposed median closure (inset: existing condition)

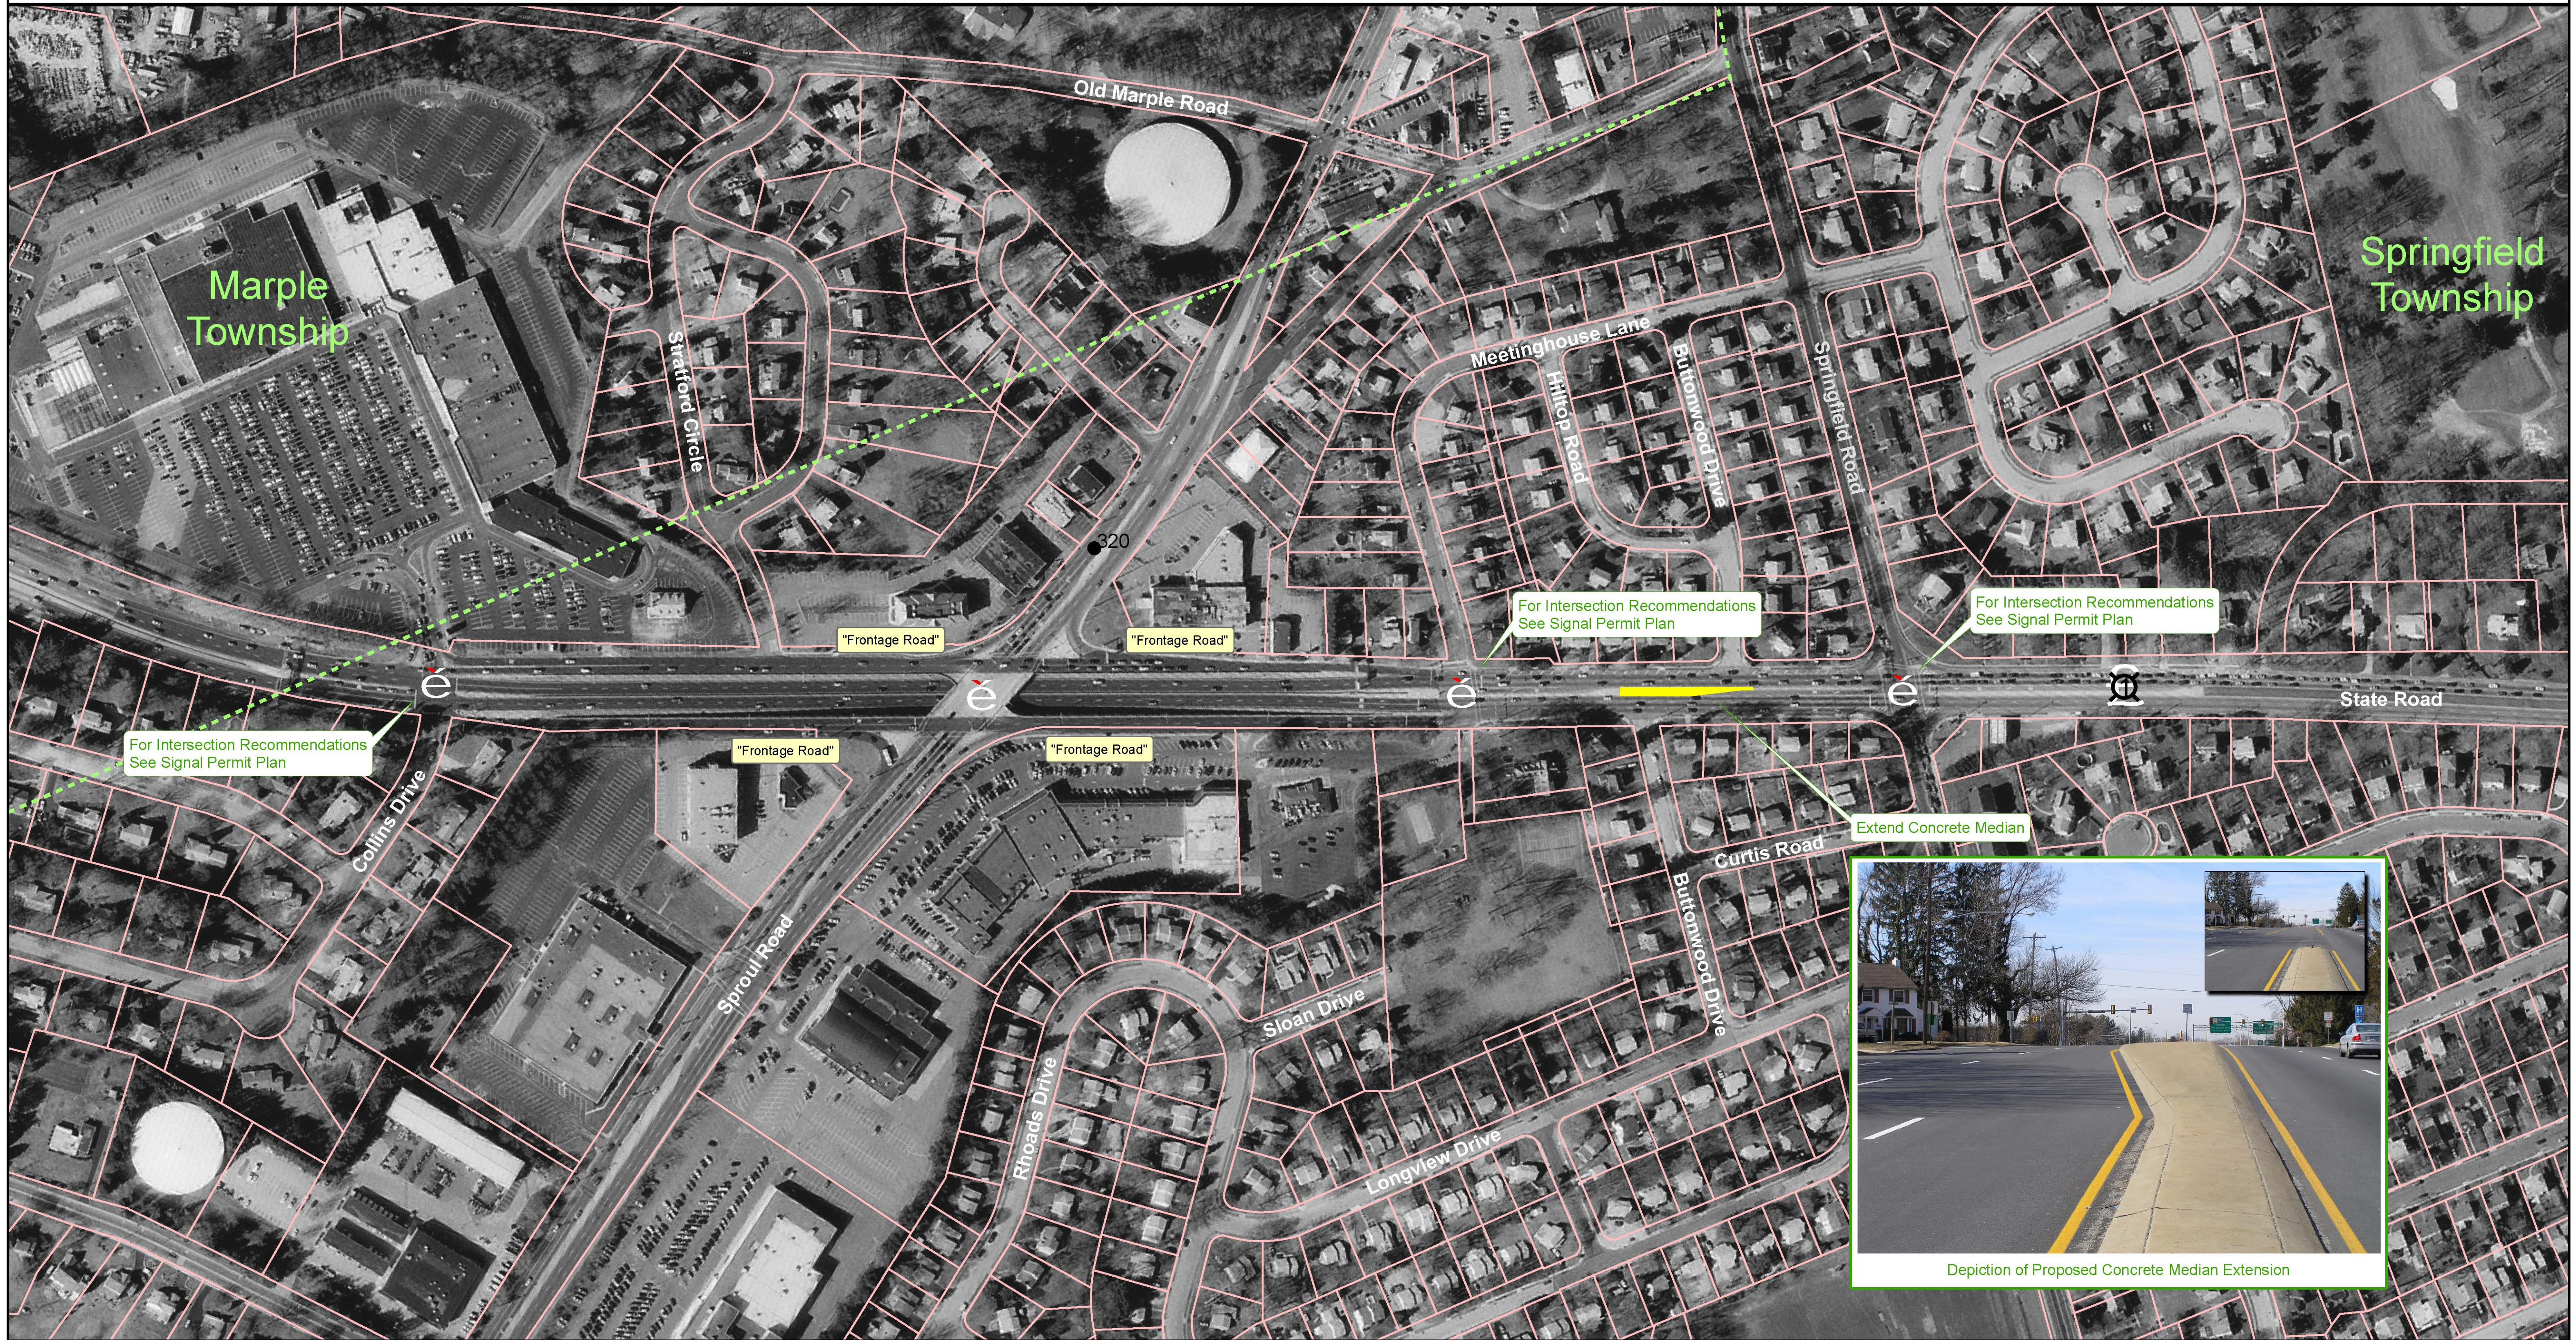
It was determined that the corridor was best analyzed at the four (4) intersections where there are median openings. Tables 3 through 6 detail the current conditions and proposed improvements along State Road – US 1 at the study intersections. Visually augmenting these tables are modified signal permit plans (Figures 6 through 8), photographs, a typical section (Figure 9), and the corridor's conceptual access management plan (Figure 10) located in the back pocket of this report.

Improvement recommendations have been illustrated on traffic signal permit drawings and on a corridor conceptual plan; and preliminary cost estimates for the improvements are provided.
