ROOSEVELT BOULEVARD CORRIDOR STUDY

Delaware Valley
Regional Planning
Commission

2007

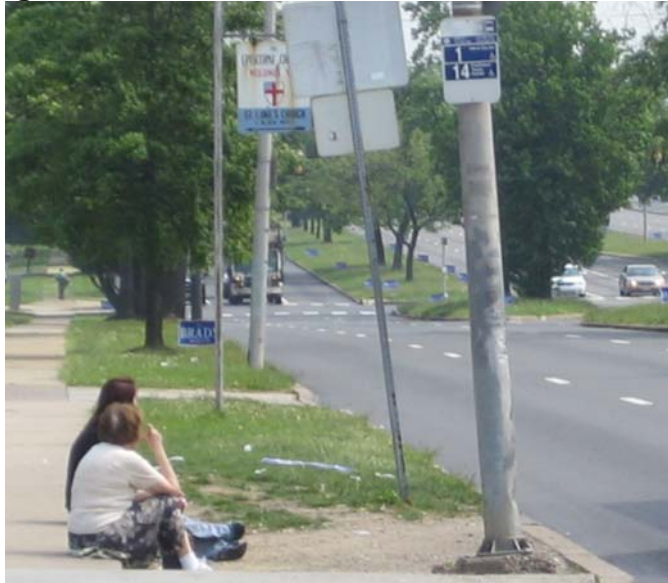
Figure 2 – Roosevelt Boulevard near Welsh Road

In several instances the infrastructure at bus stop locations is not adequate. Particularly, where not already present, bus stop shelters should be installed at peak load points and intersections that act as bus route transfer locations, and, at minimum, benches should be installed at other heavily-used boarding locations. **Figures 2 and 3** demonstrate the need for bus stop shelters and benches.

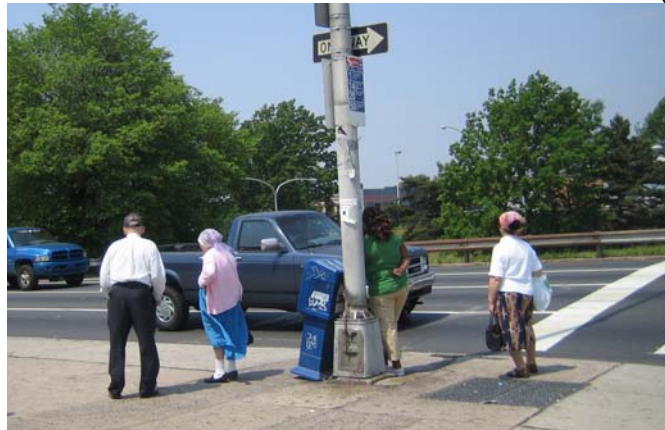
Figure 3 – Roosevelt Boulevard at Cottman Avenue (SE Quadrant)

As shown in **Figure 3**, the bus stop at Roosevelt Boulevard and Cottman Avenue, the busiest bus boarding and alighting intersection in the corridor, the adjoining gas station property does not have clearly defined ingress and egress locations, thereby creating

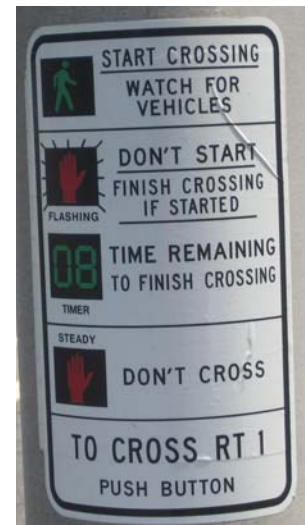
Figure 4- Crosswalk Safety Educational Sign (DVRPC, 2007)

Several recommended improvements are common among many crosswalk locations. Foremost, we recommend installing pedestrian countdown signals at all intersection crosswalk locations. Additionally, each crosswalk should be restriped, if not so already, in the international style, and have crosswalk safety educational signs posted at each crosswalk. See **Figure 4** for an example of a crosswalk safety educational sign. All of the signalized crosswalks should be timed to allow pedestrians to reach the center median with a 3.5 feet per second gait in a single cycle. Furthermore, we recommend installing pedestrian countdown signals at all mid-block crosswalk locations. **Table 6** summarizes these improvements, along with all other recommended improvements. They are explained in greater detail in the following sections.

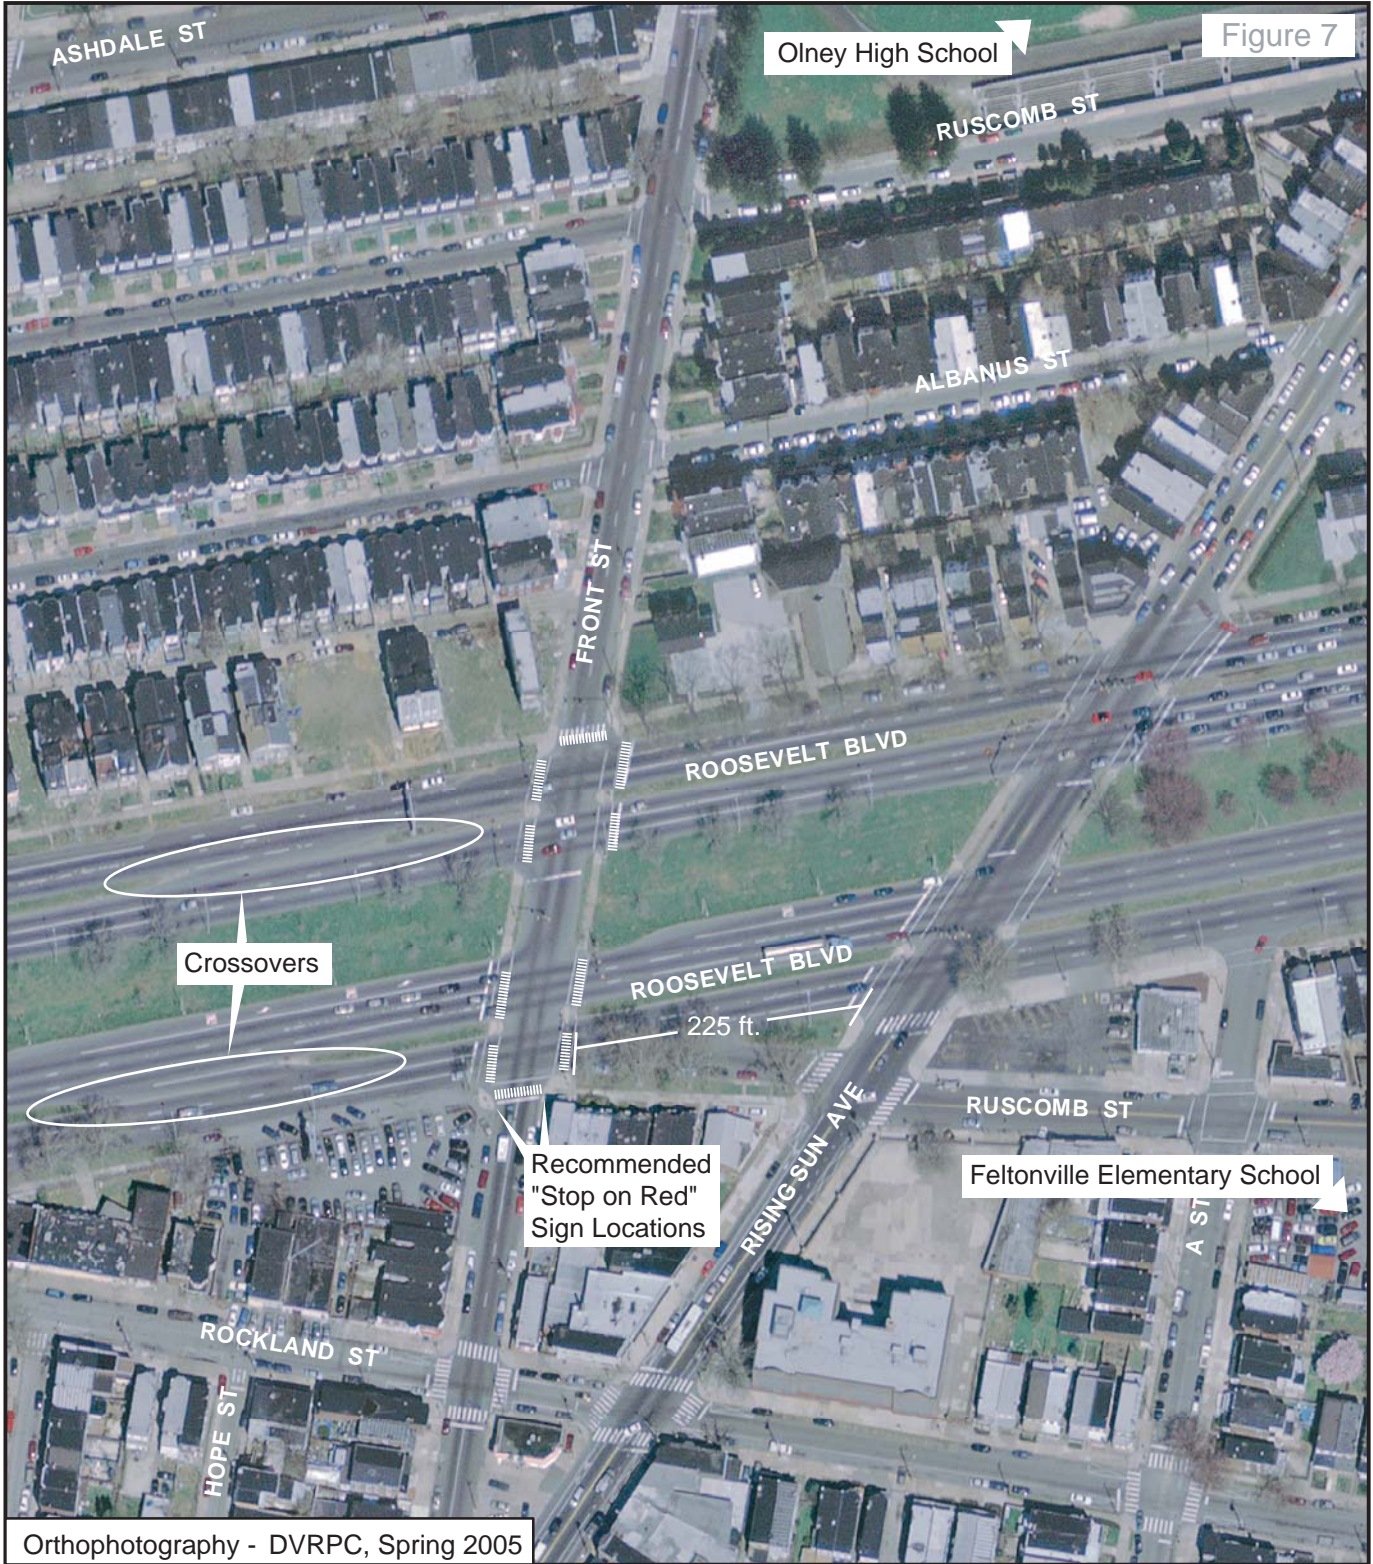
Figure 7

This intersection has seen four pedestrian/vehicle crashes between 2001 and 2005, including one fatality. The fatality occurred during the day in the southbound express lanes and was pedestrian caused. A driver-caused crash occurred during the evening in the southbound local lanes. The northbound lanes had a driver-caused daylight crash in the local lanes and a pedestrian-caused daylight crash in the express lanes.

The intersection was assessed by DVRPC personnel on Wednesday, May 16, 2007. During the assessment the following observations were noted: 1) The majority of pedestrians were school-aged children, including many who ran across the intersection in one light cycle; 2) North Front Street traffic often encroached on the crosswalk during red lights; and 3) The sidewalks along North Front Street are in disrepair.

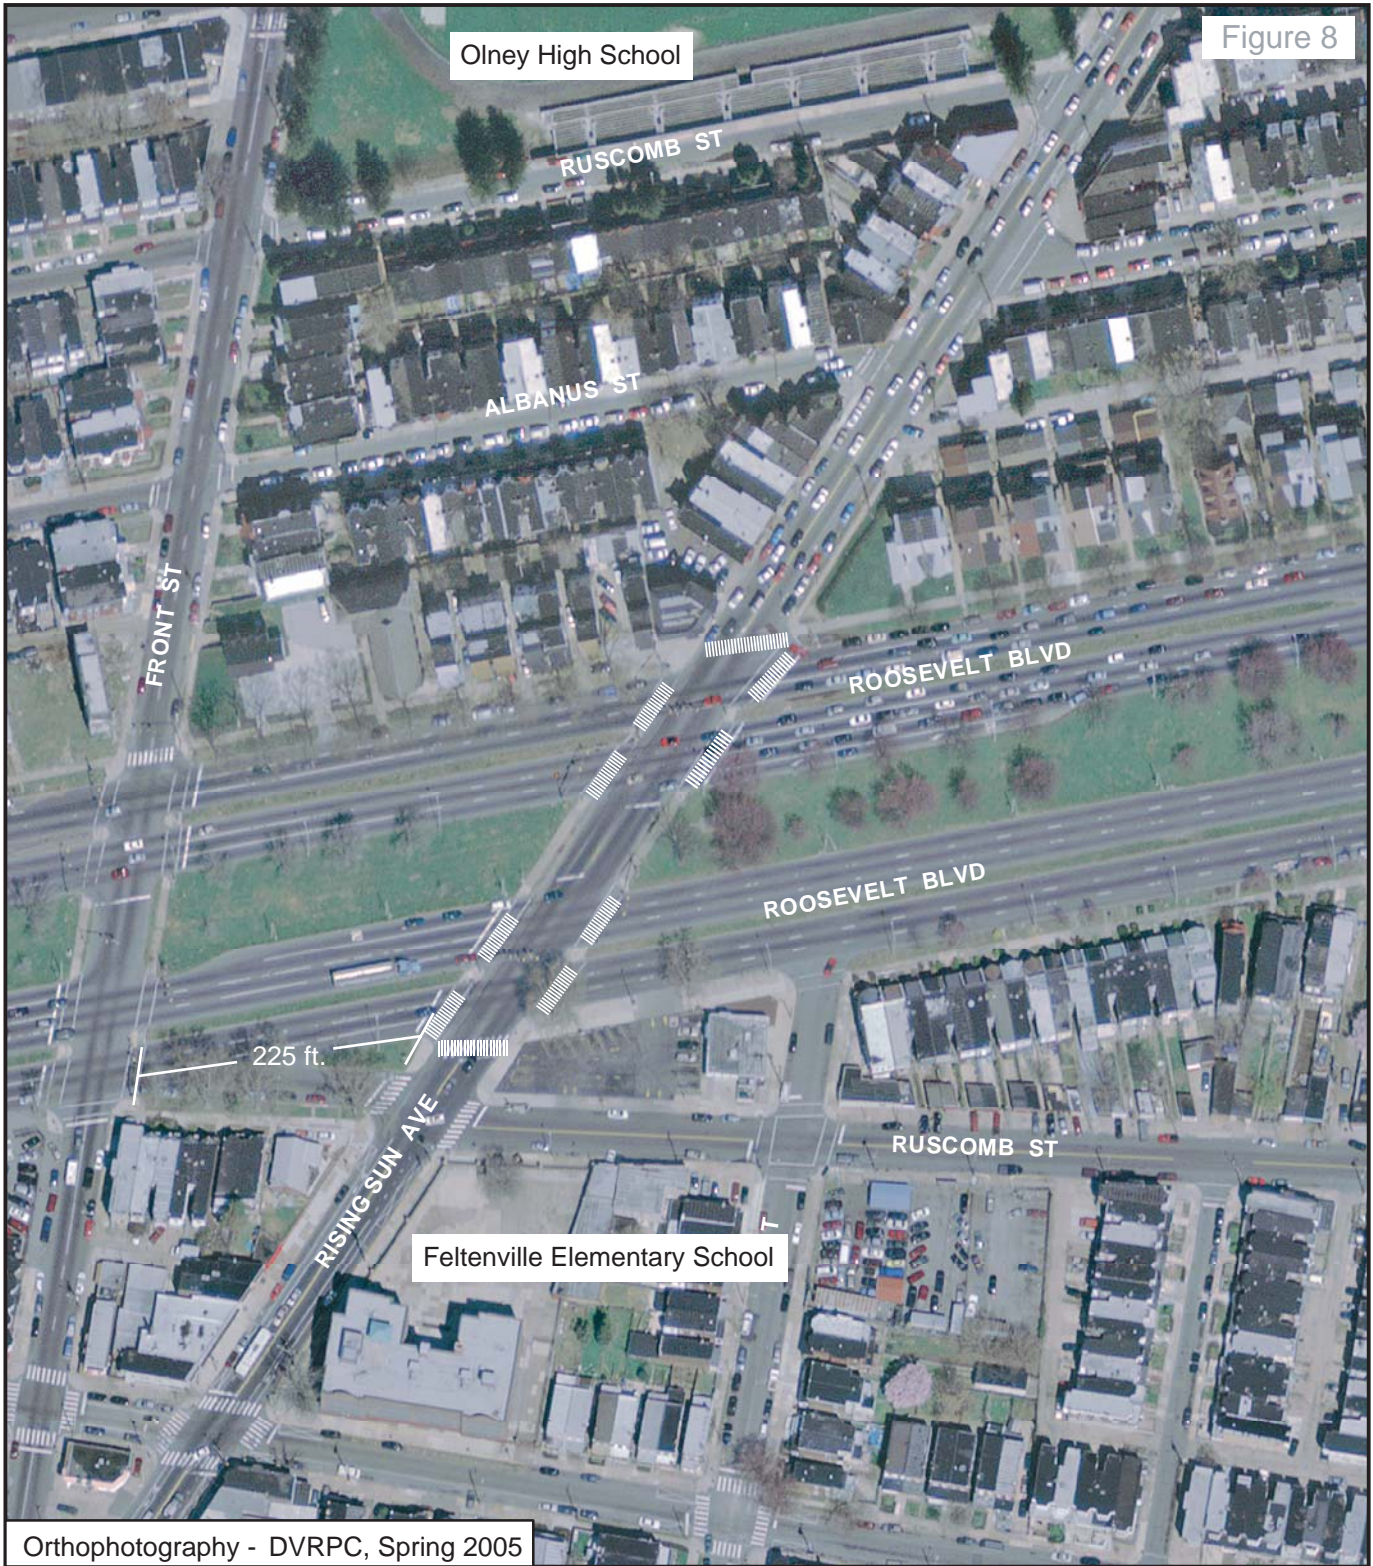
Figure 8

Six pedestrian/vehicle crashes have occurred at this intersection between 2001 and 2005. Five of the crashes occurred on the northbound side, four of which were in the northbound express lanes. Three of the crashes occurred during daylight hours, one was at night. Three were pedestrian caused and one was driver caused. The northbound local lanes crash occurred during daylight and was pedestrian caused. The single southbound crash occurred in the express lanes during daylight and was pedestrian caused. All crashes resulted in injury to the pedestrian.

The intersection was assessed by DVRPC personnel on Wednesday, May 16, 2007. The only observation noted was that an additional lane of traffic must be crossed on each side due to the presence of turning lanes.

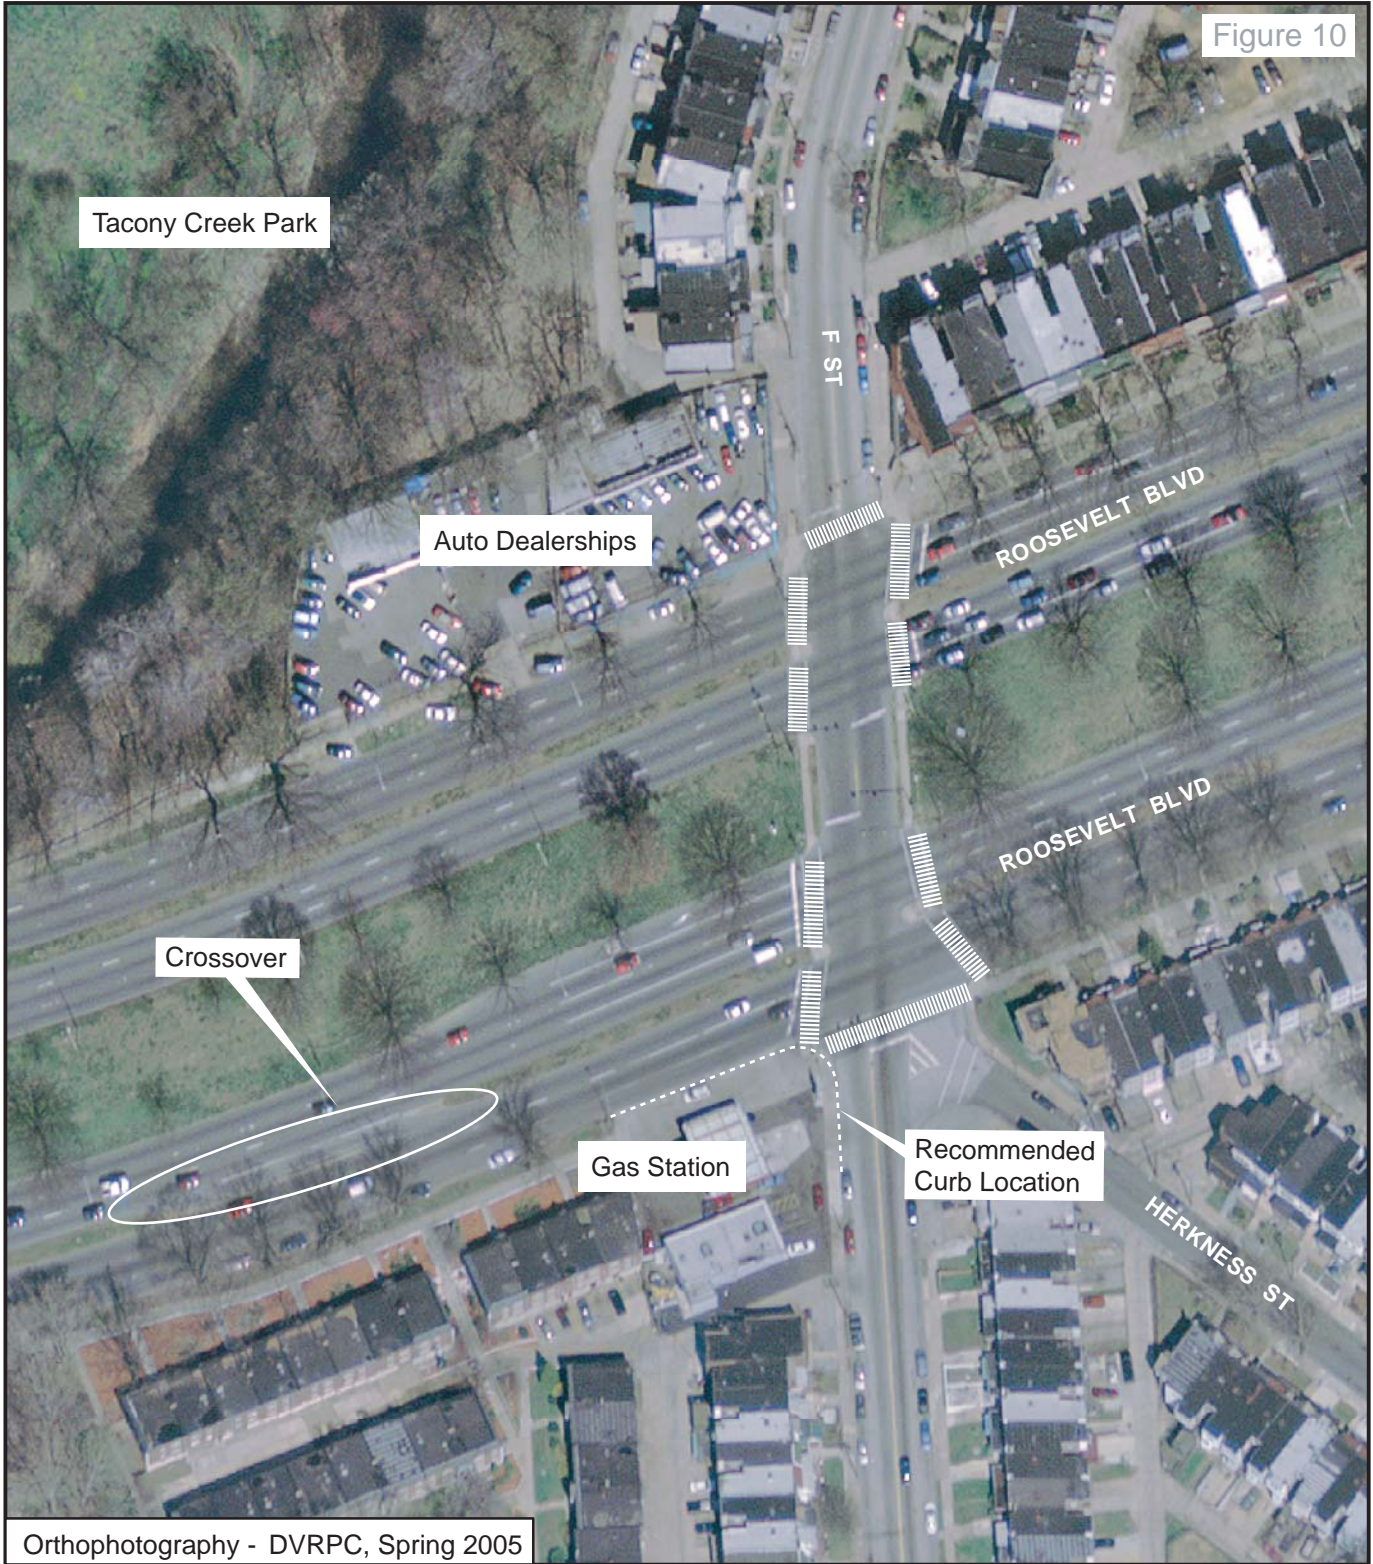
Figure 10

This intersection has seen seven pedestrian/vehicle crashes between 2001 and 2005, six of which occurred during daylight hours. The sole evening crash occurred in the northbound local lanes and was caused by the driver. The northbound local lanes also had three daylight crashes: two driver caused and one pedestrian caused. The northbound express, southbound local, and southbound express lanes each had one pedestrian-caused daylight crash. All seven crashes resulted in injury to the pedestrian.

The intersection was assessed by DVRPC personnel on Wednesday, May 16, 2007. During the assessment the following observations were noted: 1) Approximately 25% of the pedestrian traffic was school related and 25% was bus related; 2) Pedestrians adhered to crosswalk markings; and 3) The southeast corner gas station does not have a curb along its border with Roosevelt Boulevard.

During the assessment a total of 99 pedestrians crossed Roosevelt Boulevard and 248 crossed F Street. This is below average for assessed intersections. The assessment-long average was 50 pedestrians per hour, with a peak between 3:30 and 4:30pm, during which 84 pedestrians crossed. This intersection was noted as having the highest percentage of illegal crossings (74%). People who cross illegally are not necessarily jaywalkers; rather, they are often unable to cross before the walk signal expires.

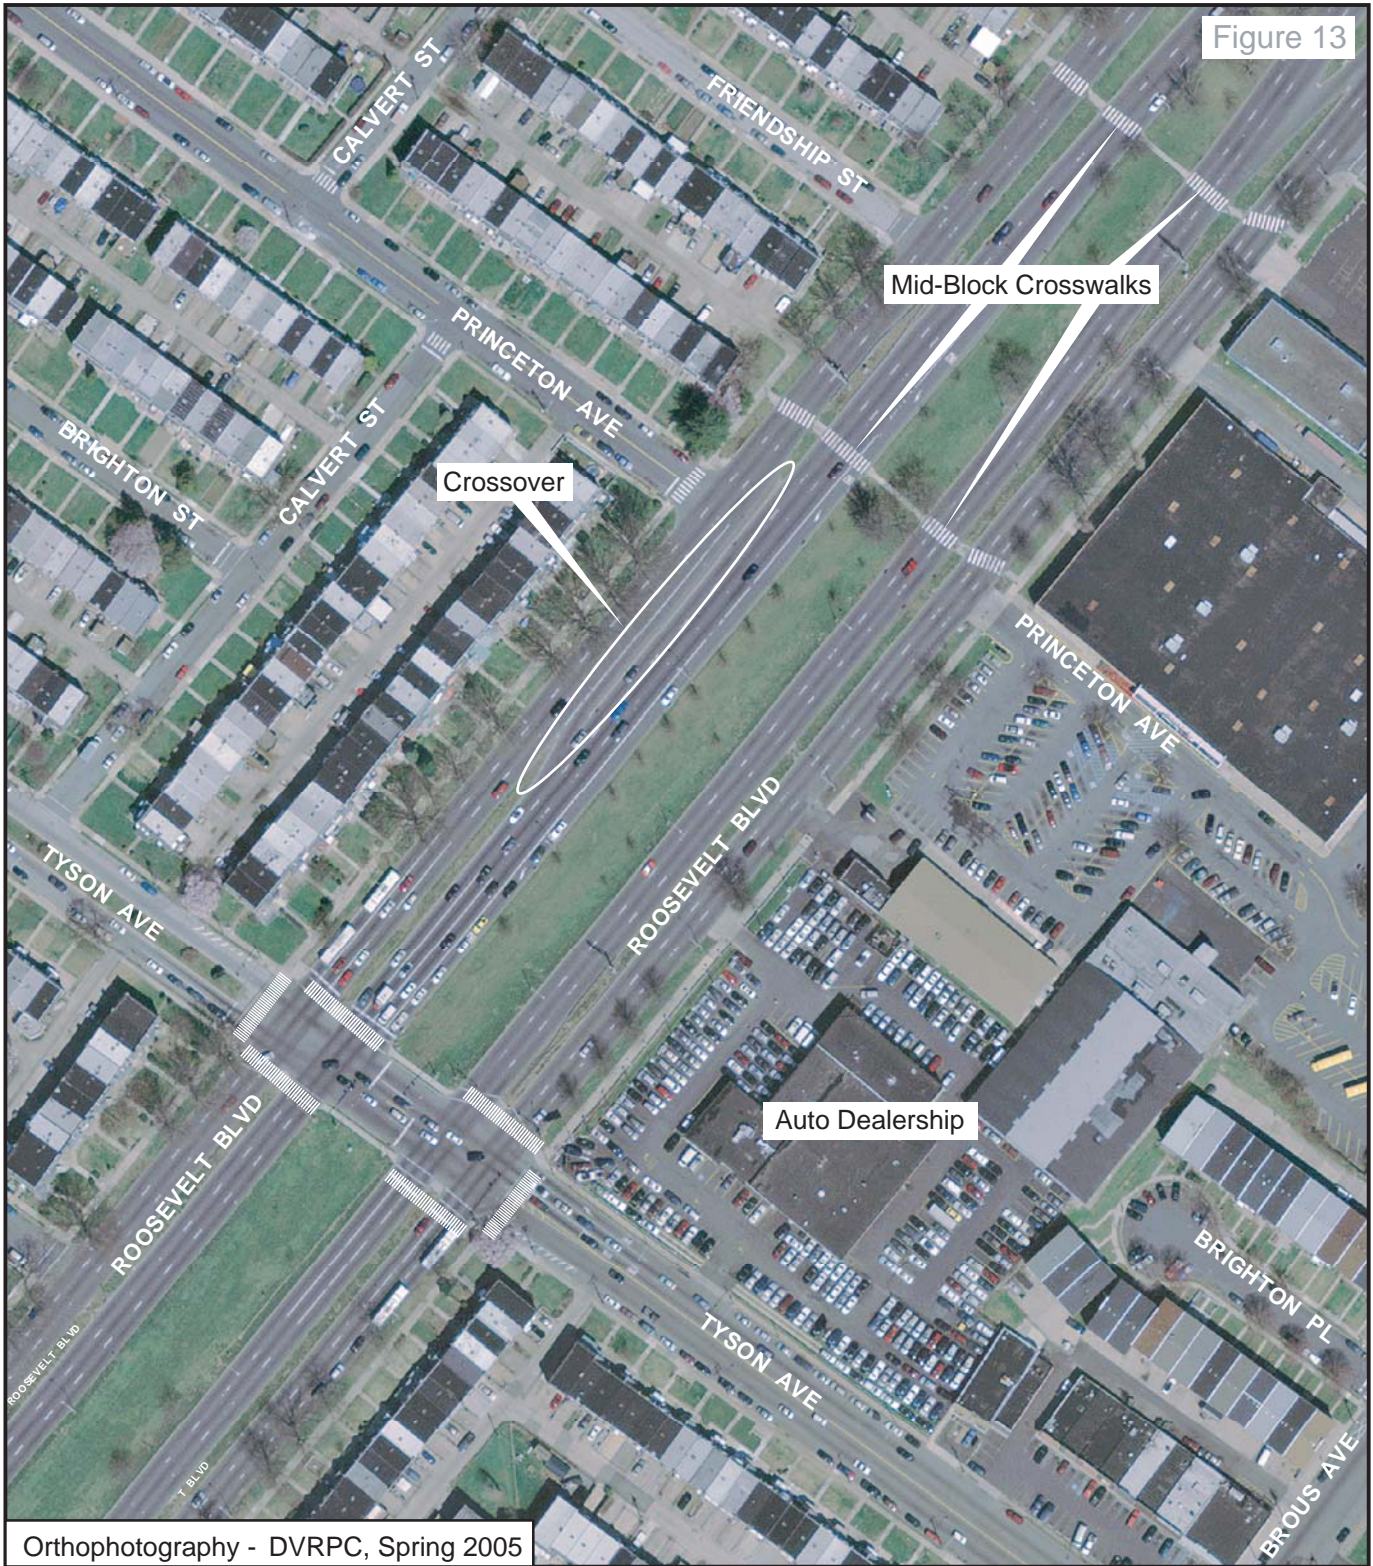
Figure 13

This intersection has seen five pedestrian/vehicle crashes between 2001 and 2005, including one fatality. The fatality occurred during the evening in the northbound express lanes and was caused by the pedestrian. The northbound express lanes also had three other evening crashes: two were caused by the pedestrian and one by environmental conditions, and all three resulted in injury to the pedestrian. The final pedestrian/vehicle crash occurred in the southbound express lanes, was pedestrian caused, and resulted in injury to the pedestrian.

The intersection was assessed by DVRPC personnel on Saturday, May 19, 2007. During the assessment the following observation was noted: the intersection crosswalks appeared to be used minimally.

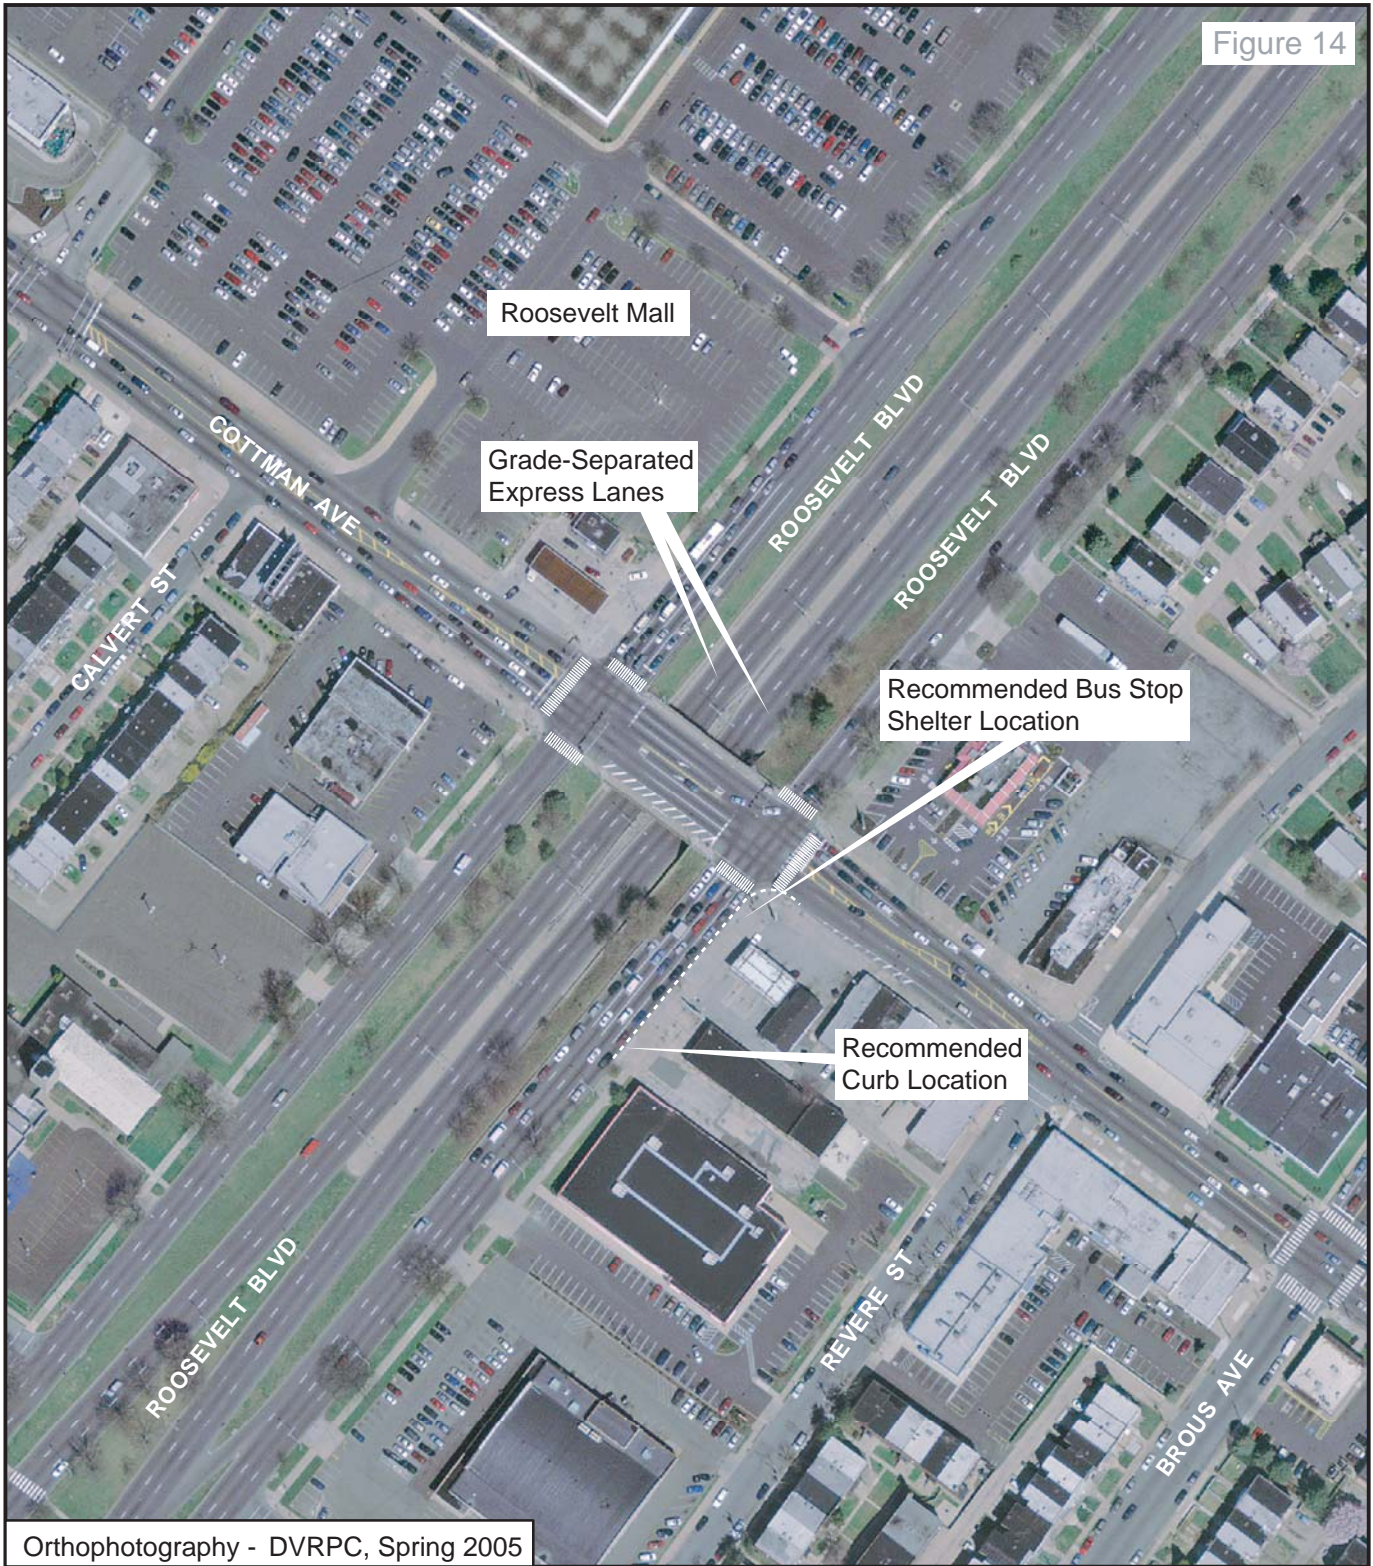
Figure 14

Five pedestrian/vehicle crashes occurred at this intersection between 2001 and 2005; all in the northbound local lanes. There were three day and one evening driver-caused crashes, and one day pedestrian-caused crash. All resulted in injury to the pedestrian.

The intersection was assessed by DVRPC personnel on Saturday, May 19, 2007. During the assessment the following observations were noted: 1) There are no pedestrian cross signals present; 2) Left-turning cars entered the box before it was clear, which created gridlock; 3) The traffic flow was primarily oriented towards Roosevelt Mall; 4) The traffic signal poles are in the middle of the walkway at the median, thereby impeding pedestrian movement; 5) There are near-side bus stops on both streets in both directions, including at the southeast corner gas station; 6) The southeast corner bus stop does not have a shelter; and 7) The southeast corner gas station does not have a curb along its property border.

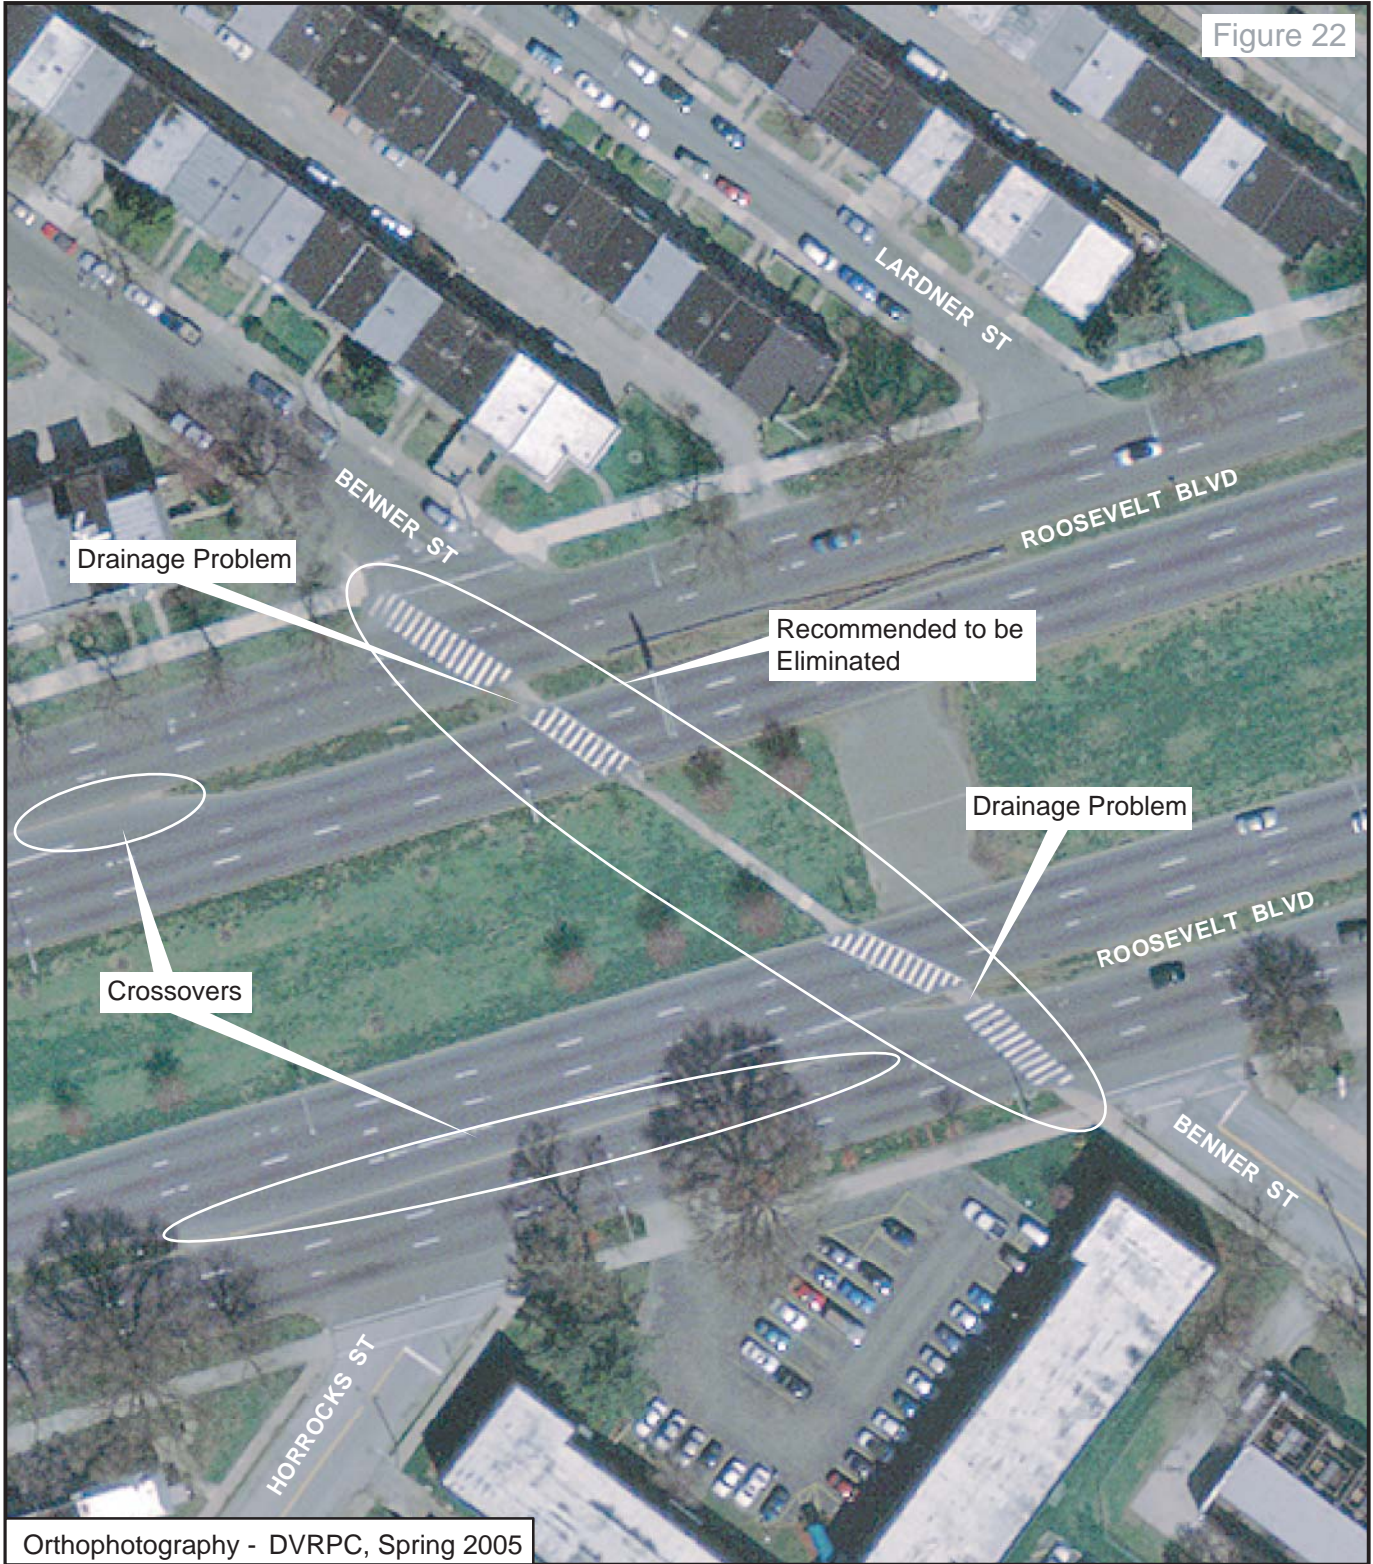
Figure 22

Two pedestrian/vehicle crashes occurred at this crosswalk between 2001 and 2005, including one fatality. Both crashes occurred in the northbound local lanes. The fatality was at night and caused by the pedestrian, while the other was a daylight driver-caused crash.

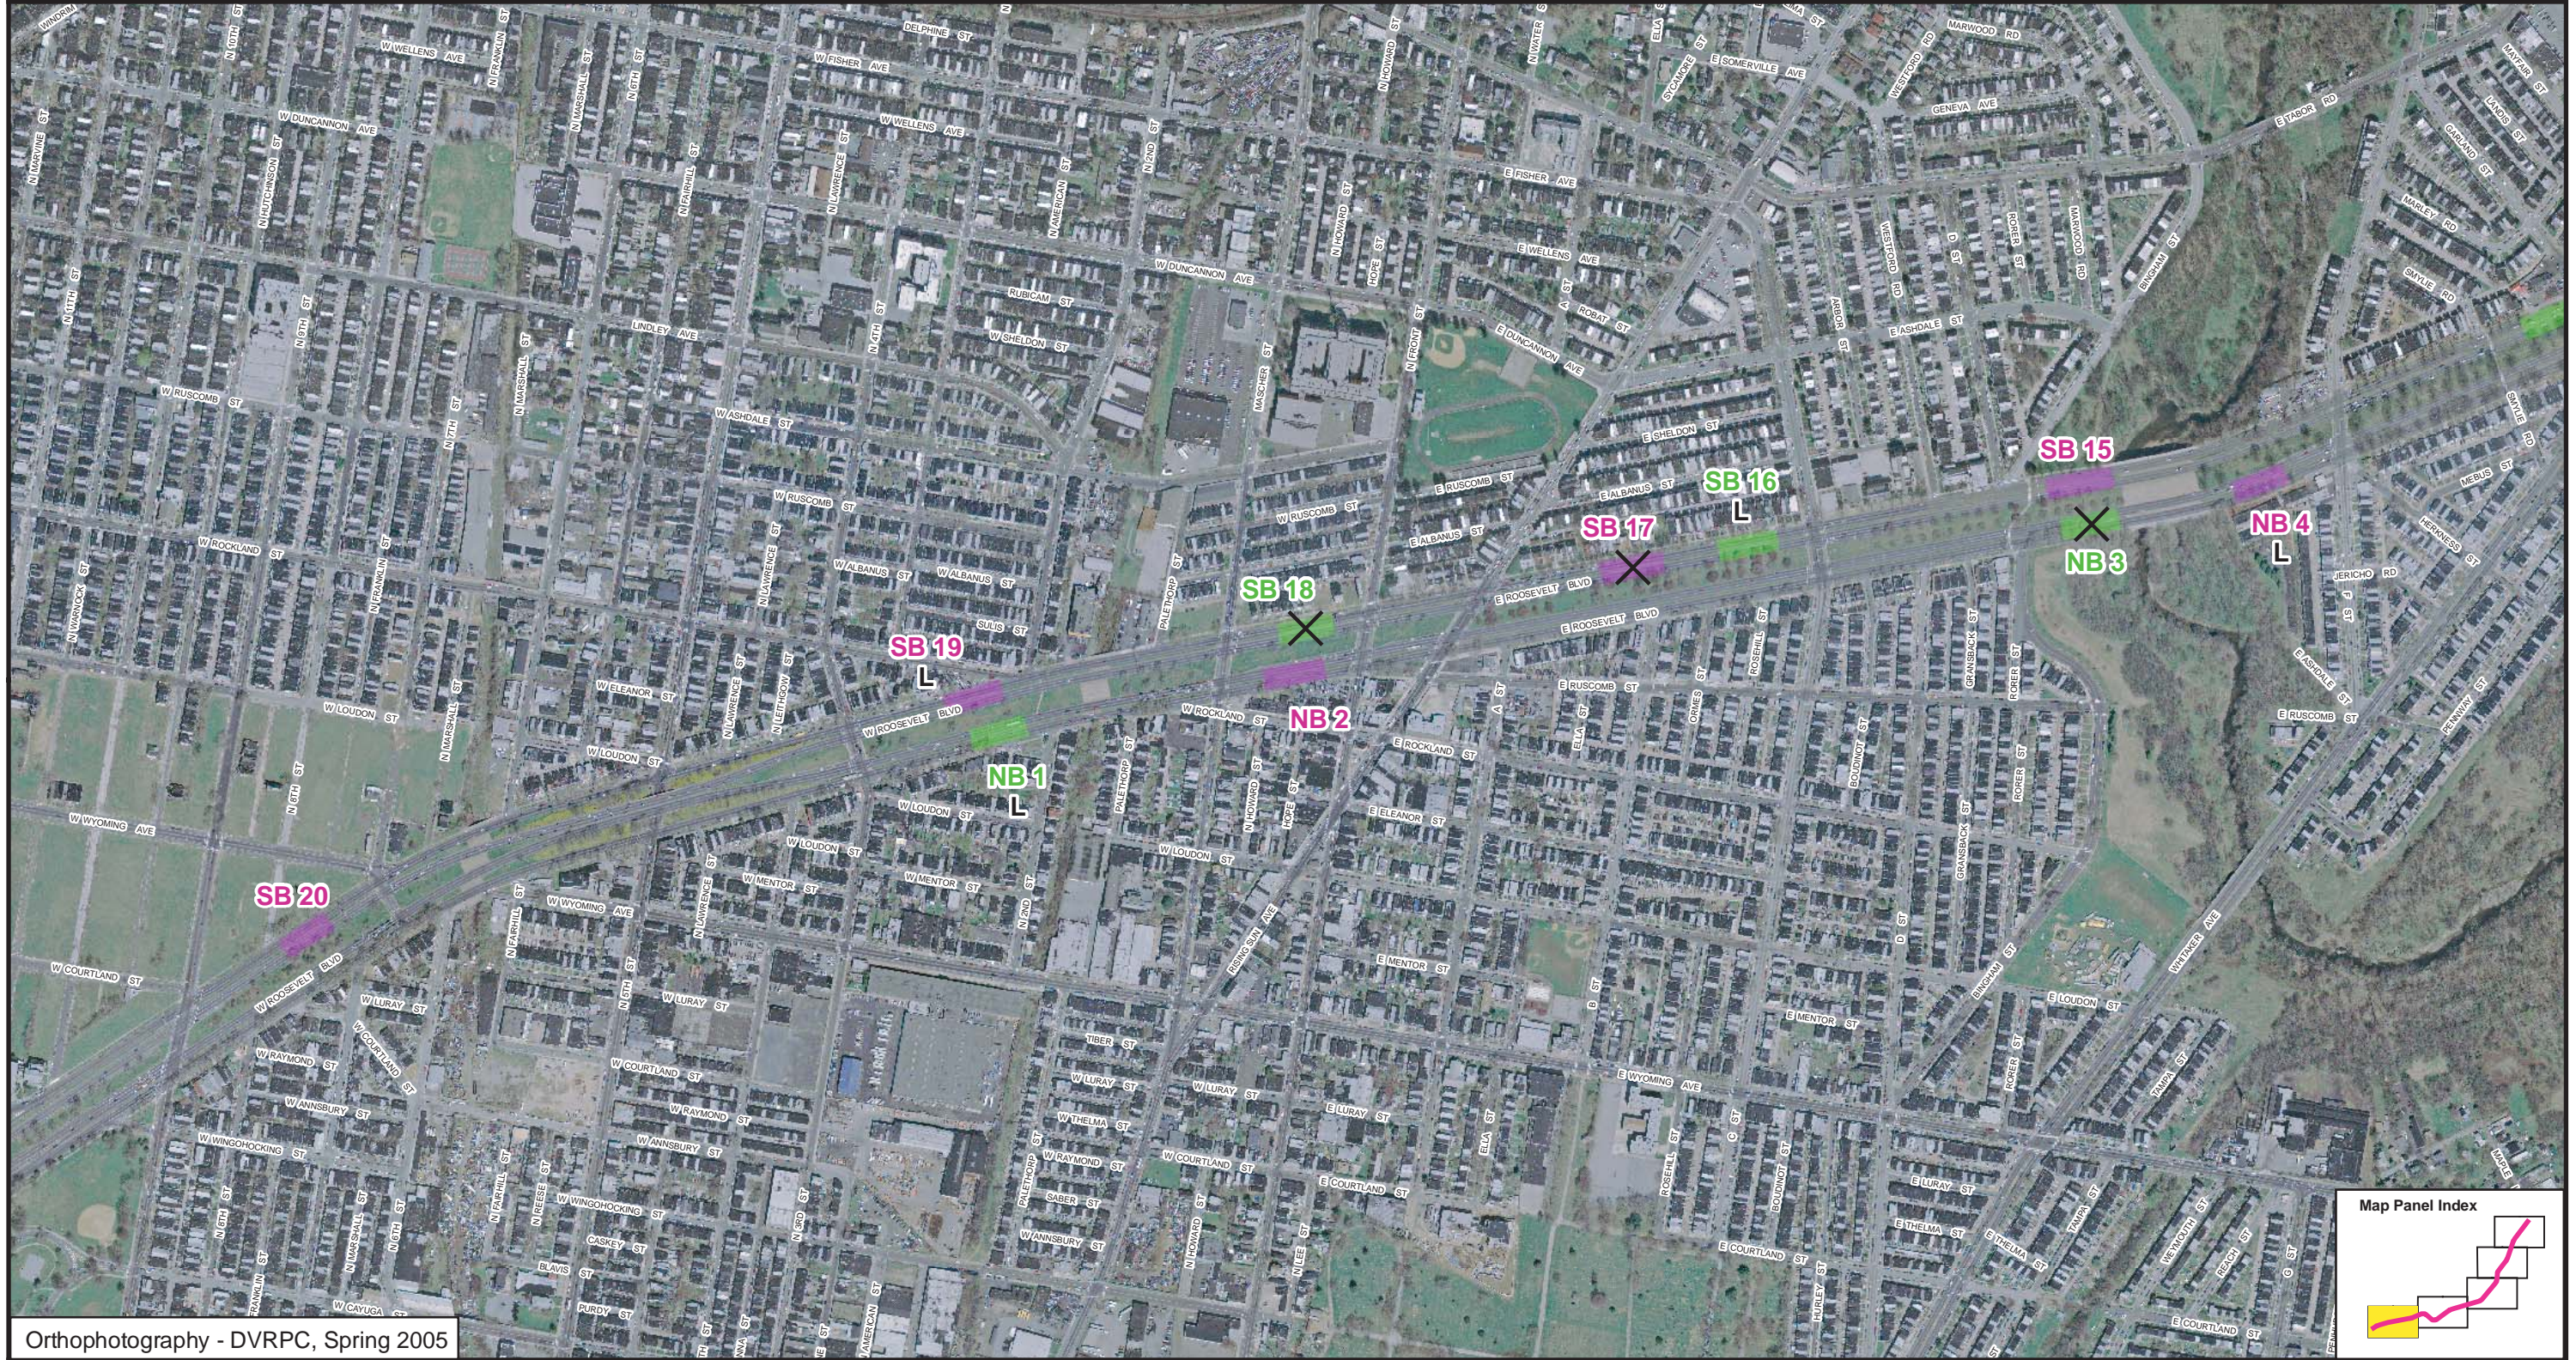
Roosevelt Boulevard Corridor Study - Crossover Locations (Panel 1)

- Express to Local Crossover
- Local to Express Crossover
- SB 19 Crossover ID
- L Crossover Lengthening Recommended
- X Crossover Elimination Recommended
