# COUNTY ROUTE

# 571

## Corridor Study

*Princeton Township  
Princeton Borough  
West Windsor Township  
East Windsor Township  
Hightstown Borough*

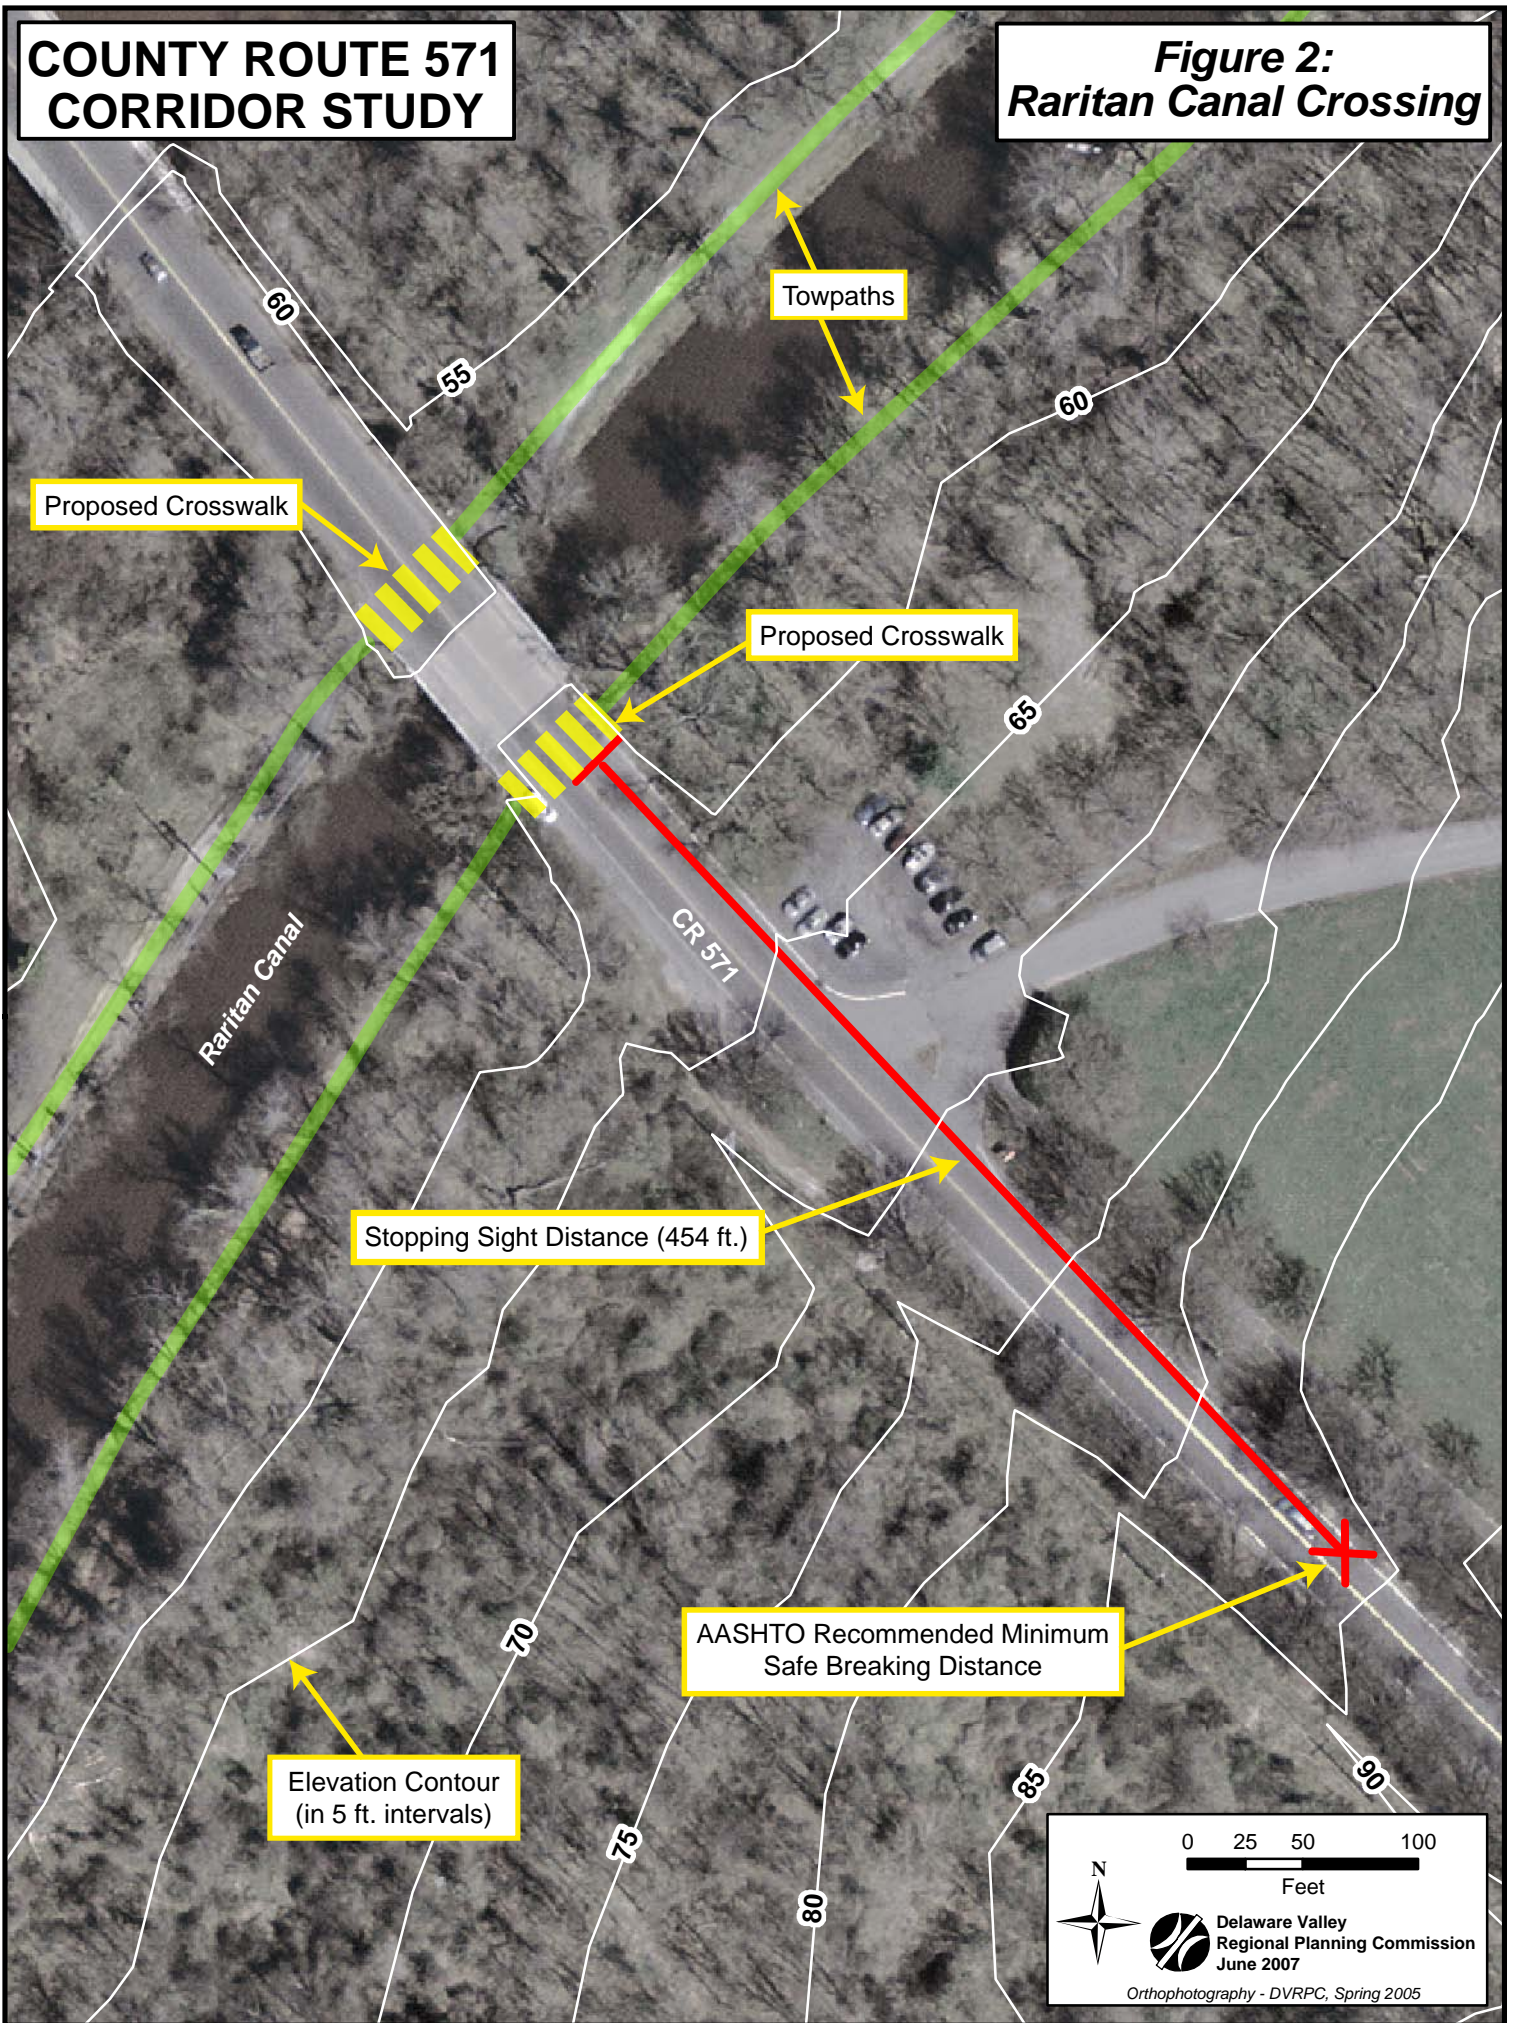
## Figure 2: Raritan Canal Crossing

A. *Poor sight distance* – As shown in **Figure 2**, there are two paths that intersect with CR 571. The first tow path is east of the canal and the second is west of the canal. The distance from the east path to the entrance of the adjacent parking area is approximately 250 feet. The road descends at approximately a 4% grade between the parking area and the tow path. Using the American Association of State Highway Transportation Official's (AASHTO) guidelines, a “stopping sight distance” of up to 454 feet can be calculated for the intersection of the paths and CR 571. **Figure 1** below shows the formula used in the calculations and **Table 1** provides the recommended stopping sight distance based on a variety of traffic speeds.

Stopping Sight Distance (454 ft.)

AASHTO Recommended Minimum  
Safe Breaking Distance

This distance highlighted in **Table 1** is the minimum distance needed for a driver traveling at 50 mph towards the towpath crossings to come to a safe stop after observing a pedestrian in the crossing. The AASHTO recommendation assumes a constant rate of deceleration (11.2 ft / sec <sup>2</sup>) and a reaction time of 2.5 seconds.

- In an effort to improve the safety of these crossings, prominent pedestrian crosswalks should be installed at the crossing to improve visibility and safety. As depicted in **Figure 3**, it is recommended that these crosswalks be made more prominent by installing in-pavement lighting to improve the visibility of the crossing to motorists. These are small fixtures embedded in the pavement along both sides of the crosswalk that flash an amber-colored light. They are activated only when a pedestrian is crossing. An example is located on CR 571 in the vicinity of the Princeton University campus, and they are also being installed by Mercer County and Princeton Township on Harrison Street and Alexander Street at the D&R Canal tow path.

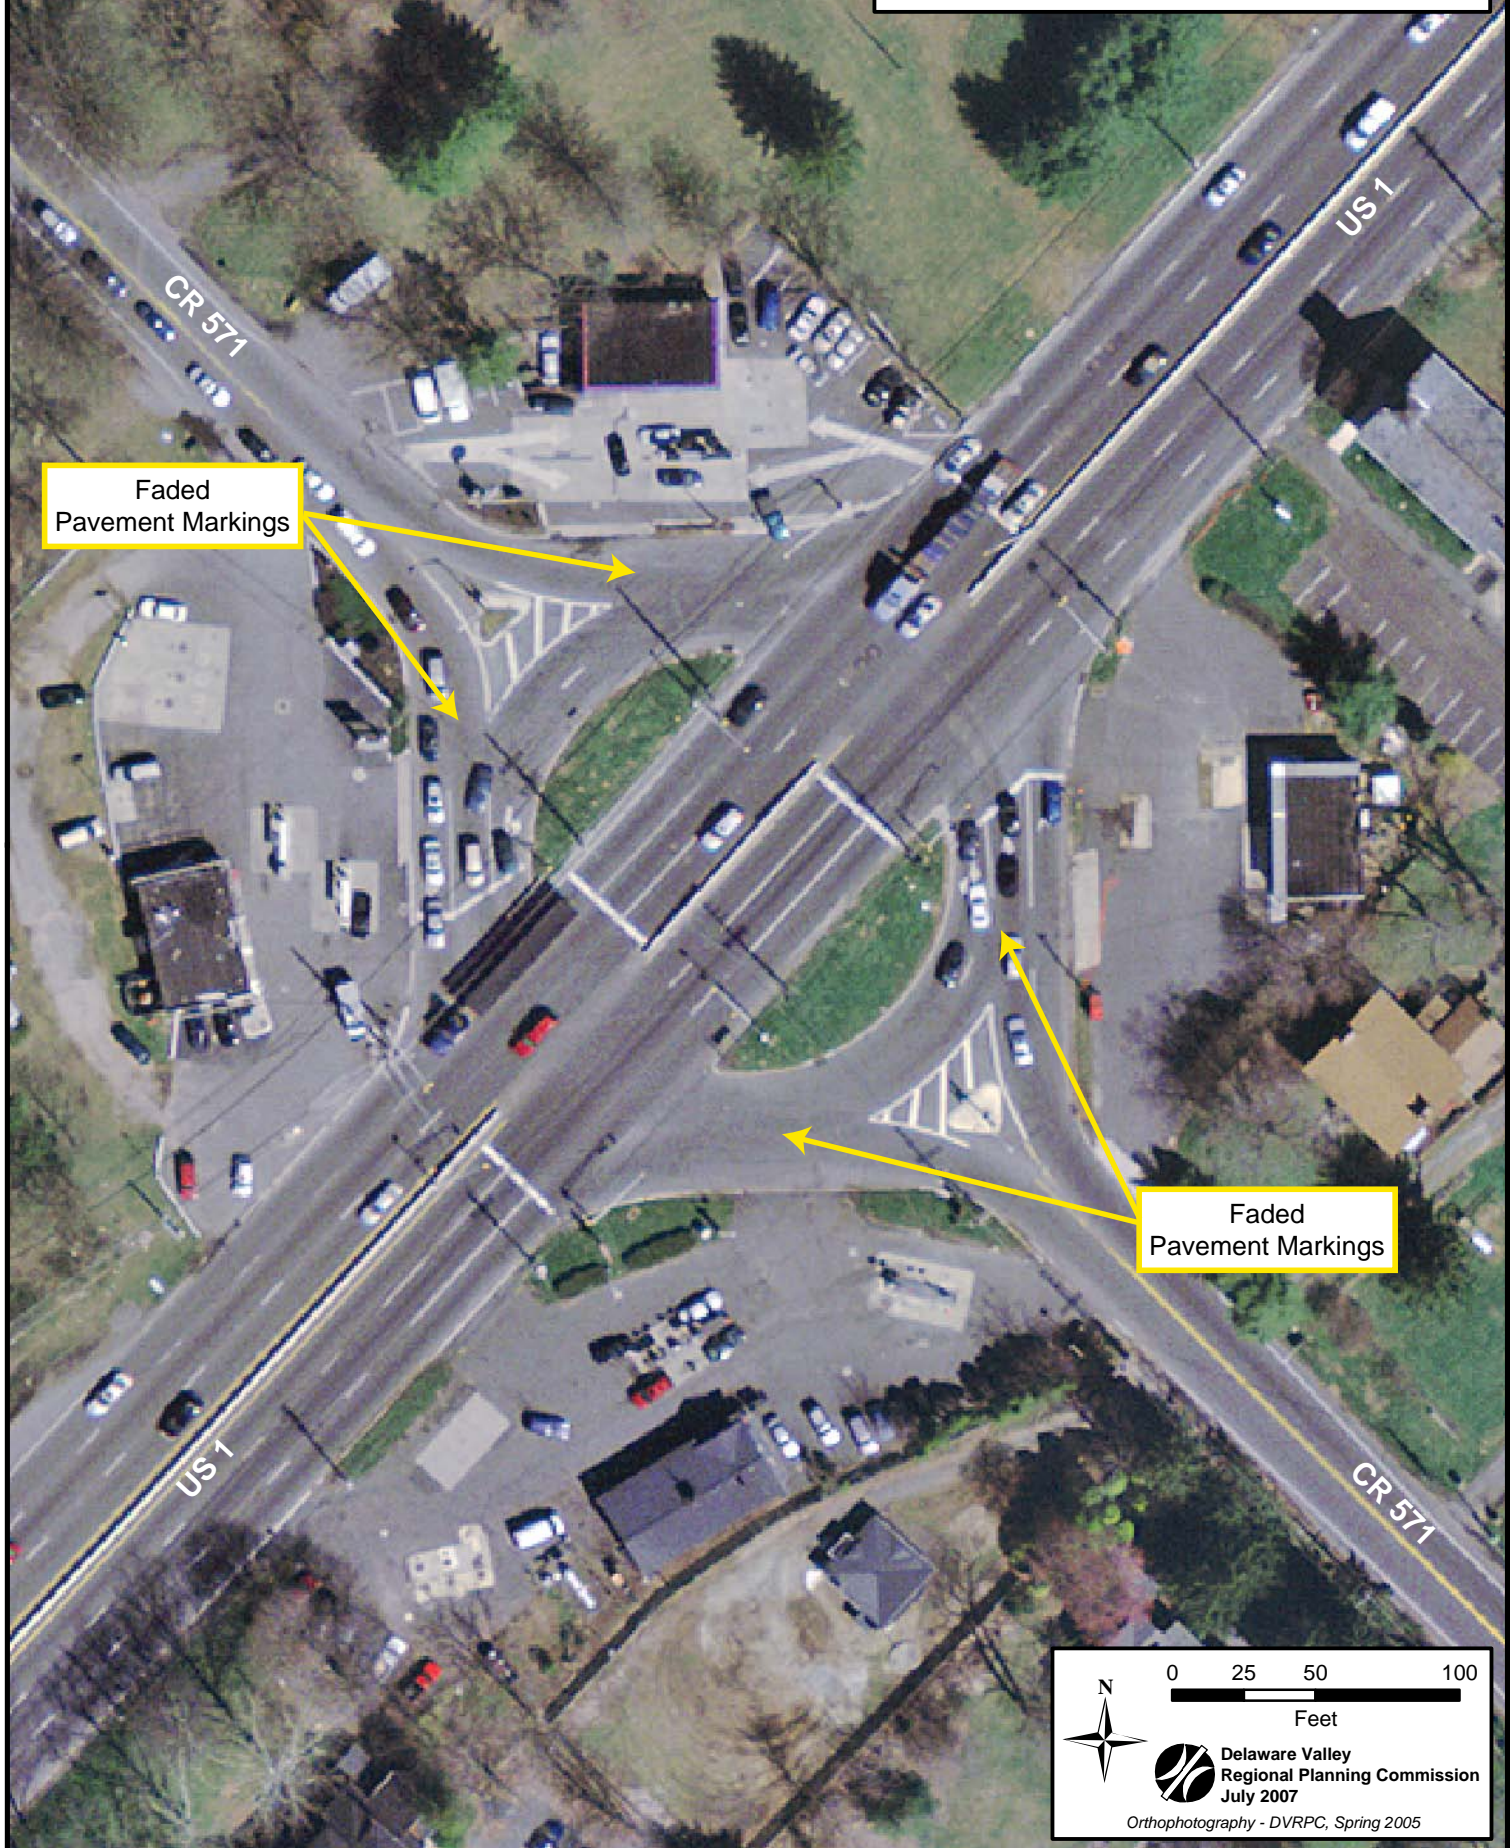
*Figure 4:  
CR 571 at US 1 -  
Existing Pavement Markings*

- A. *Faded pavement markings* – There is an absence of proper pavement markings to identify required vehicle positioning along the approaches of the intersection (**Figure 4**). This exacerbates the congestion experienced at this location since drivers cannot readily identify the appropriate lanes in which they should be positioned. This slows traffic circulation through the intersection.
- B. *Sign clutter* – As depicted in **Figure 6**, there are approximately twenty-three signs located at the approaches to this intersection. The repetition of traffic signs creates signage clutter at the intersection. Too much information listed on too many directional and destination signs makes it difficult for motorists to read and navigate safely through the intersection.

Faded  
Pavement Markings

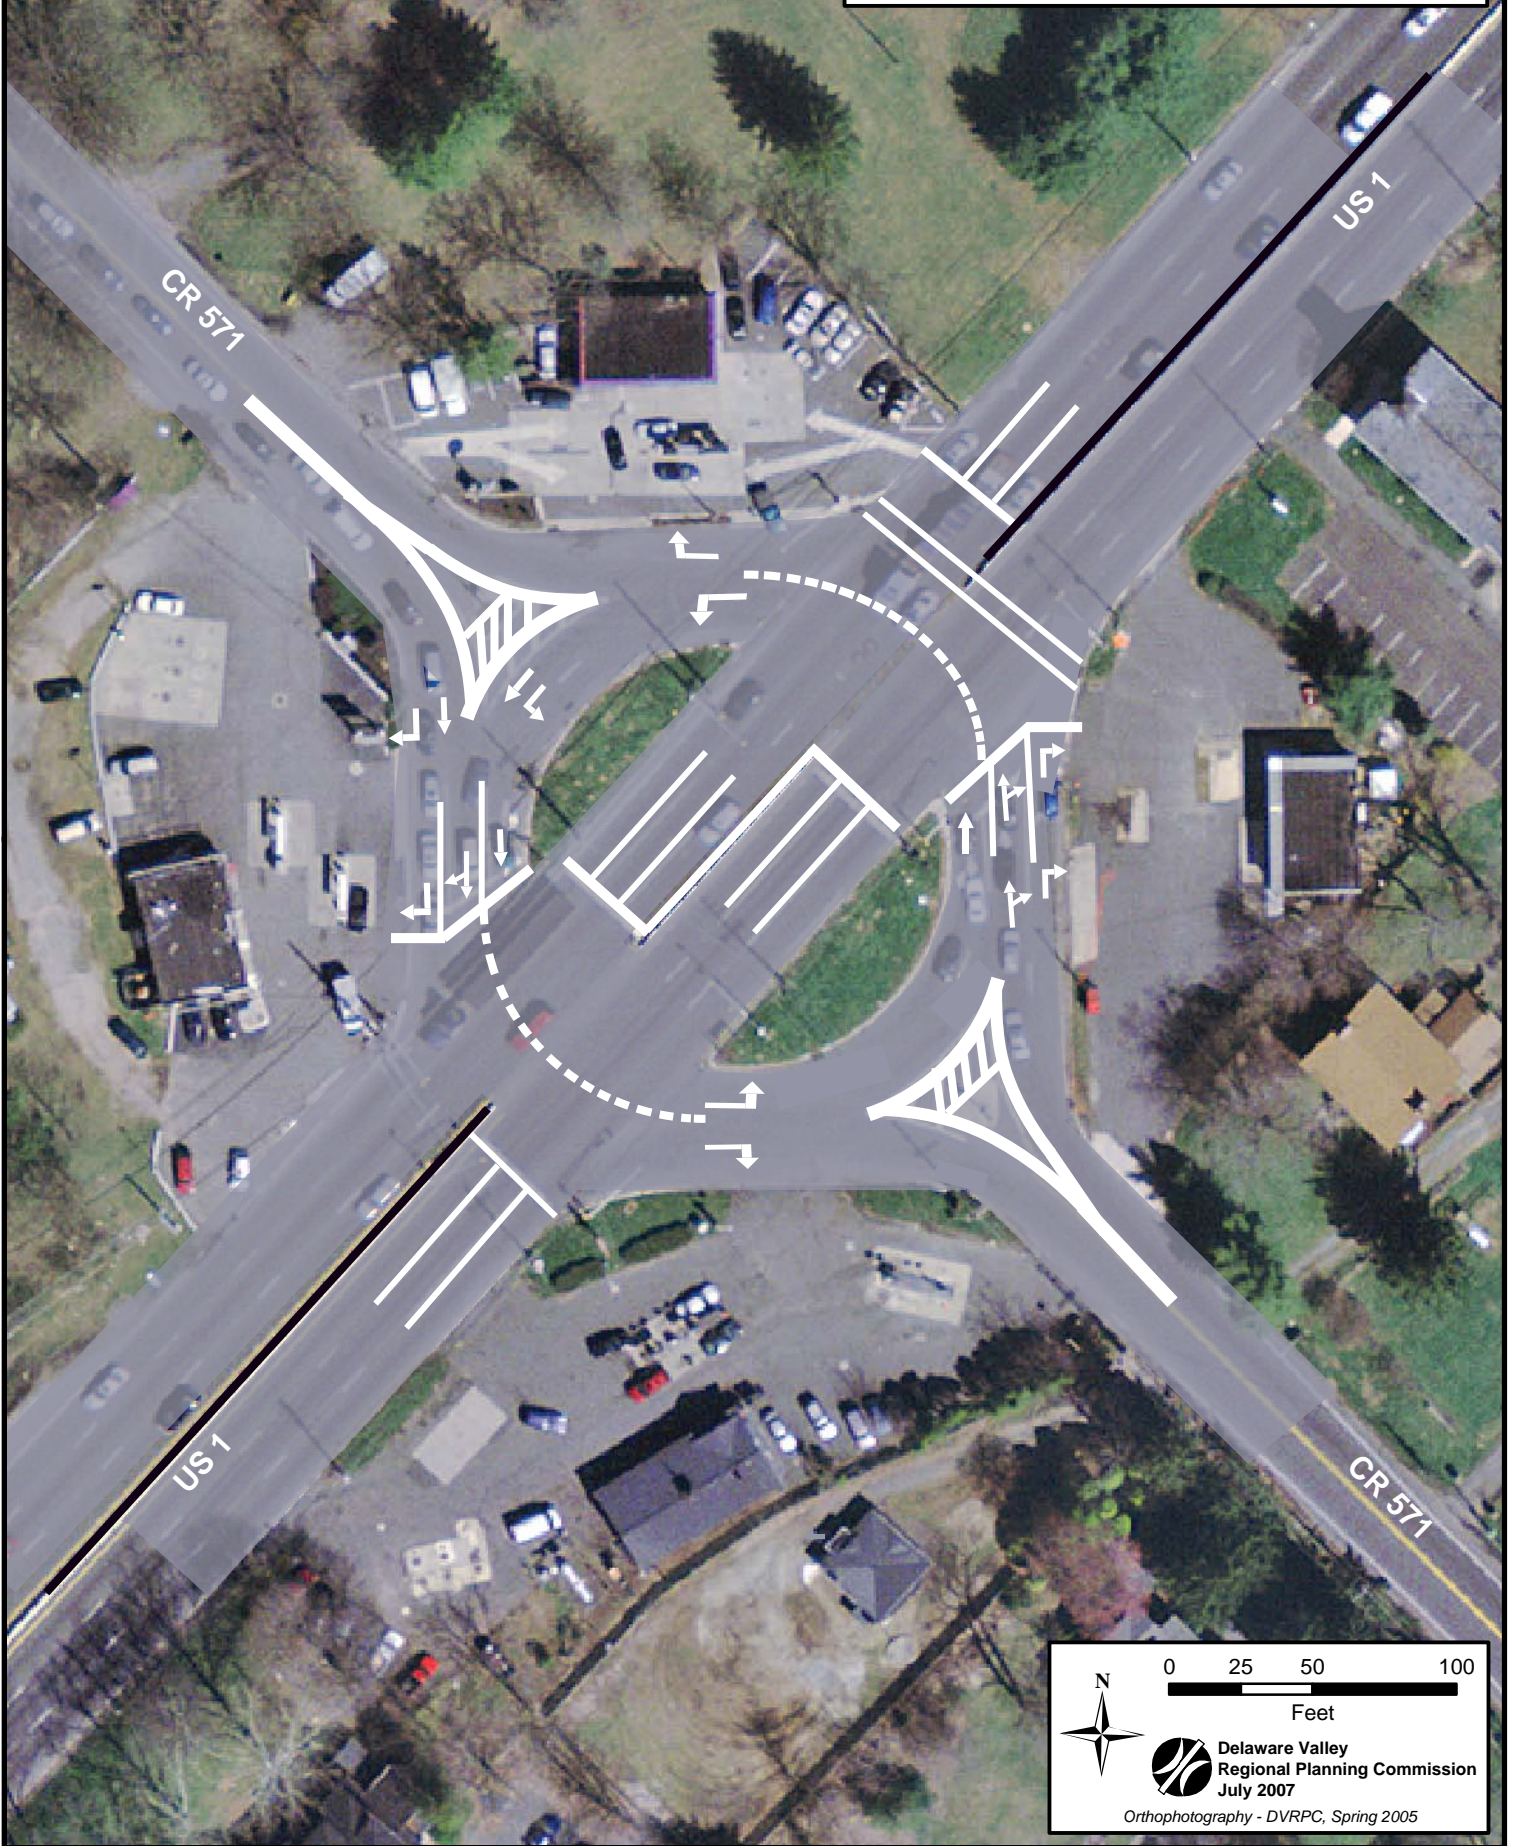
**Figure 5:  
CR 571 at US 1 -  
Enhanced Pavement Markings**

- *Pavement striping* – Improve existing pavement striping to enhance and improve traffic circulation by guiding vehicles through the intersection. Aside from restriping the stop bars and flared entry points at the approach of the circular intersection, as indicated in **Figure 5**, transverse and longitudinal lane markings and pavement arrows are recommended to better define and properly delineate the positioning of vehicles traveling through the intersection.

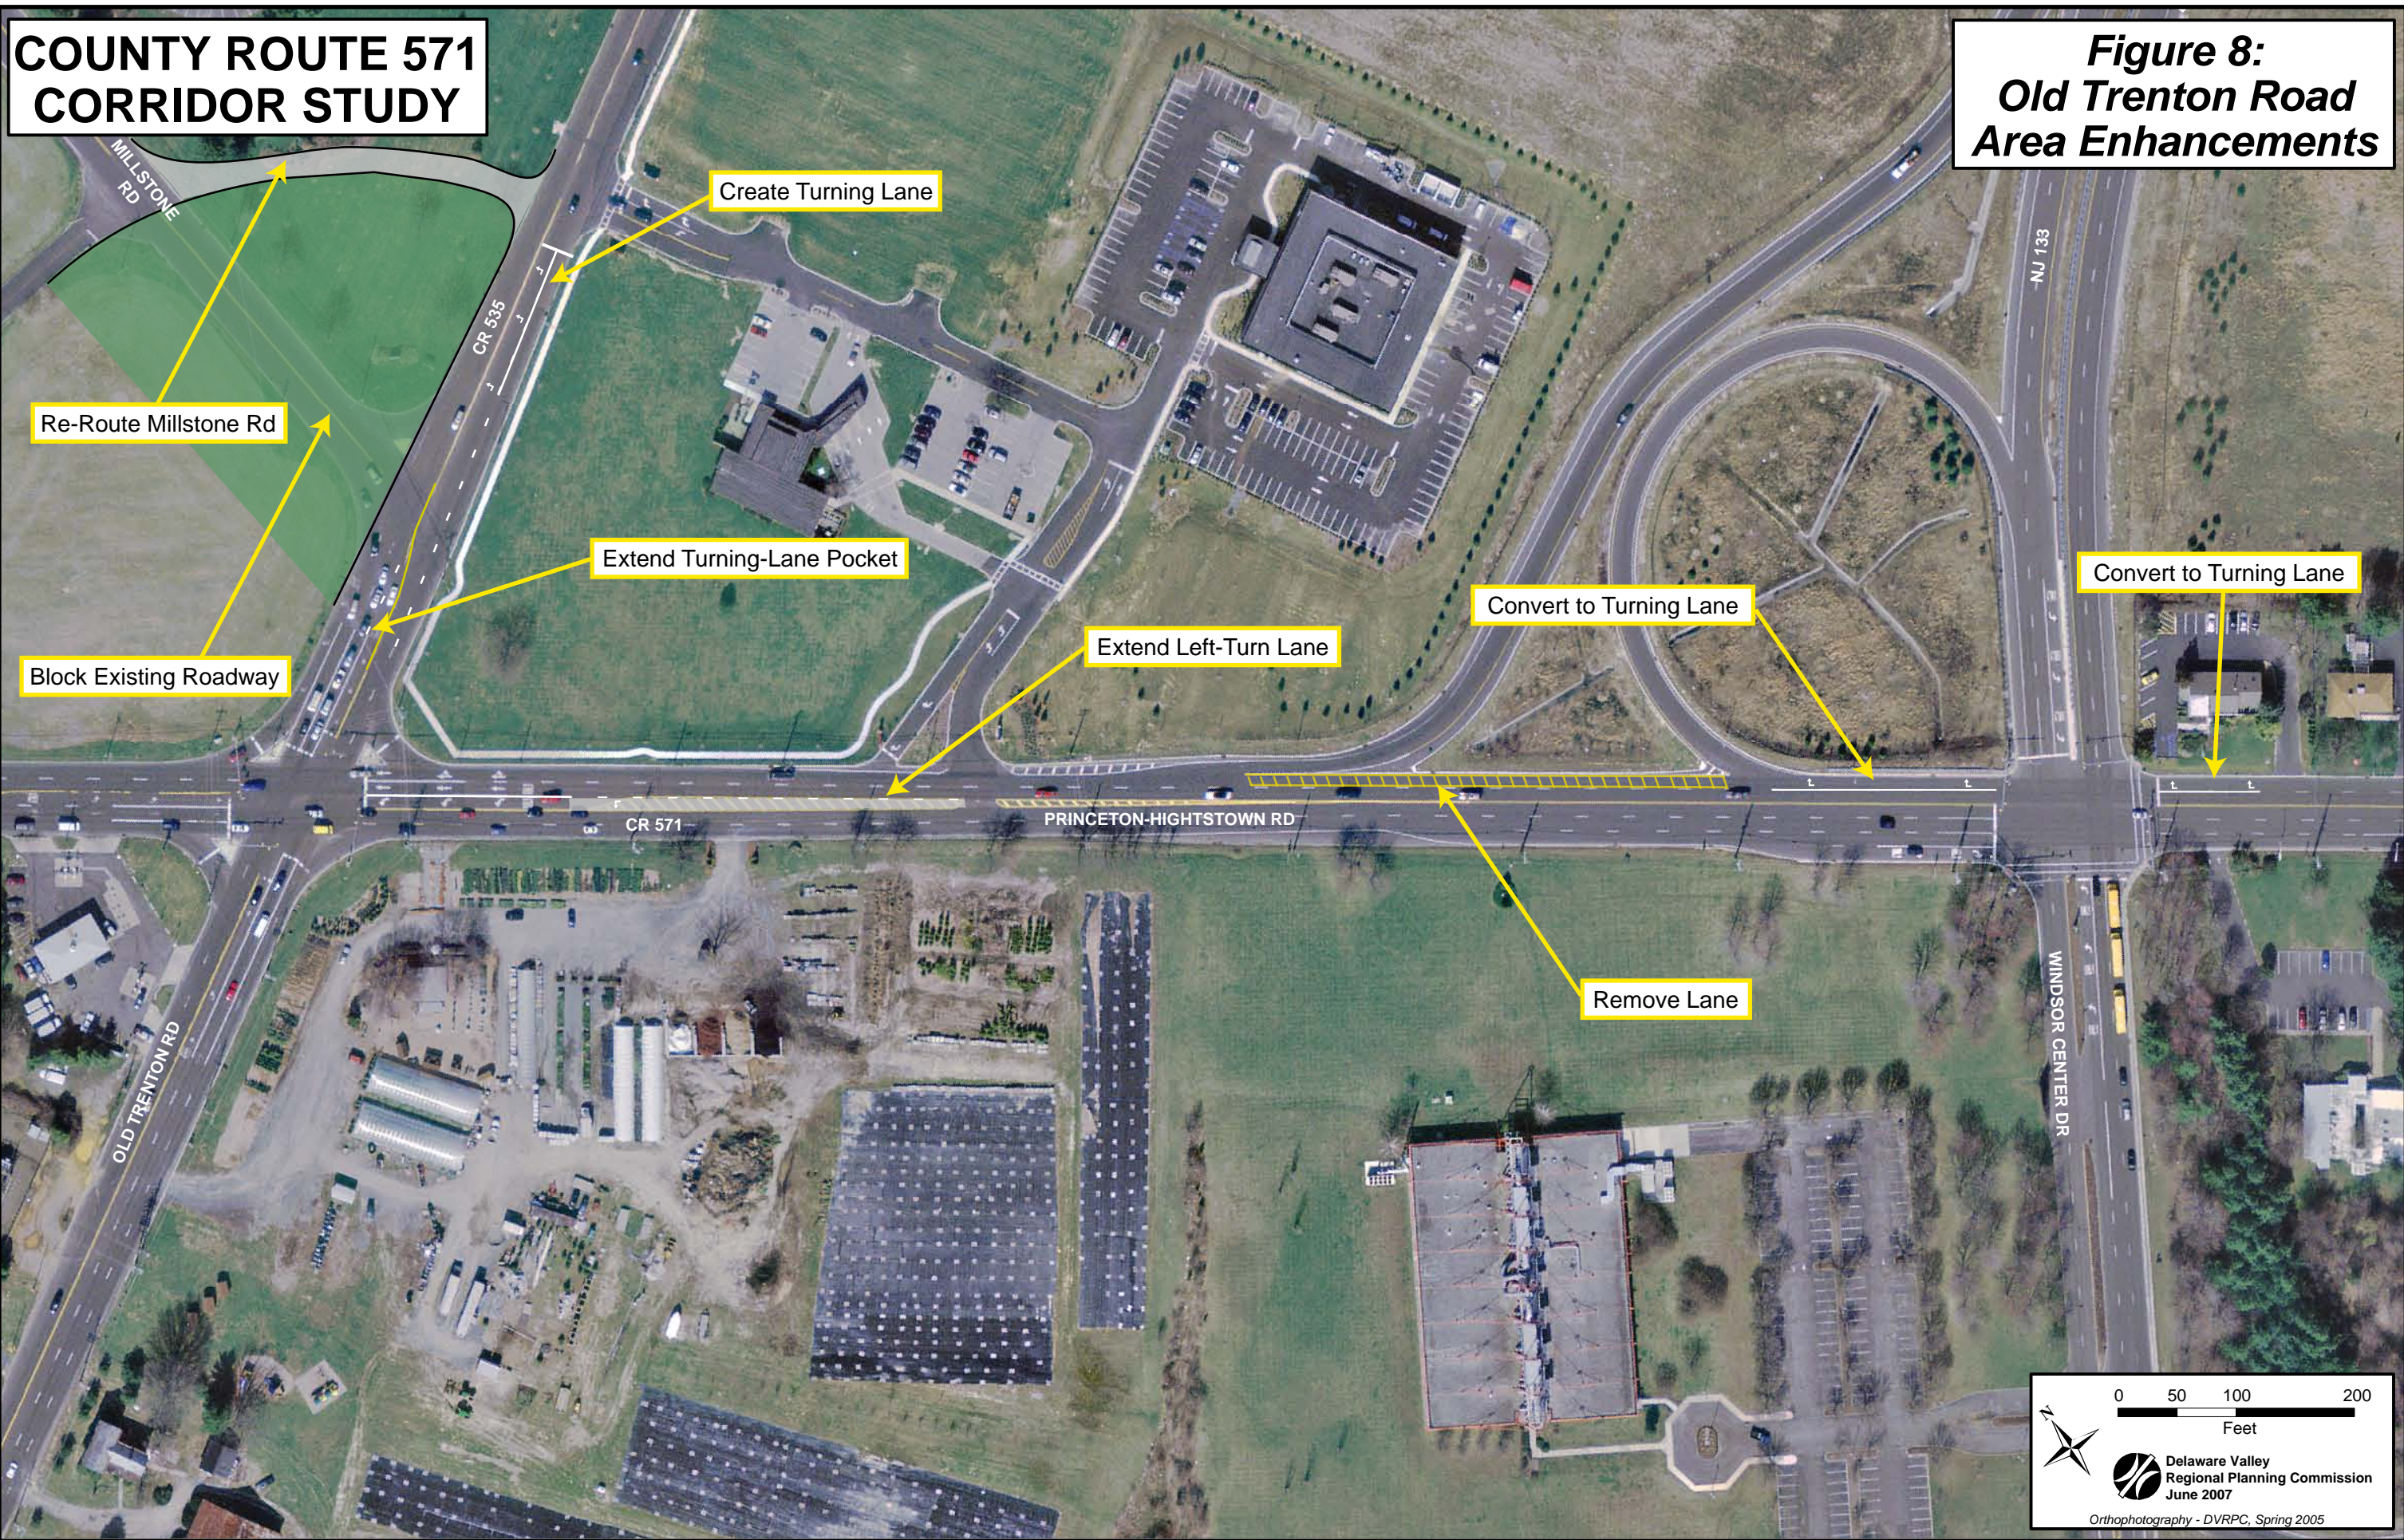
## Figure 8: Old Trenton Road Area Enhancements

- Provide for greater storage for traffic entering Millstone Road from Old Trenton Road. One method to accomplish this is by realigning Millstone Road approximately 200 feet north of its present location (**Figure 8**). This would permit the extension of the left-turn lane, thereby extending its storage capacity. The conflict with through traffic would also be minimized.

- Extend the westbound left-turn lane at CR 571/Old Trenton Road from its present 200 feet to 500 feet. This extended capacity can be gained by using the existing gore area for the left-turn lane.

- Convert the outer lane on westbound CR 571 approaching the Route 133 on-ramp to right turn only. There should be pavement markings defining this new configuration.

- Discontinue the outer through lane on westbound CR 571 for approximately 400 feet in advance of the westbound Route 133 off-ramp. This discontinuation should be indicated by a painted gore area. By narrowing the road, there will be less turbulence downstream with merging traffic from Route 133.

- Erect advanced warning signs on CR 571 westbound approaching Route 133 alerting motorists of merging traffic.
