# **CALHOUN STREET**

## Road Safety Audit

**January 2008**

## **CALHOUN STREET ROAD SAFETY AUDIT**

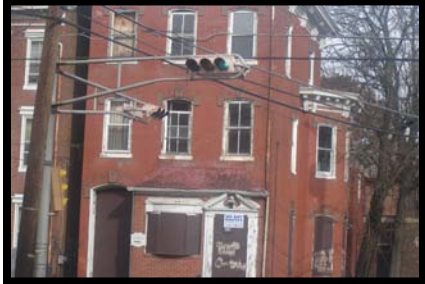
<p><b>Signals</b></p> <ul style="list-style-type: none"> <li>• Traffic signals outdated (8” heads)</li> <li>• Traffic signals do not have pedestrian man/hand or countdown heads</li> </ul> <p><b>Possible Improvement Strategies</b></p> <ul style="list-style-type: none"> <li>• Upgrade signals with 12” heads and include pedestrian heads with either man/hand or countdown.</li> </ul> <p><b>Level of Effort</b>                      <b>Potential Safety Benefit</b>                  Medium                                      High</p>

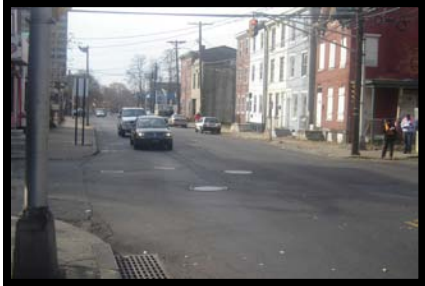
<p><b>Signals</b></p> <ul style="list-style-type: none"> <li>• Traffic signals along Calhoun Street are not coordinated</li> </ul> <p><b>Possible Improvement Strategies</b></p> <ul style="list-style-type: none"> <li>• Re-time signals for coordination along Calhoun Street</li> </ul> <p><b>Level of Effort</b>                      <b>Potential Safety Benefit</b>                  Low    High</p>

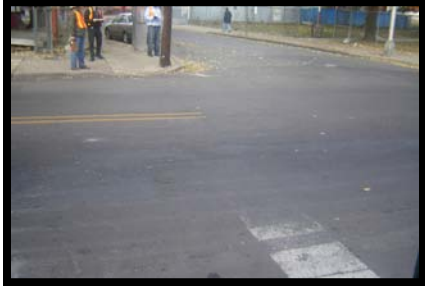
<p><b>Pavement Markings</b></p> <ul style="list-style-type: none"> <li>• Stop bars are missing at intersection approaches</li> <li>• Pavement markings are faded or missing in areas on both Calhoun Street and side streets</li> </ul> <p><b>Potential Improvement Strategies</b></p> <ul style="list-style-type: none"> <li>• Re-stripe or add pavement markings as appropriate to guide motorists</li> </ul> <p><b>Level of Effort</b>                      <b>Potential Safety Benefit</b>                  Low    High</p>

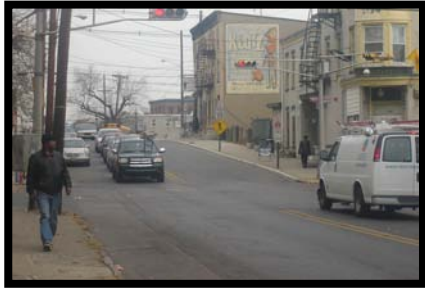
<p><b>Signage</b></p> <ul style="list-style-type: none"> <li>• Heavy pedestrian traffic in the area, only one pedestrian warning sign located at the northbound end of the study area.</li> </ul> <p><b>Potential Improvement Strategies</b>                  Install pedestrian signs north and south of the study area on the southbound and northbound sides of Calhoun Street.                  Install pedestrian crossing signs as appropriate at crosswalks.</p> <p><b>Level of Effort</b>                      <b>Potential Safety Benefit</b>                  Low    High</p>

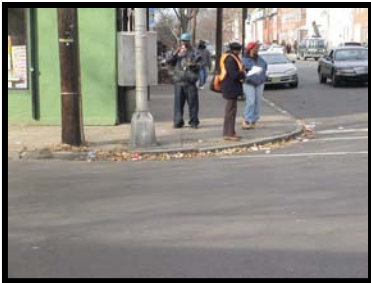
<p><b>Curb Ramps</b>                  Curb ramps are missing or are not ADA standards</p> <p><b>Potential Improvement Strategies</b>                  Upgrade or construct curb ramps to ADA standards</p> <p><b>Level of Effort</b>                      <b>Potential Safety Benefit</b>                  Low    High</p>

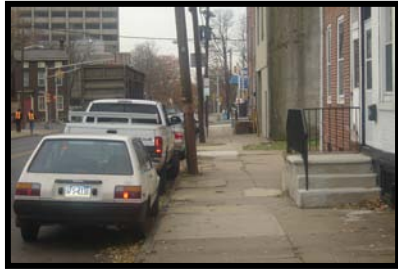
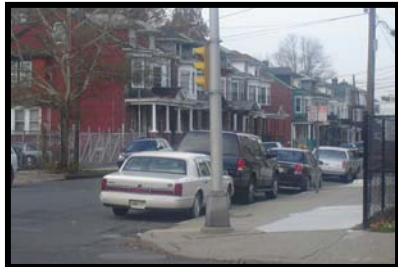
<p><b>Parking</b></p> <ul style="list-style-type: none"> <li>• Parking is allowed on one side of Calhoun Street, the southbound side. Parked cars encroach on the travel way.</li> <li>• Vehicles parked on the side streets are too close to the intersection – this makes turning movements difficult</li> </ul> <p><b>Potential Improvement Strategies</b>                  Re-stripe Calhoun Street with the northbound lane narrower to provide excess right of way on the southbound side for parking</p> <p>Install no parking zones around the intersections with painted curb and appropriate signage</p> <p><b>Level of Effort</b>                      <b>Potential Safety Benefit</b>                  Low    High</p>

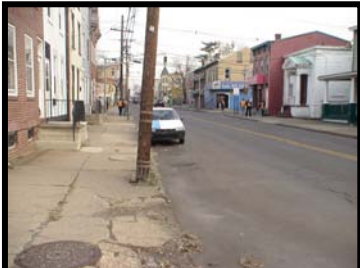
<p><b>Utility Poles</b>                  Many utility poles are within the clear zone</p> <p><b>Potential Improvement Strategies</b>                  Relocate utility poles outside the clear zone</p> <p><b>Level of Effort</b>                      <b>Potential Safety Benefit</b>                  High    High</p>

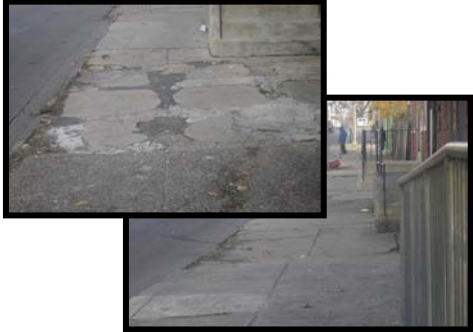
<p><b>Sidewalks</b>                  In general the sidewalk is in poor condition except for north of Spring Street</p> <p><b>Potential Improvement Strategies</b>                  Upgrade sidewalk for the entire length of Calhoun Street from State Street to Spring Street.</p> <p><b>Level of Effort</b>                      <b>Potential Safety Benefit</b>                  Medium                                      High</p>

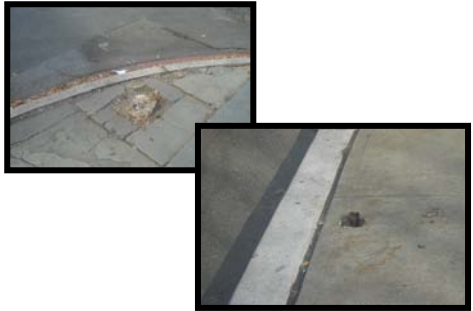
<p><b>Cut-off sign posts</b>                  Large number of cut-off sign posts sticking out in the sidewalk through out the study area</p> <p><b>Potential Improvement Strategies</b>                  Remove stubs from sidewalk to prevent pedestrians tripping.</p> <p><b>Level of Effort</b>                      <b>Potential Safety Benefit</b>                  Low    High</p>

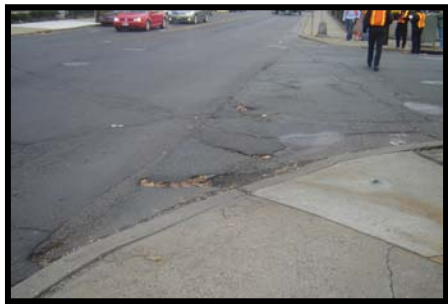
<p>Pavement markings are lacking or faded There are no crosswalks visible</p> <p><b>Potential Improvement Strategies</b> Add or re-stripe pavement markings as appropriate on Calhoun Street and Hanover Street – centerline, stop bars, pedestrian crosswalk</p> <p><b>Level of Effort</b>                      <b>Potential Safety Benefit</b> Low    High</p>

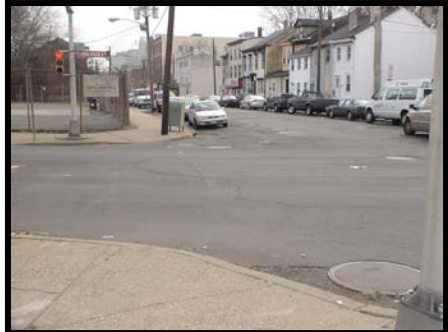
<p>According to the turning movement counts 67% of the westbound traffic on Hanover Street makes left turns during the afternoon peak hour. Angle crash was also the most frequent crash type for the period study</p> <p><b>Potential Improvement Strategies</b> Add a left turn lane for the westbound Hanover Street approach Restrict parking on Hanover Street westbound approach from Calhoun Street approximately 100 feet Re-time signal with protected/permissive left turns for the Hanover Street westbound approach during the afternoon peak period Add an all-red phase to the traffic signal timing.</p> <p><b>Level of Effort</b>                      <b>Potential Safety Benefit</b> Low    High</p>

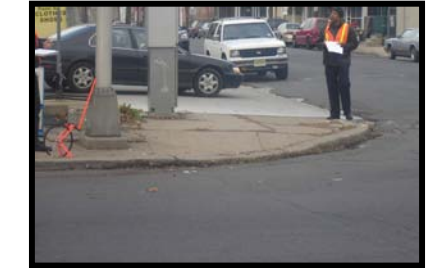
<p>Sidewalks are in poor condition</p> <p><b>Potential Improvement Strategies</b> Upgrade sidewalk. Replace northbound depressed curb sidewalk with straight curb</p> <p><b>Level of Effort</b>                      <b>Potential Safety Benefit</b> Medium    High</p>

<ul style="list-style-type: none"> <li>Sidewalks are in poor condition</li> </ul>	<ul style="list-style-type: none"> <li>Upgrade sidewalk.</li> <li>Replace northbound depressed curb sidewalk with straight curb</li> </ul>			
<ul style="list-style-type: none"> <li>Mail storage box on northeast corner is located in the clear zone – hazard</li> </ul>	<ul style="list-style-type: none"> <li>Relocate mail storage box</li> </ul>

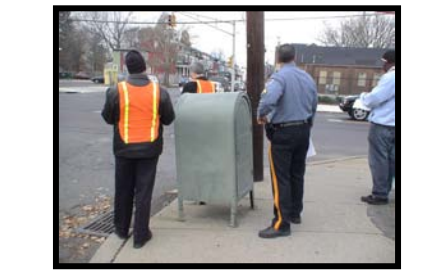
<p>Mail storage box on northeast corner is located in the clear zone – hazard</p> <p><b>Potential Improvement Strategies</b> Relocate mail storage box</p> <p><b>Level of Effort</b>                      <b>Potential Safety Benefit</b> Low    High</p>

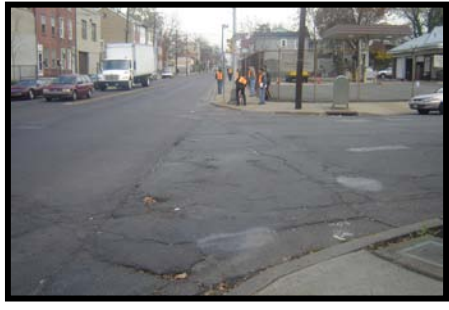
<p>Pavement on Hanover Street is in poor condition. Pavement adjacent to curb ramp on the southeast corner of the intersection is rutted</p> <p><b>Potential Improvement Strategies</b> Re-pave Hanover Street</p> <p><b>Level of Effort</b>                      <b>Potential Safety Benefit</b> Medium                                      High</p>

SAFETY ISSUES	Solution	Decision Agree/Reject	Planned Completion Date	Comments
<b><i>Hanover Street Intersection (continued)</i></b>				
<ul style="list-style-type: none"> <li>• Pavement on Hanover Street is in poor condition.</li> <li>• Pavement adjacent to curb ramp on the southeast corner of the intersection is rutted</li> </ul>	<ul style="list-style-type: none"> <li>• Re-pave Hanover Street</li> </ul>			
<ul style="list-style-type: none"> <li>• Southbound bus stop is located at the gas station access/egress.</li> </ul>	<ul style="list-style-type: none"> <li>• Consider relocation bus stop.</li> <li>• <b><i>Long Term</i></b> - Close gas station driveway nearest the intersection and widen the other on Calhoun Street</li> </ul>			
	<b>See corridor wide section for signal and pedestrian signal head issues</b>			
<b><i>Between Hanover Street and Passaic Street</i></b>				
<ul style="list-style-type: none"> <li>• Signs on the southbound side of Calhoun Street are faded</li> </ul>	<ul style="list-style-type: none"> <li>• Replace signs as appropriate</li> </ul>

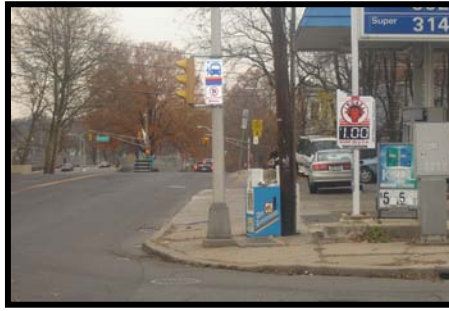
<p>Southbound bus stop is located at the gas station access/egress.</p> <p><b>Potential Improvement Strategies</b> Consider relocating bus stop.</p> <p><b>Level of Effort</b>                      <b>Potential Safety Benefit</b> Low    High</p> <p><b>Potential Improvement Strategies</b> <i>Long Term</i> - Close gas station driveway nearest the intersection and widen the other on Calhoun Street</p> <p><b>Level of Effort</b>                      <b>Potential Safety Benefit</b> Medium                                      High</p> <p><b>See corridor wide section for signal and pedestrian signal head issues</b></p>

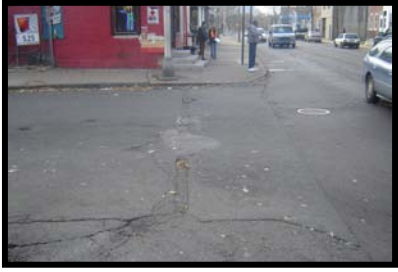
<p>There are no pavement markings on Passaic Street</p> <p><b>Potential Improvement Strategies</b> Add pavement markings as appropriate on Passaic Street – centerline, stop bars, pedestrian crosswalk</p> <p><b>Level of Effort</b>                      <b>Potential Safety Benefit</b> Low    High</p>

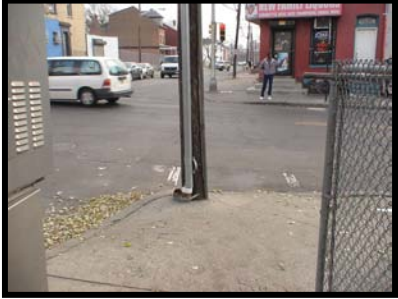
<p>There are no crosswalks or stop bars at the Calhoun Street approaches</p> <p><b>Potential Improvement Strategies</b> Add stop bars and “continental” crosswalk to the Calhoun Street approaches</p> <p><b>Level of Effort</b>                      <b>Potential Safety Benefit</b> Low    High</p>

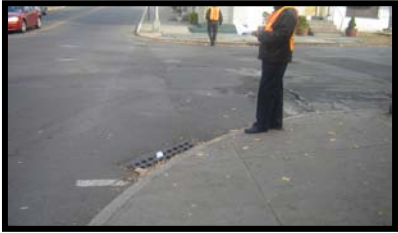
<p>High pedestrian traffic, lack of pedestrian amenities</p> <p><b>Potential Improvement Strategies</b> Add pedestrian crossing warning signs at crosswalk</p> <p><b>Level of Effort</b>                      <b>Potential Safety Benefit</b> Low    High</p>

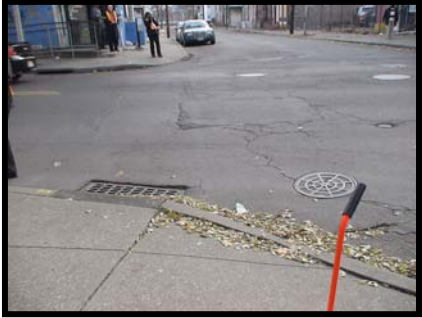
<p>At the westbound approach of the intersection, vehicles are parked too close to intersection; this further compromises an already tight turning radius</p> <p><b>Potential Improvement Strategies</b> Restrict parking at the intersection using appropriate signage and painted curb</p> <p><b>Level of Effort</b>                      <b>Potential Safety Benefit</b> Low    High</p>

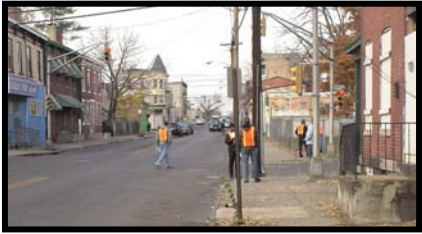
<p>There are no “one-way” signs for west leg of Passaic Street</p> <p><b>Potential Improvement Strategies</b> Install back to back “one-way” signs at the intersection</p> <p><b>Level of Effort</b>                      <b>Potential Safety Benefit</b> Low    Medium</p>

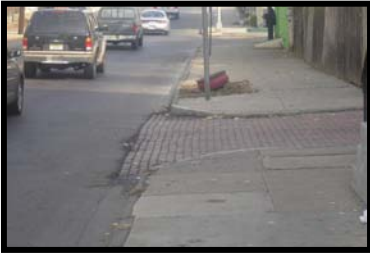
<p>No curb ramps at alley intersection with Calhoun Street</p> <p><b>Potential Improvement Strategies</b> Construct curb ramp per ADA standards</p> <p><b>Level of Effort</b>                      <b>Potential Safety Benefit</b> Low    High</p>
<p><b><i>Spring Street Intersection</i></b></p>

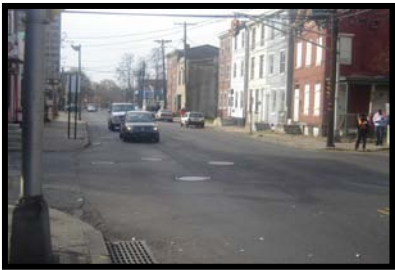
<p>There are no curb ramps</p> <p><b>Potential Improvement Strategies</b> Construct curb ramps at all corners of the intersection according to ADA standards</p> <p><b>Level of Effort</b>                      <b>Potential Safety Benefit</b> Low    High</p>

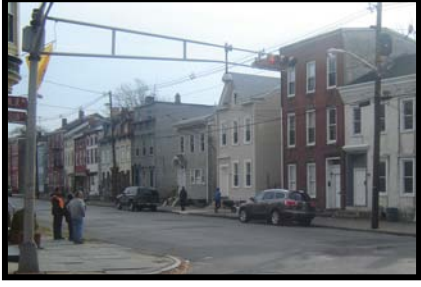
<p>Over head horizontal signal with no post mounted signals for pedestrians</p> <p><b>Potential Improvement Strategies</b> Re-pave and stripe as appropriate including centerline, stop bar and “continental” crosswalk</p> <p><b>Level of Effort</b>                      <b>Potential Safety Benefit</b> Medium                                      High</p>

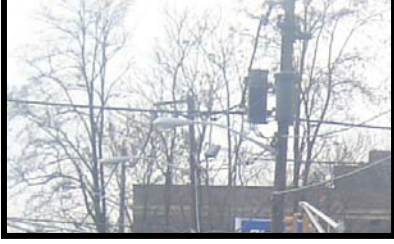
<p>137 to 141, street light is too dim, lens and bulb missing</p> <p><b>Potential Improvement Strategies</b> Replace lens and bulbs</p> <p><b>Level of Effort</b>                      <b>Potential Safety Benefit</b> Low    Medium</p>
<p><b>See corridor wide section for signal and pedestrian signal head issues</b></p>

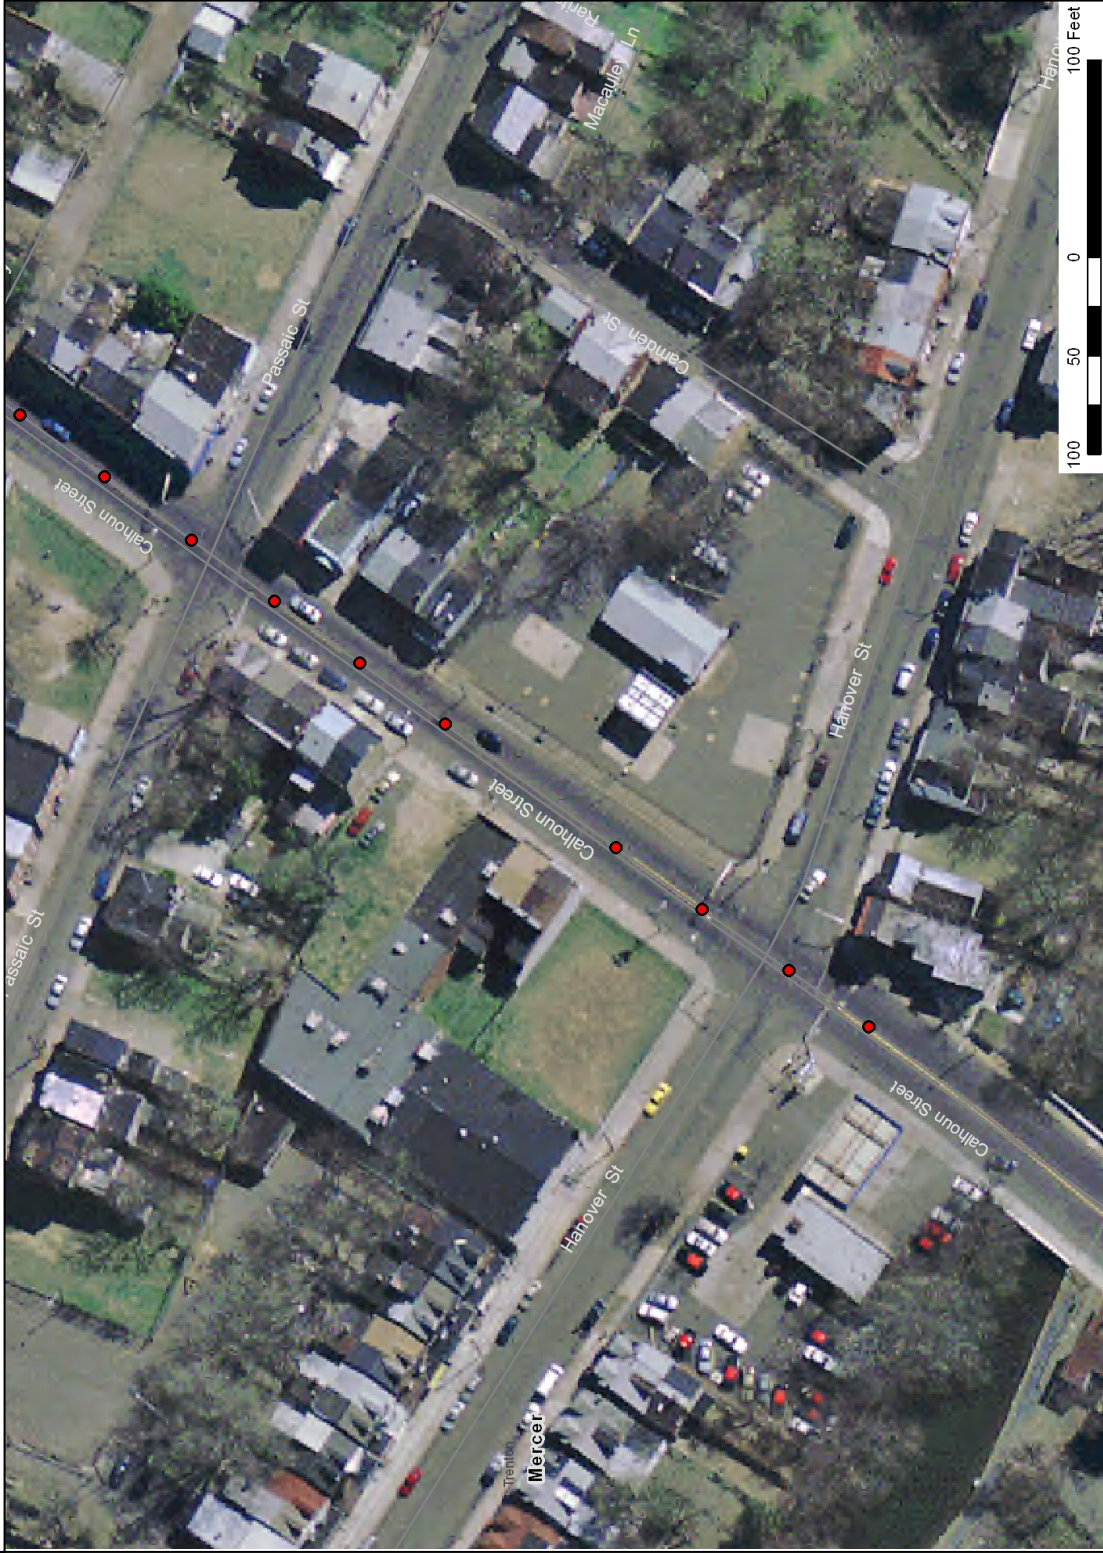
**1. Calhoun Street CR 653, Southern Section**  
 Milepost 0.08 to Milepost 0.18

COLLISION TYPE	
Angle	15
Rear End	14
Pedestrian	5
Same Direction Side Swipe	5
Fixed Object	2
Left/U Turn	2
Other	2
Backing	1
Head-On	1
Parked Vehicle	1
<b>Total</b>	<b>48</b>
LIGHT CONDITION	
Daylight	32
Dark	15
Dusk	1
<b>Total</b>	<b>48</b>
SURFACE CONDITION	
Dry	38
Wet	9
Icy	1
<b>Total</b>	<b>48</b>
SEVERITY	
Fatal	0
Major Injury	3
Moderate Injury	2
Minor Injury	11
Property Damage Only	32
<b>Total</b>	<b>48</b>

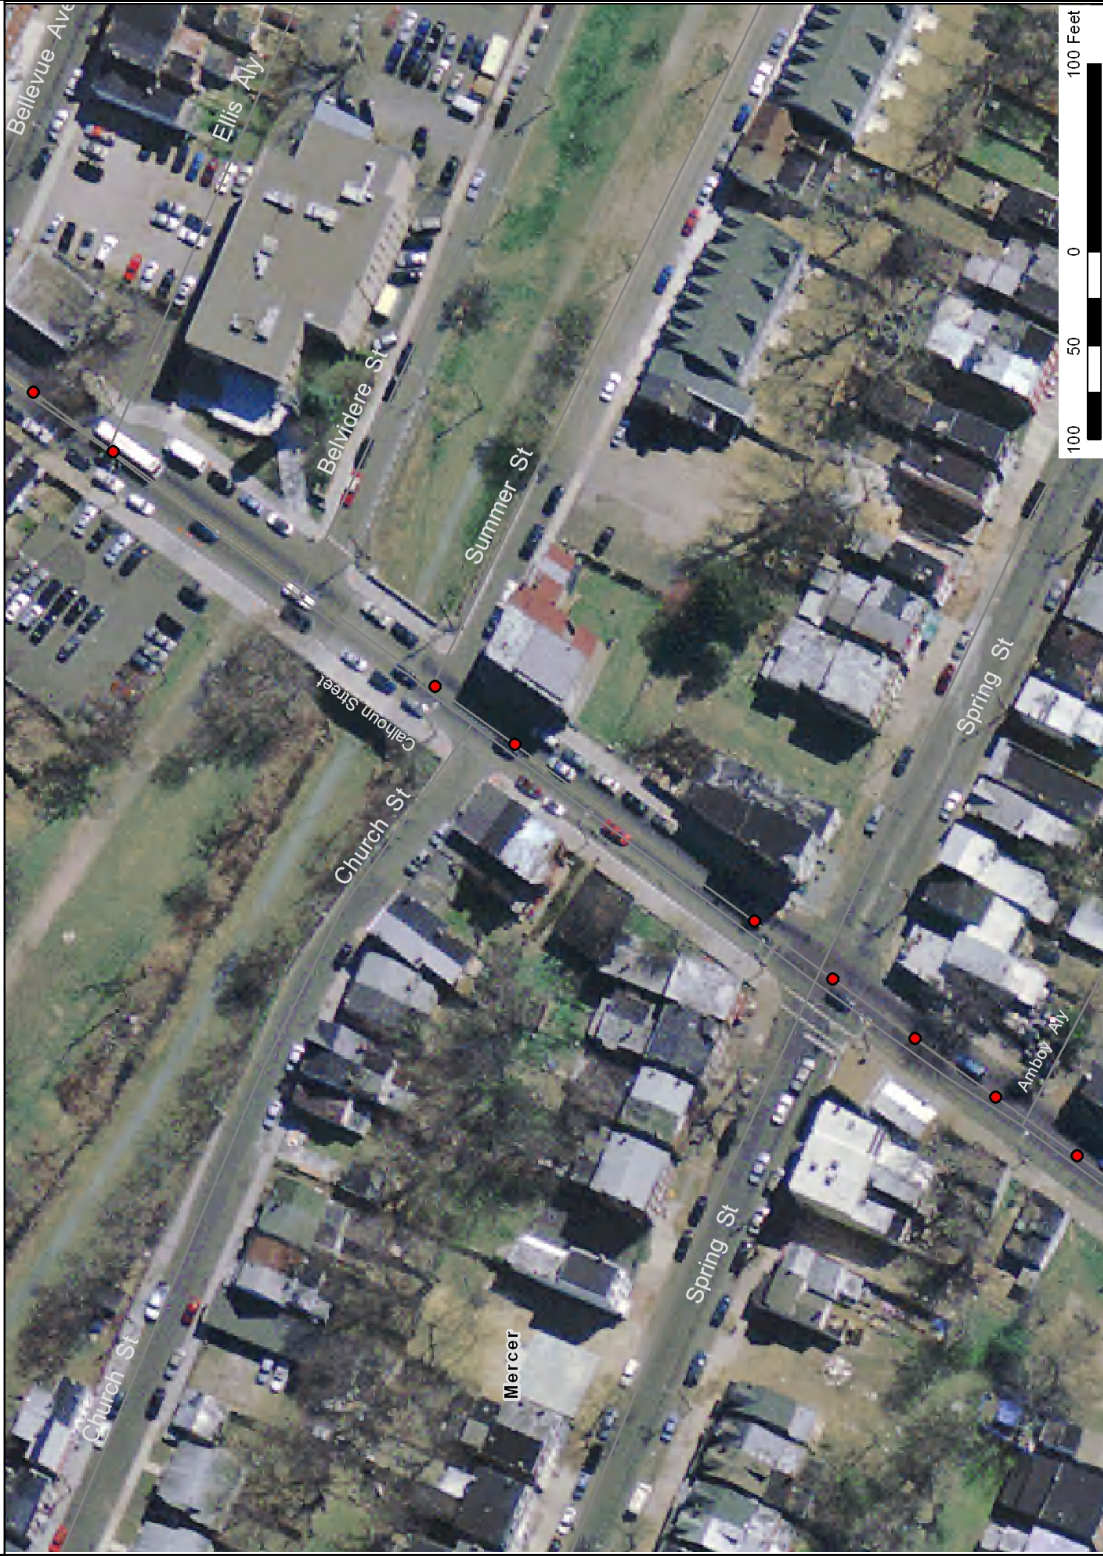
**2. Calhoun Street CR 653, Northern Section**  
 Milepost 0.20 to Milepost 0.30

COLLISION TYPE	
Angle	9
Same Direction Side Swipe	8
Rear End	6
Left/Right Turn	4
Parked Vehicle	4
Other	2
Head-On	1
<b>Total</b>	<b>34</b>
LIGHT CONDITION	
Daylight	25
Dark	6
Dawn	1
Dusk	1
N/A	1
<b>Total</b>	<b>34</b>
SURFACE CONDITION	
Dry	28
Wet	6
<b>Total</b>	<b>34</b>
SEVERITY	
Fatal	0
Major Injury	0
Moderate Injury	3
Minor Injury	15
Property Damage Only	16
<b>Total</b>	<b>34</b>
