**DELAWARE VALLEY
REGIONAL PLANNING
COMMISSION**

MEDFORD TOWNSHIP, BURLINGTON COUNTY

CONGESTION
CRASH site
Analysis
Program

TAUNTON BOULEVARD AND TUCKERTON ROAD, MEDFORD TOWNSHIP

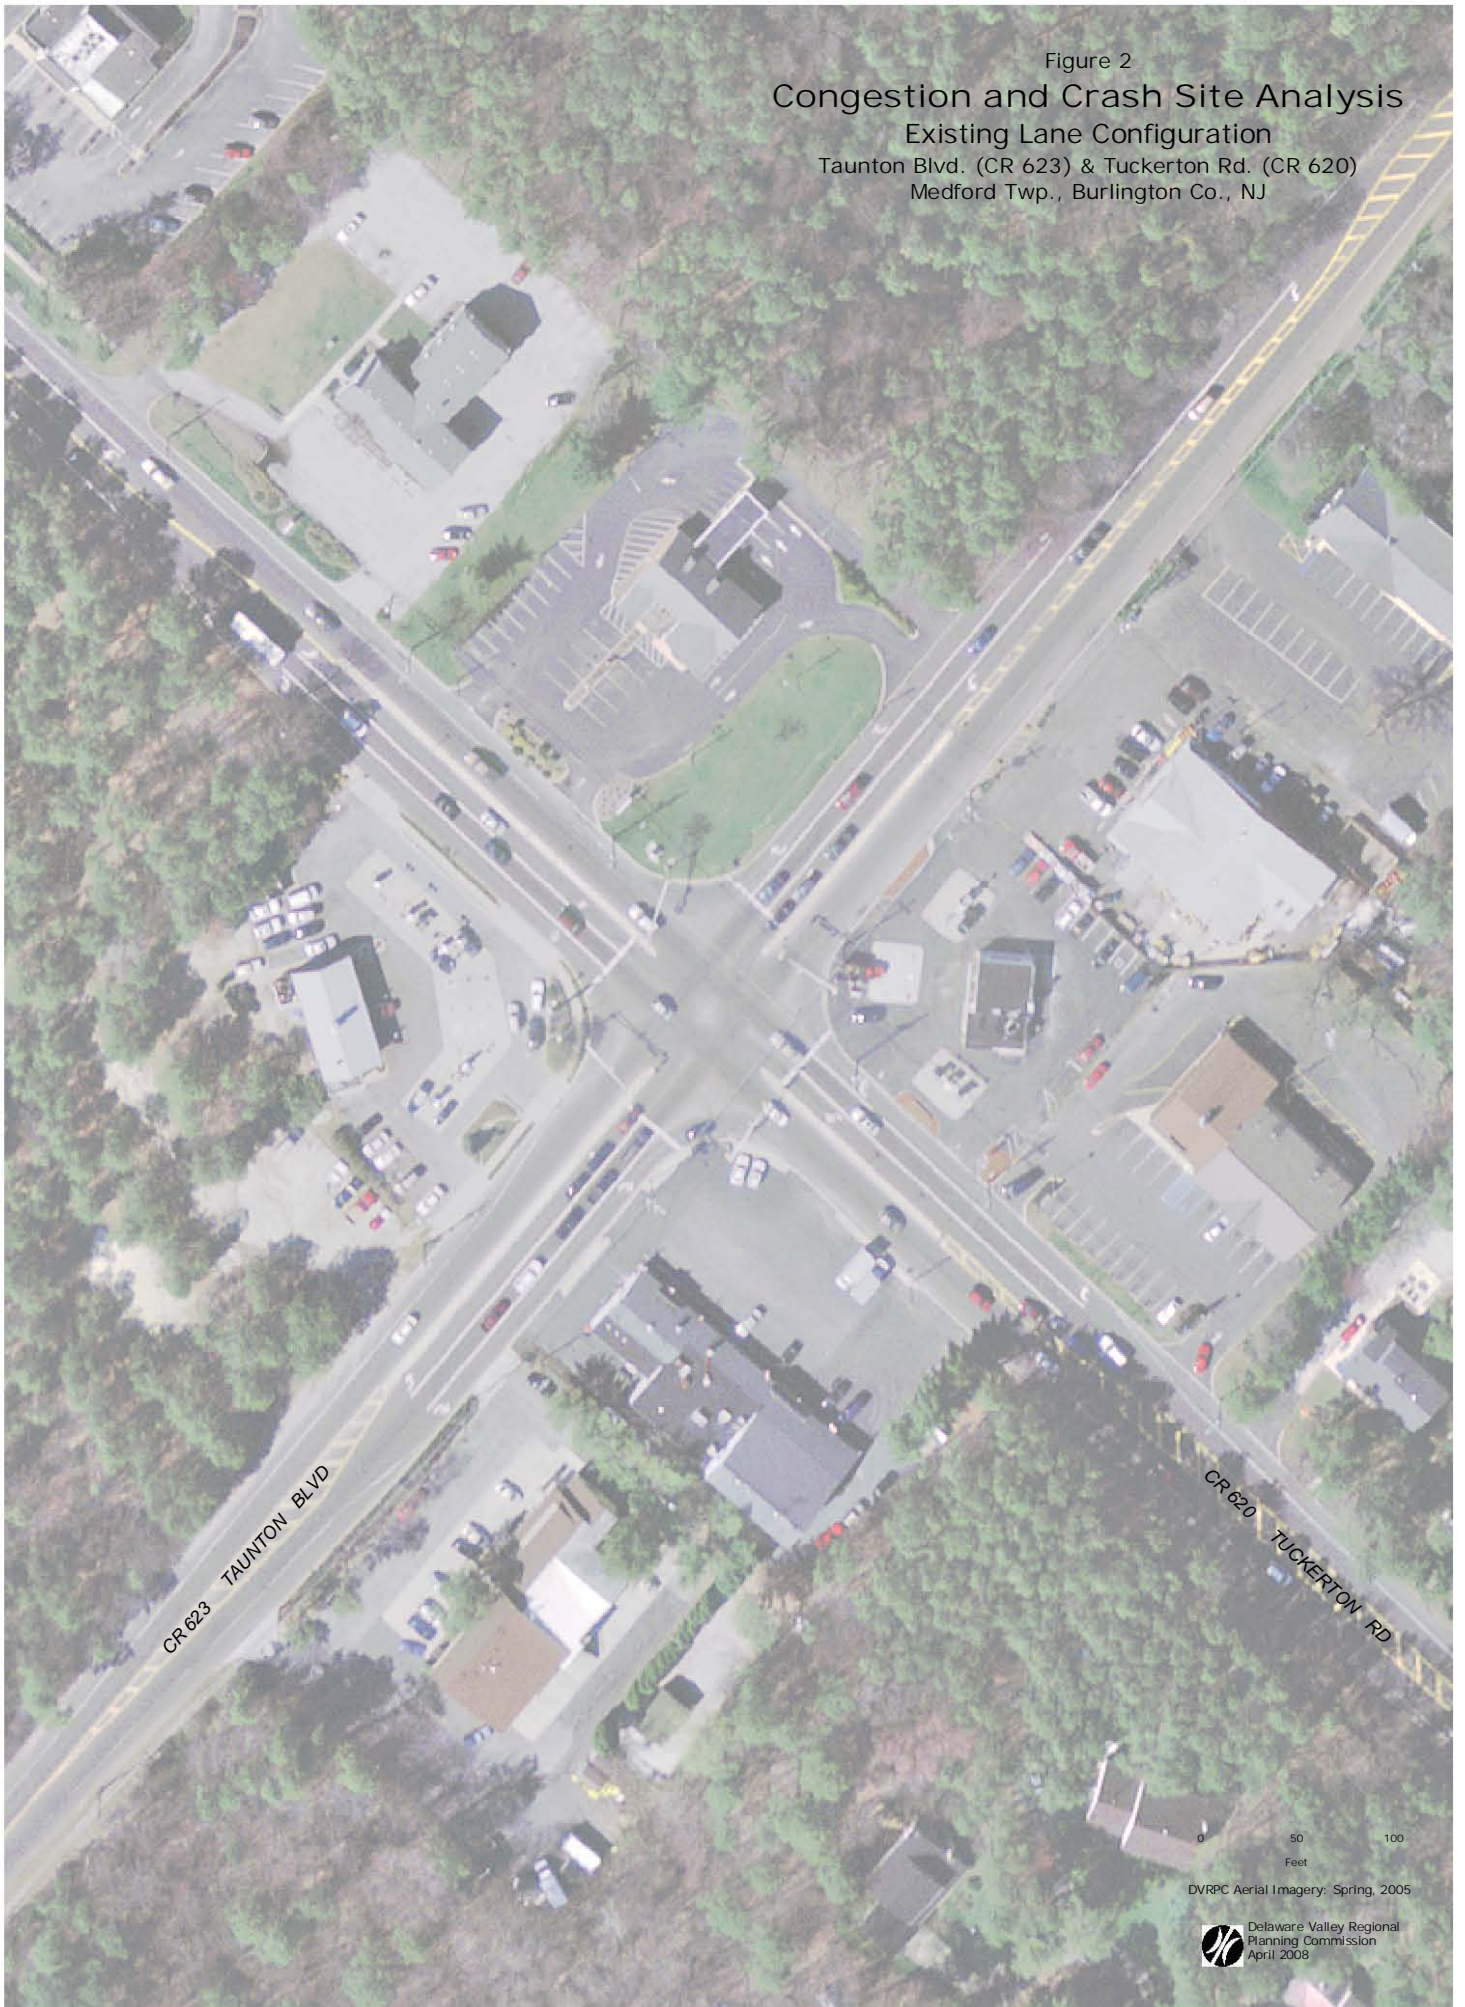
Figure 2
Congestion and Crash Site Analysis
Existing Lane Configuration
Taunton Blvd. (CR 623) & Tuckerton Rd. (CR 620)
Medford Twp., Burlington Co., NJ

Taunton Boulevard has two lanes, with one lane in each direction. As shown in **Figure 2**, at the intersection there are three lanes at each approach; the southbound and northbound directions both provide dedicated right-turn and left-turn lanes and one through lane. There is no shoulder available at the intersection and a raised median separates the northbound and southbound traffic. The speed limit on Taunton Boulevard is 35 MPH.

Tuckerton Road has two lanes, with one lane in each direction. At the intersection there are three lanes at each approach; eastbound and westbound directions provide dedicated right-turn and left-turn lanes and one through lane. There is no shoulder available at the intersection and a raised median separates the eastbound and westbound traffic. The speed limit on Tuckerton Road is 45 MPH.

Currently, the intersection experiences congestion during the peak periods. All four approaches have three lanes: dedicated left turn, through, and right turn. Left turns at the intersection are facilitated by protected left-turn signal phasing.

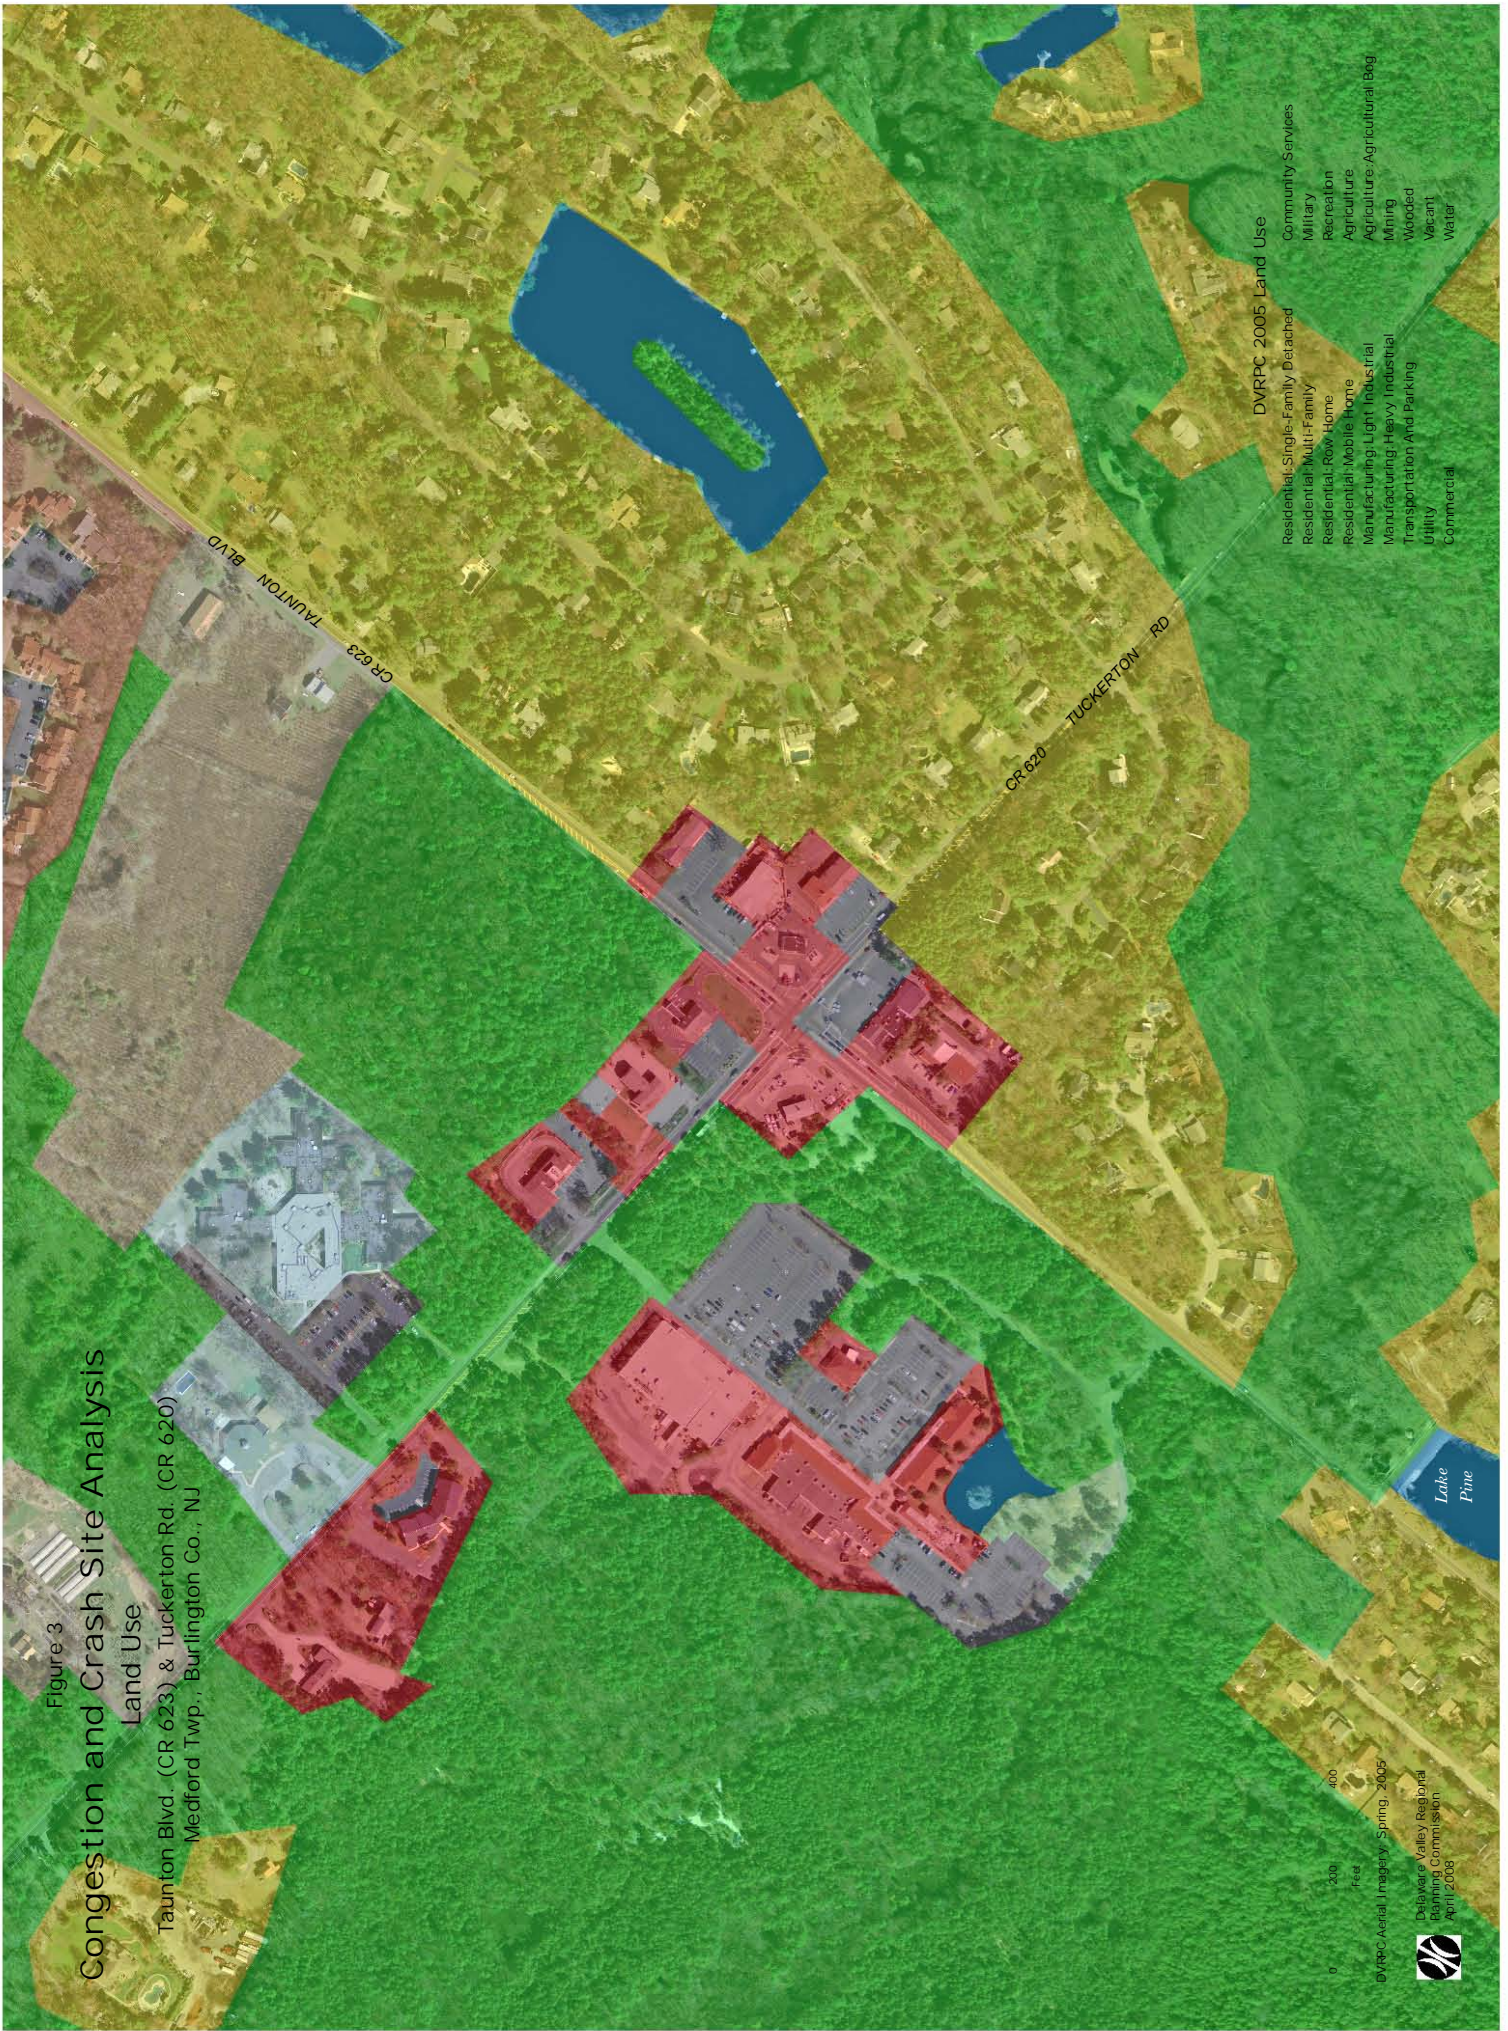
Figure 3
 Land Use
 Taunton Blvd. (CR 623) & Tuckerton Rd. (CR 620)
 Medford Twp., Burlington Co., NJ

As can be seen in **Figure 3**, the neighboring area of the study intersection is mixed commercial and residential. In the southeast and southwest, the land use is residential with single family detached housing. The intersection provides access for these residential areas to commercial business and adjacent neighborhoods. To the northwest and northeast, the area is primarily wooded, with pockets of commercial and community service uses.

The land use in the area immediately surrounding the study intersection is commercial. There are commercial uses occupying each corner of the intersection and all provide multiple access points on both Taunton Boulevard and Tuckerton Road. There are gas stations with access points directly at the intersection on the northwest and southeast corners of the intersection. Next to the gas station on the southeast corner are a Wawa Convenience store and dry cleaning business on Tuckerton Road, and a hardware store

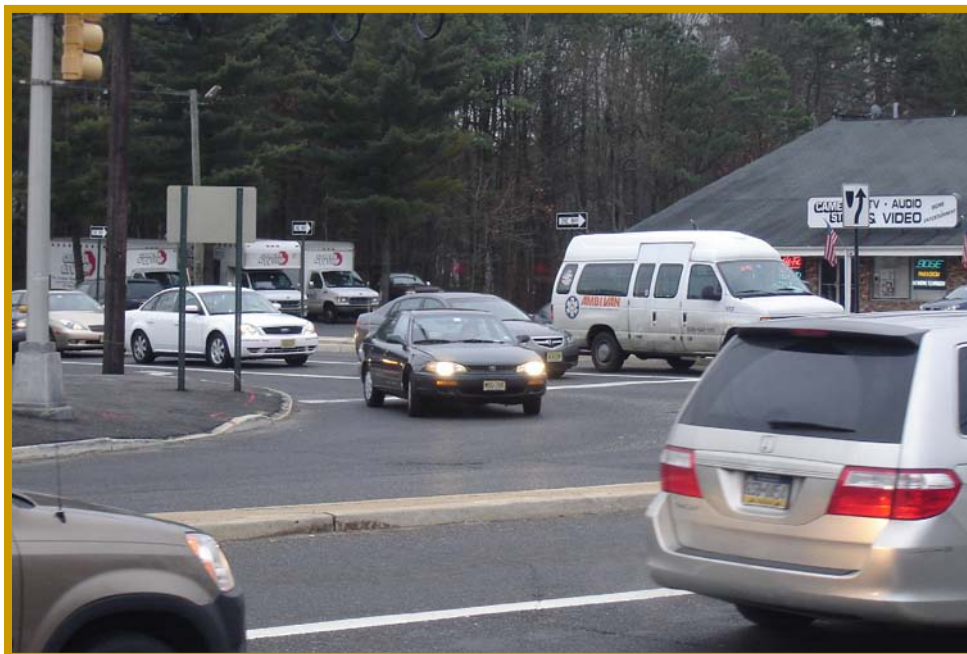
Congestion at the intersection of these two roadways occurs during the morning and afternoon peak periods on weekdays. Traffic constantly backs up on westbound Tuckerton Road and northbound Taunton Boulevard in the morning peak period and in the opposite direction during the evening peak. Although the intersection approaches are each served by three lanes, the roadways leading to the intersection have only one lane in each direction, all carrying high volumes of traffic. The congested situation is further exacerbated by numerous driveways at or in close proximity to the intersection actively serving commercial land uses.

Intersection traffic during the AM Peak

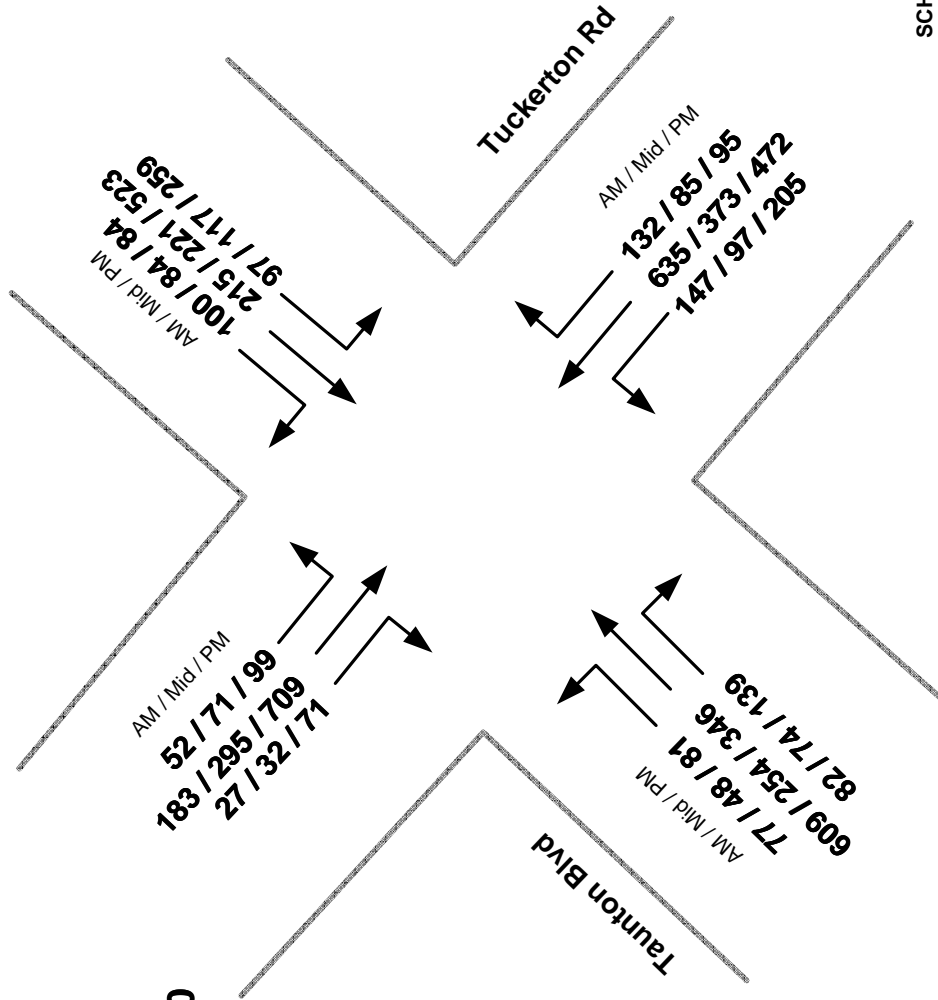
Figure 4 shows the turning movement counts for the morning, midday, and afternoon peak hours. There are 2,356 vehicles moving through the intersection during the morning peak hour. The dominant movements are the westbound approach of Tuckerton Road, with 39 percent of the total, and northbound approach of Taunton Boulevard, with 33 percent. The north-westbound Tuckerton Road through movement is the single largest movement, with 635 vehicles, or 27 percent of the morning peak-hour total volume. This approach also carries heavy left-turning movement onto Taunton Boulevard: 147 vehicles, or 16 percent of that approach's morning peak-hour volume. During this period, there are heavy right-turn movements from the northbound and westbound approaches of both roadways. As a result of the protected left-turn movements, turning conflict should be minimal. "Right turn on red" is permitted at the intersection and can cause potential conflicts during peak periods.

Existing Peak Hour Turning Movement Counts

Tuckerton Road and Taunton Boulevard Intersection

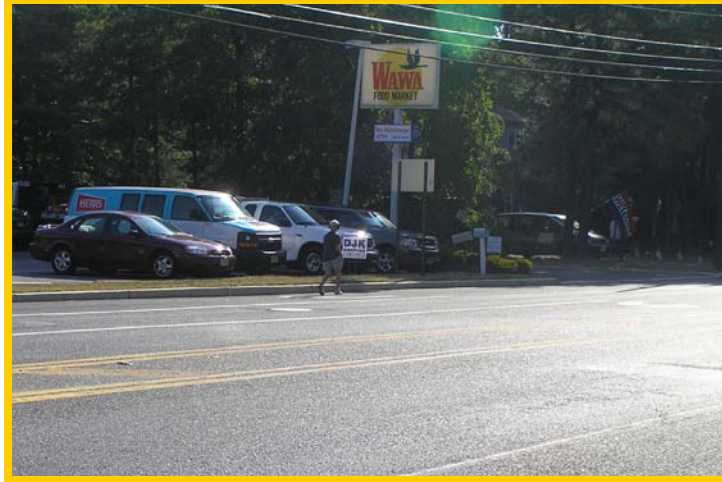
The area is not pedestrian friendly. The sidewalk is discontinuous or nonexistent. A sidewalk is located on the southwest quadrant of the intersection in front of the Exxon gas station, after which it ends abruptly. There are no crosswalks at the intersection approaches or in the vicinity.

Pedestrian using the right-turn lane to travel eastbound on Tuckerton Road

When considering pedestrian crashes, the concern is greater than with any other collision type due to the vulnerability of pedestrians in a crash for injury or death. Pedestrians were observed crossing the intersection. Due to the close proximity of residential areas to this intersection and its retail facilities, improved pedestrian accommodations should be pursued as a high priority.

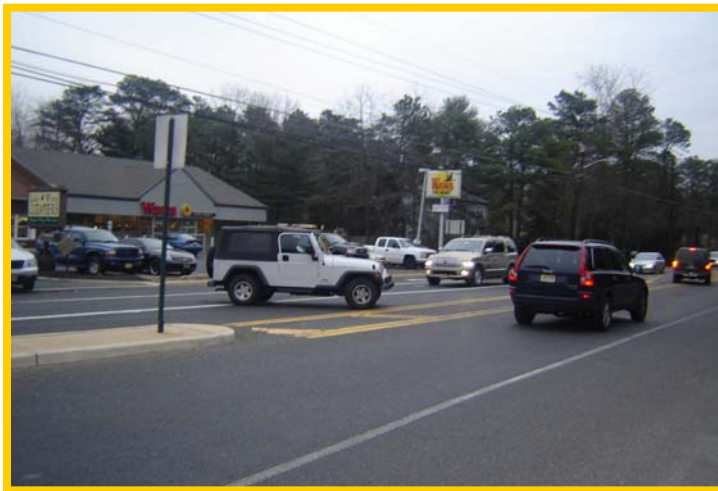
Businesses at three of the four corners of the intersection currently have four access and egress points for each property. Vehicles slowing to enter or exit these businesses are in conflict with traffic moving through the intersection. Additionally, vehicles making a left turn from the Wawa parking lot travel across three active lanes of traffic to access eastbound Tuckerton Road.

Vehicle making left turn from WAWA driveway

This is an opportunity to address the Wawa driveway, which has experienced a number of crashes over the study period. Recommended strategies will address physical as well as behavioral safety of the area.

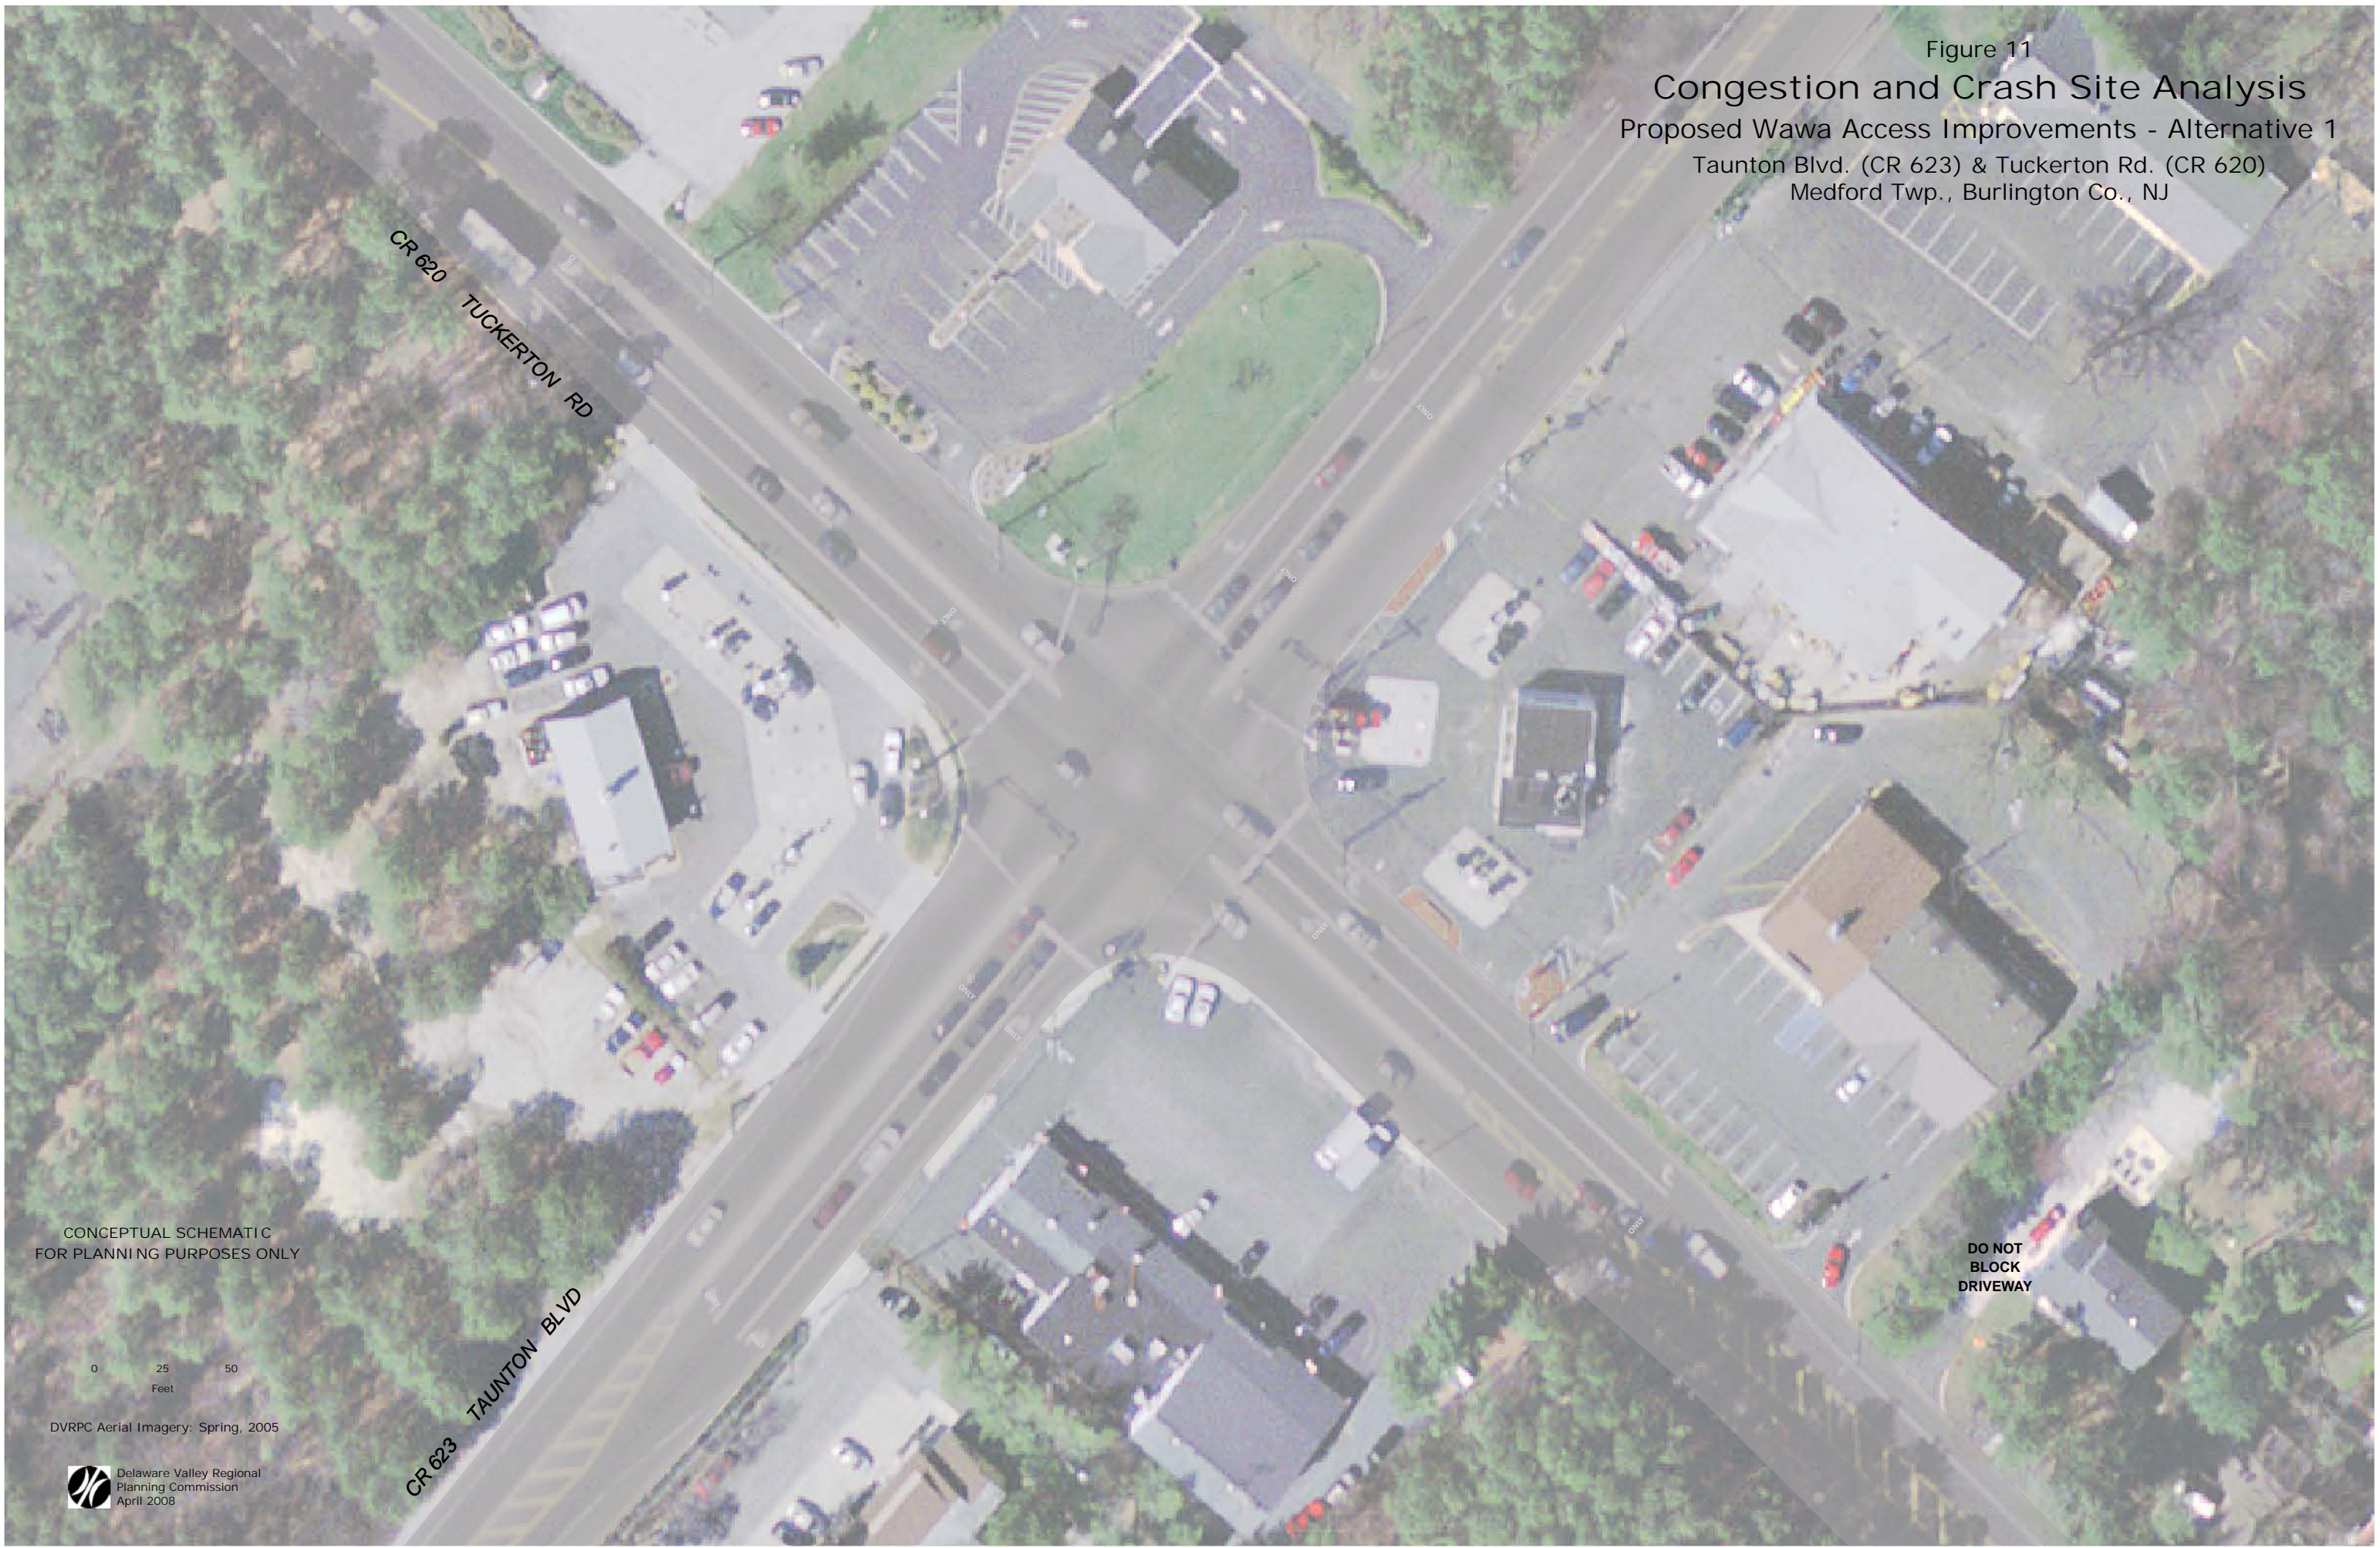
Figure 11
Congestion and Crash Site Analysis
Proposed Wawa Access Improvements - Alternative 1
Taunton Blvd. (CR 623) & Tuckerton Rd. (CR 620)
Medford Twp., Burlington Co., NJ

- Eliminates unsafe left-turn movements from “exit” driveway and accommodate these movements at the existing “entrance” driveway, which is further away from the intersection and crosses only one lane of traffic.
- Relieves congestion in the parking lot.

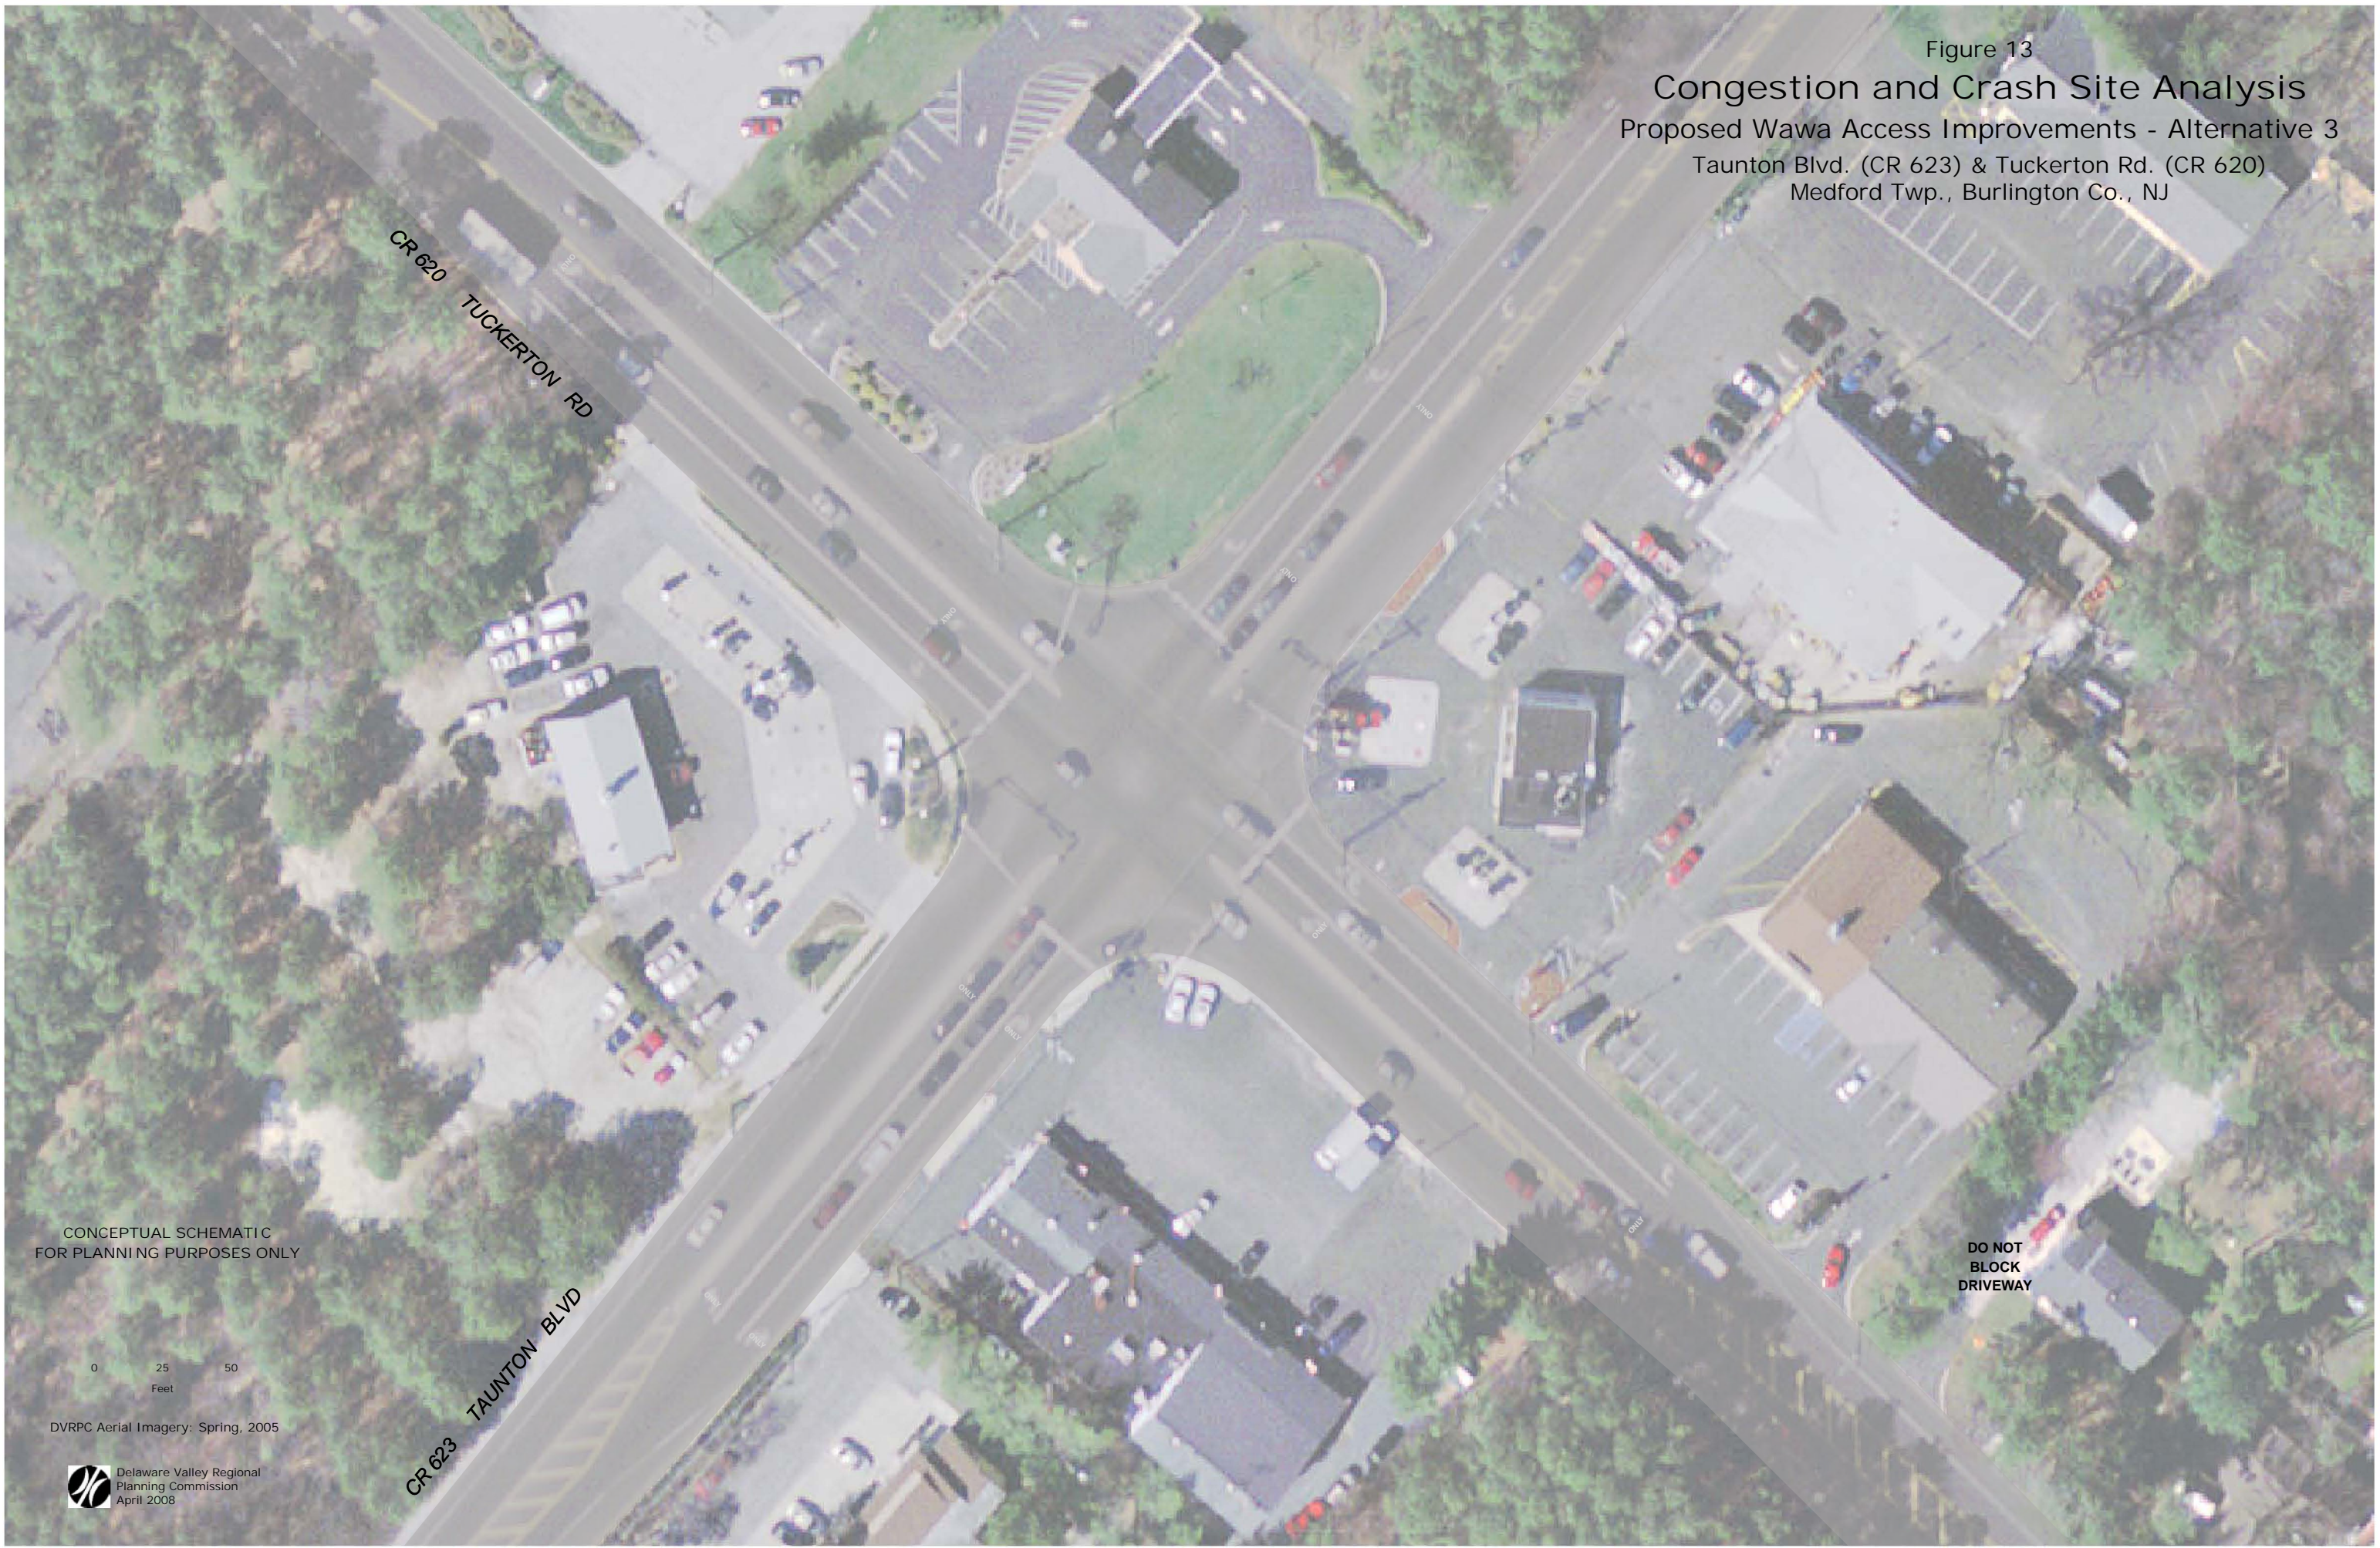
Figure 13

Congestion and Crash Site Analysis
Proposed Wawa Access Improvements - Alternative 3
Taunton Blvd. (CR 623) & Tuckerton Rd. (CR 620)
Medford Twp., Burlington Co., NJ

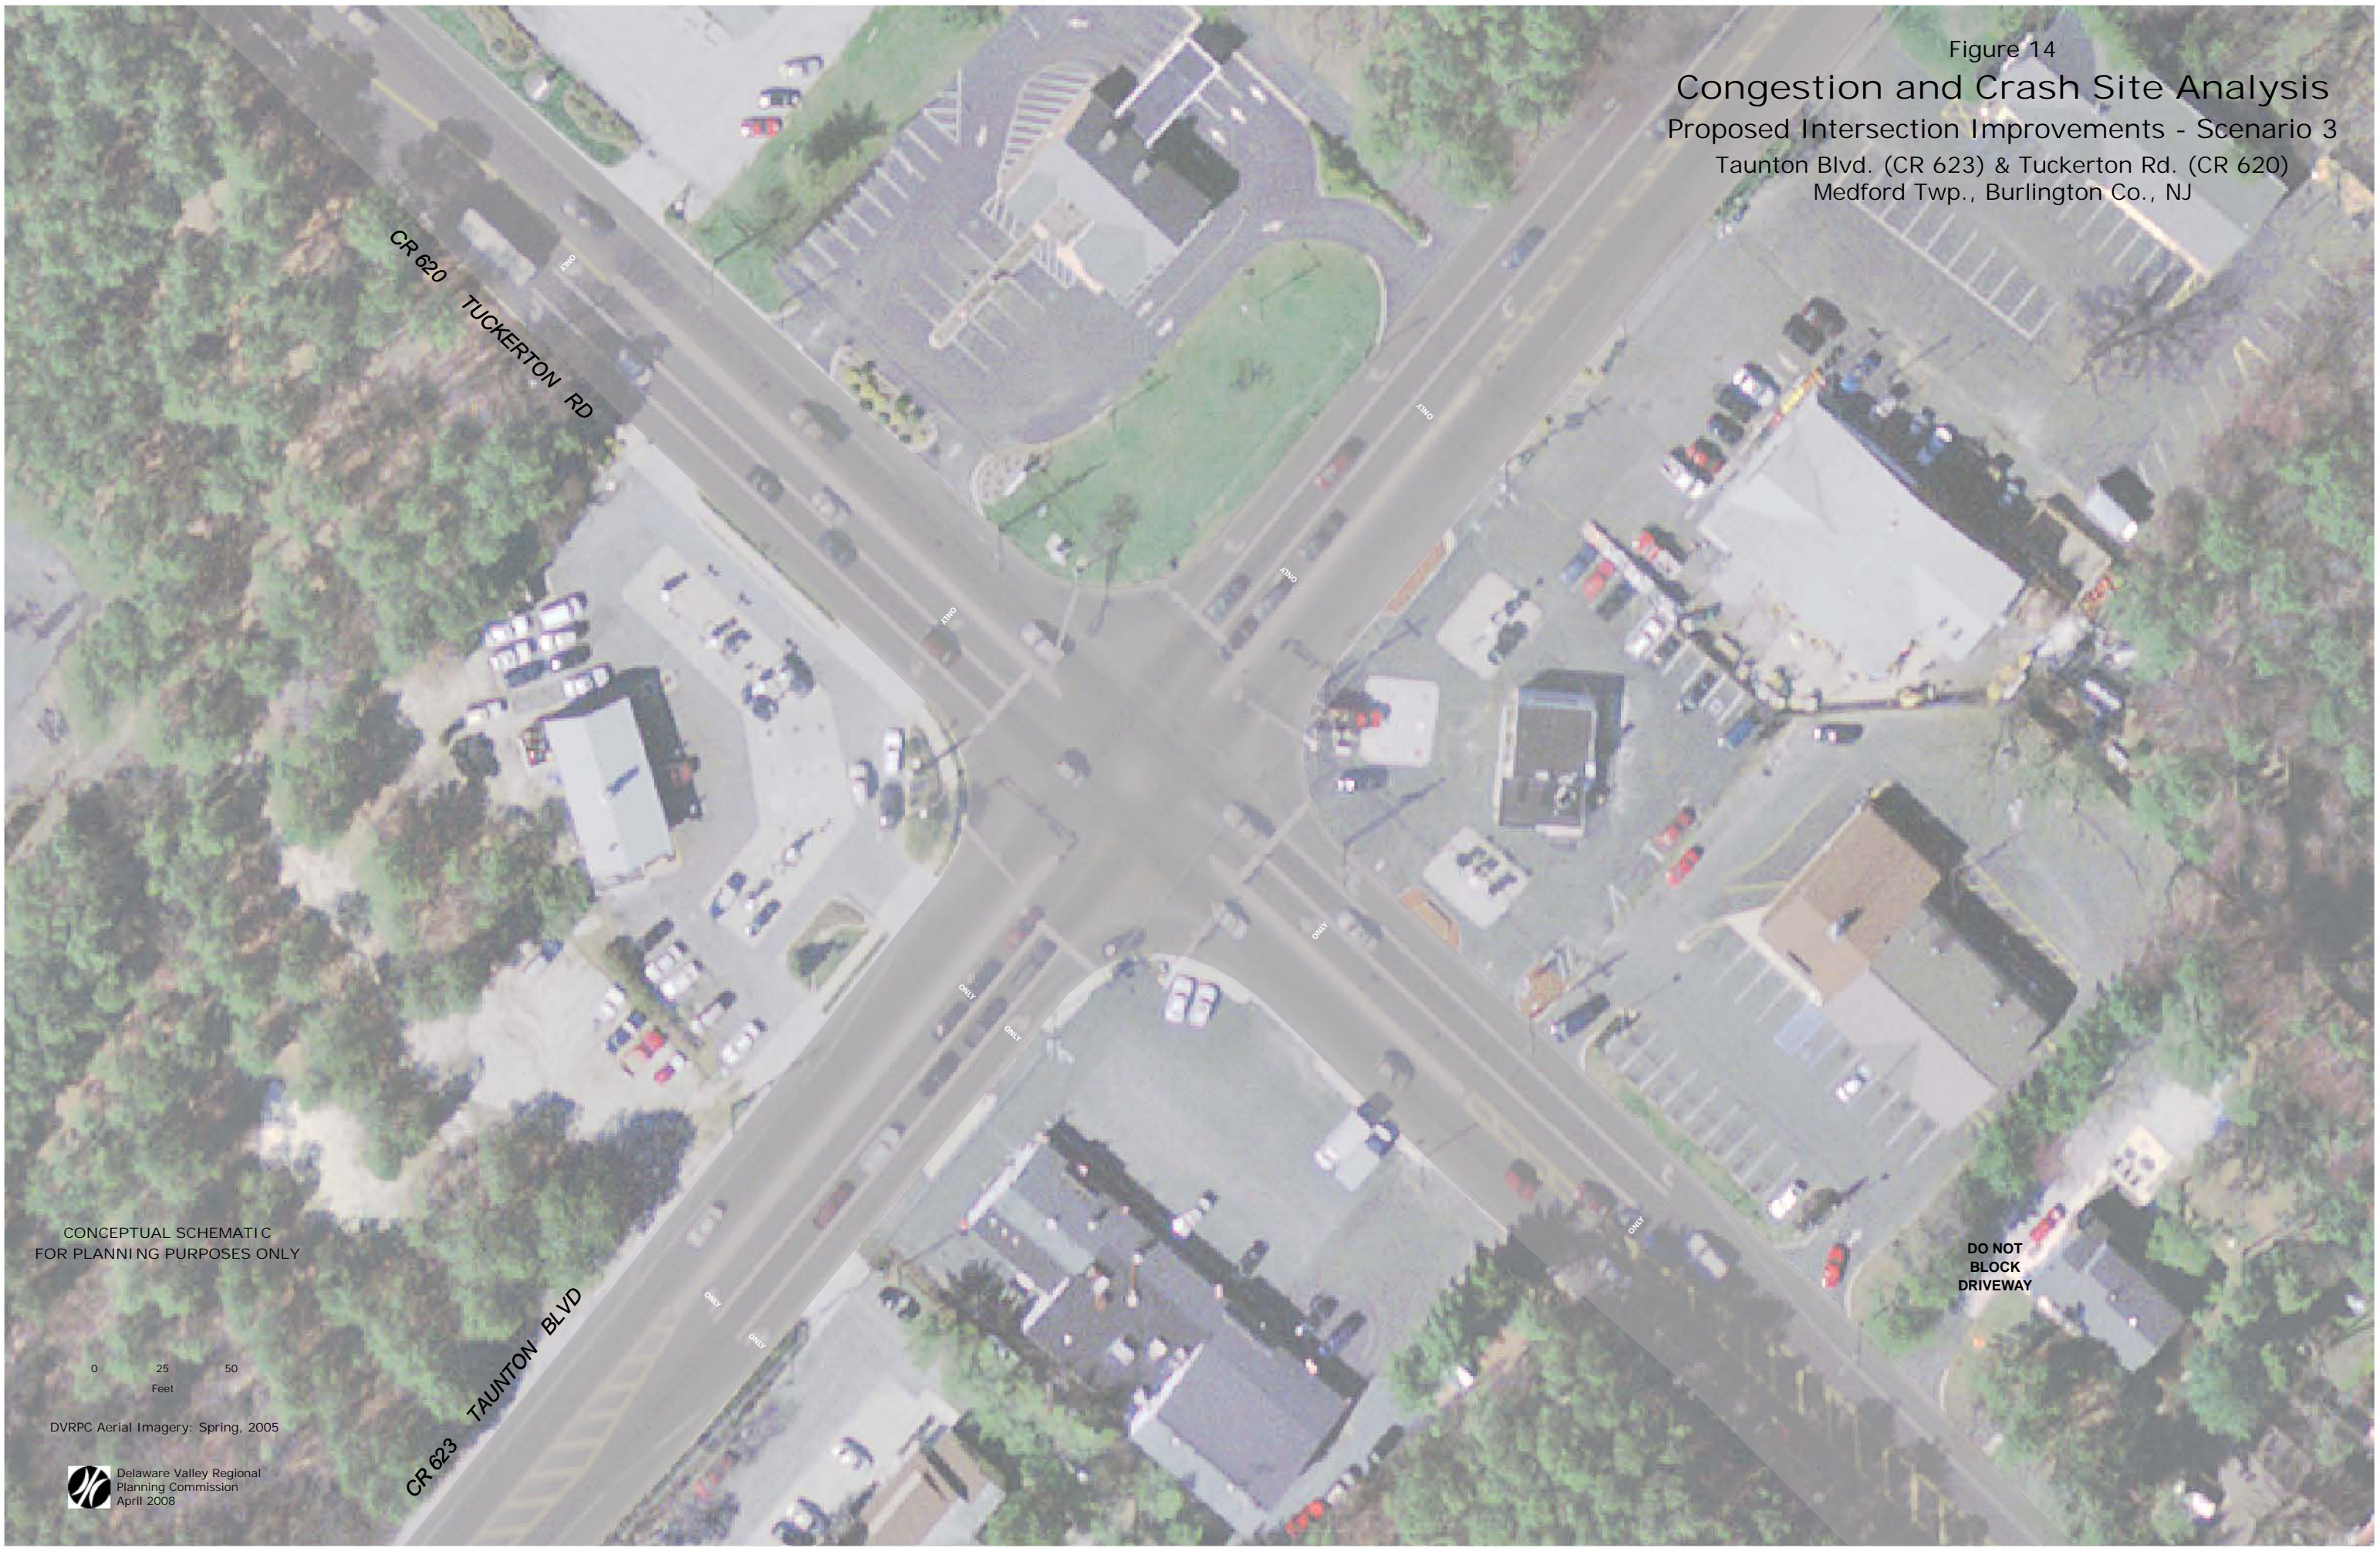
Figure 14

- Same as *Scenario 2*.
- No right-of-way acquisition necessary; the shoulder at the receiving lane of southbound Taunton Boulevard can be used to accommodate new configuration.
- Increased capacity for the through movement for southbound Taunton Boulevard will improve traffic flow through the intersection, especially during the afternoon peak.
- For both peak periods, the cycle length is reduced from the existing conditions.
- Improved traffic flow north of the intersection will provide better access to those businesses.
- Potential reduction in crashes, especially angle and left-turn crashes, related to running the red light.

Congestion and Crash Site Analysis
Proposed Intersection Improvements - Scenario 3
Taunton Blvd. (CR 623) & Tuckerton Rd. (CR 620)
Medford Twp., Burlington Co., NJ

As shown in **Table 4**, the overall LOS for the intersection is an E for both morning and afternoon peak periods. During the morning peak the westbound Tuckerton Road approach is failing with 81 seconds of delay, one second higher than existing. Eastbound Tuckerton Road also experiences an increase in delay over the existing but both Taunton Boulevard approaches experiences reduced delay. All approaches except southbound Tuckerton Road had increased delay and movement in LOS from Ds to F and Es when compared to *Scenario 2*.
