**DELAWARE VALLEY
REGIONAL PLANNING
COMMISSION**

MEDFORD TOWNSHIP, BURLINGTON COUNTY

CONGESTION
CRASH site
Analysis
Program

TAUNTON BOULEVARD AND TUCKERTON ROAD, MEDFORD TOWNSHIP

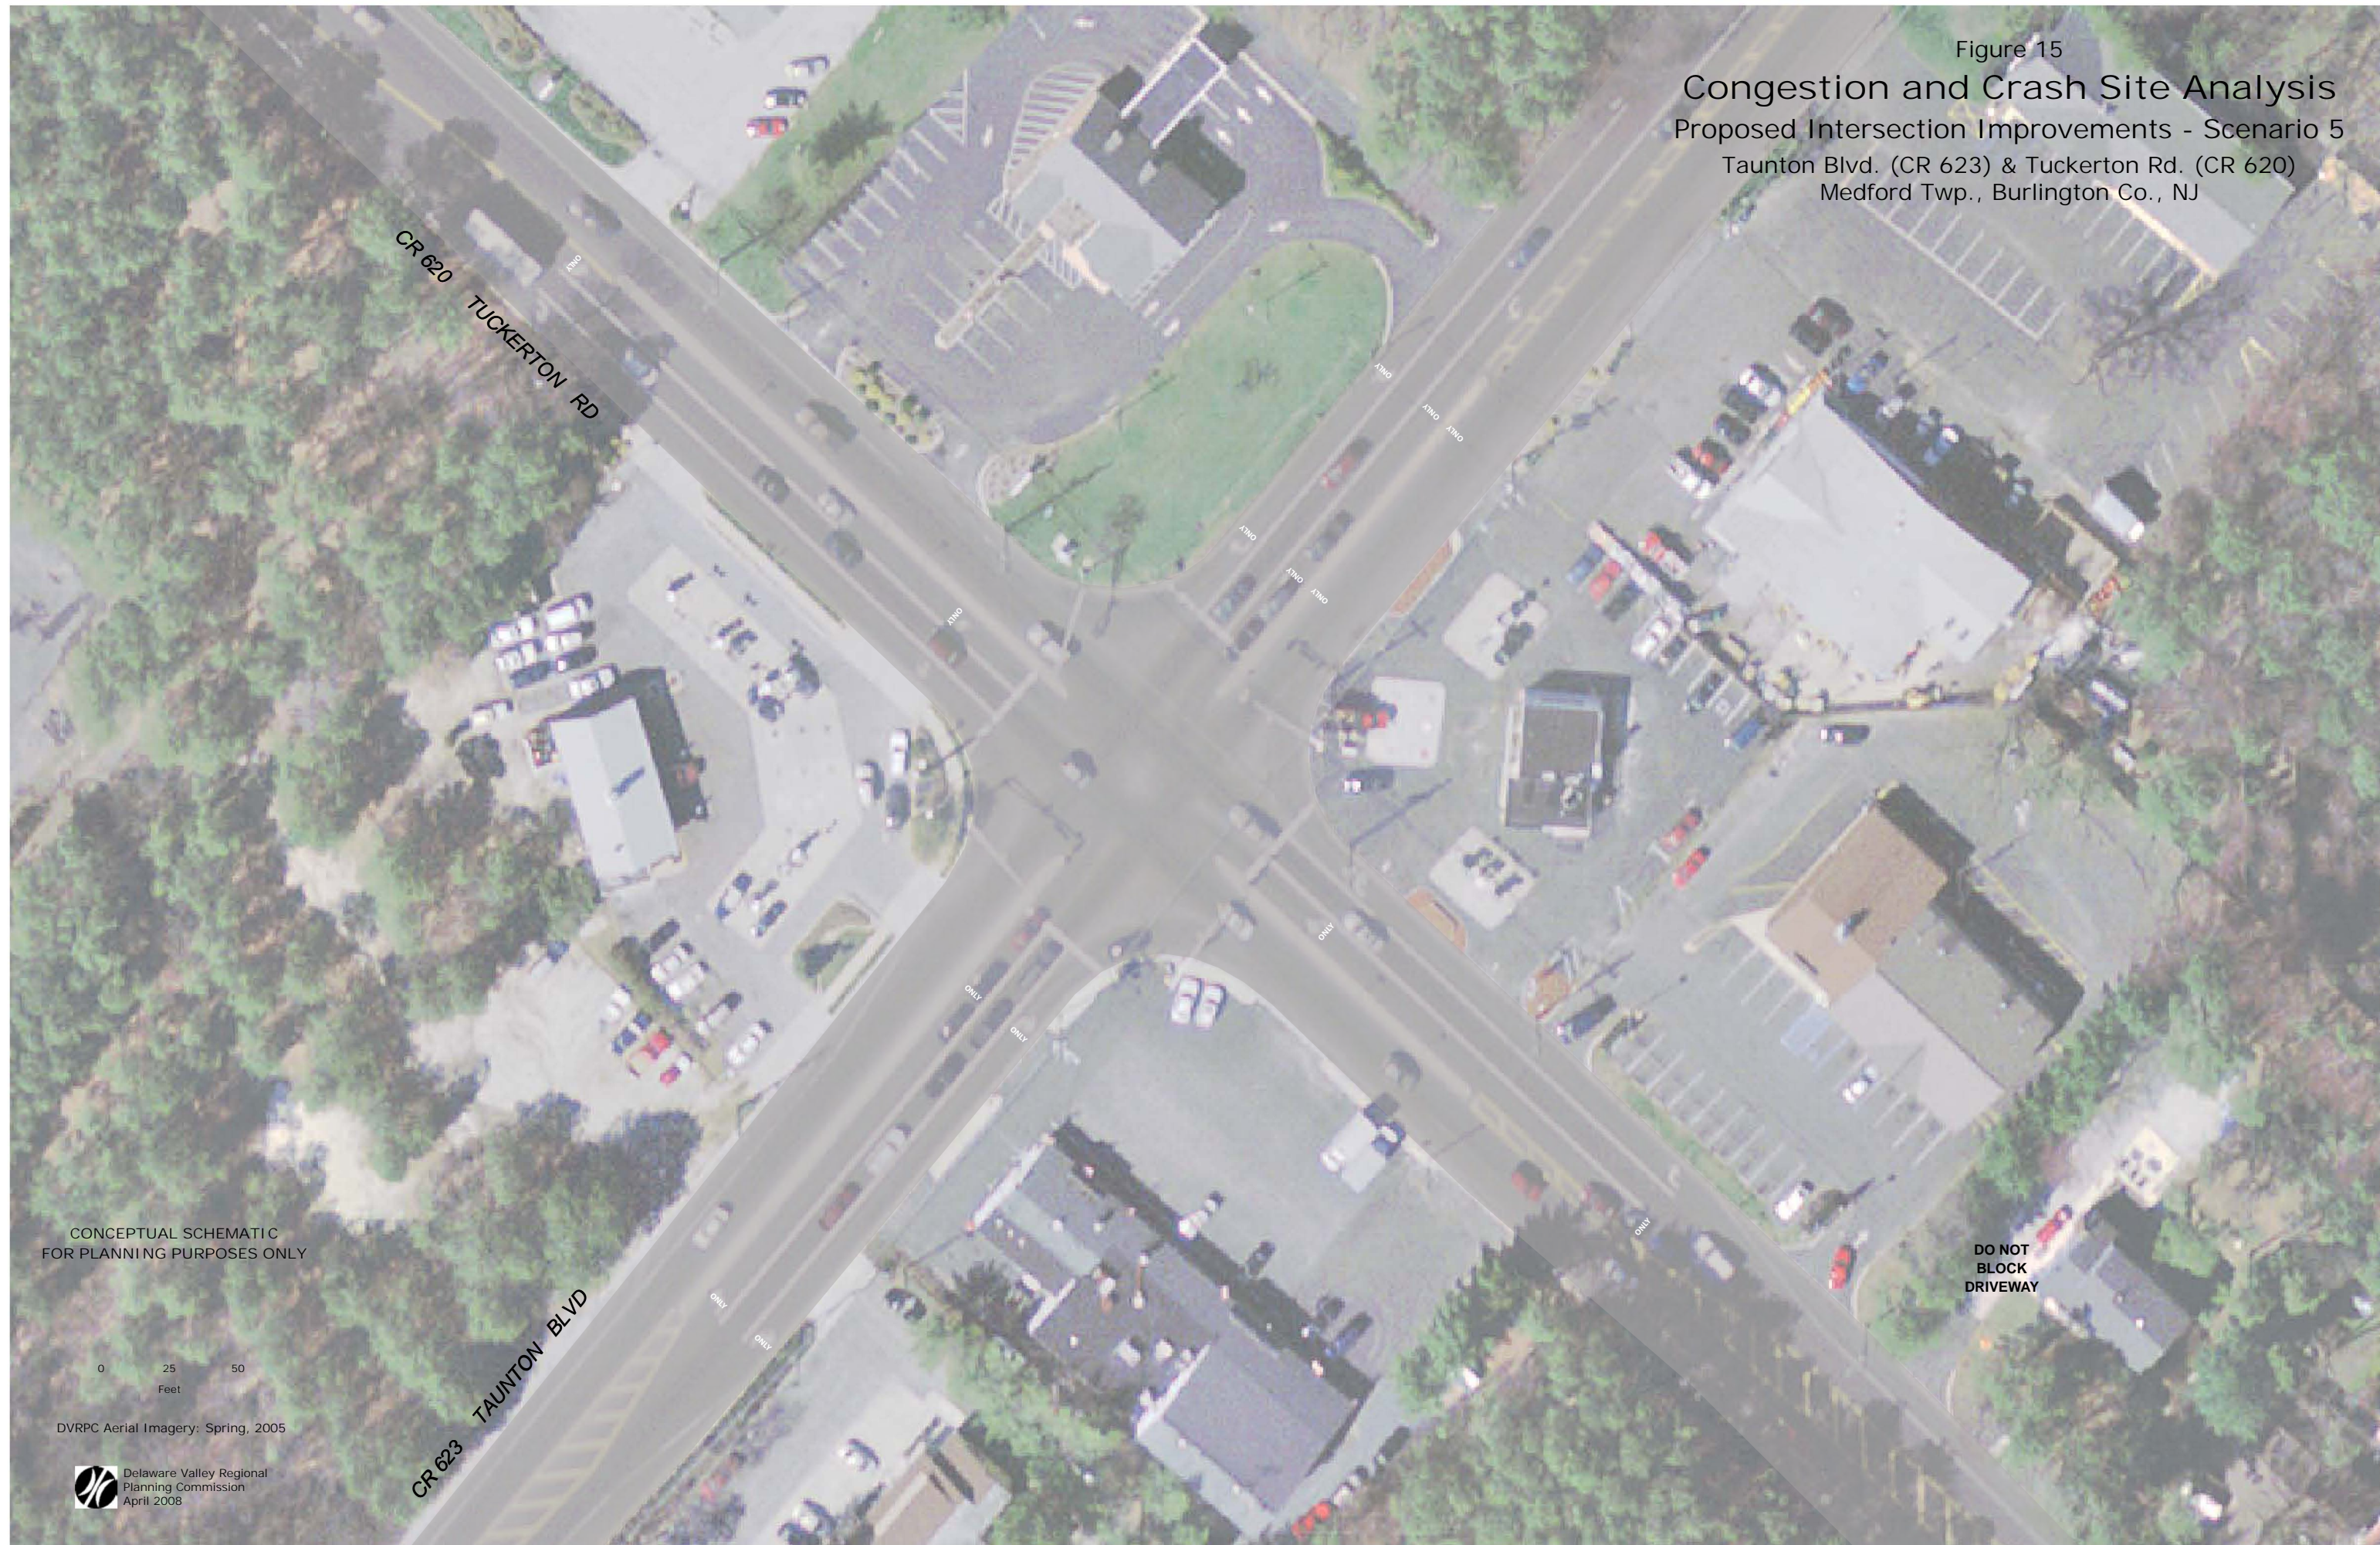
Figure 15
Congestion and Crash Site Analysis
Proposed Intersection Improvements - Scenario 5
Taunton Blvd. (CR 623) & Tuckerton Rd. (CR 620)
Medford Twp., Burlington Co., NJ

- Add another left-turn lane to southbound Taunton Boulevard.
- Replace island on the outside of the left-turn lanes.

In the afternoon, the intersection overall LOS is also an E, with a vehicle delay of 56 seconds. Compared to the afternoon existing conditions, the delay on the southbound Taunton Boulevard approach is reduced from 259 seconds to 53 seconds. The LOS improves from an F to a D. The northbound approach of the intersection has increased delays of 23 seconds over the existing conditions. When compared to *Scenario 3* all approaches experienced a reduction in delay and the eastbound approach had an improvement in level of service.
