Intersection Road Safety Audit

Maple Avenue & Main Street

Evesham Township,
Burlington County

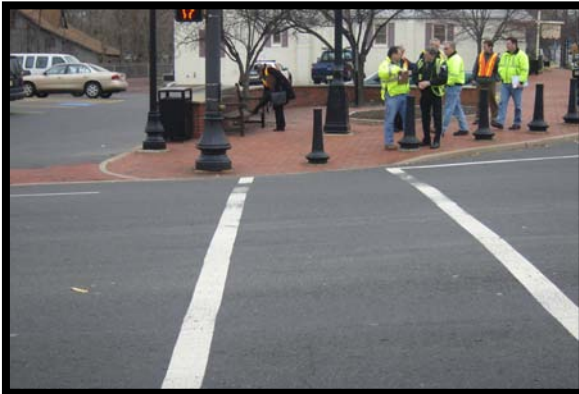
- Pedestrian ramp on the northeast corner doesn't connect with the crosswalk.

Relocate pedestrian ramp to allow roadway crossing in the crosswalk.

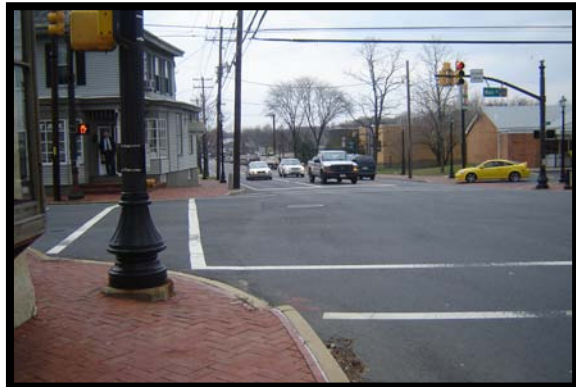
- Traffic signal pole is in the pedestrian ramp on the southwest corner.

- Bollard is located in the pedestrian ramp on the northeast corner.

- Relocate the traffic signal pole. It also blocks pedestrian movement on the sidewalk.

- The municipality should remove the bollard from the curb ramp.

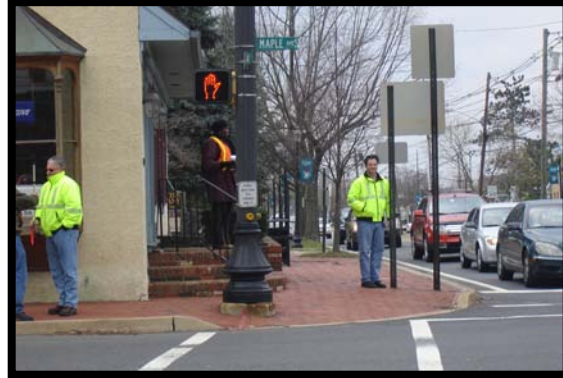
Cable and other wires are tripping hazard on the sidewalk on the northbound side of Maple Avenue.

- Traffic signal pole on the southwest corner of the intersection blocks the sidewalk.

- Bury the wires underground.

- Relocate the traffic signal pole.

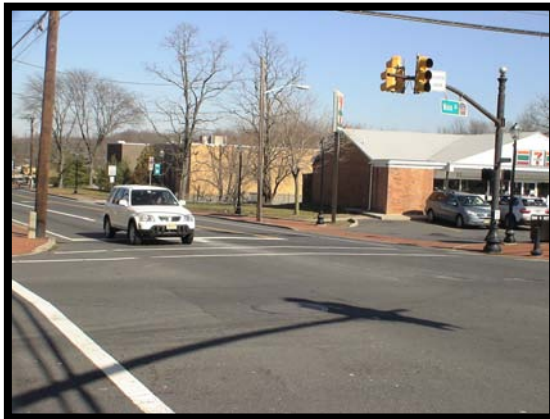
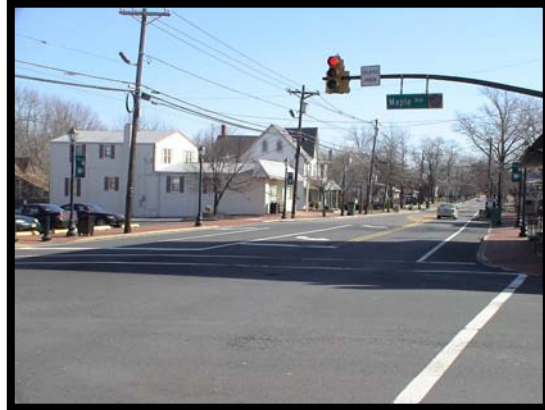
Crosswalks are faded in areas and should be made more visible.

Repaint crosswalks and upgrade to continental style.

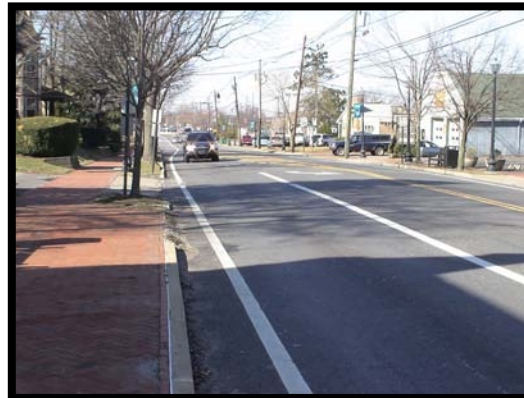
- There are no bicycle amenities at the intersection or in the vicinity.

- Install “Share the Road” signs on the roadways leading to the intersection.

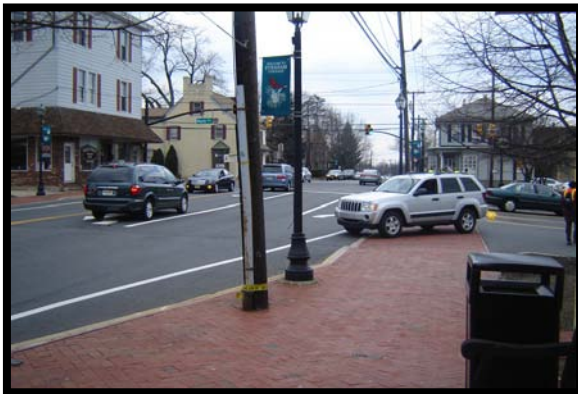
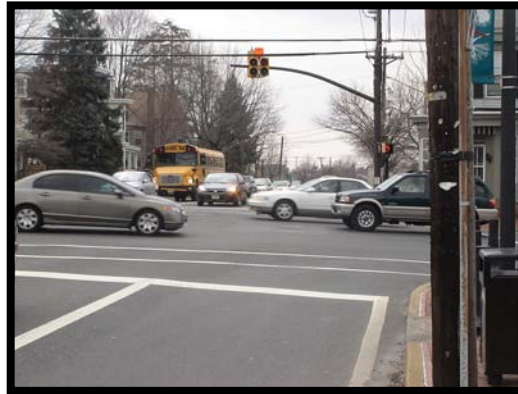
- Intersection is skewed and buildings intrude on the sight distances for turning traffic – compromise crosswalk.
- Intersection is currently congested and is expected to become more congested during the construction phase of the scheduled elimination of the Marlton Circle.

- Driveways are too close to the intersection. Left-turns from these driveways are potentially unsafe considering they are crossing multiple lanes of traffic. From the collision diagram there are a number of crashes associated with the 7-11 convenience store driveways.

- Signal timing changes:
 - Add protected/permissive left-turn phase for all approaches and retime the signal to accommodate volumes. Possible strategy – Add northbound and eastbound left-turn phases (for northbound Maple Avenue a 3 to 5 seconds left turn phase; for eastbound Main Street a 3 to 12 seconds left-turn phase); following the termination of the northbound lead left allow the southbound thru to be initiated while the southbound left-turn continues; establish a “No Turn on Red”; install a NTOR blank out sign or create an overlap for the westbound right-turn to run simultaneously with the southbound protected left-turn phase.
 - Install pedestrian countdown signals on all of the approaches.
 - Install a pedestrian lead prior to the initiation of the Maple Avenue Right-of-Way.
 - Install backplates on the Main Street traffic heads.

- Consider an additional approach lane for northbound Maple at NJ 70 to improve operation of both intersections.

- Prohibit left-turns from the 7-11 driveways on Maple Avenue and Main Street.
NJDOT approval of a local ordinance and county resolution will be required prior to the implementation of the prohibitions.
- In the longer term, modify the driveway for right-turns only.

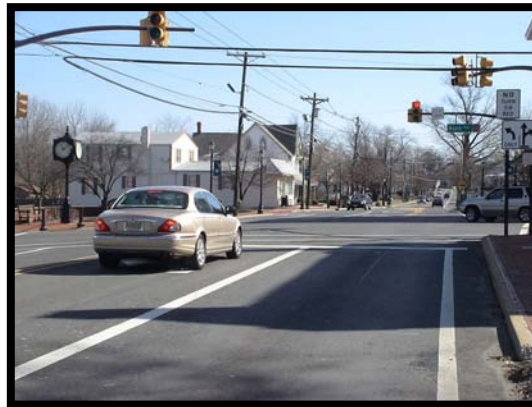
- NJ Transit bus serves this intersection, stops are not indicated.

Sign existing bus stops for the information of the motorists and the safety of the passengers getting on or off the buses.

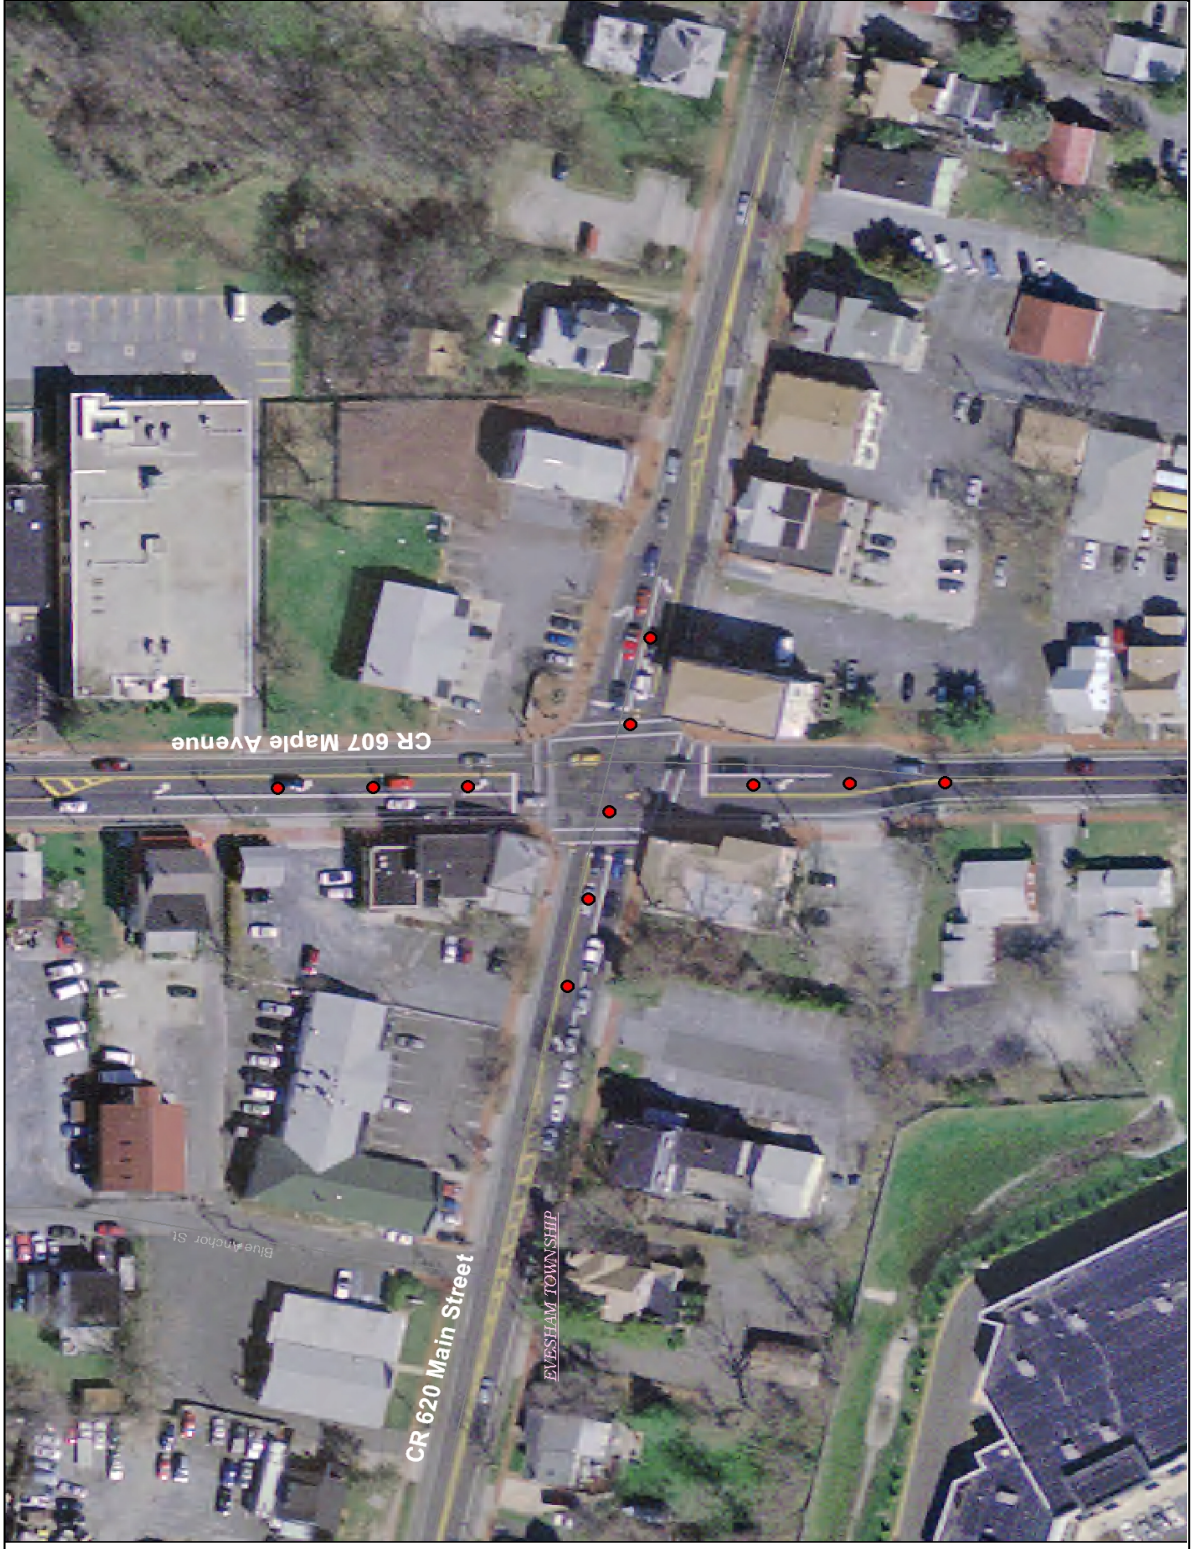
Intersection of Main Street and Maple Avenue
 Evesham Township, New Jersey

Intersection Crash Summary
 NJDOT Crash Database
 2004 - 2006

COLLISION TYPE	
Rear End	14
Right Angle	12
Same Direction Side Swipe	3
Left/Right Turn	3
Opposite Dir / Head-On	1
Fixed Object	1
Total	34
LIGHT CONDITION	
Day	25
Night	8
Dusk	1
Total	34
SURFACE CONDITION	
Dry	24
Wet	9
Snowy	1
Total	34
SEVERITY	
Fatal	0
Major Injury	1
Moderate Injury	0
Minor Injury	6
Property Damage Only	27
Total	34

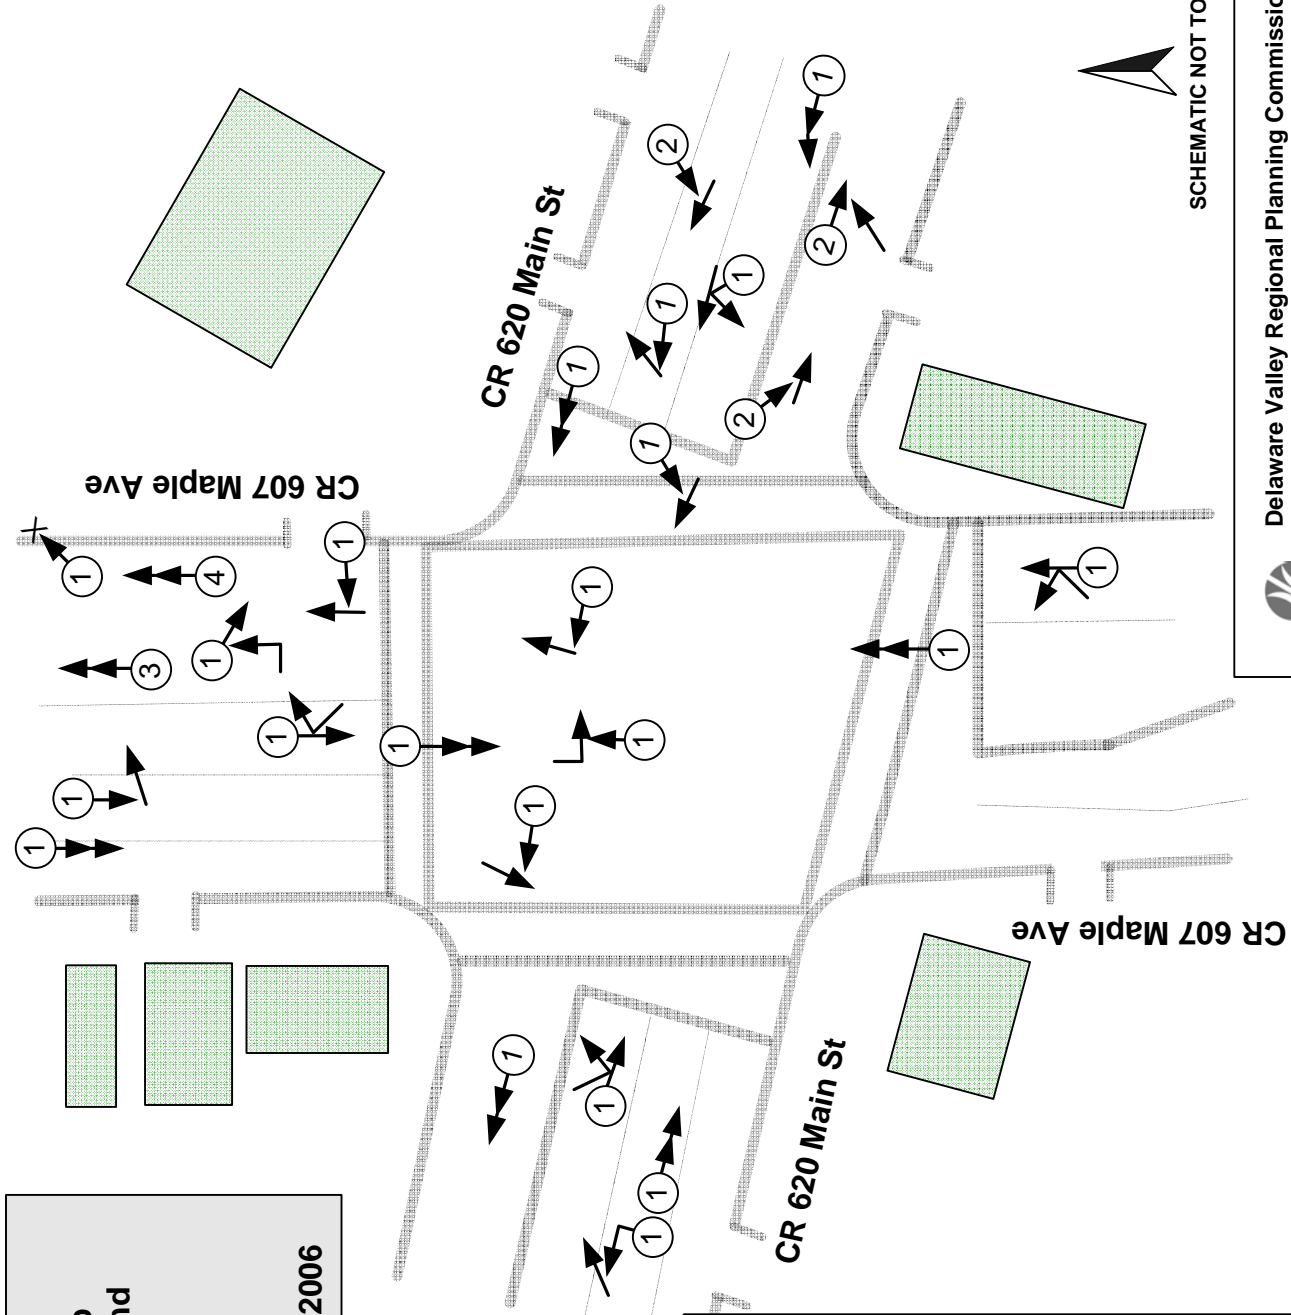
Collision Diagram
Crash Data Years 2004-2006

Total Crashes = 34
 Pedestrian Crashes = 0
