Intersection Road Safety Audit

Williamstown Road & Erial Road

Winslow Township,
Camden County

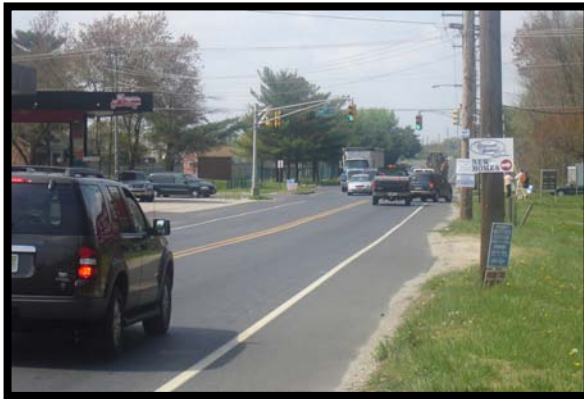
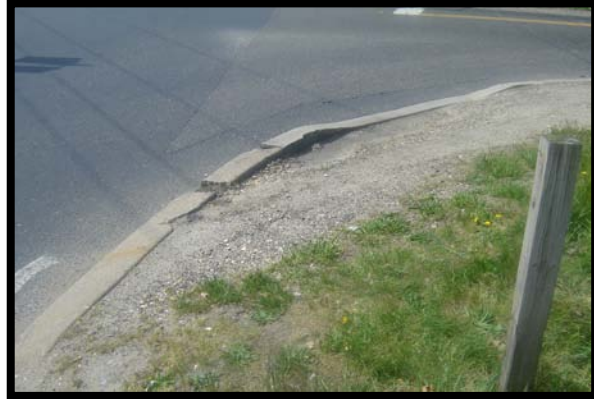
Geometry Improvement

- High intersection volumes, with relatively high left turning volumes from Williamstown Road onto Erial Road.
- Left-turning traffic blocking through movements at Williamstown Road approaches – Aggressive Driving.
- High number of left-turn and angle crashes.

- Consider adding dedicated left-turn lanes for both approaches on Williamstown Road
- Upgrade traffic signal and timing to accommodate protected left-turn movements.
- Consider reconfiguring the channelized island to accommodate additional lane.
- Upgrade all pavement markings at the intersection (lane lines, shoulders, edgelines, and stop bars).

The Road Safety Audit team considered this a **HIGH** priority.

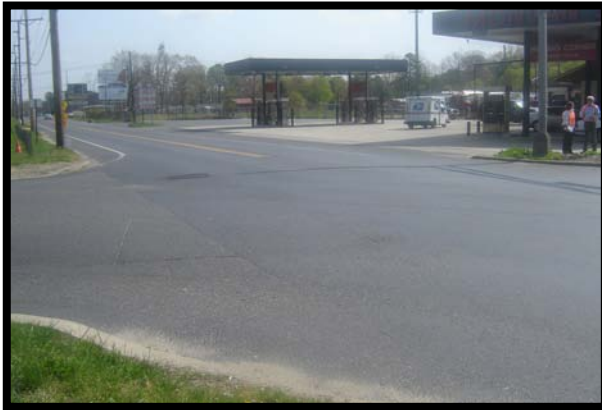
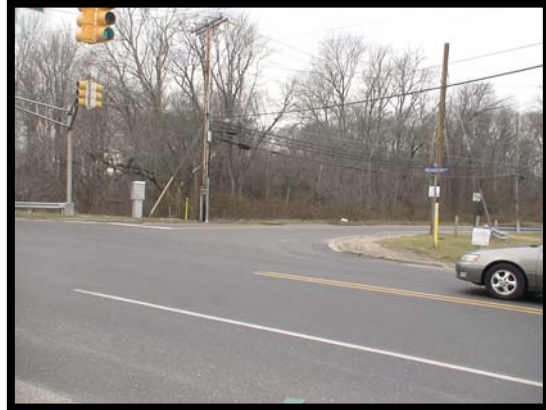
Striping

- Stop bar on the southeast approach of Erial Road is too close to the intersection. This results in difficult turning movements from Williamstown Road onto northbound Erial Road.

- Stop bars are missing/faded at all approaches of the intersection.

- The intersection has no crosswalks.

- Move stop bar back from intersection to accommodate safer turning movements.

- Add or repaint stop bars as appropriate.

- Install crosswalks at the intersection at the northwest approach of Erial Road and the southwest approach of Williamstown Road.

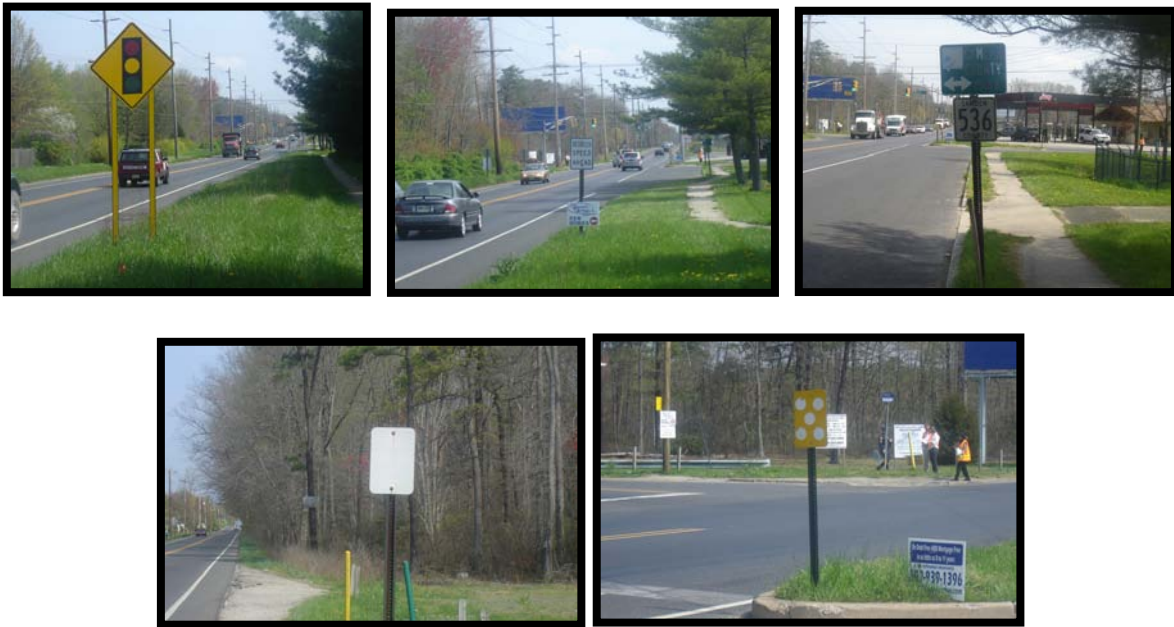
Signs

- “No Standing Anytime” signs have faded, they are mounted too low, and they are on non-breakaway posts.

- “Reduce Speed Ahead” sign is mounted too low on non-breakaway posts.

- Existing county route designation signs are not up to current standards.

<p><u>Issue</u></p> <ul style="list-style-type: none"> • Several guide signs (church and hospital) are in poor condition and are mounted too low. <p>Possible Improvement Strategies</p> <ul style="list-style-type: none"> • Remove or replace signs as appropriate. <p>Level of Effort Potential Safety Benefit Low Medium</p>	
<p><u>Issue</u></p> <ul style="list-style-type: none"> • Camden County Park guide sign at the intersection is faded. <p>Possible Improvement Strategies</p> <ul style="list-style-type: none"> • Replace sign and mount according to MUTCD guidance. <p>Level of Effort Potential Safety Benefit Low Medium</p>	
<p><u>Issue</u></p> <ul style="list-style-type: none"> • “Traffic signal ahead” signs are redundant. At the sign motorists are able to see the traffic signal. <p>Possible Improvement Strategies</p> <ul style="list-style-type: none"> • Replace these signs with “Junction” signs with county route designation for the intersection. <p>Level of Effort Potential Safety Benefit Low Medium</p>

<p><u>Issue</u></p> <ul style="list-style-type: none"> • Reflective signs in the right-turn channelized island are leaning and oriented in the wrong direction. <p>Possible Improvement Strategies</p> <ul style="list-style-type: none"> • Upgrade signs according to MUTCD guidance and supplement with raised pavement markers on the edgeline of the northeast Williamstown Road approach lane and the southeast Erial Road receiving lane. <p>Level of Effort Potential Safety Benefit Low High</p>

- Replace signs and mount according to MUTCD guidance.

- Remount sign according to MUTCD guidance.

- Replace signs according to current standards and mount according to MUTCD guidance.

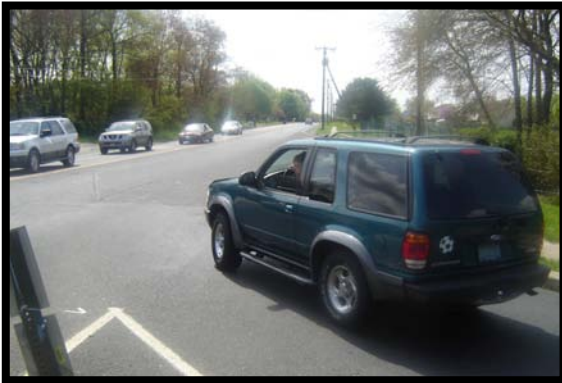
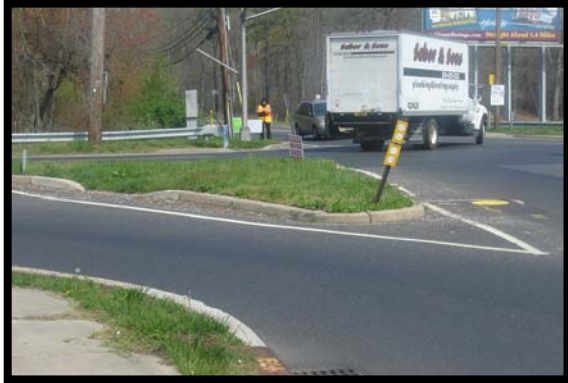
Channelized Island

- No striping for northeast Williamstown Road approach channelized right-turn lane.

- There are no “yield” or “stop” signs or pavement markings for the channelized right-turn lane.

- On the Erial Road side of the island, add solid line for southeast Erial Road receiving lane edgeline and extend this line approximately 50 feet further from the island and continue with dashed striping for the merge.

- Install a “yield” sign and/or saw tooth yield pavement markings.

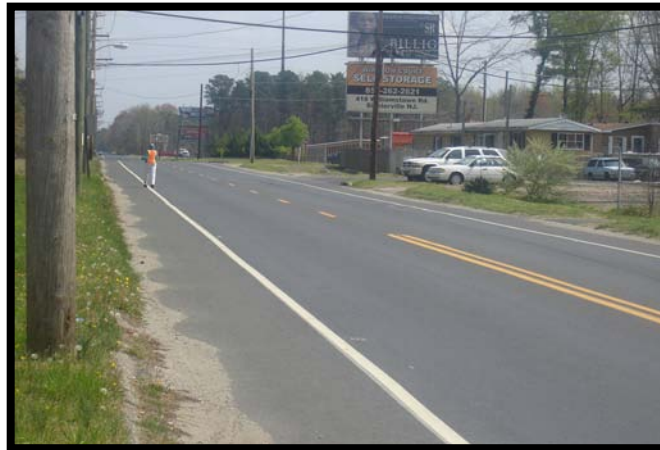
- Passing Zone begins too close to the active driveways of the Mongan’s Service Station and the Winslow Court intersection.

- There are no warning signs to advise motorists traveling southwest on Williamstown Road of the end of the passing zone.

- Extend No Passing Zone north of the storage facility driveway located north of Winslow Court.

- Install “No Passing Zone” signage for motorists traveling southwest on Williamstown Road.

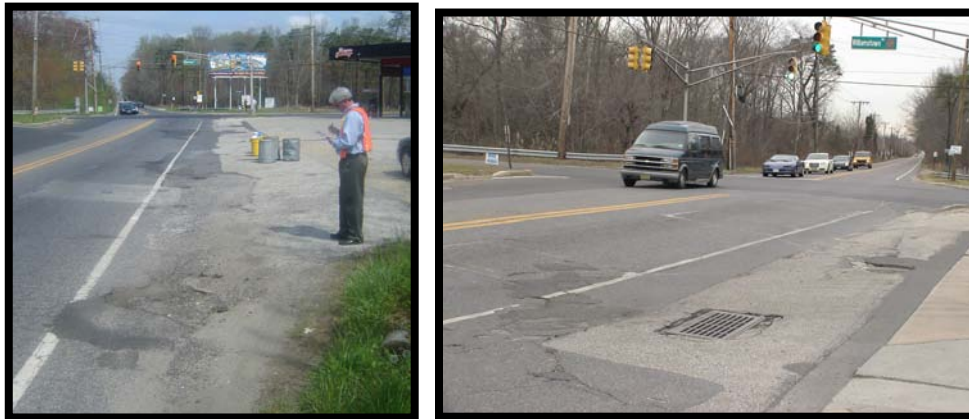
- Pavement on Erial Road on the south side of the intersection is in disrepair.

- Repave the roadway.

(County paving project is scheduled for Erial Road from the intersection south)

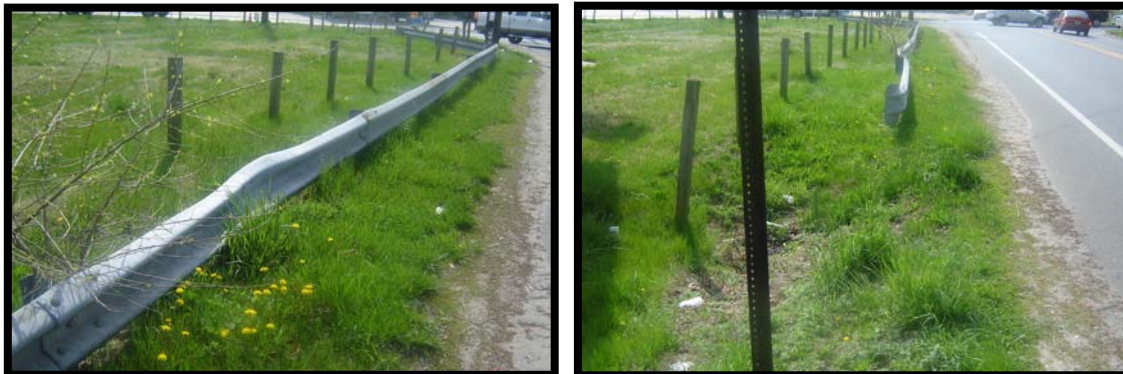
Guide Rail

- Guide rails are damaged.

- Replace existing guide rail with end treatments consistent with AASHTO guidelines.

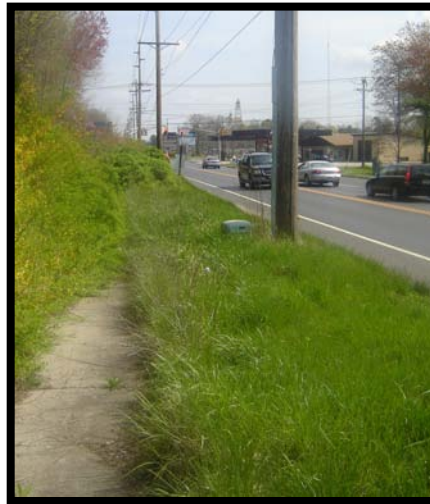
Vegetation

- Shrubs at the intersection are overgrown and interfere with motorist sight distance.

- Channelized island is overgrown and presents a hazard for pedestrians.

- Trim shrubs at the intersection.

- Hardscape the island (low maintenance).

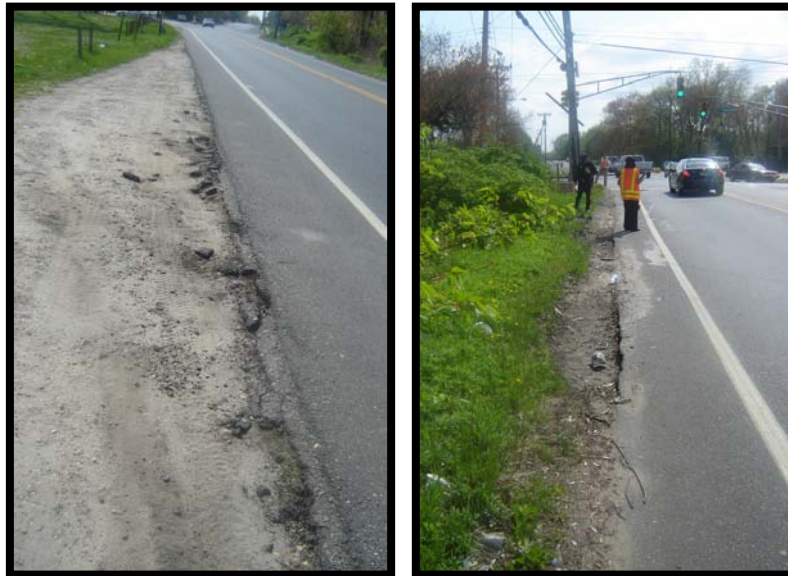
Drop Off

- Edge drop off on the north side of the intersection on Erial Road.

- Crash history of ‘hit fixed object’ crashes in the vicinity.

- Pave the shoulder with a tapered transition to make traversable.

- Consider installing edge line rumble strips, especially for the Erial Road approach, where there is a history of ‘hit fixed object’ crashes.

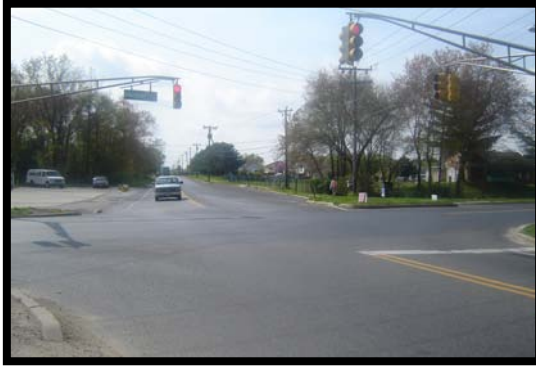
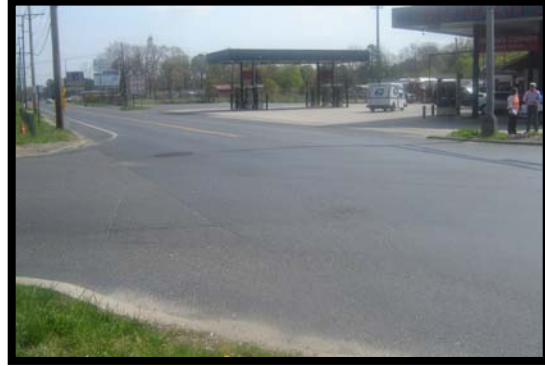
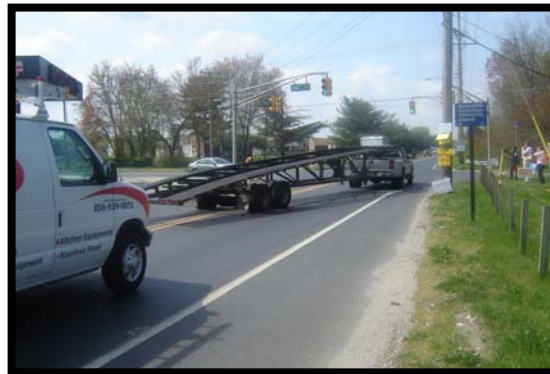
Access Management

- Trucks exiting the Mongan’s Service station block both lanes of traffic on Williamstown Road.
- The service station has no defined access/egress points on both roadways at the intersection.
- Motorists make unsafe turns from service station driveways.

- Coordinate with business owner to define driveway access according to current county access management policy.
- Consider restricting left turns from service station.

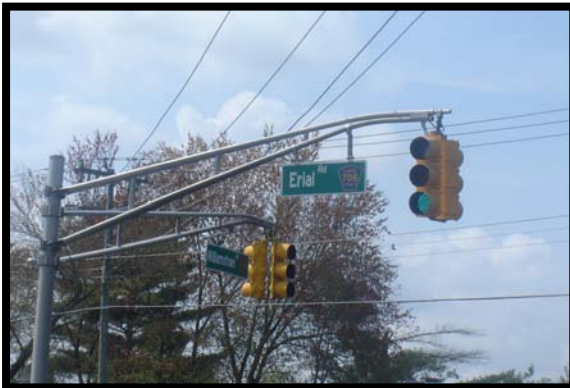
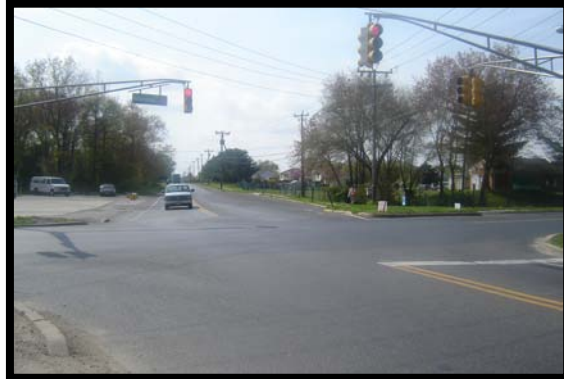
Traffic Signal

- High number of angle and left-turn crashes.

- Sun glare makes it difficult to see the signal at specific times of the day.

- There are no pedestrian signal heads.

- Revisit the signal timing and possibly increase the all-red phase.

- Add backplates to signal heads to enhance visibility.

- Add pedestrian signal heads and push button.

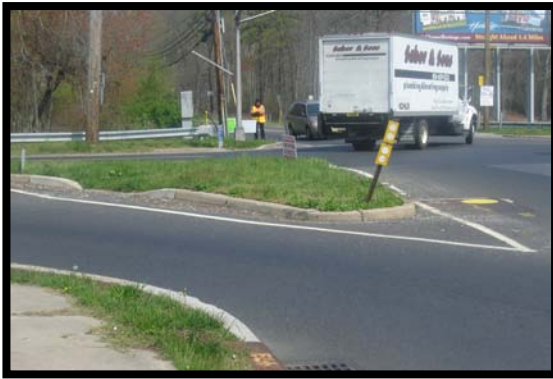
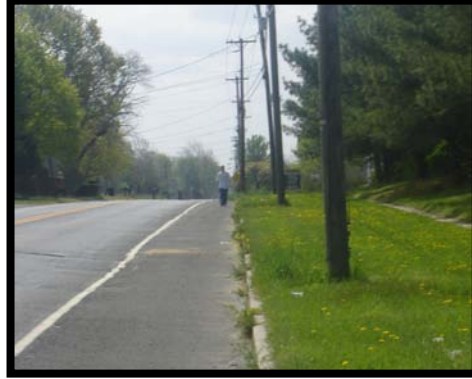
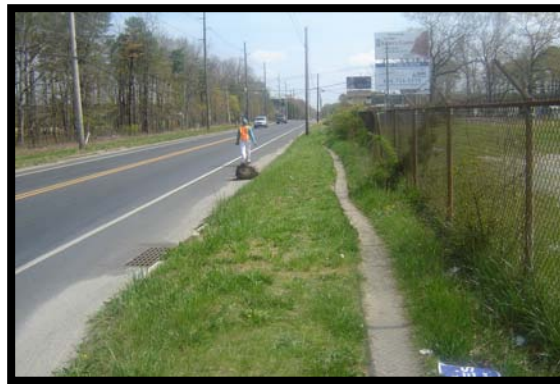
Pedestrians

- Sidewalk is in poor condition.

- Curb ramps are not ADA compliant.

- Upgrade/maintain sidewalks.

- Install ADA-compliant curb ramps.

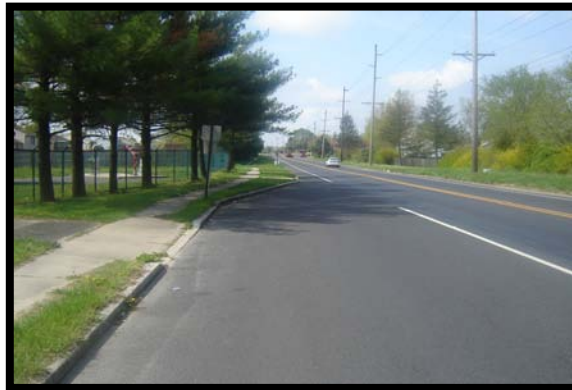
Delineation

- Raised pavement markers are too far apart.

- Install additional raised pavement markers to enhance their safety effect.
