City of Philadelphia North Broad Street Pedestrian Safety Audit

May 2009

North Broad Street Pedestrian Safety Audit

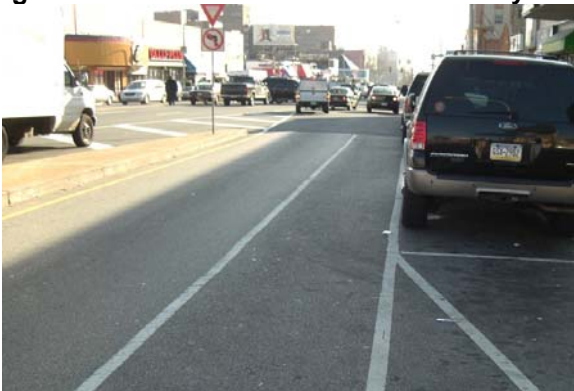
Figure 2: Photos of Conditions Near Olney Avenue

1. Discontinuous bicycle lanes (southbound north of Broad Street, bi-directional south of Broad Street) as well as the fact that bicyclists would have to cross over a busy intersection make bicycling in the area unattractive and dangerous.

Discontinued bike lane (See location 1)

6. The bike lanes on Old York Road are discontinued for approximately one-quarter mile over the portion of Broad Street that is shared by Old York Road as it crosses both Broad Street and Olney Avenue.

- Due to the lack of north-south bike routes through the city, it is recommended that proper bicycle facilities or accommodations be implemented here. Improving roadway conditions for cyclists will have a positive impact on pedestrian safety by reducing conflict on sidewalks between these two groups.

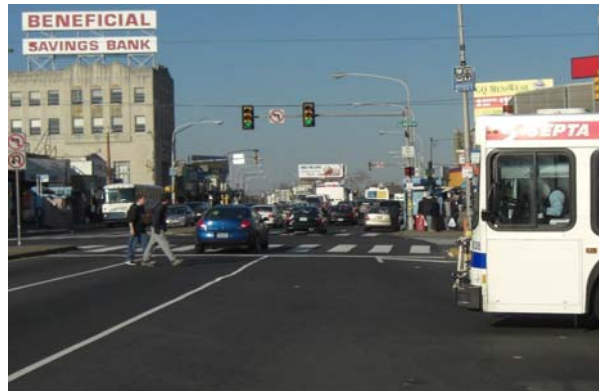
- Poor access management and low curbs
 - Poorly designed traffic islands
3. At Tabor Road:
 - Buses proceeding north maneuver between crowds waiting on the island and at the roadside bus stop

- Drivers are directed to turn right on Tabor in order to avoid conflict with buses exiting the terminal, but signage is commonly ignored
 - Island lacks clear pedestrian striping and proper walkways

- Lots of jaywalking to/from the bus island
4. At Albert Einstein Drive:
 - Missing and misaligned ADA ramps opposite Albert Einstein

Jaywalkers conflicting with bus traffic (See location 3)

8. Many crossing locations make unrealistic expectations of pedestrians and do not sufficiently consider their needs. Examples include Tabor Road and Belfield Avenue.

- Install crossing locations where pedestrians are more likely to use them or are already improvising by jaywalking.
9. Frequently, intersections are of an atypical or skewed configuration, where pedestrians are unaware of which crosswalk has a green light or where traffic should be coming from. Drivers may also be unsure of how far their right-of-way extends as they leave one signal and travel through another. Specific locations include Lindley and Wagner avenues and Ruscomb Street.

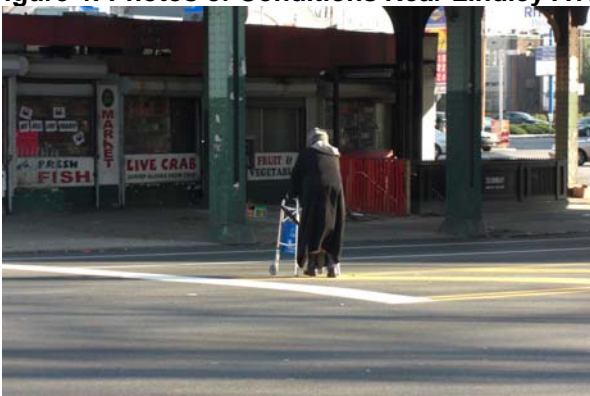
Figure 4: Photos of Conditions Near Lindley Avenue

9. At Lindley Avenue:
 - Sunken curb near storm water inlet
 - Faded striping on Lindley avenue
 - Pedestrian signal needs repair (on east side) – signals should be repaired and synchronized

- Unrealistic, poorly designed pedestrian crossings

Poor pedestrian accommodation at Lindley Avenue
(See location 9)

- Improve/adjust signal timings and consider changing some junctions into a single intersection or 'no turn on red.'
10. Poor access management causes conflict between pedestrians and vehicles. Driveways should be firmly defined by lower curbs, crossovers, and well-marked sidewalk boundaries on both the road and property sides.

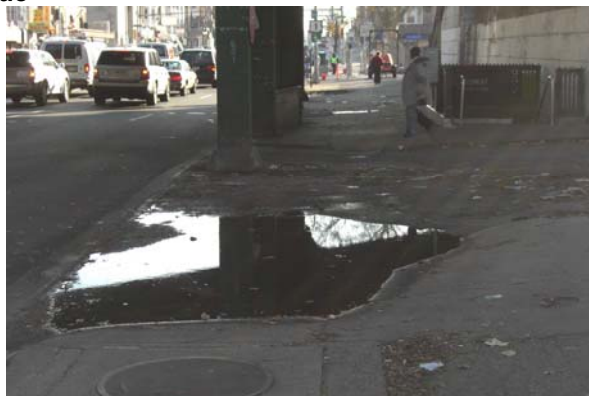
Unsafe pedestrian environment beneath underpass at Fishers Lane
(See locations 9 and 10)

- Sunken sidewalk and poor drainage
- Lack of illumination under rail tracks near SEPTA Logan Station (west side)
- Overpass supports severely hinder visibility

12. Overpass supports severely hinder visibility, most notably at Fishers Lane.
 - Pedestrian access to the cartway should be impaired by installing railing between the supports.

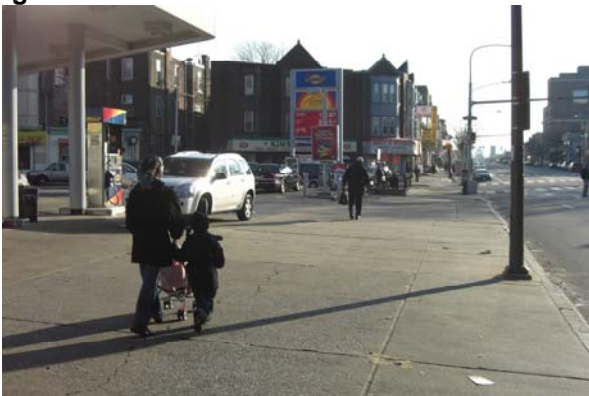
Figure 6: Photos of Conditions Near Windrim Avenue

- Uncontrolled access to these businesses encourages all road users to travel without regard for standards of use or the expectations of others (parking and driving on sidewalk, quick turns into Sunoco lot)
- Uncontrolled use of the center lane by drivers both entering and exiting Broad Street causes conflicts over right-of-way
- Excessive jaywalkers add to the sense of disorder and unruliness
- No pedestrian signals, striping, or any regulation of movement
- Uneven sidewalks and missing striping (west side)

Poor access management (See location 11)

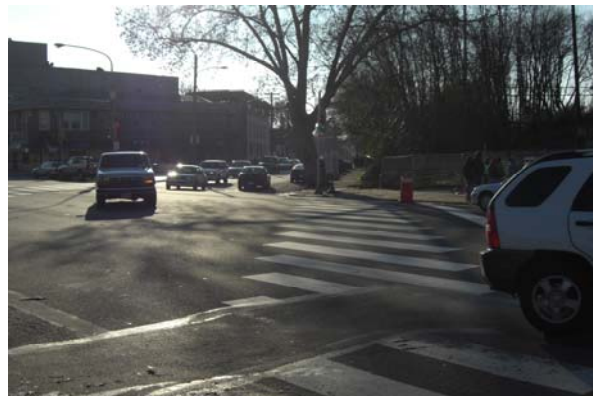
- The intersection is an atypical configuration where pedestrians are unaware of which crosswalk has a green light or where traffic should be coming from. Drivers may also be unsure of how far their right-of-way extends as they leave one signal and travel through another
- Long blocks with residential and commercial attractors contributing to considerable midblock jaywalking
- Missing striping on Ruscomb Street (west side)

Pedestrian green signal in conflict with vehicle traffic (See location 12)

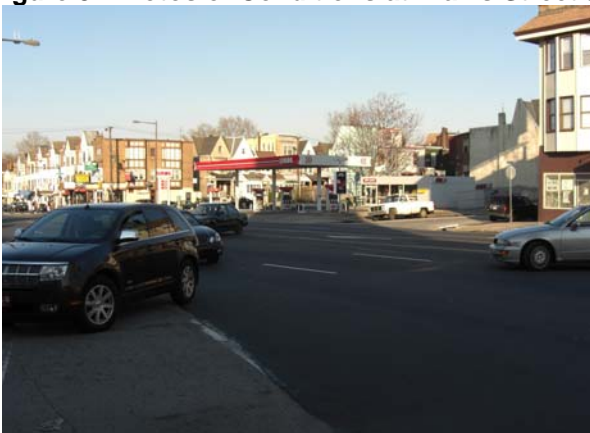
Figure 8: Photos of Conditions at Blavis Street and Hunting Park Avenue

- Striping missing on Blavis Street
- No obvious crossing point to supermarket on west side of Broad Street
- Uncontrolled access to the grocery store on west side creates a traffic free-for-all

Traffic disorder at entrance to supermarket (See location 16)

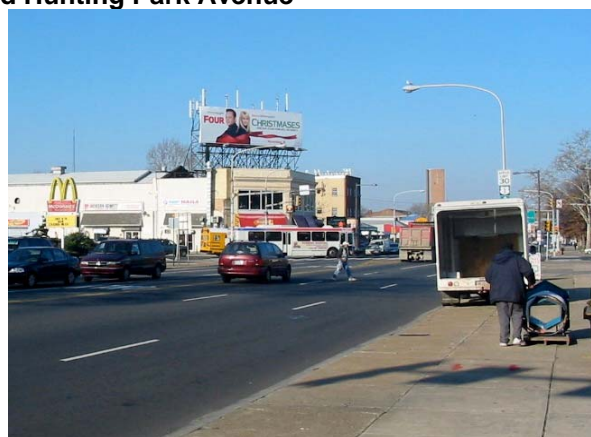
- The McDonald's on east side of Broad Street is a major attractor – people coming out of subway dash across street to McDonald's and vice versa
- Poorly striped and inadequate pedestrian signals
- The land use mixes pedestrians and automobiles poorly – open access for cars but unclear access for pedestrians

Unrestricted pedestrian movements across Broad Street (See location 18)

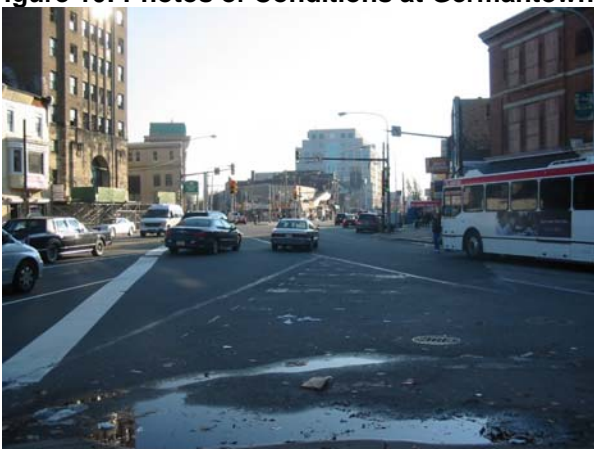
Figure 10: Photos of Conditions at Germantown and Erie avenues

- Faded/missing striping on Germantown Avenue
- Cars parked in crosswalk
- Lacks adequate markings and controls, causing a sense of traffic chaos

Inadequate lane markings and pedestrian facilities (See location 21)

- Inconsistent lane alignment and continuity across intersections should be resolved, (e.g., three lanes becoming two, shoulders becoming travel lanes, etc.). This problem can be found at many locations, specifically Olney Avenue and Germantown Avenue.

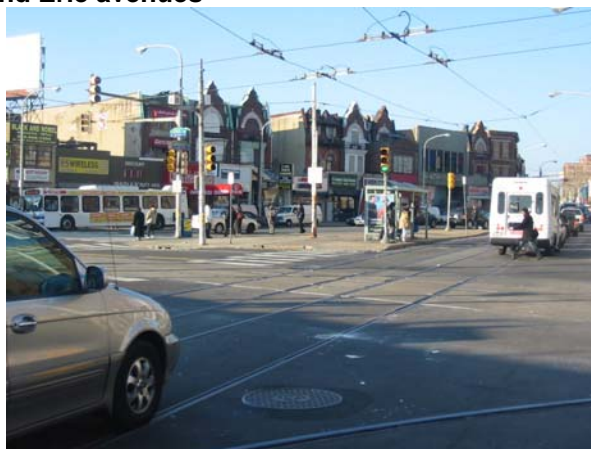
- Sidewalk on east side of Broad Street in state of general disrepair
- Pedestrian crossing over Erie Avenue on eastside of Broad Street is very long and undefined; lane striping faded or missing
- High pedestrian volumes, and movements are erratic; missing pedestrian signal heads; signs missing and/or damaged
- Undefined or inconsistent parking; parked vehicles compromise sight distance
- Nonexistent lane markings on Erie Avenue and Germantown Avenue and inconsistent alignment across the intersection cause disorder

No pedestrian facilities and poor vehicle guidance (See location 22)

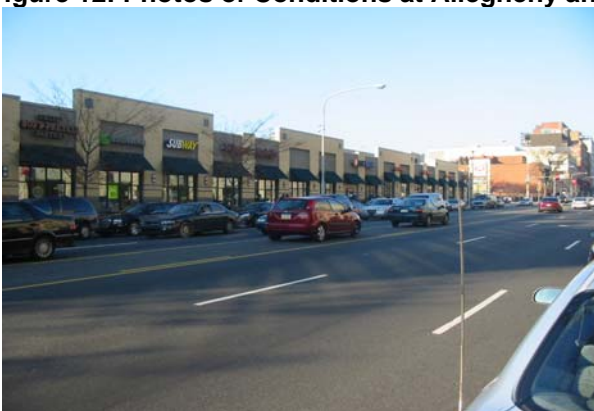
Figure 12: Photos of Conditions at Allegheny and Glenwood avenues

- Drivers use center lane for parking
- All crosswalks need restriping
- Lacks sufficient pedestrian controls considering the number of attractors (subway entrance/exits and fast food restaurants)
- Pedestrian refuge needed
- Cars running red lights appear to be an issue at this intersection (on both streets)

Drivers using center lane for parking (See location 23)

4. Unclear or worn signage or lack of signage should be replaced and/or assessed for clarity and visibility.
5. Uncontrolled use of the center lane by drivers both entering and exiting Broad Street causes conflicts over right-of-way. Access to the center lane should be more regulated, possibly with barriers being installed in high-problem locations.

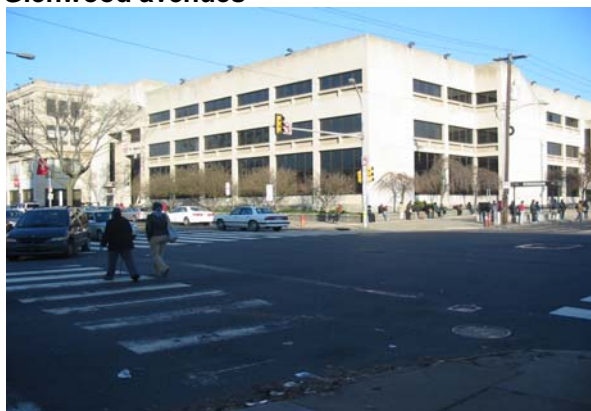
Poor road markings and pedestrian facilities (See location 23)

1. The primary cost-effective improvement is striping and restriping of all missing or faded crosswalks, bike lanes, and shoulders.
2. Enhance crossing safety and regulate pedestrian movements more effectively through the following measures:

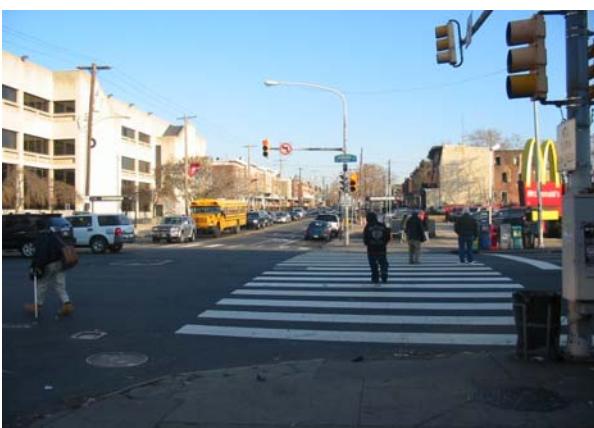
Excessive jaywalking and inadequate pedestrian controls (See location 23)

- Ensure that walk signal phases are of sufficient length
 - Consider implementing all-red signal phases in some locations
 - Install pedestrian signals that provide dedicated right-of-way to pedestrians

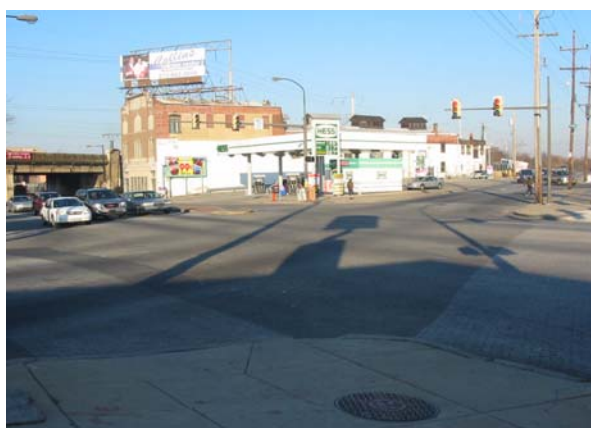
- All road markings need restriping

Inadequate road markings and poor access management (See location 24)
