DECEMBER 2009

NORTHAMPTON TOWNSHIP, BUCKS COUNTY

CONGESTION & CRASH

Analysis Program

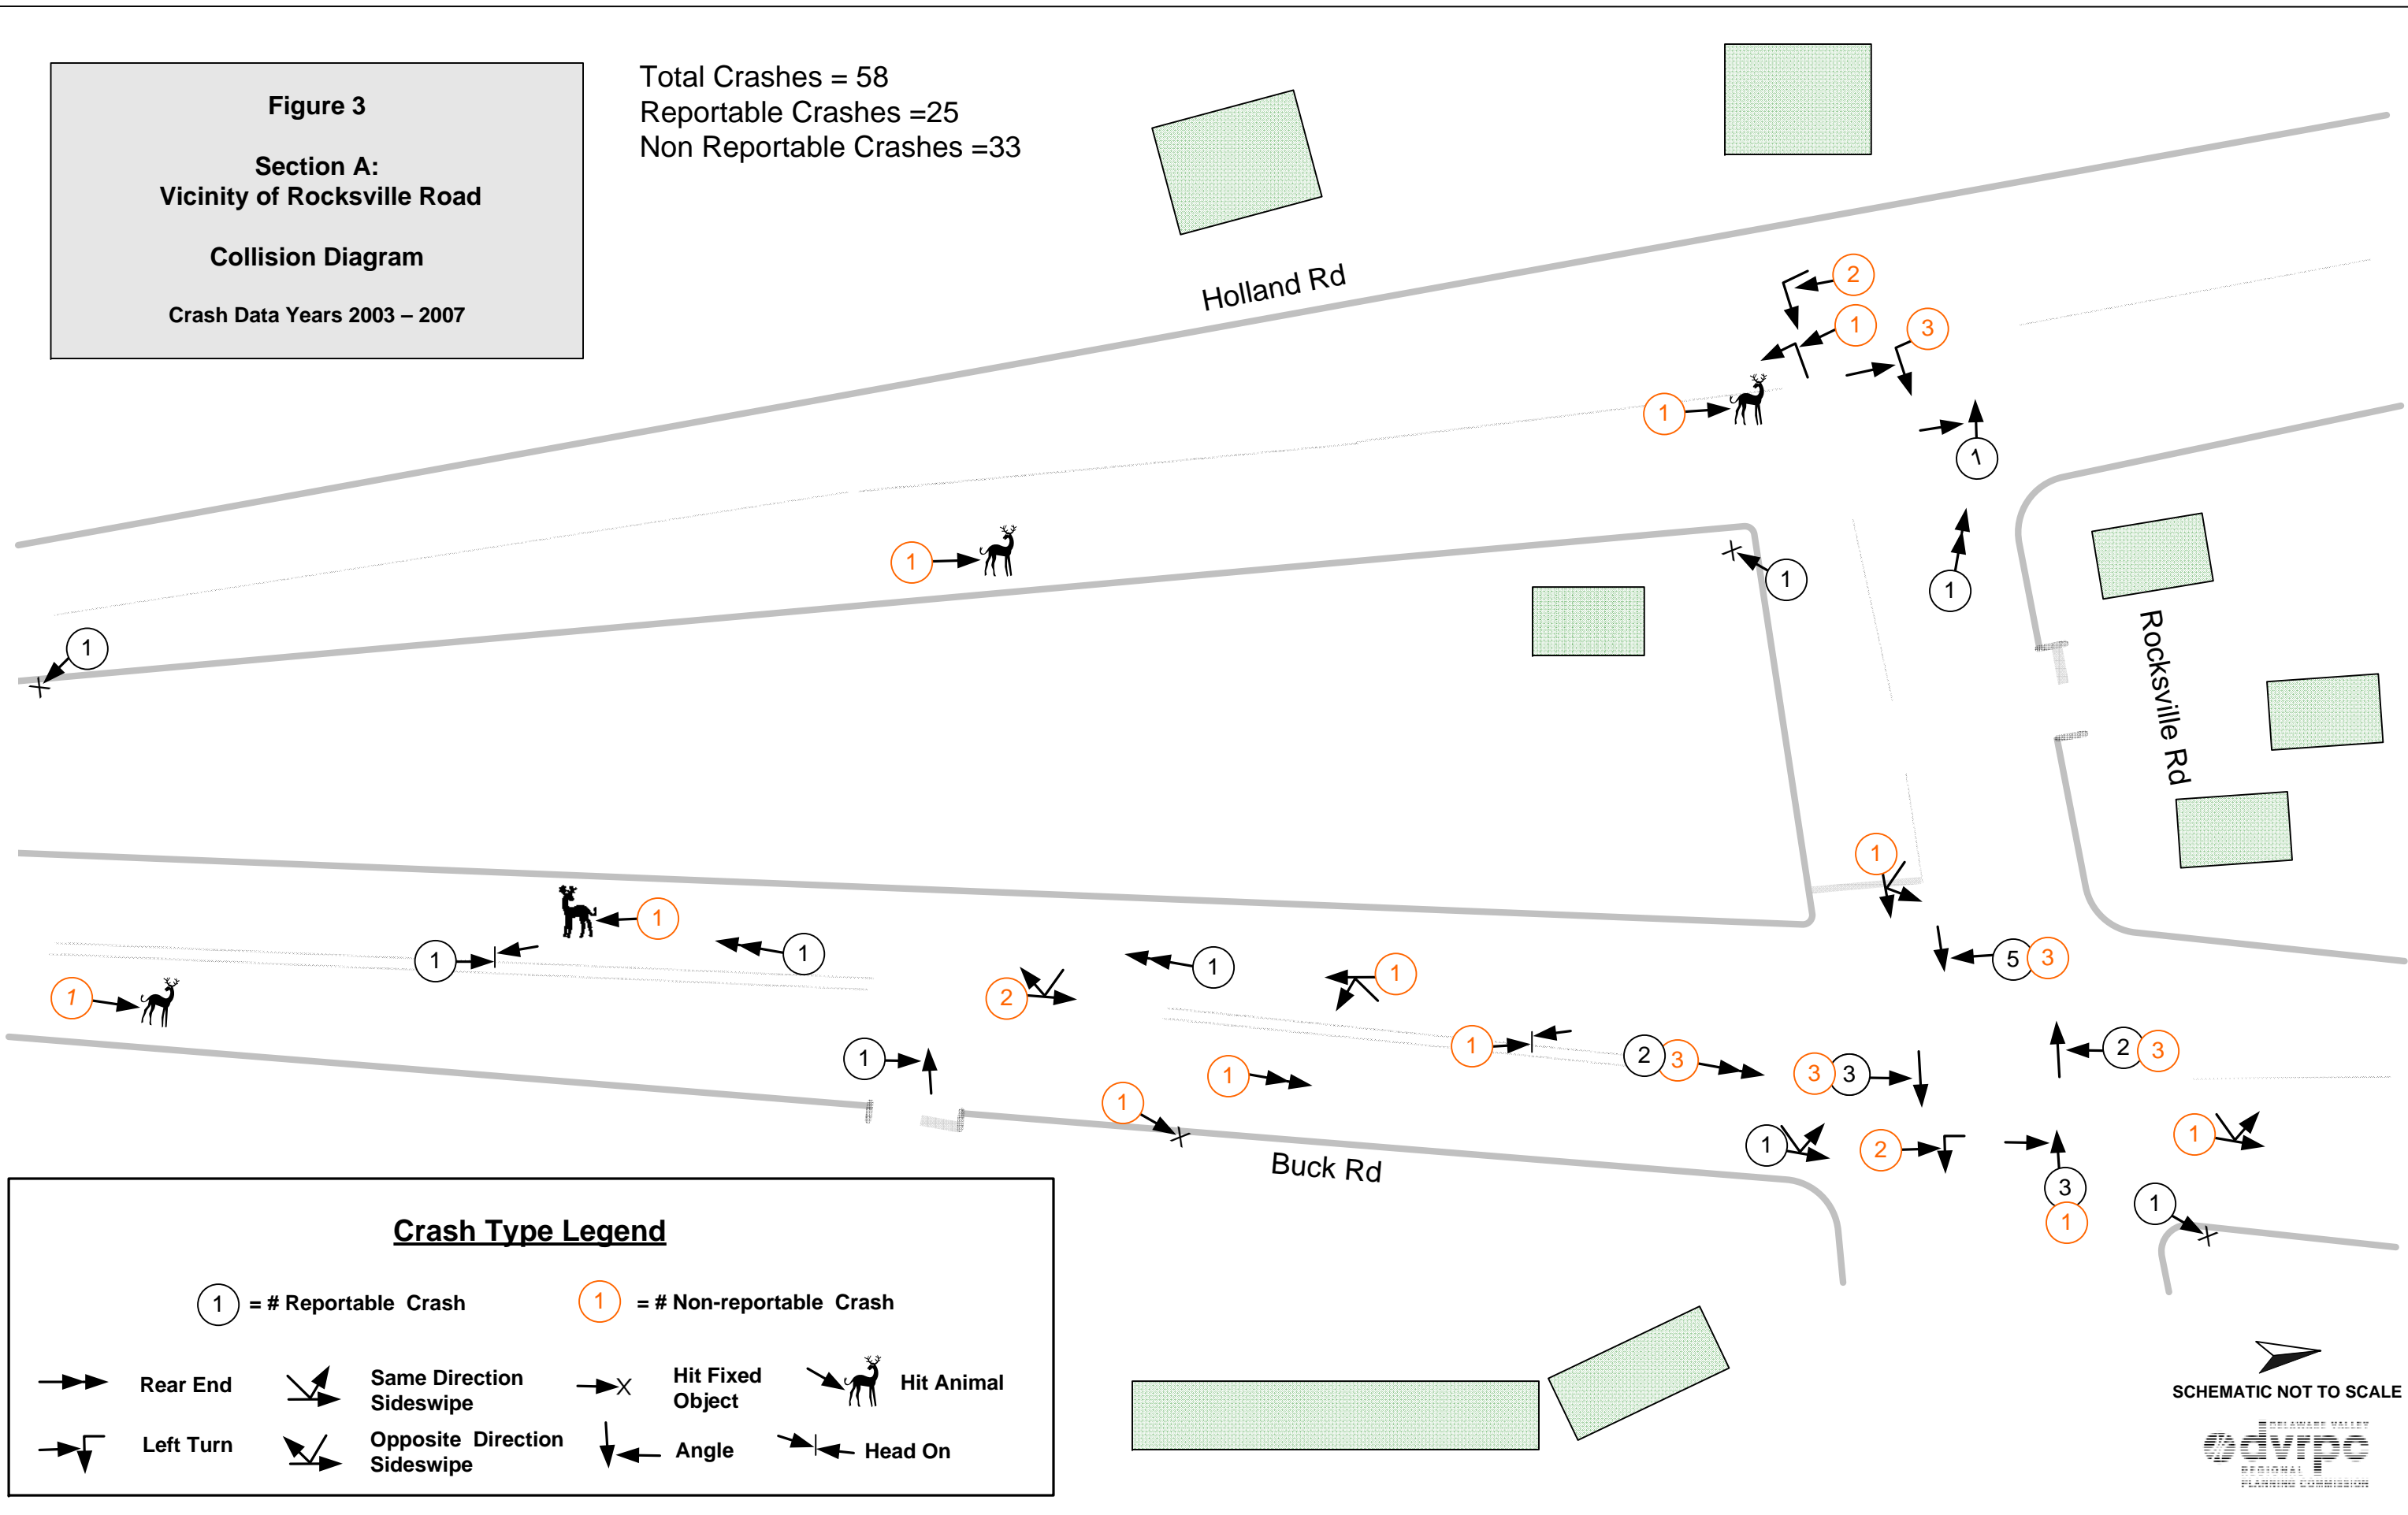
Figure 3
Section A:
Vicinity of Rocksville Road
Collision Diagram
 Crash Data Years 2003 – 2007

Total Crashes = 58
 Reportable Crashes = 25
 Non Reportable Crashes = 33

As shown in [Figure 3](#), rear-end crashes were not the predominant crash type in Section A. Instead, angle crashes topped the list, at 43 percent (25 crashes), which is more than twice the rear-end crashes, at 16 percent. Crashes associated with left turns accounted for 14 percent. As a result of higher speeds along Buck Road, these left-turn movements become more problematic. There were also four hit animal crashes, all of which were deer. This section of the study area is flanked by forest.

On average there were over 11 crashes per year between 2003 and 2007. During most months, this section saw between three and seven crashes, with the only anomaly being November, when nine crashes occurred. Regarding frequency by day of week the highest total occurred on Saturday, when 13 crashes were recorded. Unlike sections B and C, the time-of-day crash line shows frequency scattered throughout the daytime hours of 7:00 AM to 6:00 PM. Given the fact that the majority of incidents along Buck Road occurred at the intersection and in the vicinity of shopping plaza entrance (which are closely spaced to one another), exchanges to and from Buck Road are likely contributors to this trend.

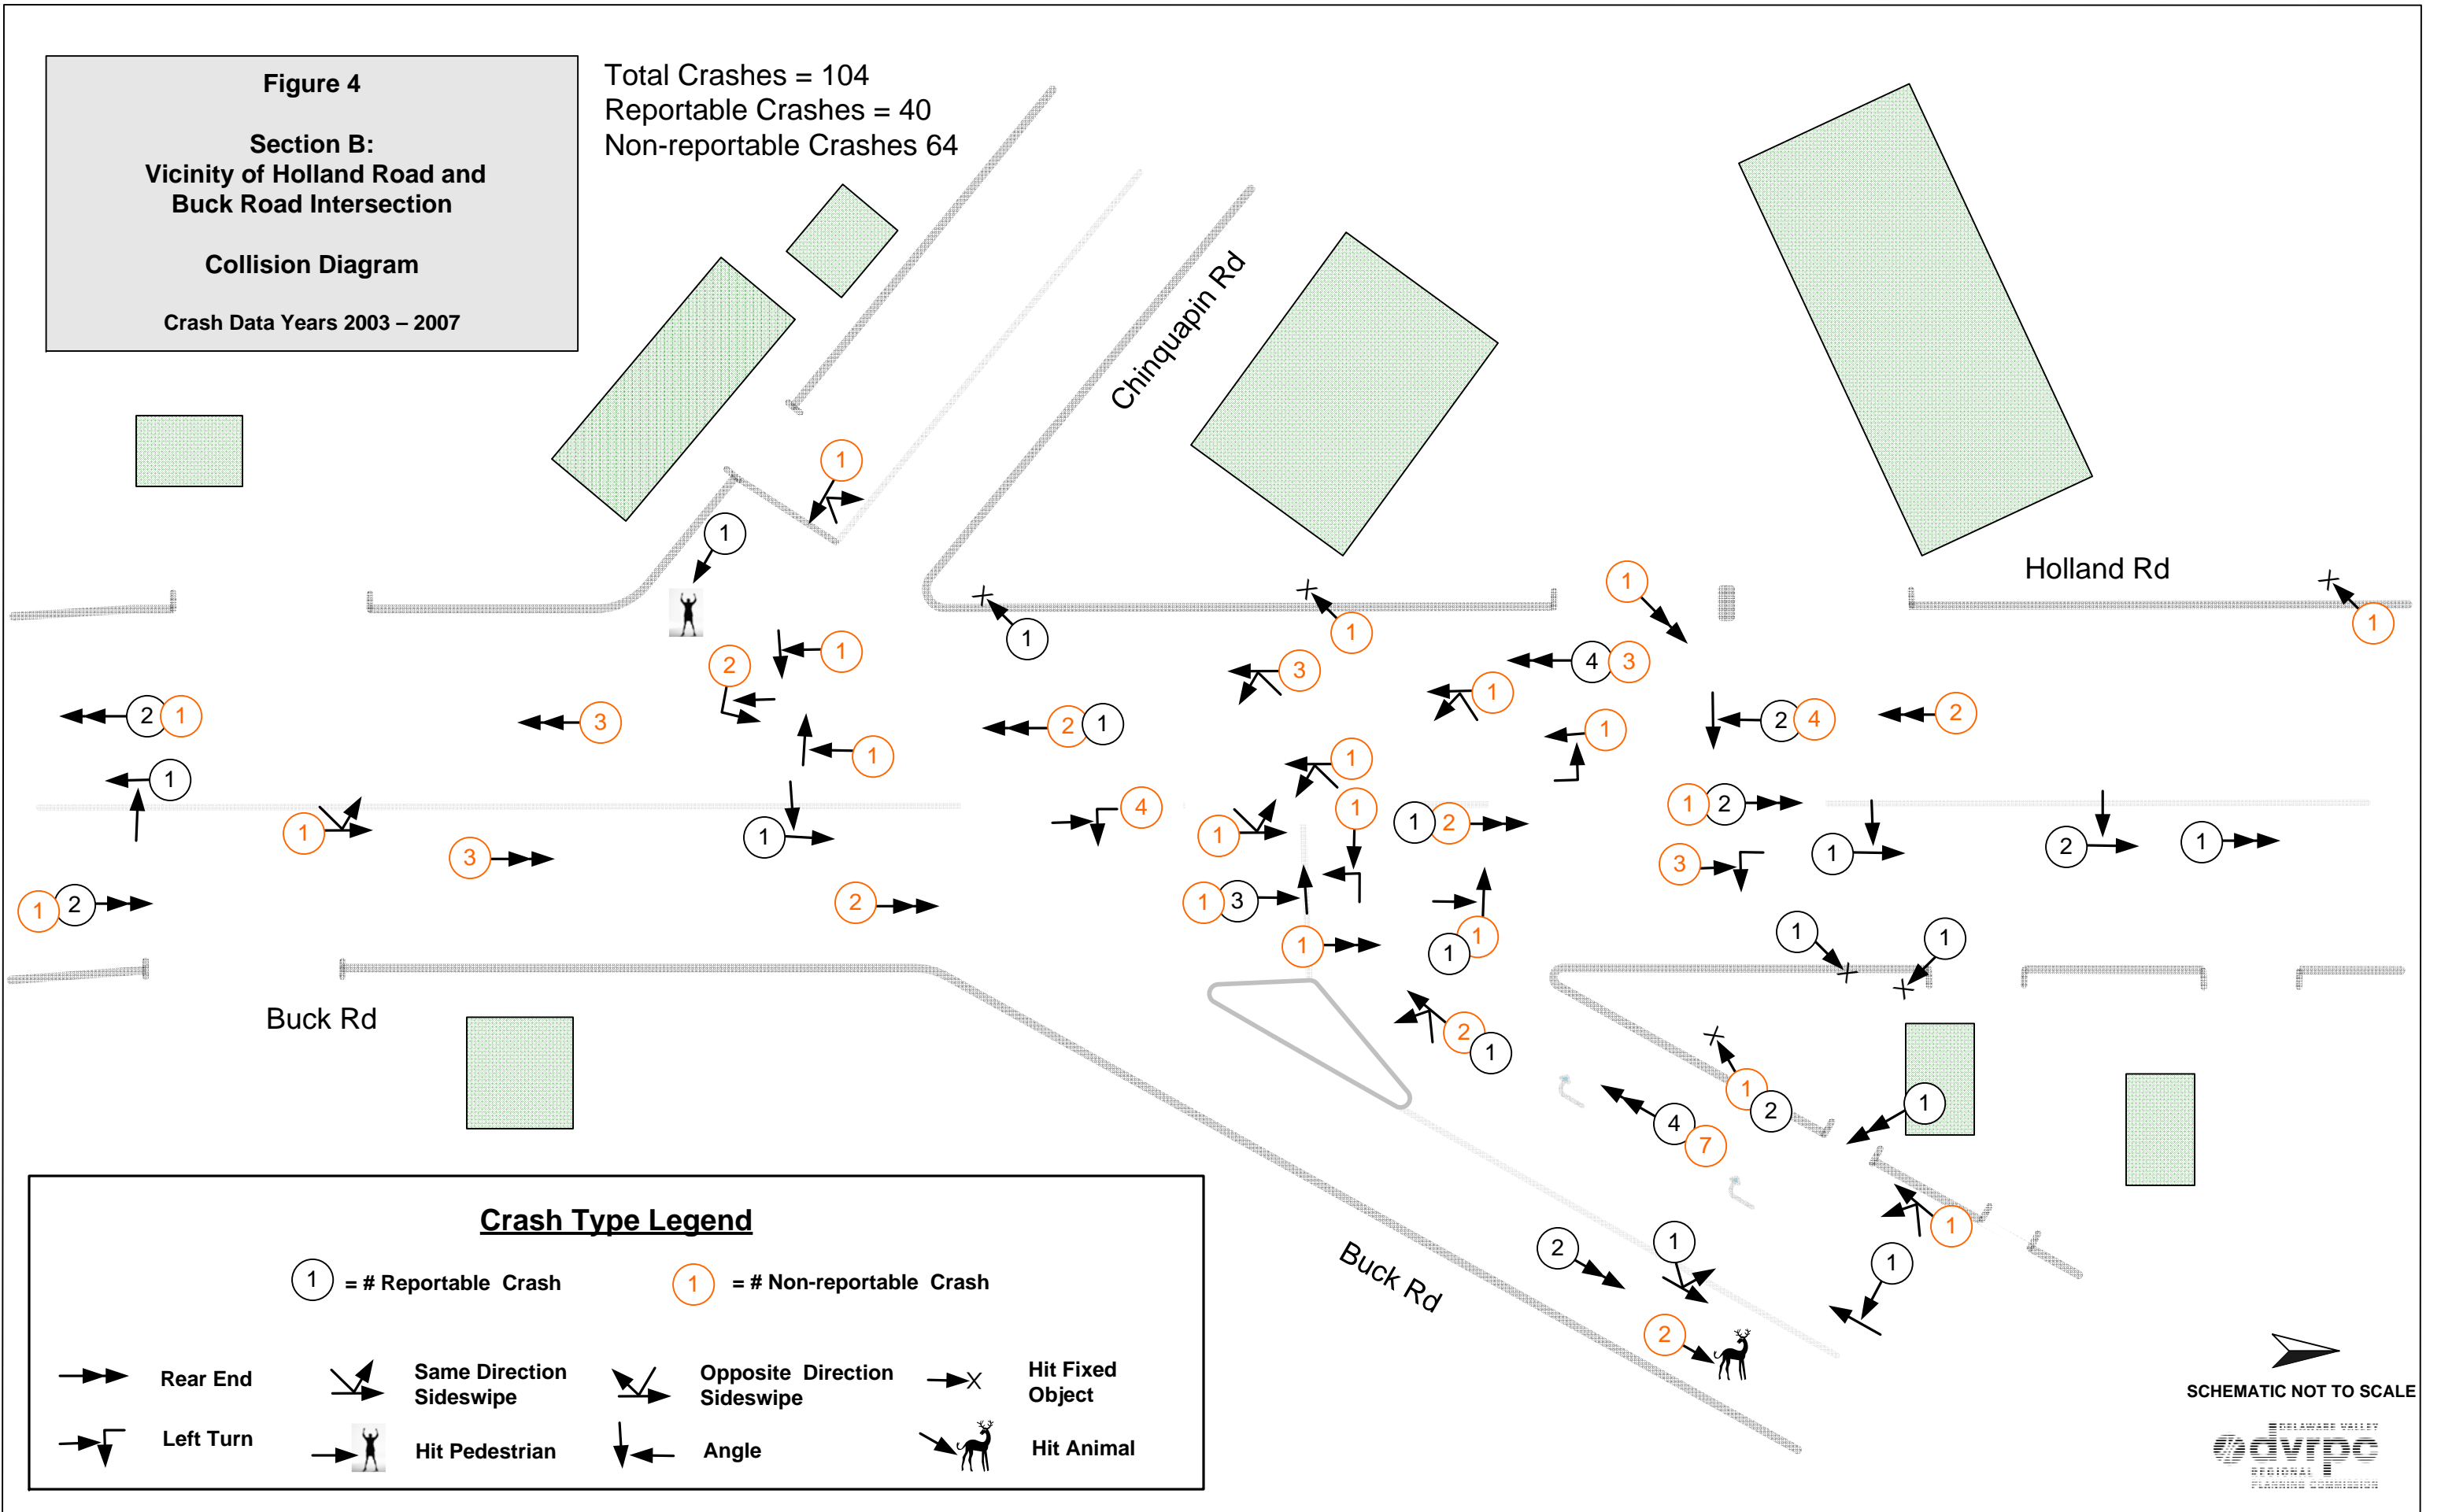
Figure 4
Section B:
Vicinity of Holland Road and
Buck Road Intersection
Collision Diagram
 Crash Data Years 2003 – 2007

Total Crashes = 104
 Reportable Crashes = 40
 Non-reportable Crashes 64

As indicated in [Figure 4](#) rear-end crashes were the predominant crash type, at 47 percent (49 crashes), though angle crashes were also significant, at 19 percent, or 20 crashes. This can be attributed to the greater number of driveways located in Section B (i.e., gas station, Wawa, and office center; in addition, Chinquapin Road intersects here). Same-direction sideswipe crashes were more significant here than anywhere else in the study area (11 percent). Field observations revealed that northbound traffic uses the shoulder to circumvent vehicles queuing to turn left onto Chinquapin Road. This issue is addressed in the recommendations section.
