DELAWARE VALLEY
dvrpc
REGIONAL
PLANNING COMMISSION

JANUARY 2010

NORTH OLDEN AVENUE

Road Safety Audit

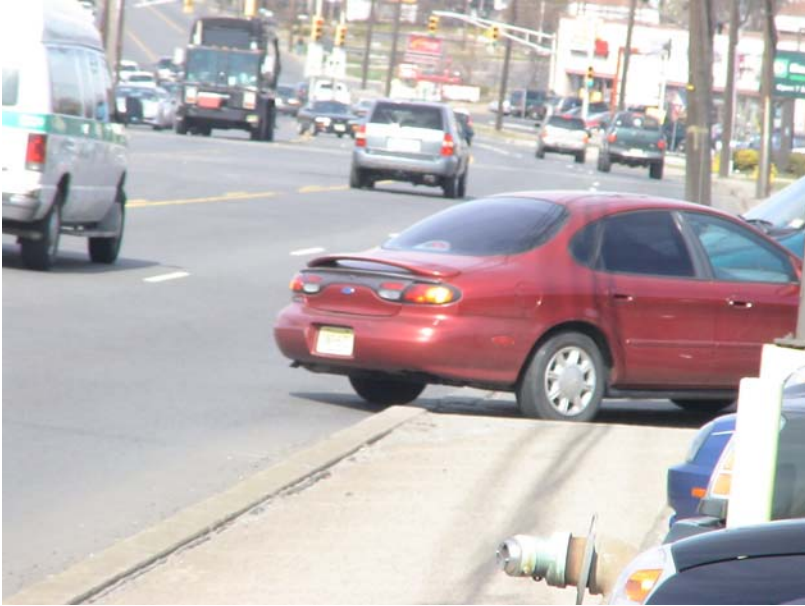
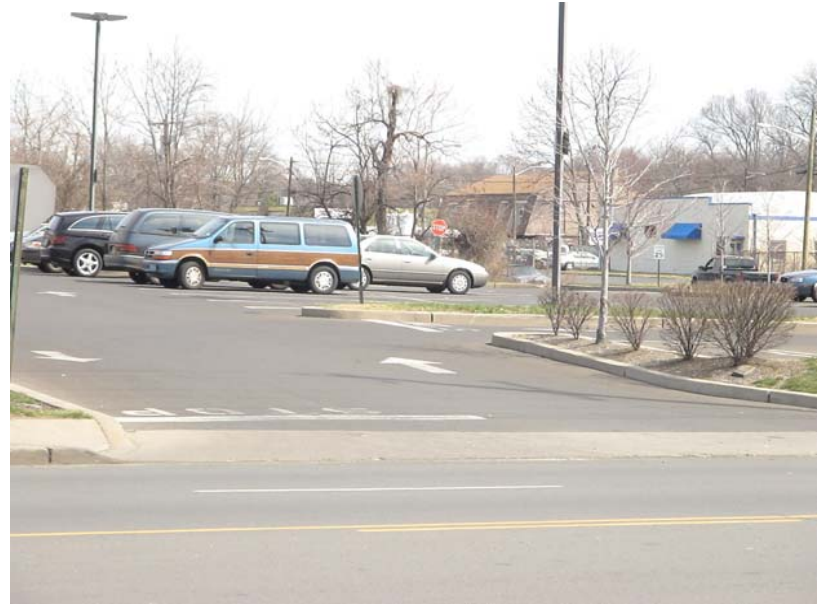
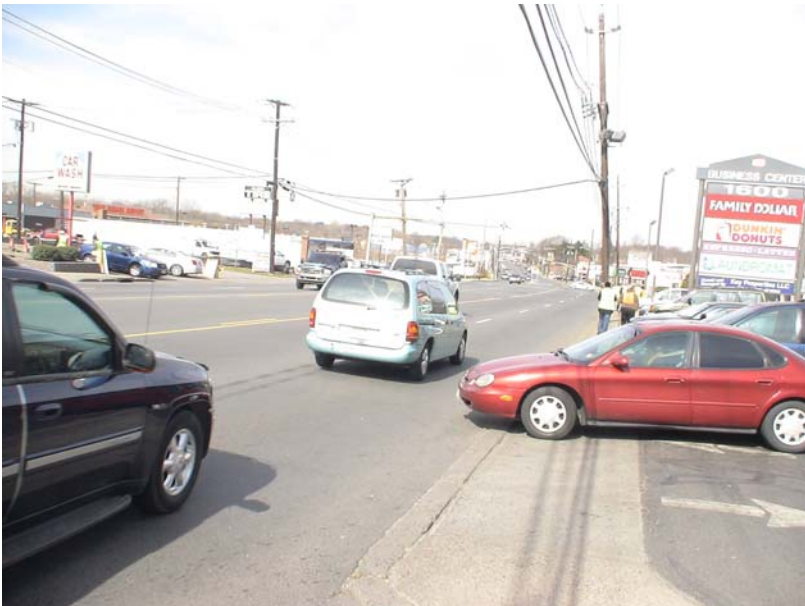
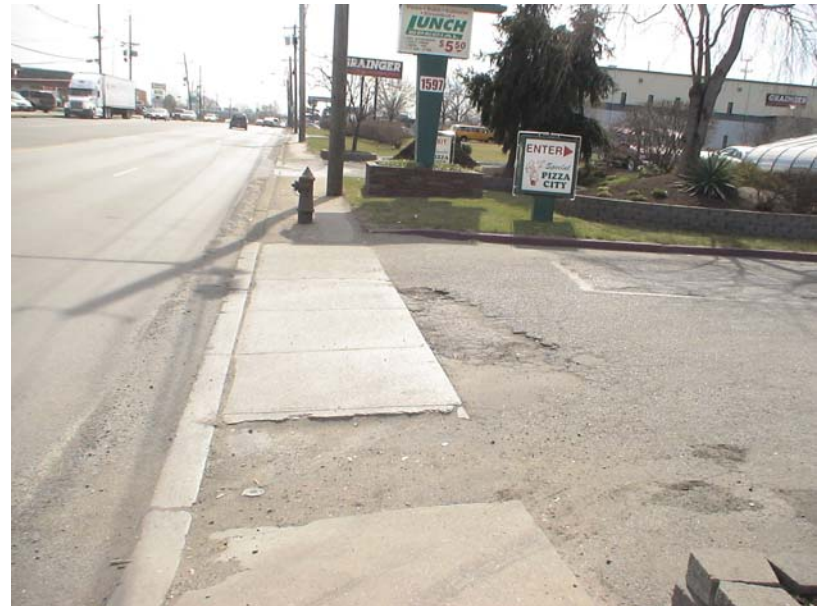
Driveways

2c. Visually, many driveways are poorly delineated;			
2d. Insufficient building setbacks in some locations make circulation in parking areas problematic, especially when combined with entering and exiting vehicles.			
3a. Very tight turning radii for vehicles making right turns into or out of Olden Avenue causes drivers to slow dramatically;			
3b. Exiting some driveways can be problematic due to compromised sight distance and high speed of through traffic on Olden Avenue.	3. Consider narrowing the lane widths, especially the TWLTL, which appears to be unnecessarily wide, to slow traffic and improve safety.	Medium	High

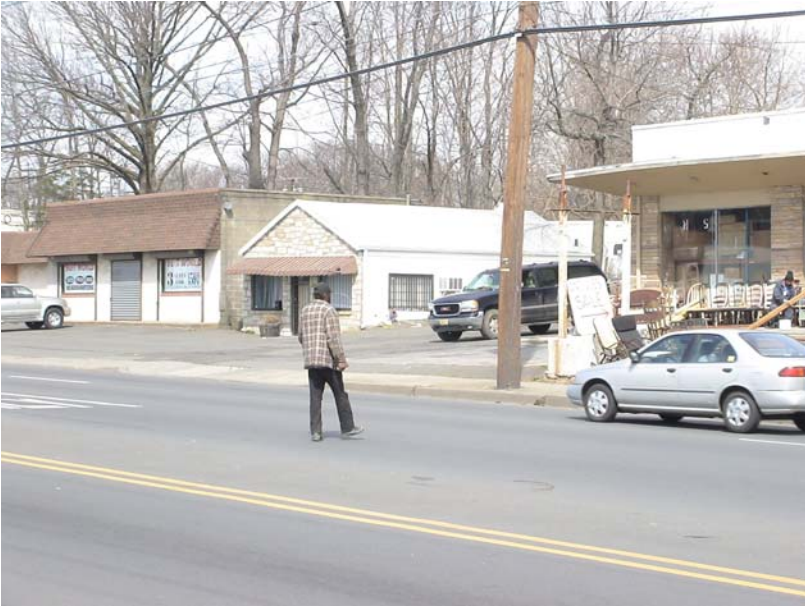
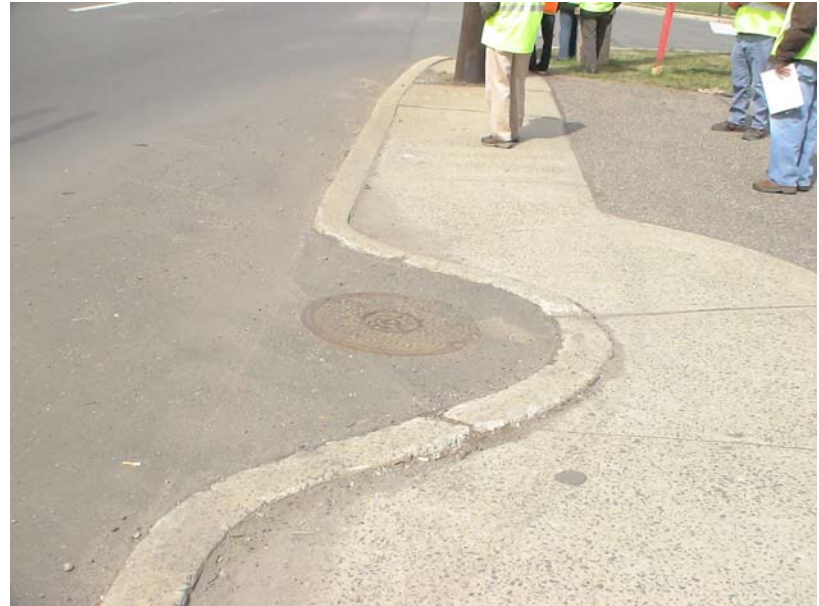
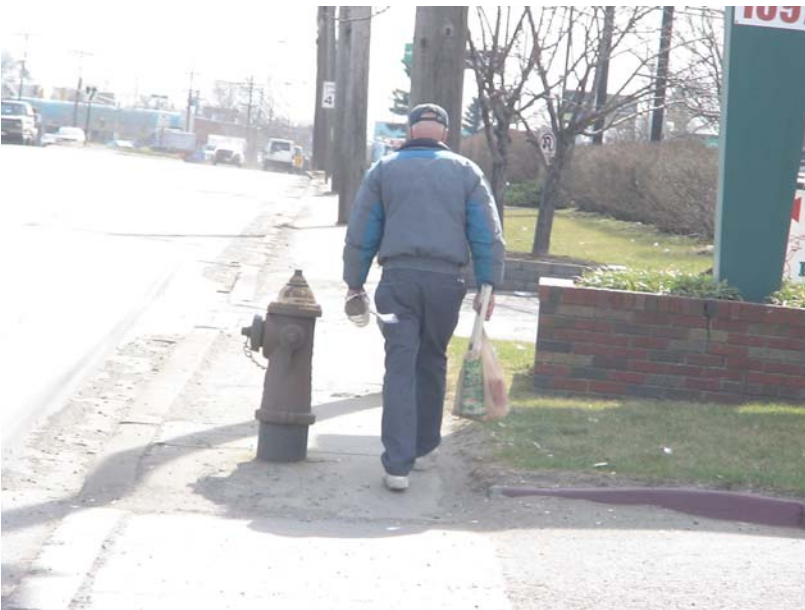
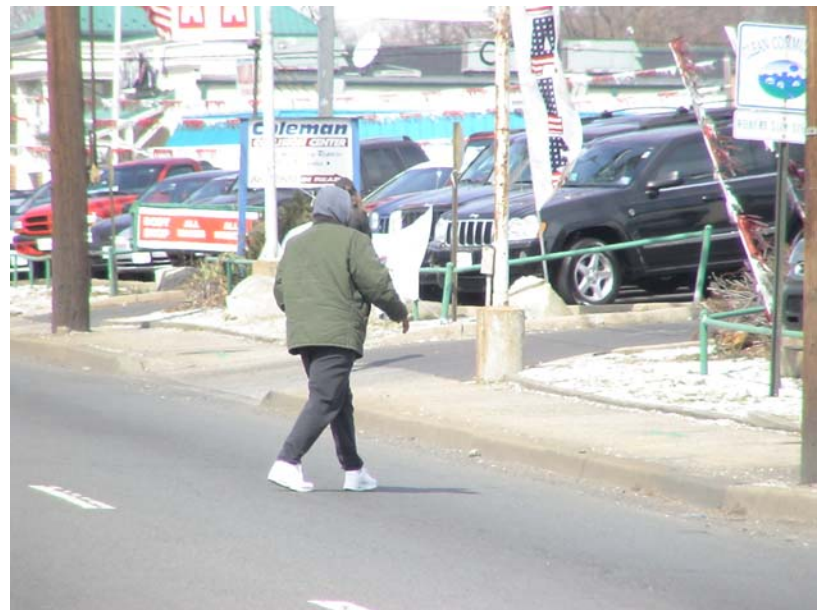
Pedestrian Conditions

Corridor-wide Issue	Potential Strategy	Level of Effort	Estimated Safety Benefit
Pedestrian Environment			
<ol style="list-style-type: none"> Uneven, damaged, excessively pitched, and missing sidewalk blocks throughout, especially between Capitol Plaza and Princeton Avenue; along Olden Avenue eastbound dirt and debris are accumulating on sidewalk and compromising the sidewalk width; Sidewalk obstructed by utility poles throughout and sidewalks narrow to accommodate manholes along the road's edge; The number and width of driveways expose pedestrians to more vehicular conflict points with traffic; Intermittently missing ADA ramps at intersections 	<ol style="list-style-type: none"> Sidewalks need repair and general maintenance; add missing sidewalk segments; address the excessive slope of the sidewalks through maintenance; Evaluate the cost/benefit of mitigating the telephone pole obstructions by either relocating the poles (very costly), or adding more sidewalk area to allow for safer circumnavigation of the poles and manholes (likely less costly); this will also address the manhole obstructions; Implement access management plan to reduce the number and size of driveways; Add ADA ramps where missing; 	<p>Medium</p> <p>High</p> <p>High</p> <p>Low</p>	<p>Medium</p> <p>High</p> <p>High</p> <p>Medium</p>

<ol style="list-style-type: none"> Vehicles parked alongside the sidewalk in parking lots partially obstruct the pedestrian path; 	<ol style="list-style-type: none"> Enforce on-site parking regulations to prevent parked vehicles from obstructing the sidewalk; 	<p>Medium</p>	<p>High</p>
<ol style="list-style-type: none"> Crash data reveals pedestrian crashes in the mid-block; field visit revealed great distances between formal crossing opportunities at signalized intersections; frequent pedestrian crossings are common near shopping areas; Numerous pedestrian crashes along this relatively short study segment of Olden Avenue. 	<ol style="list-style-type: none"> Consider a mid-block crossing in vicinity of ShopRite plaza; combine with a bus shelter where appropriate; Investigate details of the pedestrian crashes in search of trends or commonalities that can be mitigated through safety improvements. 	<p>Low</p> <p>Low</p>	<p>Low</p> <p>Medium</p>

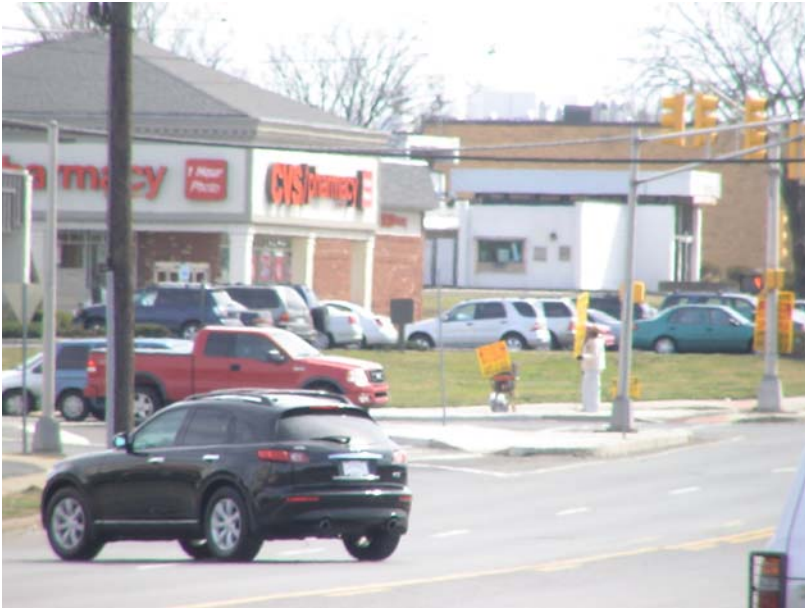
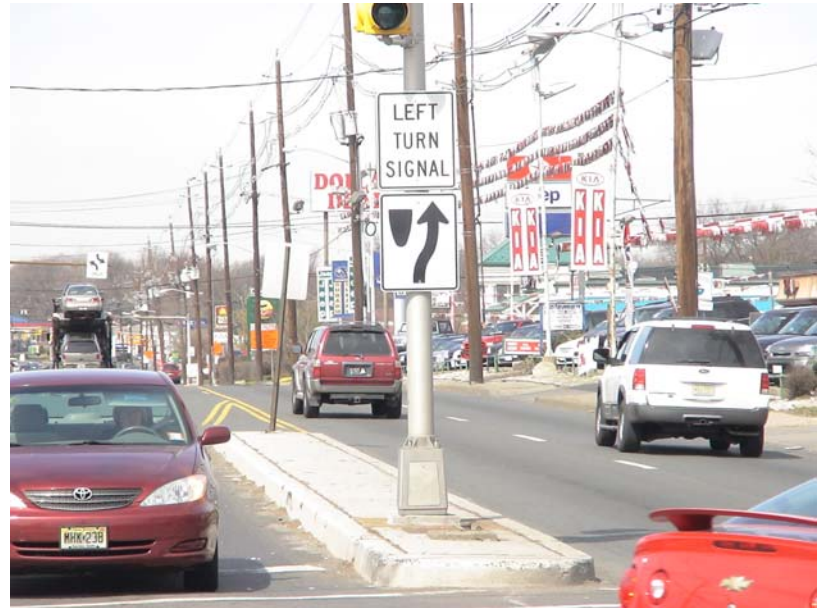
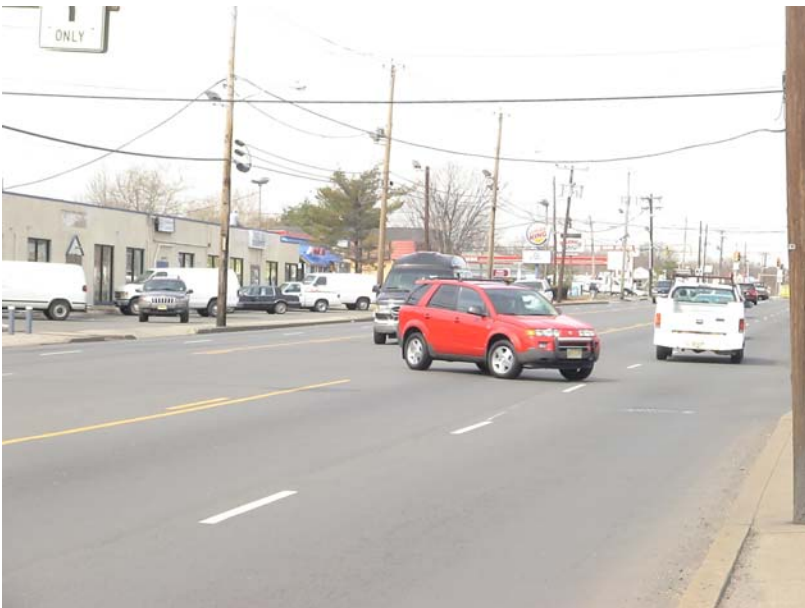
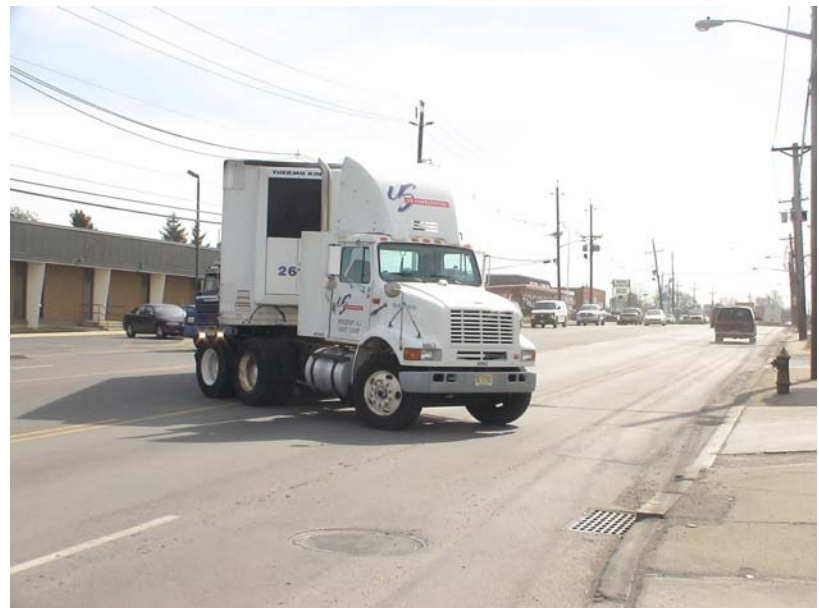
Left Turns

Corridor-wide Issue	Potential Strategy	Level of Effort	Estimated Safety Benefit
Access Management			
1. The two-way left turn lane (TWLTL) is being misused as a lane for by-passing congested traffic lanes, and this situation may be contributing to crash frequency;	1a. Increase enforcement to target improper passing, weaving, speeding, and improper use of the TWLTL;	High	High (temporary benefit)
2a. Duplicative and seemingly unregulated driveways for business access adds conflict points to Olden Avenue and contributes to the crash frequency along the study corridor;	1b. Upgrade the corridor with colored and/or textured (e.g.: thermo-plastic) pavement markings to distinguish the appropriate left-turn opportunities in the TWLTL, and to discourage inappropriate use of the in-between sections as a travel lane;	Low	High
2b. Duplicative driveways also present additional conflict points for pedestrians;	2. Develop access management plan to identify and eliminate duplicative driveways and regulate the size and operations of driveways, not only on individual sites but also shared access between multiple sites for both vehicular and pedestrian traffic;	Medium	High

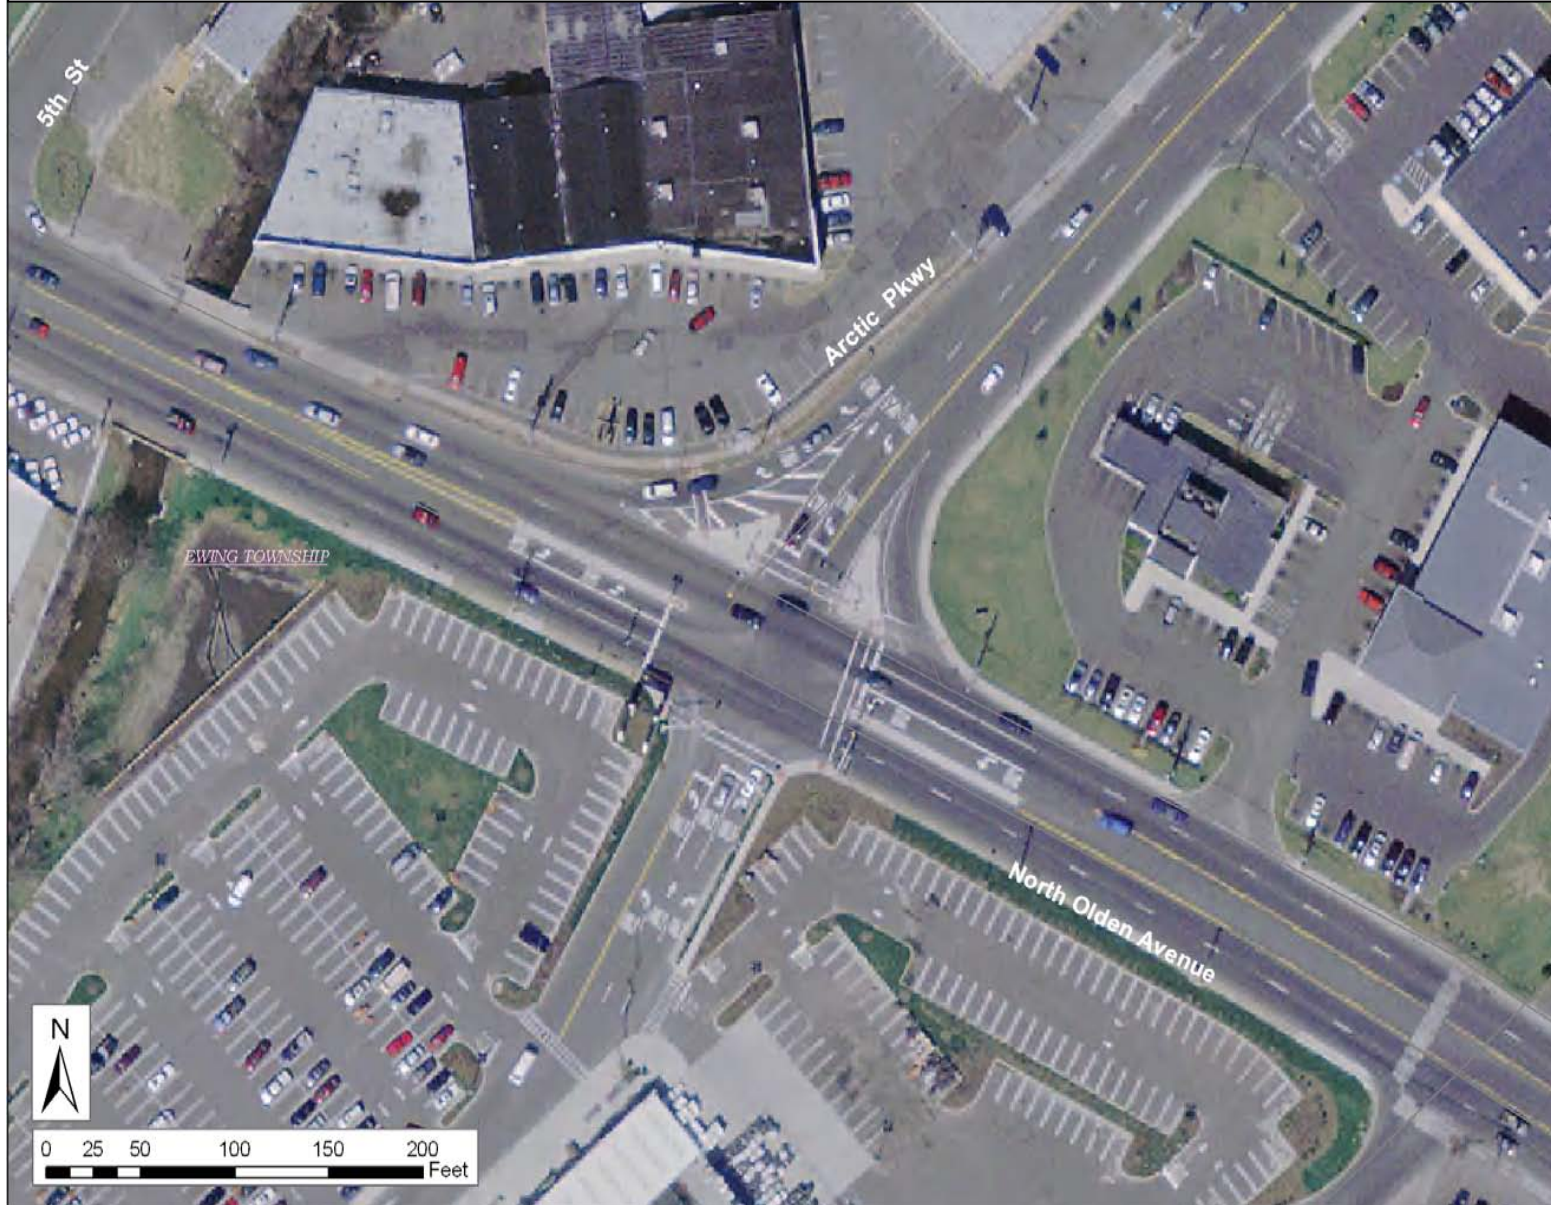
1. CR 622 North Olden Avenue at Arctic Parkway
 Mile Post 4.64 – 4.69

COLLISION TYPE	
Rear End	25
Sideswipe	9
Angle	13
Head On	1
Left Turn / U Turn	5
Fixed Object	1
total	54
INTERSECTION	
At Intersection	16
Between Intersections	38
total	54

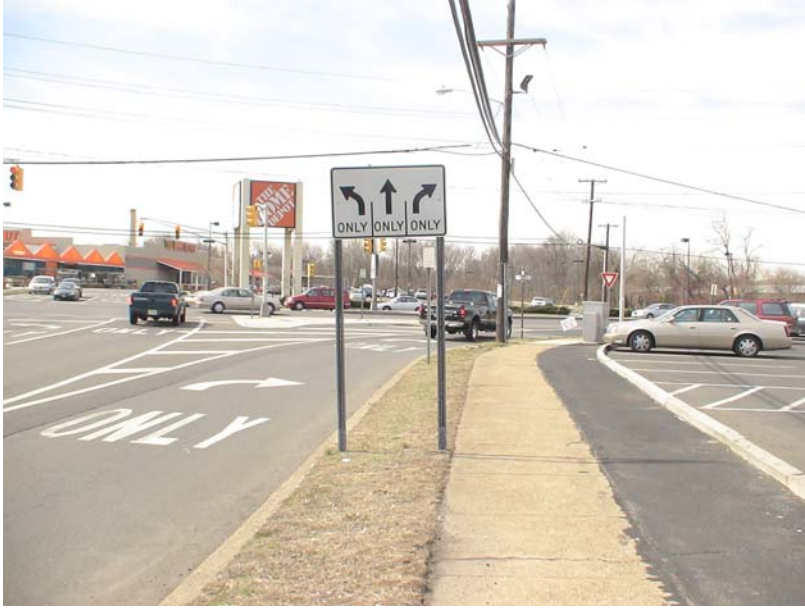
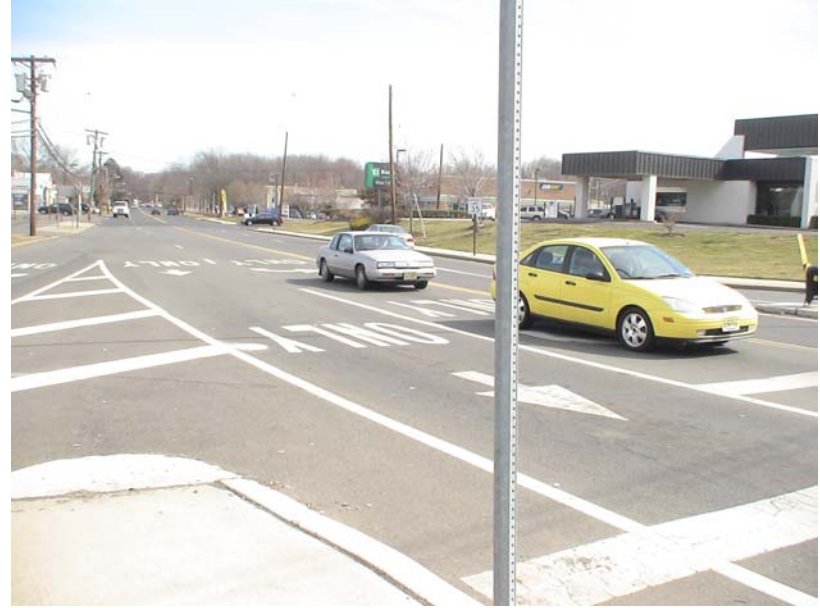
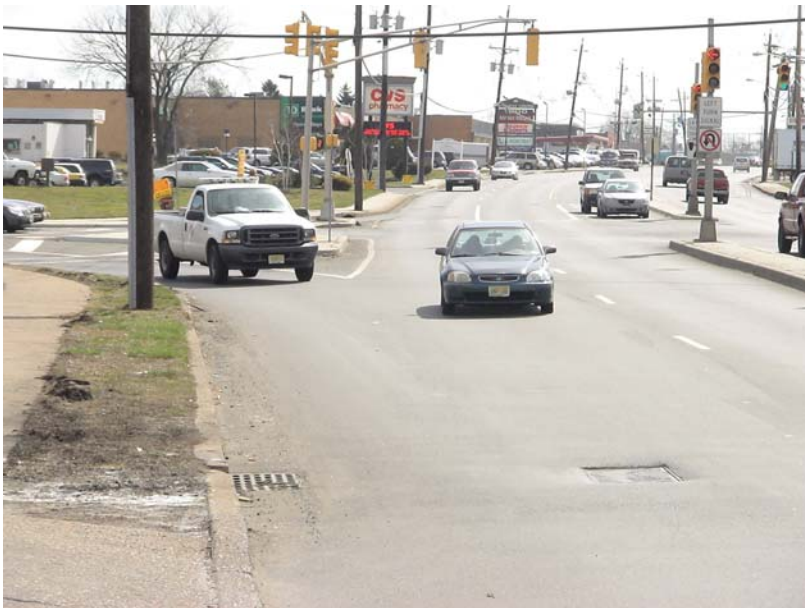
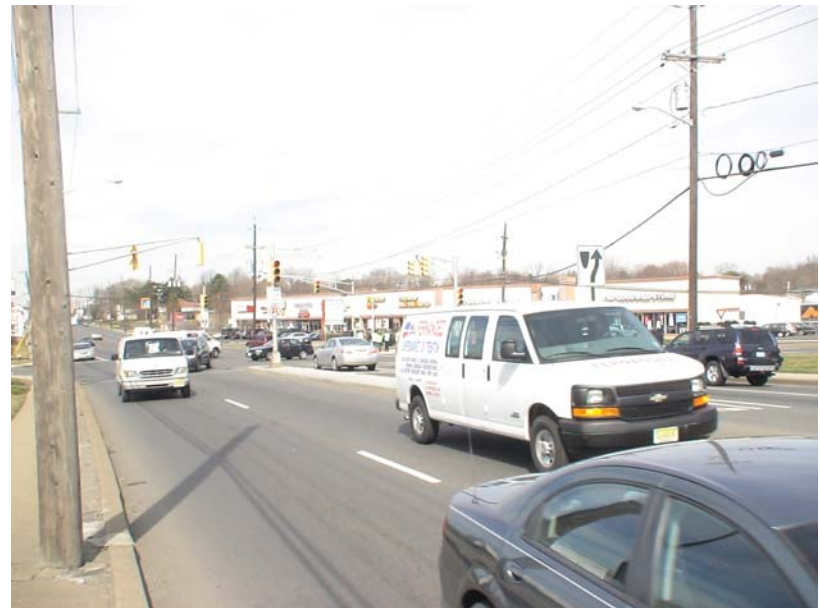
North Olden Avenue at Arctic Parkway

Site Specific Issue	Potential Strategy	Level of Effort	Estimated Safety Benefit
Arctic Parkway Intersection and Vicinity			
1. The right-turn slip ramp from Arctic Parkway southbound onto Olden Avenue westbound is reportedly the site of many rear-end crashes coded to Arctic Parkway (not part of the original RSA crash analysis);	1. A cursory follow-up analysis of crashes on Arctic Parkway revealed 13 rear-end crashes coded at the Olden Avenue intersection; more analysis is needed to determine northbound or southbound direction of travel;	Low	Medium

2. Sight distance for traffic turning right from Arctic Parkway southbound onto Olden Avenue westbound is compromised by the severe angle at which the slip ramp meets Olden Avenue;	2. Restripe the Arctic Parkway southbound right turn slip ramp to Olden Avenue westbound to make it more perpendicular to improve sight distance;	Medium	High

3. Motorists were observed not to stop at the crosswalks for the Arctic Parkway right-turn slip ramps (northbound and southbound);	3. Enhance signs and crossing pavement markings for the Arctic Parkway southbound leg to improve pedestrian safety. Also, consider relocating the northbound slip ramp crossing further north along Arctic Parkway as well as add appropriate crossing amenities (signal heads, push buttons, striping);	Low	High

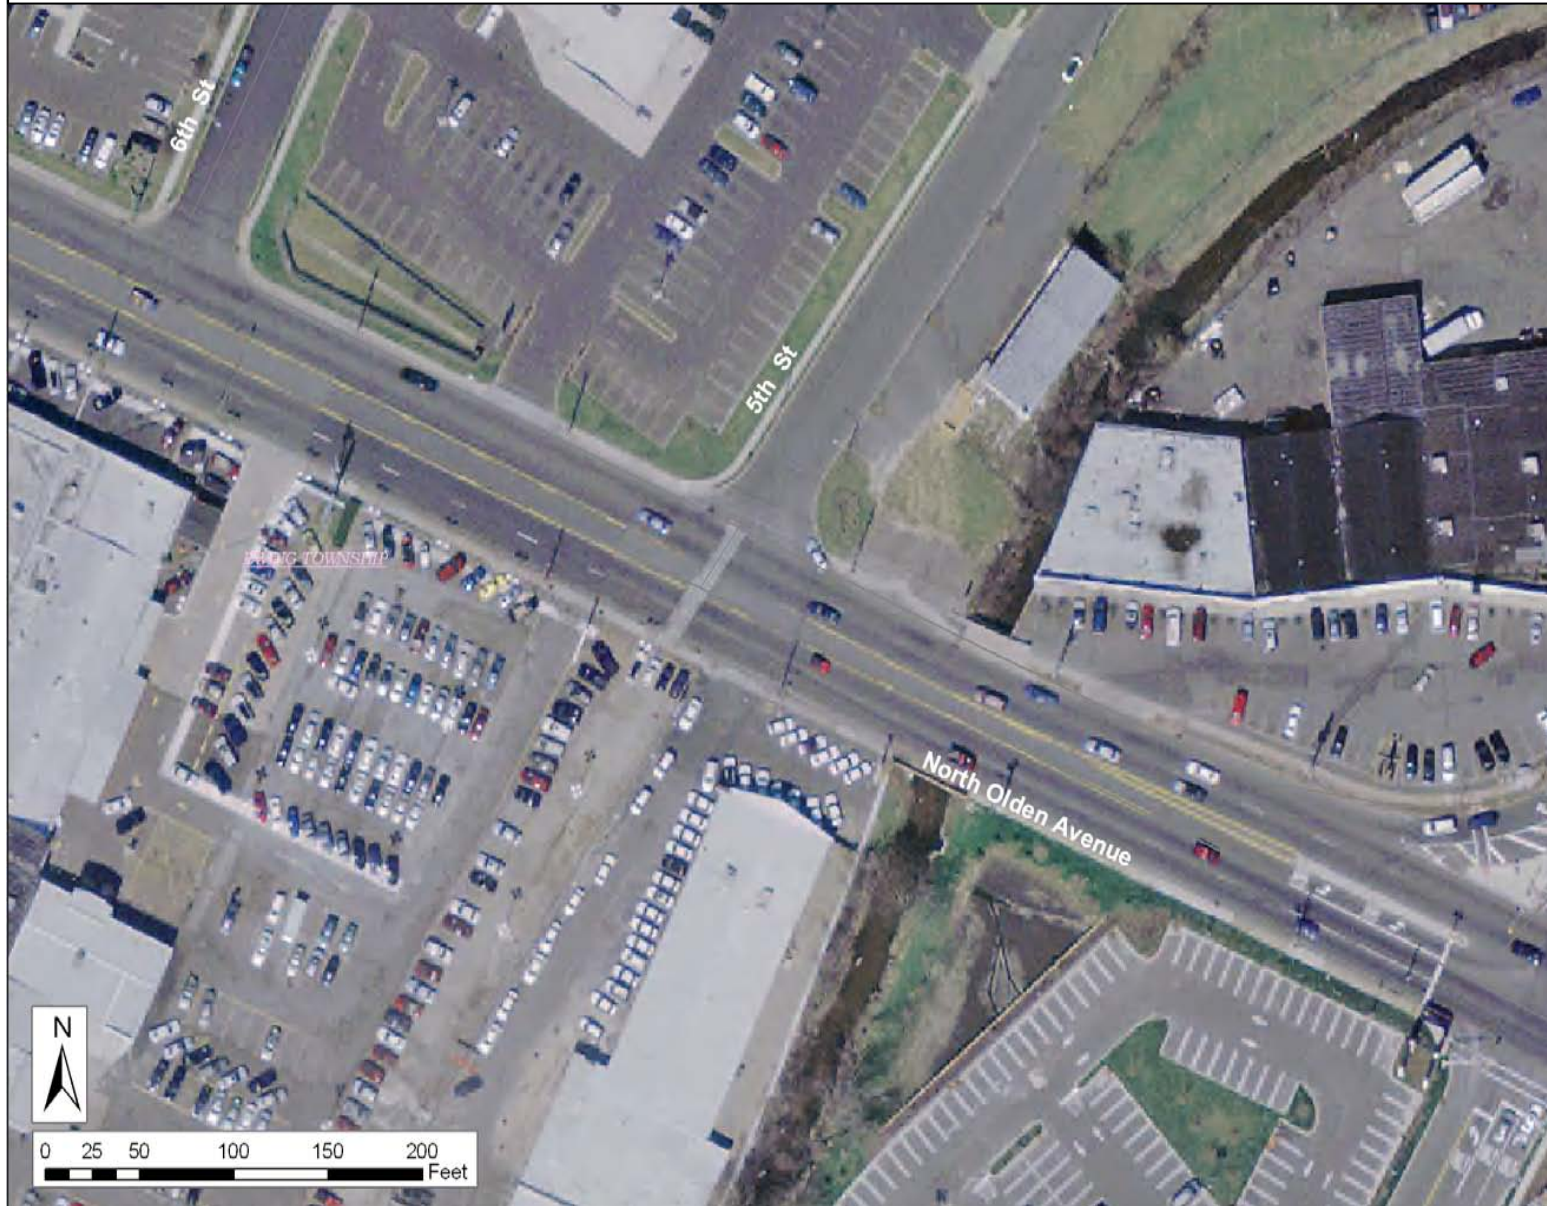
2. CR 622 North Olden Avenue in the Vicinity of 5th Street
 Mile Post 4.70 – 4.75

COLLISION TYPE	
Rear End	6
Sideswipe	10
Angle	9
Pedalcycle	2
Left Turn / U Turn	3
Fixed Object	3
Parked Vehicle	1
Encroachment	1
total	35
INTERSECTION	
At Intersection	4
Between Intersections	31
total	35

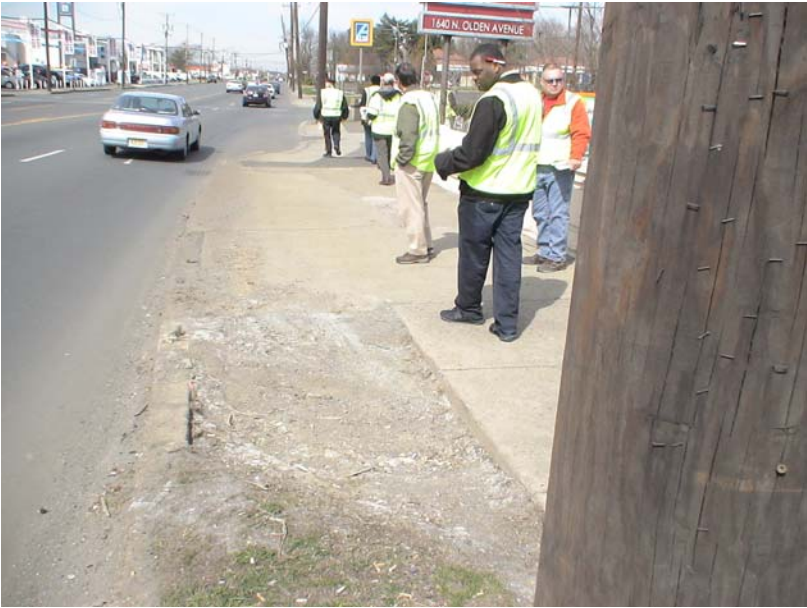
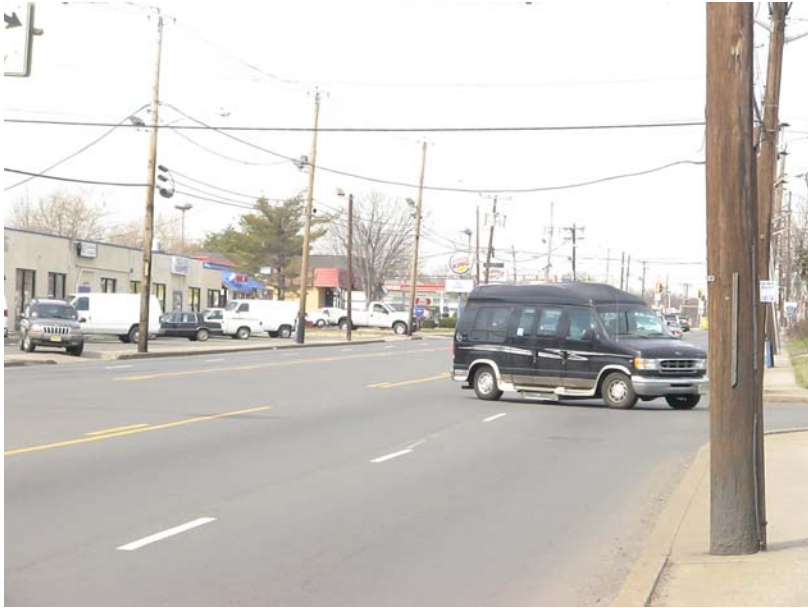
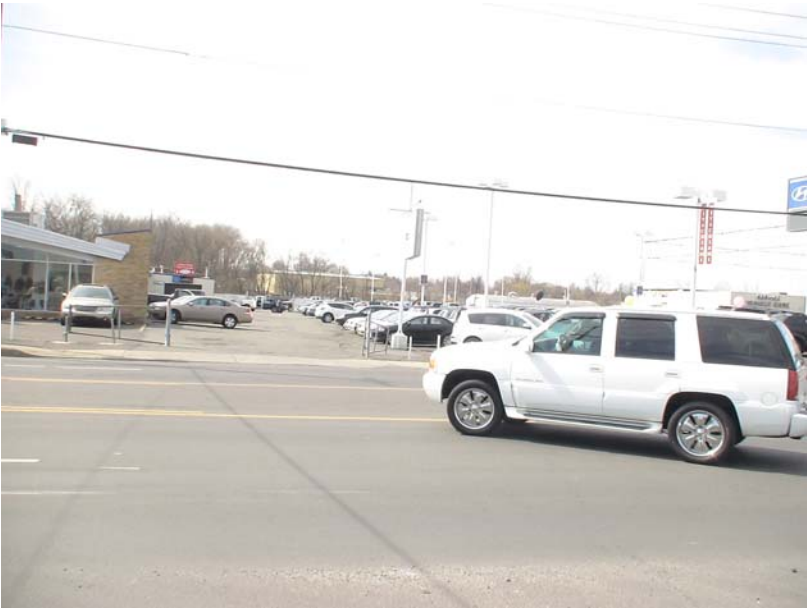
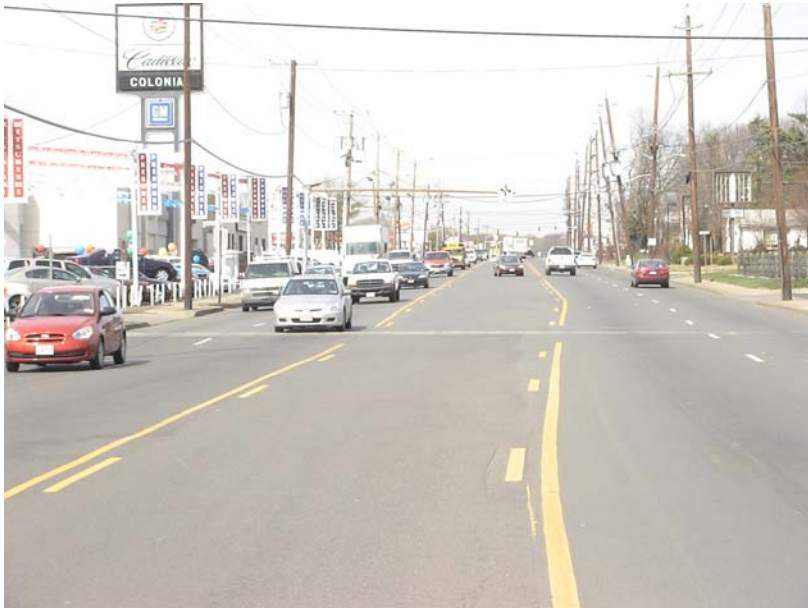
North Olden Avenue in the Vicinity of 5th Street

<p>5th Street</p> <p>1. Sight distance is compromised looking east from 5th Street due to a private sign and garbage receptacle obstructing the viewshed;</p>	<p>1a. Remove/relocate the private sign and garbage receptacle;</p> <p>1b. Consider modifying the 5th Street approach using striping for improved sight distance;</p>	<p>Low</p> <p>Medium</p>	<p>High</p> <p>Medium</p>

Site Specific Issue	Potential Strategy	Level of Effort	Estimated Safety Benefit
2. 5 th and 6 th Streets are very close to each other on Olden Avenue and are connected to each other via two additional side streets parallel to Olden Avenue; this duplication unnecessarily creates an extra conflict point;	2. Consider making 5 th Street one-way, as half of a one-way pair with 6 th Street serving the other direction, to improve access management and reduce conflict opportunities and thus potential crashes;	Medium	Medium

3. No ADA curb ramps or crosswalk striping across 5 th Street;	3. Add ADA curb ramps and a pedestrian crosswalk;	Medium	High
4. Eastbound near the creek between 5 th Street and Arctic Parkway there is a large slab of asphalt in the sidewalk.	4. Remove the unneeded asphalt to improve the pedestrian way.	Low	High
Between 5th and 6th

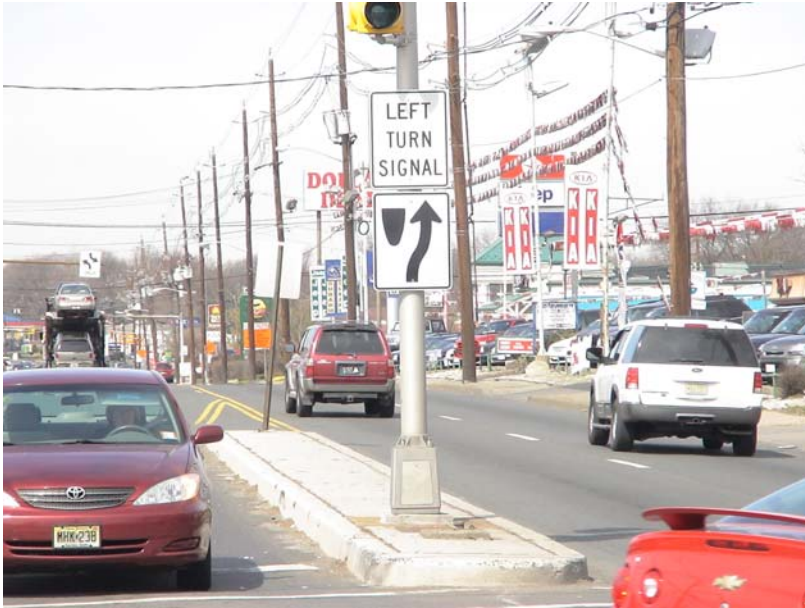
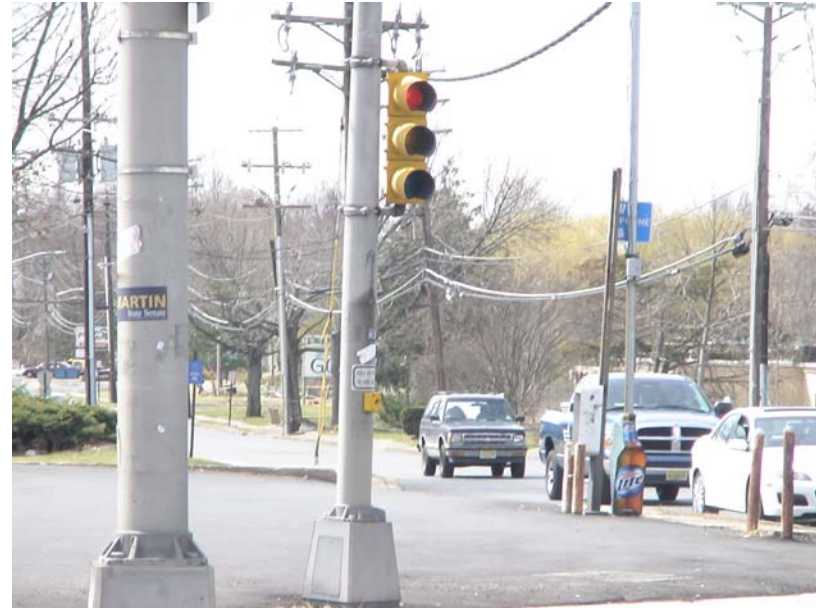
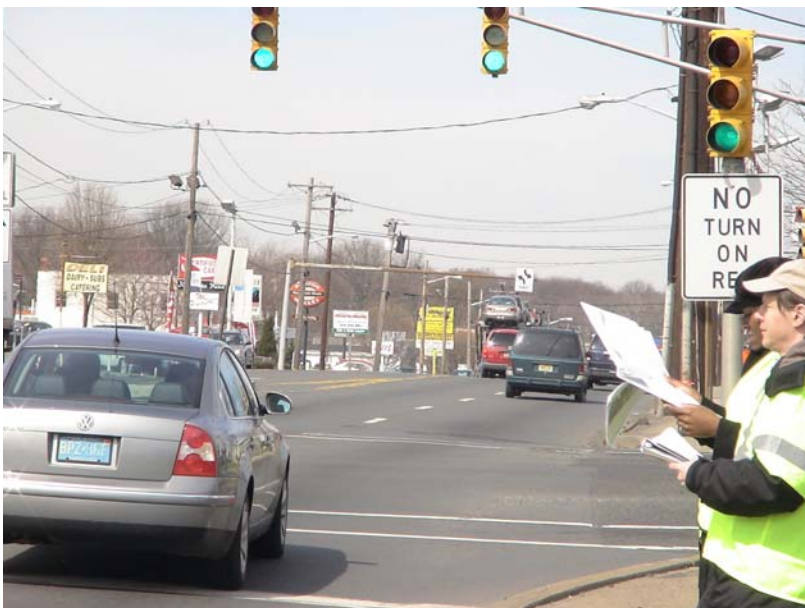
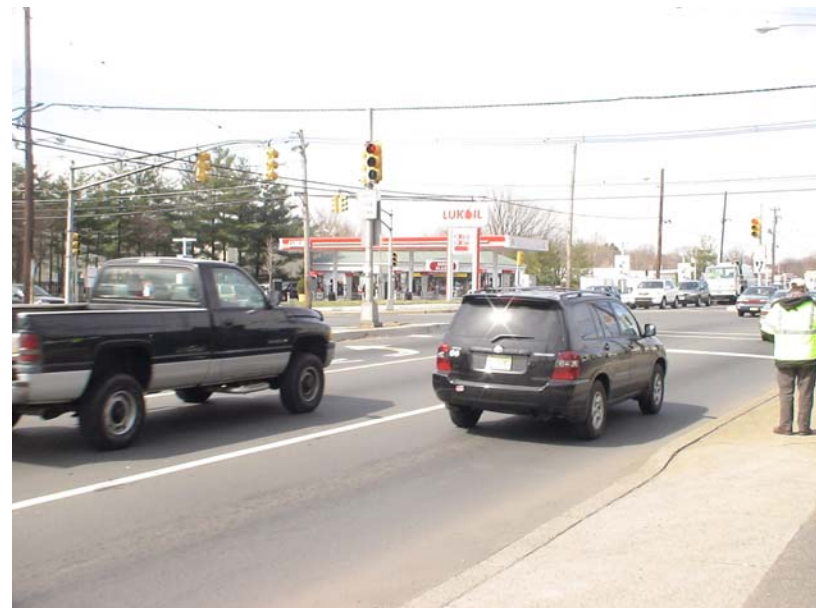
North Olden Avenue at Prospect Street

1. Of the 47 total crashes, 21 were same direction rear-end crashes which occurred mostly at the approaches to the intersection—this may be related to congestion;	1. Evaluate the safety and operational benefits of signal optimization and coordination;	Low	High

2. Turns into and out of driveways near the intersection, especially left-turns, may be contributing to the angle and left-turn crash problem in the vicinity of the intersection;	2. Consider access management controls to prevent left-turns into and out of businesses; e.g.: extend the concrete median;	Medium	High

Site Specific Issue	Potential Strategy	Level of Effort	Estimated Safety Benefit
4. Outdated storm water drainage grate in the vicinity of the intersection presents safety issue for bicyclists.	4. Replace with bicycle compatible drainage grate.	Low	High
	<p>NOTE: Mercer County is in the process of updating the Prospect Street and Arctic Parkway intersections of Olden Avenue which will include upgrades to pedestrian signals, removal of signal posts in the median and possible signal optimization and coordination.</p>
