CR 534

BLACKWOOD-CLEMENTON RD

Road Safety Audit

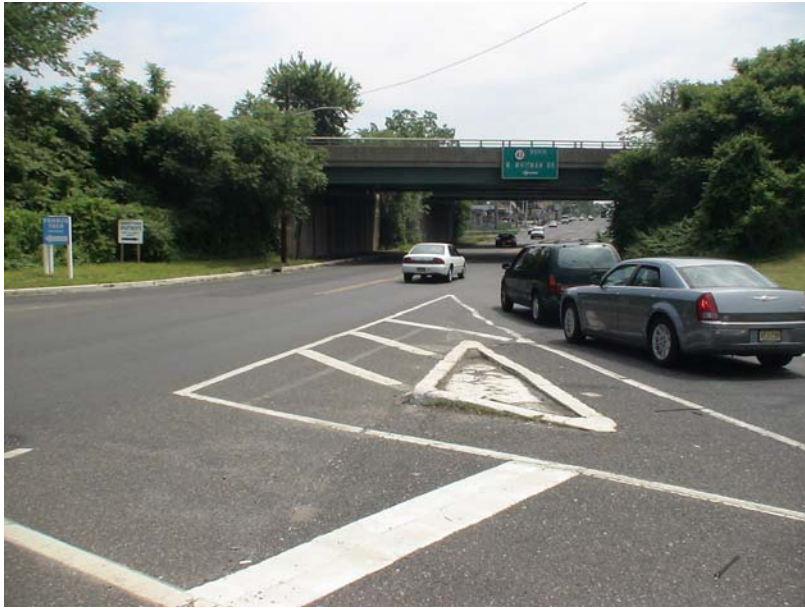
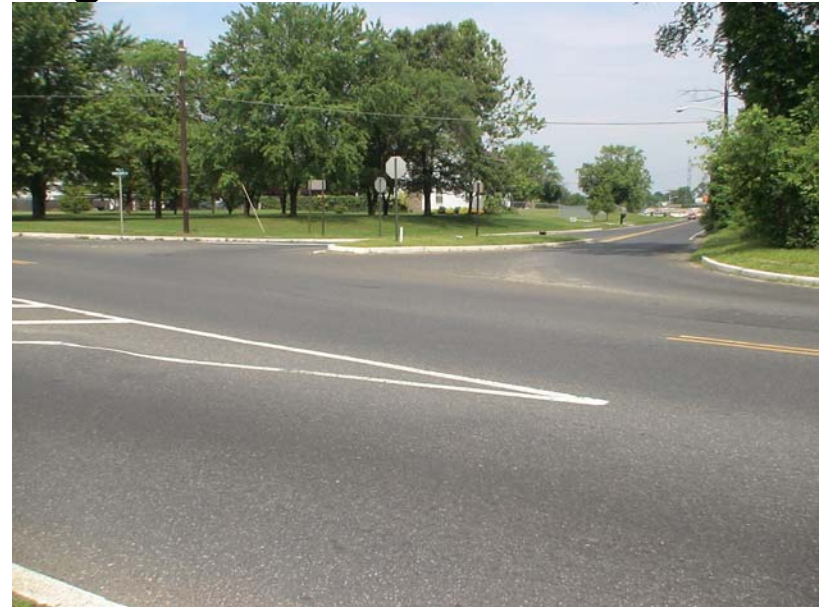
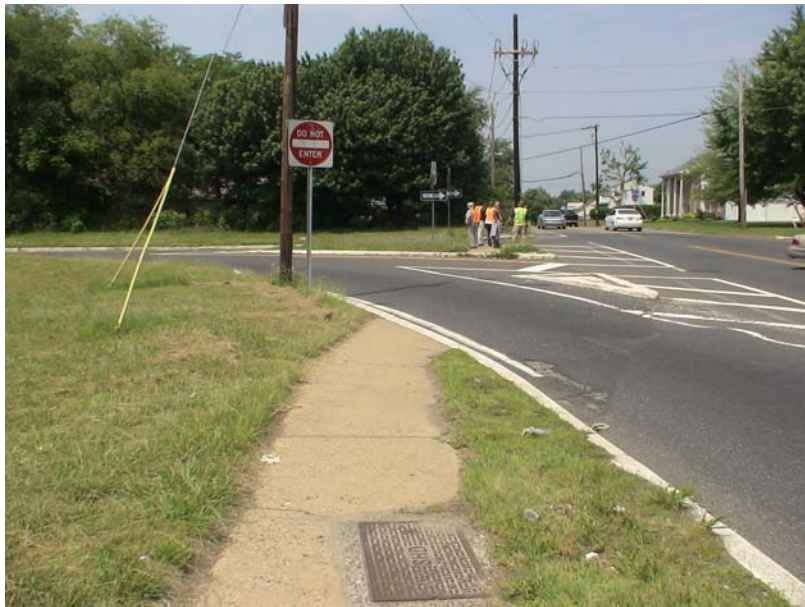
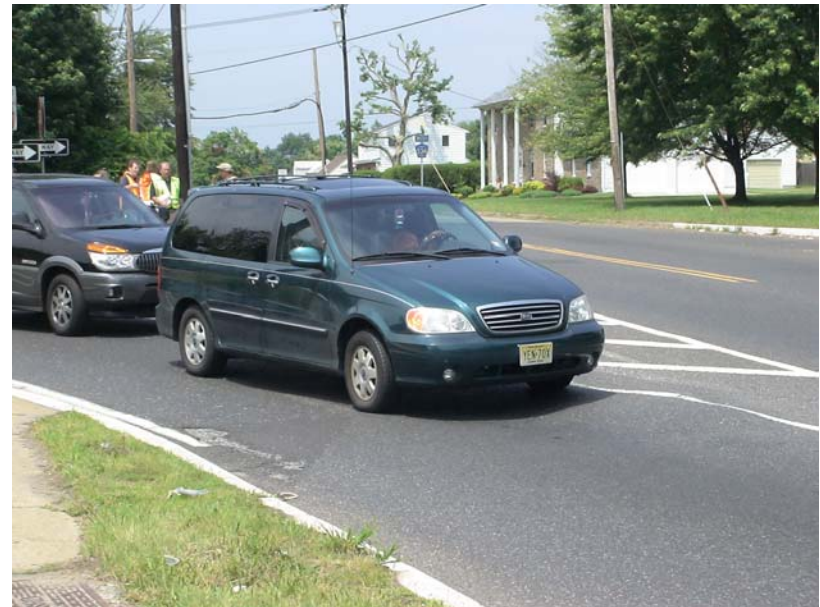
Vicinity of Erial Road (east and west) and NJ 42 Interchange

4. Congestion at the NJ 42 southbound off ramp to CR 534 backs up onto the NJ 42 through lane due to the intersection's inability to process the volume of off ramp traffic efficiently during the evening peak period.	4. A new traffic signal is currently being designed for the off ramp and CR 534 intersection which will address this issue. It is recommended that vacant land within the off ramp be utilized to widen the intersection approach to accommodate dedicated right turns.	Low	High

7. Missing left turn storage for eastbound Blackwood-Clementon Rd traffic turning left to access NJ 42 northbound.	7. Accommodate these turns in the redesign of the section of Blackwood-Clementon Rd between the NJ 42 off-ramp and the Erial Rd intersection.	Medium	High

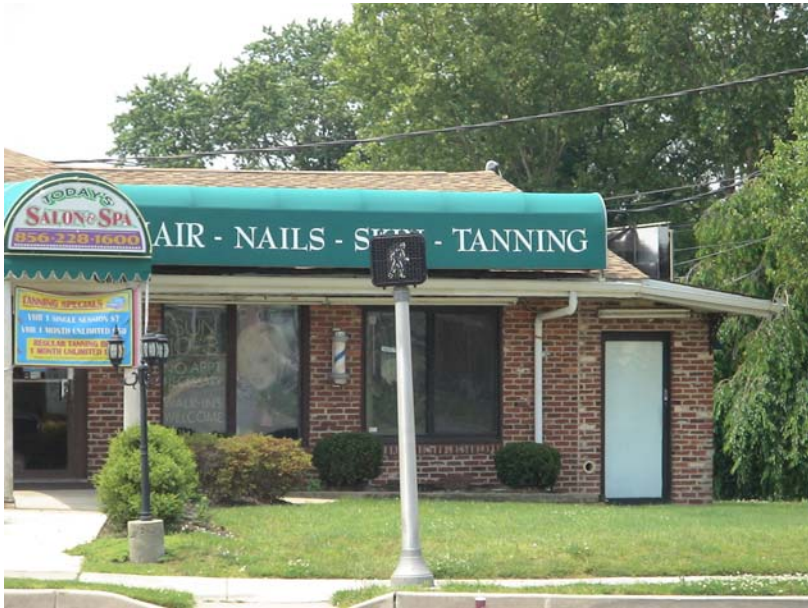
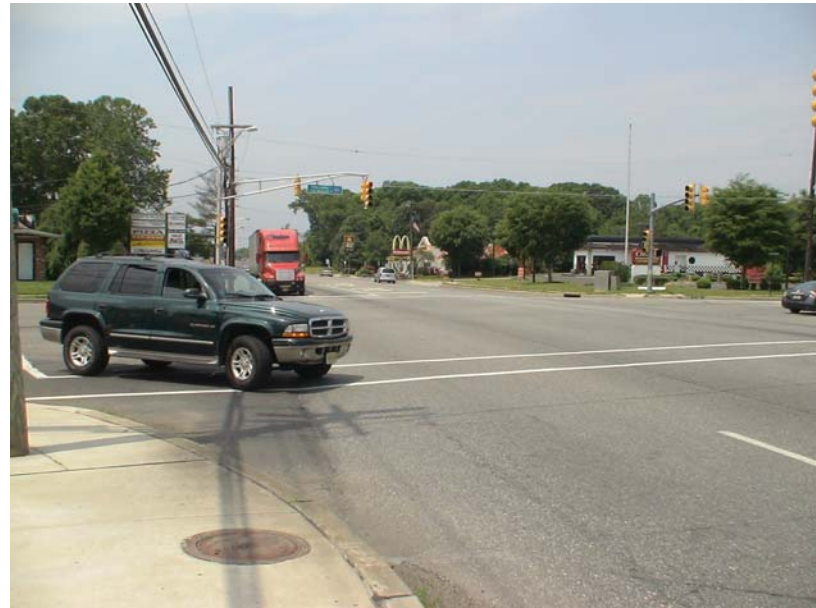
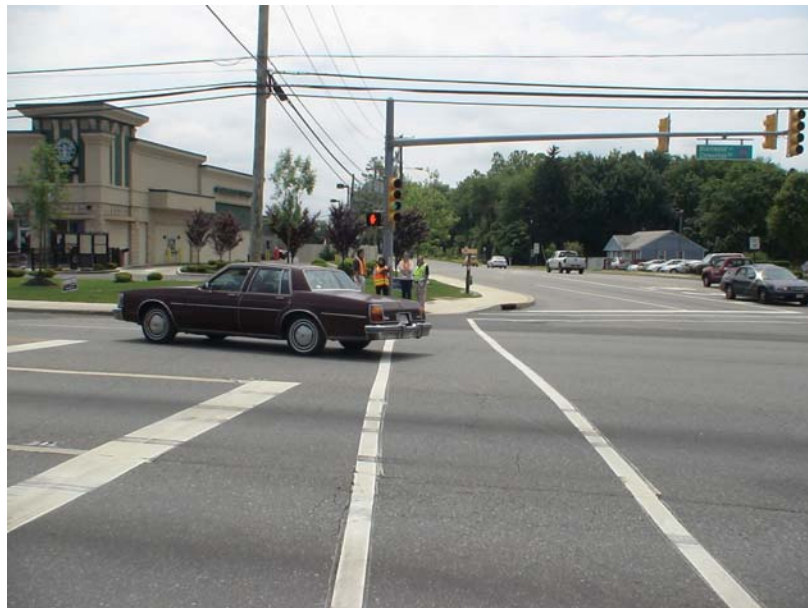
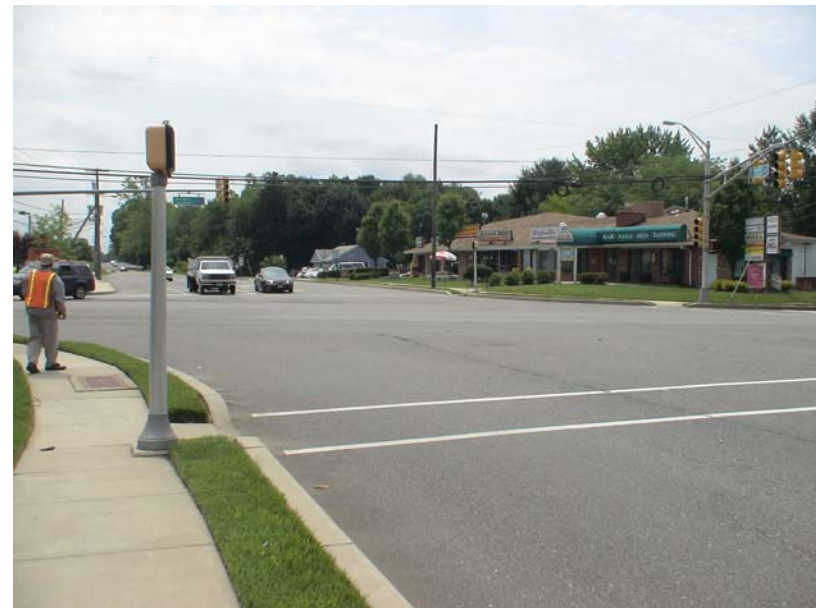
At CR 759 (Little Gloucester Road)

Site-Specific Issue	Potential Strategy	Level of Effort	Estimated Safety Benefit
Little Gloucester Rd			
1. Pedestrian crossing time was observed to be inadequate.	1. Re-evaluate the pedestrian crossing priority and pedestrian amenities at this intersection.	Low	High

2. Broken pedestrian signal head on the southwest intersection corner.	2. Repair or replace non-working signal head.	Medium	Medium
3. Signal layout does not meet standard.	3. Evaluate signal layout and redesign as appropriate.	Medium	Medium
Cherrywood Dr to Millbridge Rd

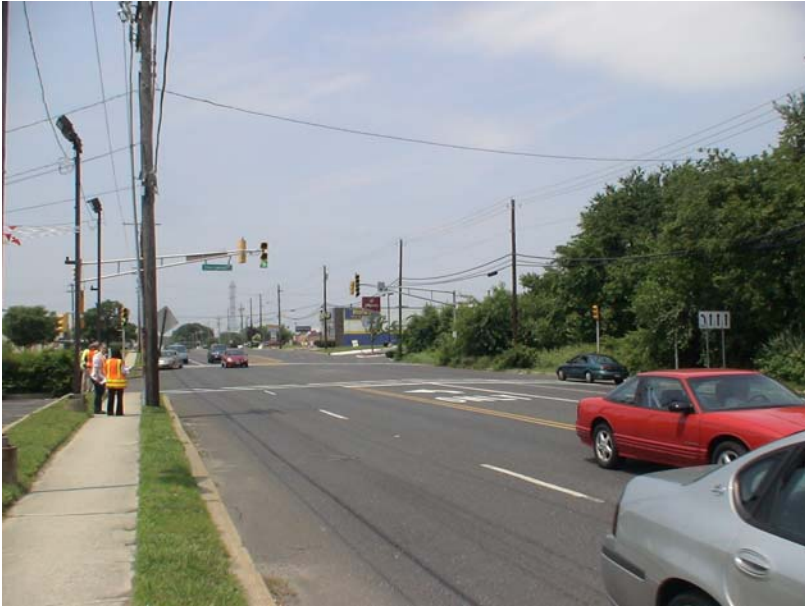
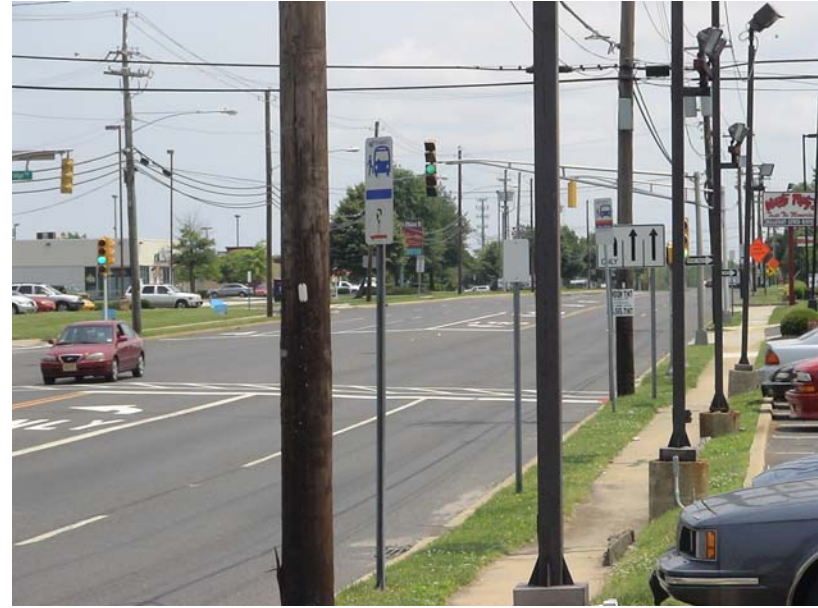
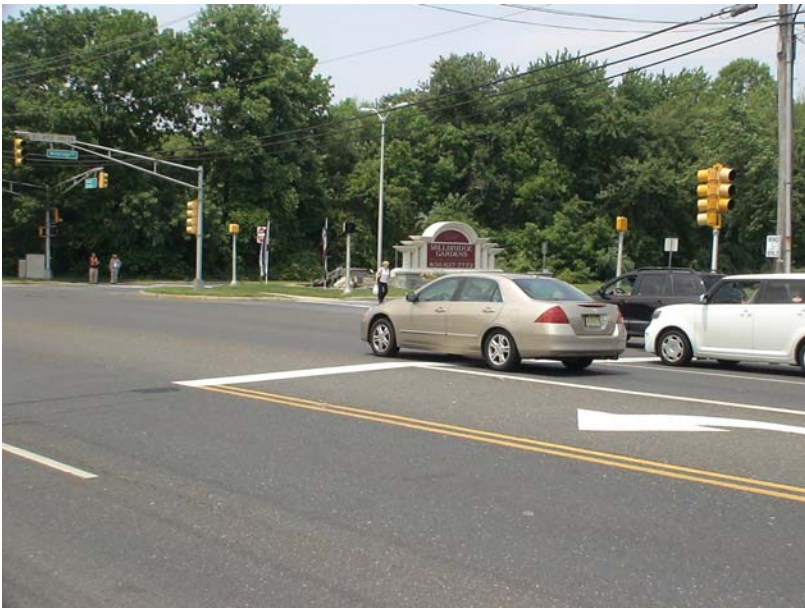
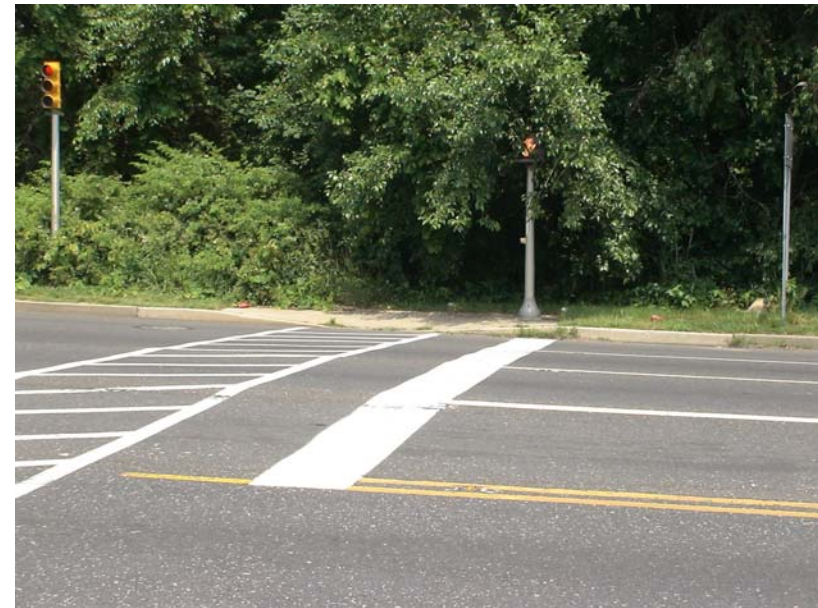
From Cherrywood Drive to Millbridge Road

3. Crosswalks from south side to north side lead to nowhere, as there is no sidewalk provided along the westbound side of Blackwood-Clementon Rd.	3. To provide corridor-wide pedestrian access add sidewalk where missing in this vicinity.	High	High

4. Mix of conventional and programmable signal heads for the intersection approach may be confusing to motorists, because the conventional signal is visible from farther away than the programmable – making the effect of the programmable null.	4. Replace the five-section vertical programmable signal head on the mast arm with the “doghouse” style signal assembly. Make all signals facing the inside approaches at these intersections programmable.	High	High

8. The pedestrian push button at northeast corner of CR 534 & Cherrywood Drive intersection is not working.	8. Replace or repair the pedestrian push button. *Note: Cherrywood Dr and Millbridge Rd signals are slated to get Red Light Running cameras during 2009.	Low	Medium

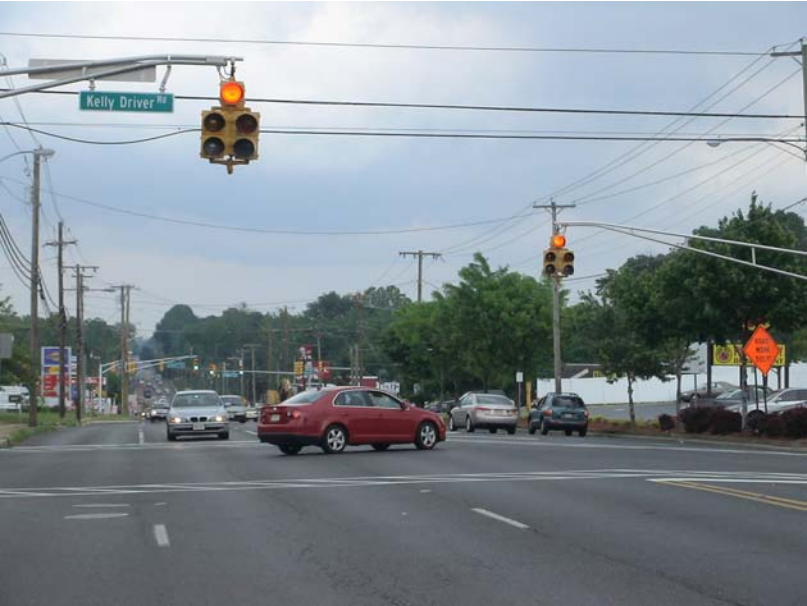
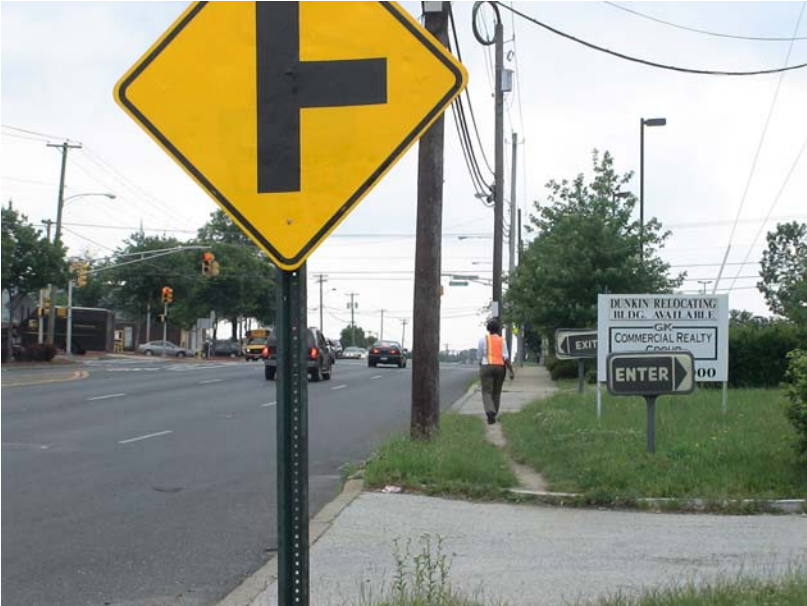
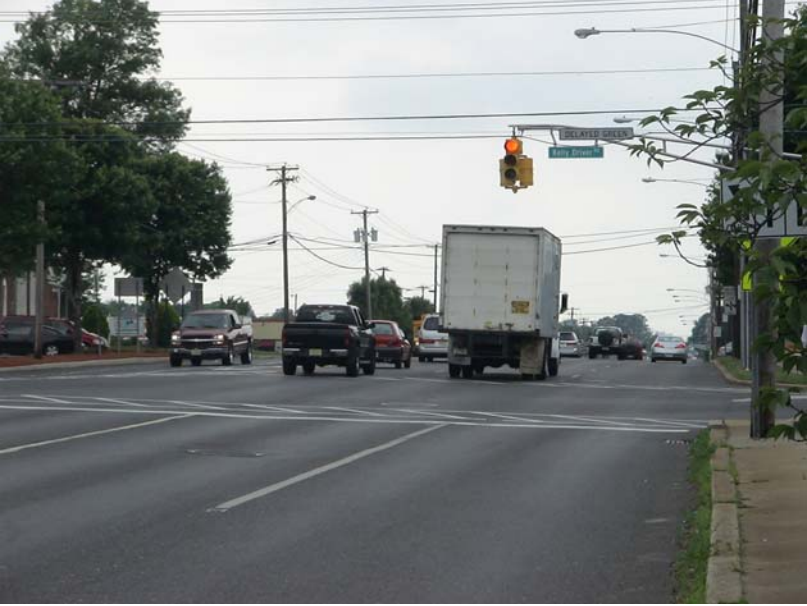
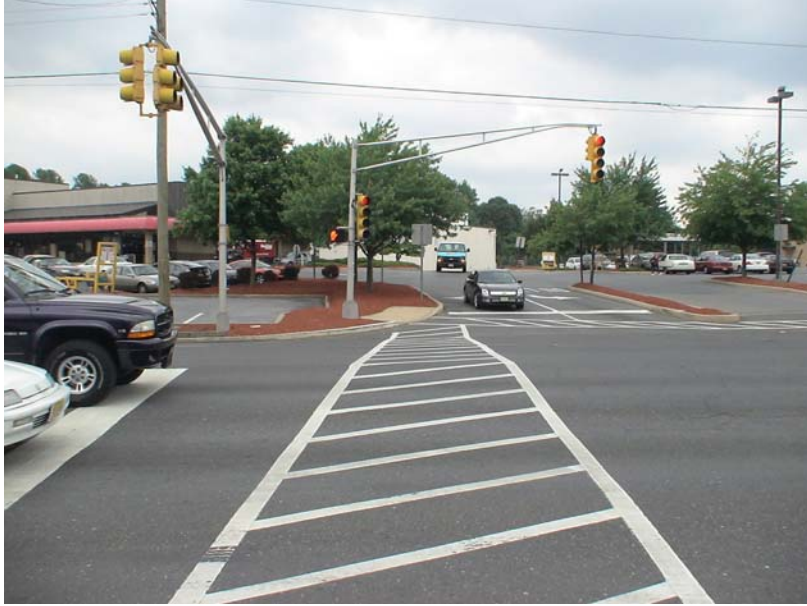
At Kelly Driver Lane

Site-Specific Issue	Potential Strategy	Level of Effort	Estimated Safety Benefit
<p>Kelly Driver Ln</p> <p>1. Broken pedestrian button on the northwest intersection corner.</p> <p>2. No left-turn protection for left turns from westbound Blackwood-Clementon Rd and a significant number of left-turn crashes.</p> <p>3. Secondary signal heads are greatly misaligned with travel lanes.</p> <p>4. Intersection is actuated but there may be a detection problem.</p> <p>5. The Shop Rite grocery store served by this intersection is a major trip generator. One bike and one pedestrian crash were recorded here during the analysis period. Pedestrian crossing time was observed to be inadequate.</p>	<p>1. Repair or replace damaged button.</p>	<p>Low</p>	<p>Medium</p>
	<p>2. Examine the effects on LOS when the westbound left turn movement is eliminated, or both left turns (east and westbound) are made protected only. Currently the protected/permmissive left turn movement eastbound does not conform to NJDOT policy as it allows permissive left turns across three traffic lanes.</p>	<p>Medium</p>	<p>High</p>
