# US 130/US 206 Road Safety Audit

Bordentown City and Bordentown Township, Burlington County, NJ

September 2012

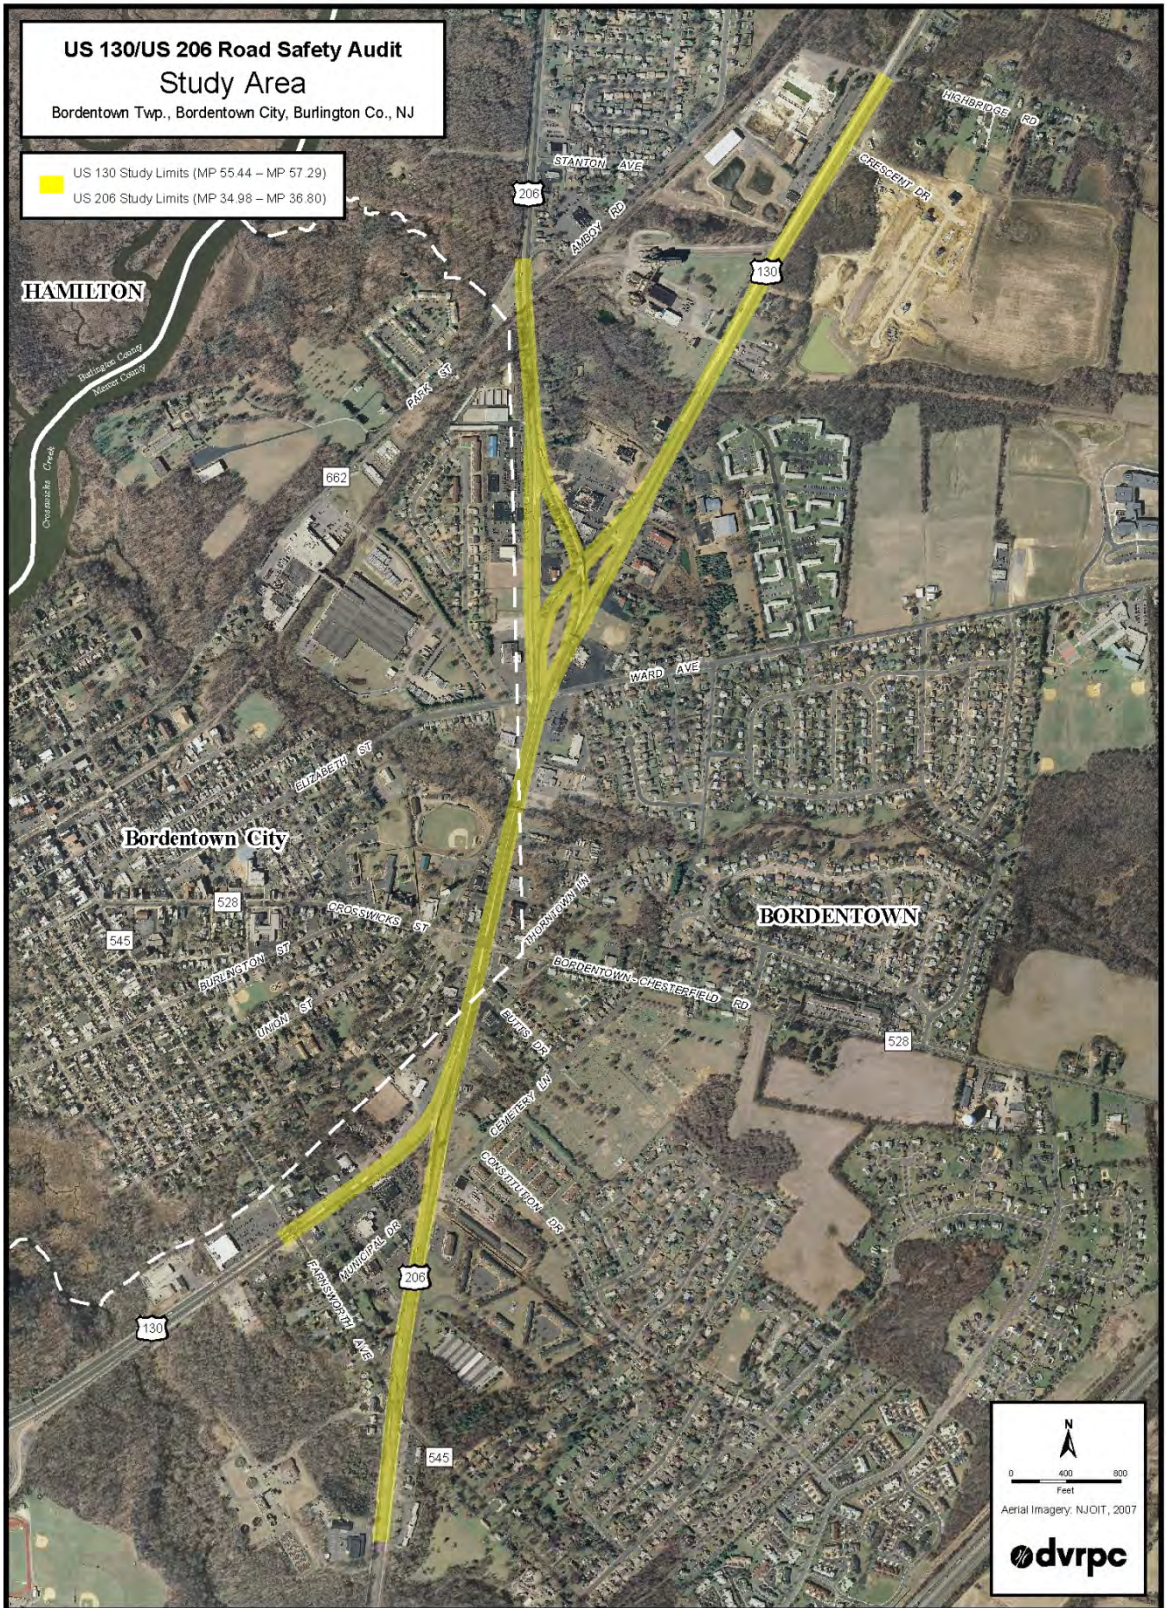
Figure 1: US 130/US 206 Road Safety Audit Study Area

The study area consists of approximately 1.83 miles of US 130, from the intersection of Farnsworth Avenue northeast to the intersection of Highbridge Road, and 1.16 miles of US 206, from the intersection of Farnsworth Avenue northwest to East Park Street (see Figure 1 on page 6). The two roadways overlap in the center of the study area for approximately three-tenths of a mile. This section is designated as US 130 for crash coding purposes. Both routes pass through Bordentown City and Bordentown Township. The frontage along each corridor is primarily commercial, with residential uses beyond. Downtown Bordentown City lies west of the study area and Bordentown Township is to the east, both located in northern Burlington County, New Jersey (please see Appendix B for all maps used during the audit process).

US 130 and US 206 are classified as urban principal arterials. The study corridors were divided into five analysis sections corresponding to the five cross-section types (see Figure 1). The study area also has five signalized intersections: (1) Farnsworth (CR 545) at US 130, (2) Farnsworth (CR 545) at US 206, (3) Butts Drive at US 130, (4) Crosswicks Street/Bordentown-Chesterfield Road (CR 528) at US 130, and (5) Park Street (CR 662) at US 206. Access to businesses in the study area is predominantly by right-in and right-out access because both roadways are divided highways. There are also seven unsignalized intersections and approximately 93 driveways. Sidewalks are inconsistently available throughout the corridor. There are no bike lanes, and shoulders that could serve as de facto bike lanes are inconsistently available.

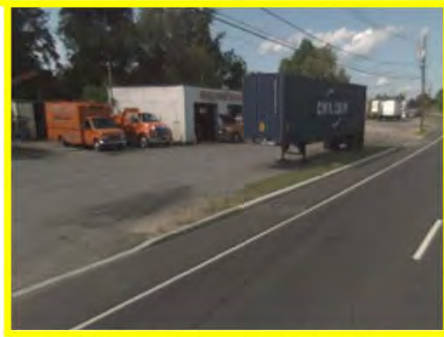
ROW encroachment along US 130

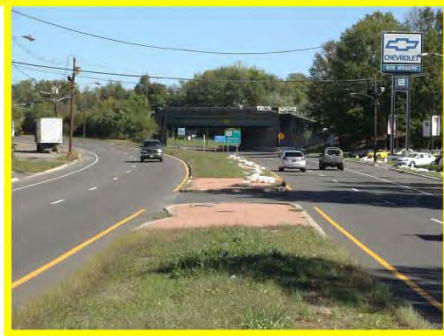
Median opening located on US 130,  
north of Farnsworth Avenue

3. Median opening located north of the intersection has an antiquated design and presents a safety hazard;	3. Close median opening--U-turns can be made at the intersection or further north between existing opening and the Butts Avenue intersection;	3. Low	3. High	3. NJDOT

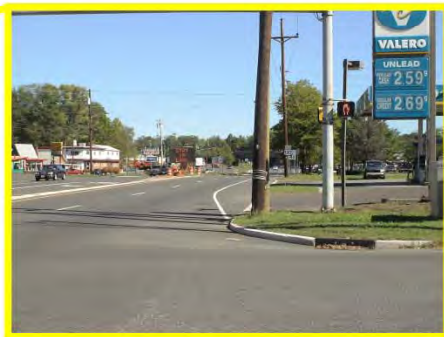
Missing pedestrian crossings and curb ramps  
on select approaches of the Farnsworth Avenue  
and US 130 intersection

1. Missing pedestrian crossings and curb ramps on select approaches at the Farnsworth Avenue and US 130 intersection;	1. Install/upgrade all crossings with striping, ADA-compliant curb ramps, and signal heads, and extend medians into crosswalks; <b>NJDOT</b>	1. Medium	1. High	1. NJDOT

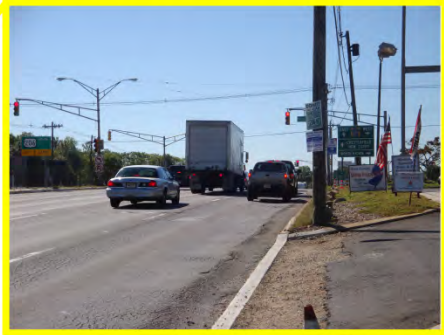
Missing sidewalk along 130/206

1. Missing sidewalk along both US 130 NB and SB directions for most of panel, and along north side of Crosswicks Street;	1. Install sidewalks, where missing, to accommodate pedestrians between and through the intersections; <b>NJDOT</b>	1. Medium	1. High	1. NJDOT

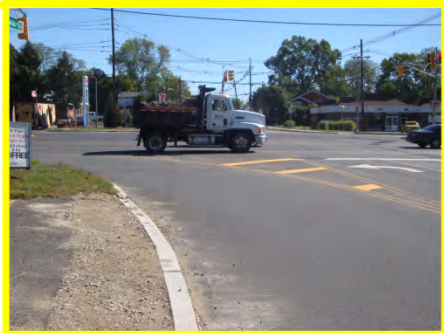
Dedicated right turn lane at Crosswicks intersection creates unsafe conditions for pedestrians and bicyclists

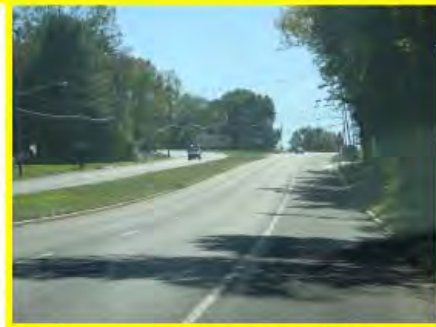
No sidewalks or pedestrian accommodations along US 130 and US 206

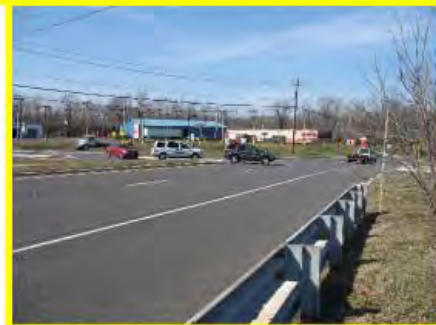
Limited sight distance and high travel speeds occur where there is cross-over access from the access road to 206 NB and Mastori's Restaurant

Site-Specific Issue	Potential Strategy (NJDOT - indicates consistency with Baker study)	Level of Effort	Estimated Safety Benefit	Responsible Agency
<p>1. The major issue at this location is the crossover access to US 206 NB from the access road that serves the businesses located between the US 206 NB and SB lanes (see graphic). The crossover also serves the entrance to Mastoris Diner. A combination of limited sight distance of the oncoming traffic from the US 206 NB two-lane slip ramp, and reportedly higher-than-posted travel speeds, create a safety hazard at this location. This is further complicated by the horizontal and vertical curvature of US 206 NB approaching the crossover. Though the total number of crashes at this location is comparatively lower than others in the study area, the potential for higher severity crashes is cause for alarm. Also, vegetation overgrowth compromises sight distance;</p>	<p>1. This location can be improved by providing advance warning to drivers and slowing the through traffic to increase reaction time. Specifically, provide driveway ahead (or other appropriate) warning signs and pavement markings along US 206 NB slip ramp at appropriate intervals in advance of the cross-over. These should be used to supplement a flashing beacon. Note: <i>There is a feeling that the flashing beacon will be ineffective over time due to over-exposure.</i> Additionally, efforts should be made to clear the sight triangle obstructing this location. The long-term improvement is to relocate the cross-over to a spot with better sight distance, and possibly narrowing the passage to one lane to calm traffic;</p>	<p>1. Low-Medium</p>	<p>1. High</p>	<p>1. NJDOT/ Local MCDs/ Burlington County</p>

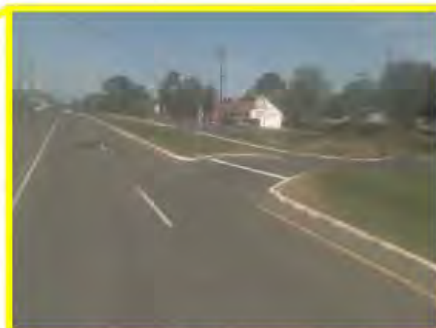
Limited sight distance on US 130 SB ramp cross-over

Site-Specific Issue	Potential Strategy (NJDOT - indicates consistency with Baker study)	Level of Effort	Estimated Safety Benefit	Responsible Agency
<p>the crossover on the US 130 SB ramp. Located just beyond the crest of a vertical curve after an overpass, similar to the cross-over described in Issue #1, the limited sight distance presents a potential safety hazard;</p> <p>3. No sidewalks or other pedestrian accommodations between E. Park Street and Crosswicks Street for the entire length of the stretch.</p>	<p>3. Improve pedestrian access between E. Park Street and Crosswicks Street. The addition of sidewalks to Park Street along US 206 would accommodate pedestrians commuting to jobs along the corridor. Pedestrians were observed along this part of the study area during the field visit; <b>NJDOT</b>.</p>	<p>3. High</p>	<p>3. High</p>	<p>3. NJDOT/ Local MCDs/ Burlington County</p>

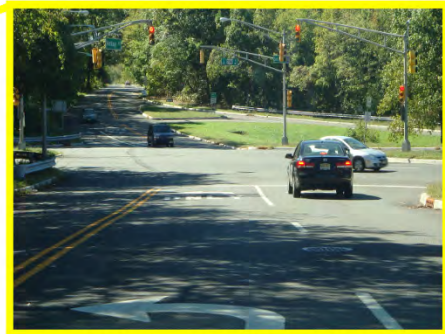
No pedestrian accommodations at intersection

Site-Specific Issue	Potential Strategy (NJDOT - indicates consistency with Baker study)	Level of Effort	Estimated Safety Benefit	Responsible Agency
1. Pedestrian accommodations are missing at the intersection; e.g., no sidewalks or crosswalks, no curb ramps. There are push buttons, but missing signal heads render them useless. Pedestrians were observed crossing this location during the field visit;	1. Add sidewalks, crosswalk, curb ramps, and pedestrian signal heads to accommodate pedestrians. A long-term improvement to complement ground-level access involves utilizing the adjacent freight rail line ROW to provide east-west pedestrian access; <b>NJDOT</b>	1. High	1. High	1. NJDOT

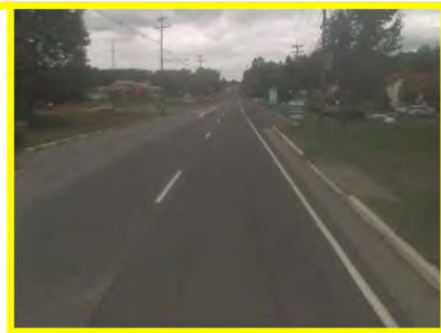
No advance warning of traffic entering US 130 NB from cross-over

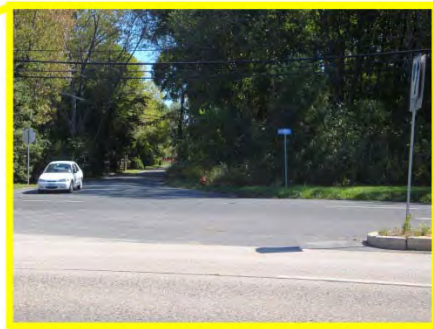
Illegal u-turns made at the median break for Highbridge Road

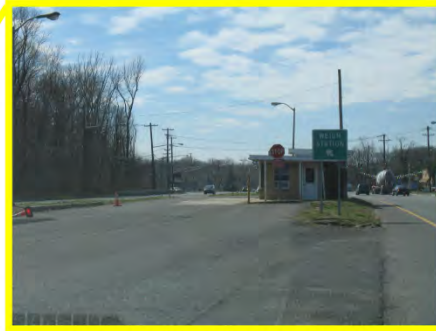
Defunct weigh station approximately 100 feet north of intersection

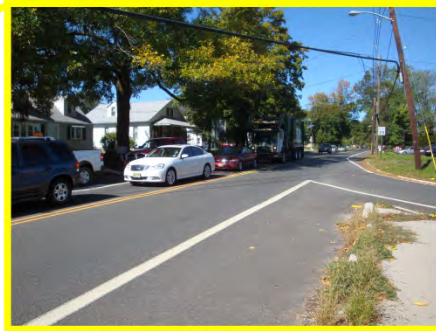
Traffic on Farnsworth Avenue backs up between US 130 and US 206

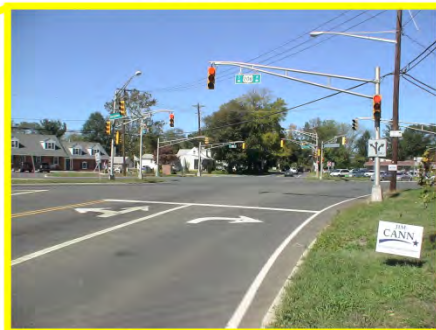
Missing pedestrian crossing accommodations on every leg of intersection

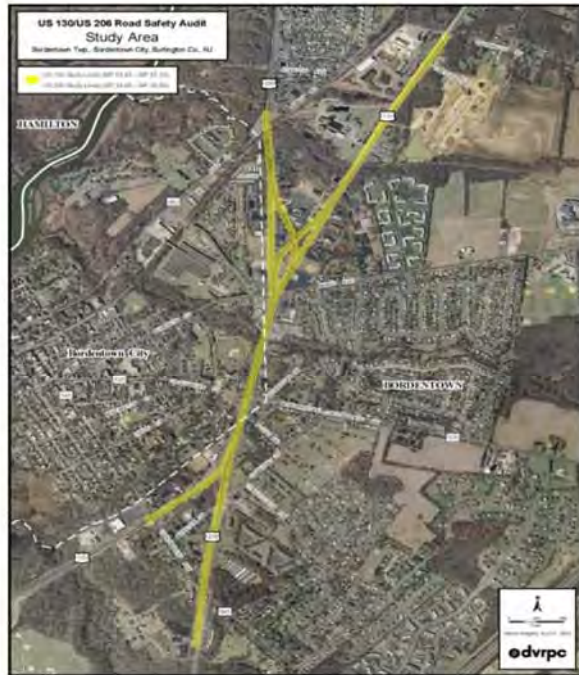
## Study Area

- US 130
  - 1.83 miles
  - Farnsworth Ave to Highbridge Rd
- US 206
  - 1.16 miles
  - Farnsworth Ave to E Park St
- Land Use
  - Predominantly commercial frontage along each corridor
  - Residential beyond

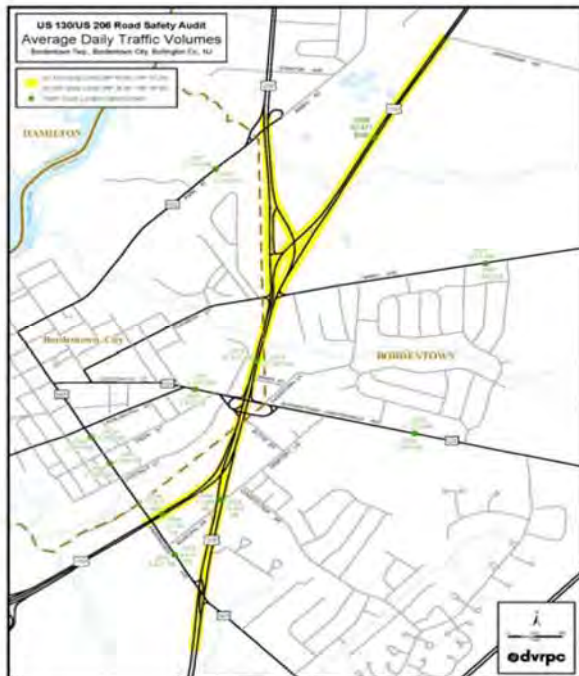
## Traffic Volumes

- Traffic volumes provided by:
  - Michael Baker, Jr. Inc.
  - DVRPC
  - NJDOT SLD
- AADTs
  - South: 11,000 vehicles per direction on US 206; 12,000 vehicles per direction on US 130
  - Central: approx. 25,000 vehicles in each direction
  - North: 11,000 vehicles per direction on US 130

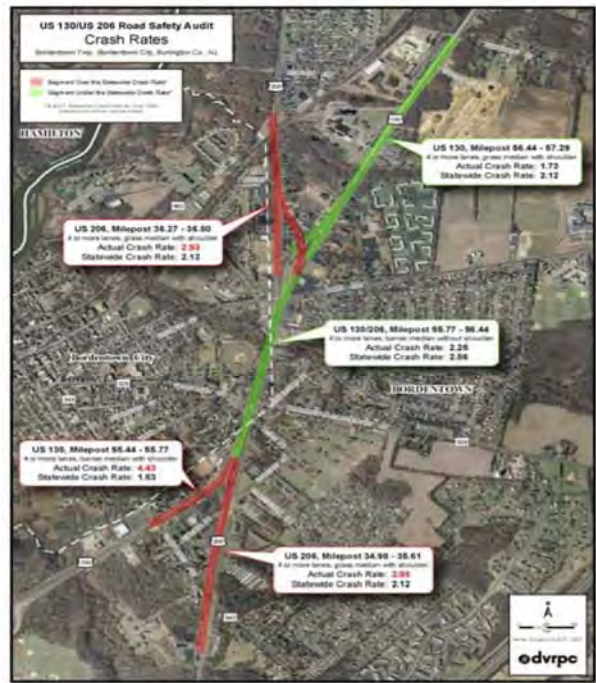
# NJDOT Crash Rates by Cross-section Geometry

- Three road sections (highlighted in red) exceed statewide crash rate:
  - US 130 Farnsworth to merge
  - US 206 Farnsworth to merge
  - US 206 Split to E. Park St.

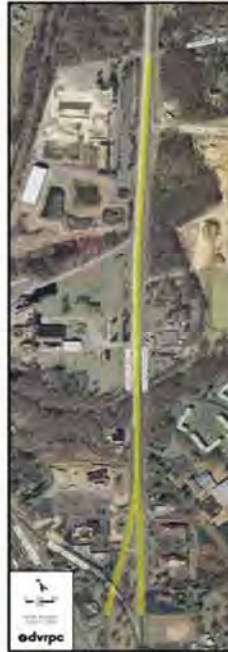
### US 130 North Section

- Length – 0.85 miles
- Crashes – 45 (2007 – 2009)
- Crash Rate – 1.73 (state: 2.12)
- Directional Split
  - Northbound 15
  - Southbound 29
  - EB 0, WB 1
- Predominant Collision Types
  - Sideswipe, left turn, backing, hit fixed object, hit animal, and non-fixed object crashes exceed statewide crash rate
- Other Trends
  - Majority of crashes occurred during the daytime and on dry surface condition
- Crash Concentrations
  - 26%: vicinity of Mastori's access (MP 56.60-MP 56.63 aprx. 180 ft)
  - 20%: vicinity of Highbridge Rd (MP 57.29 at intersection)

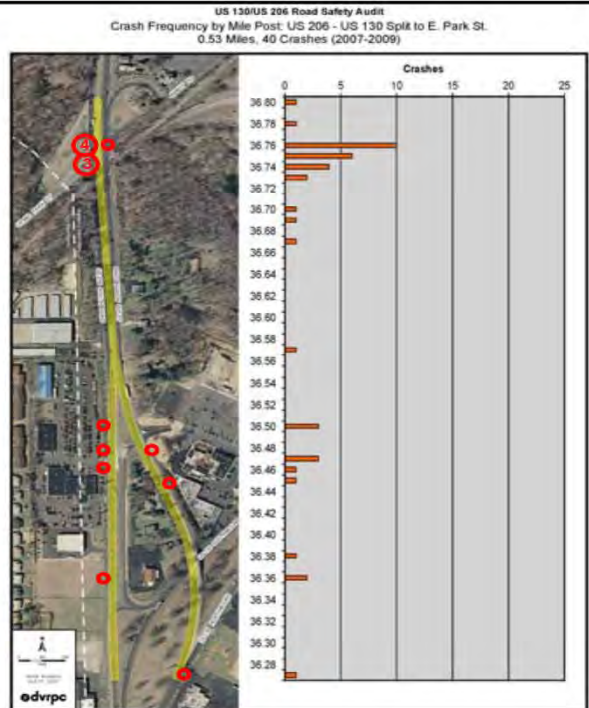
## US 206 North Section Injury Crashes

- **Severity (crashes)**
  - 15 injury crashes
  - 25 property damage only
  - NB direction 4
  - SB direction 8
  - EB 3, WB 0
  - At Signalized Intersection: 8
- **No Bicycle or Pedestrian Crashes**
