CONGESTION & CRASH

Analysis Program

TABERNACLE TOWNSHIP, BURLINGTON COUNTY

Publication Title: Congestion and Crash Site Analysis Program –
Tabernacle Township, Burlington County

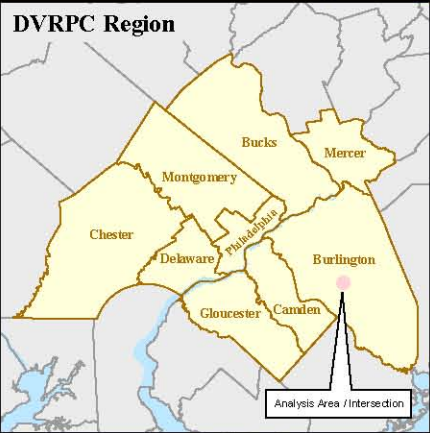
Figure 1
Study Area

The focus of the study as shown in [Figure 1](#) is the intersection of CR 648 and CR 532. CR 648 provides access to Wharton State Forest, connects directly to US 206, and serves as a coastal evacuation route. On a regional level, CR 532 provides access to Medford Lakes Borough and connects with several key roads, including CR 541, NJ 72, and US 206. During the summer months, CR 532 serves as a major thoroughfare for motorists heading to and from the Jersey Shore.

CR 648 runs in a northwesterly and southeasterly direction. For the purposes of this document, the orientation of CR 648 will be referenced as north and south. CR 532 runs in an east-west direction.

Northbound CR 648 is classified as a rural local roadway. It contains one shared through and left-turn lane, and a channelized right-turn lane that provides access to eastbound CR 532. Southbound CR 648 is classified as an urban collector and contains one shared through, left-turn, and right-turn lane. Eastbound and westbound CR 532 is classified as a principal arterial. The lane configuration is the same in both directions, consisting of one shared through, left-turn, and right-turn lane. This intersection is four-way stop-controlled, with shoulders, and bike lanes along CR 532.

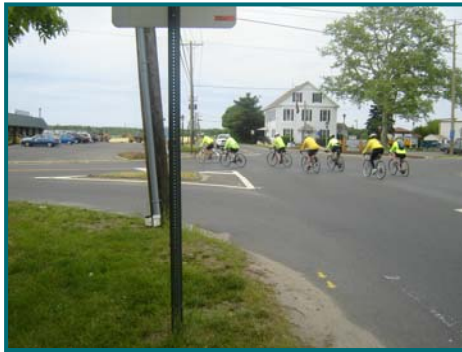
View of bicyclists traveling through the intersection
(Source: DVRPC)

Bicyclist activity is evident in the study area. The eastbound and westbound CR 532 segments of the intersection are part of Burlington County's existing on-road bicycle network. Several bicyclists were observed traveling through the intersection during a field visit to the site location.

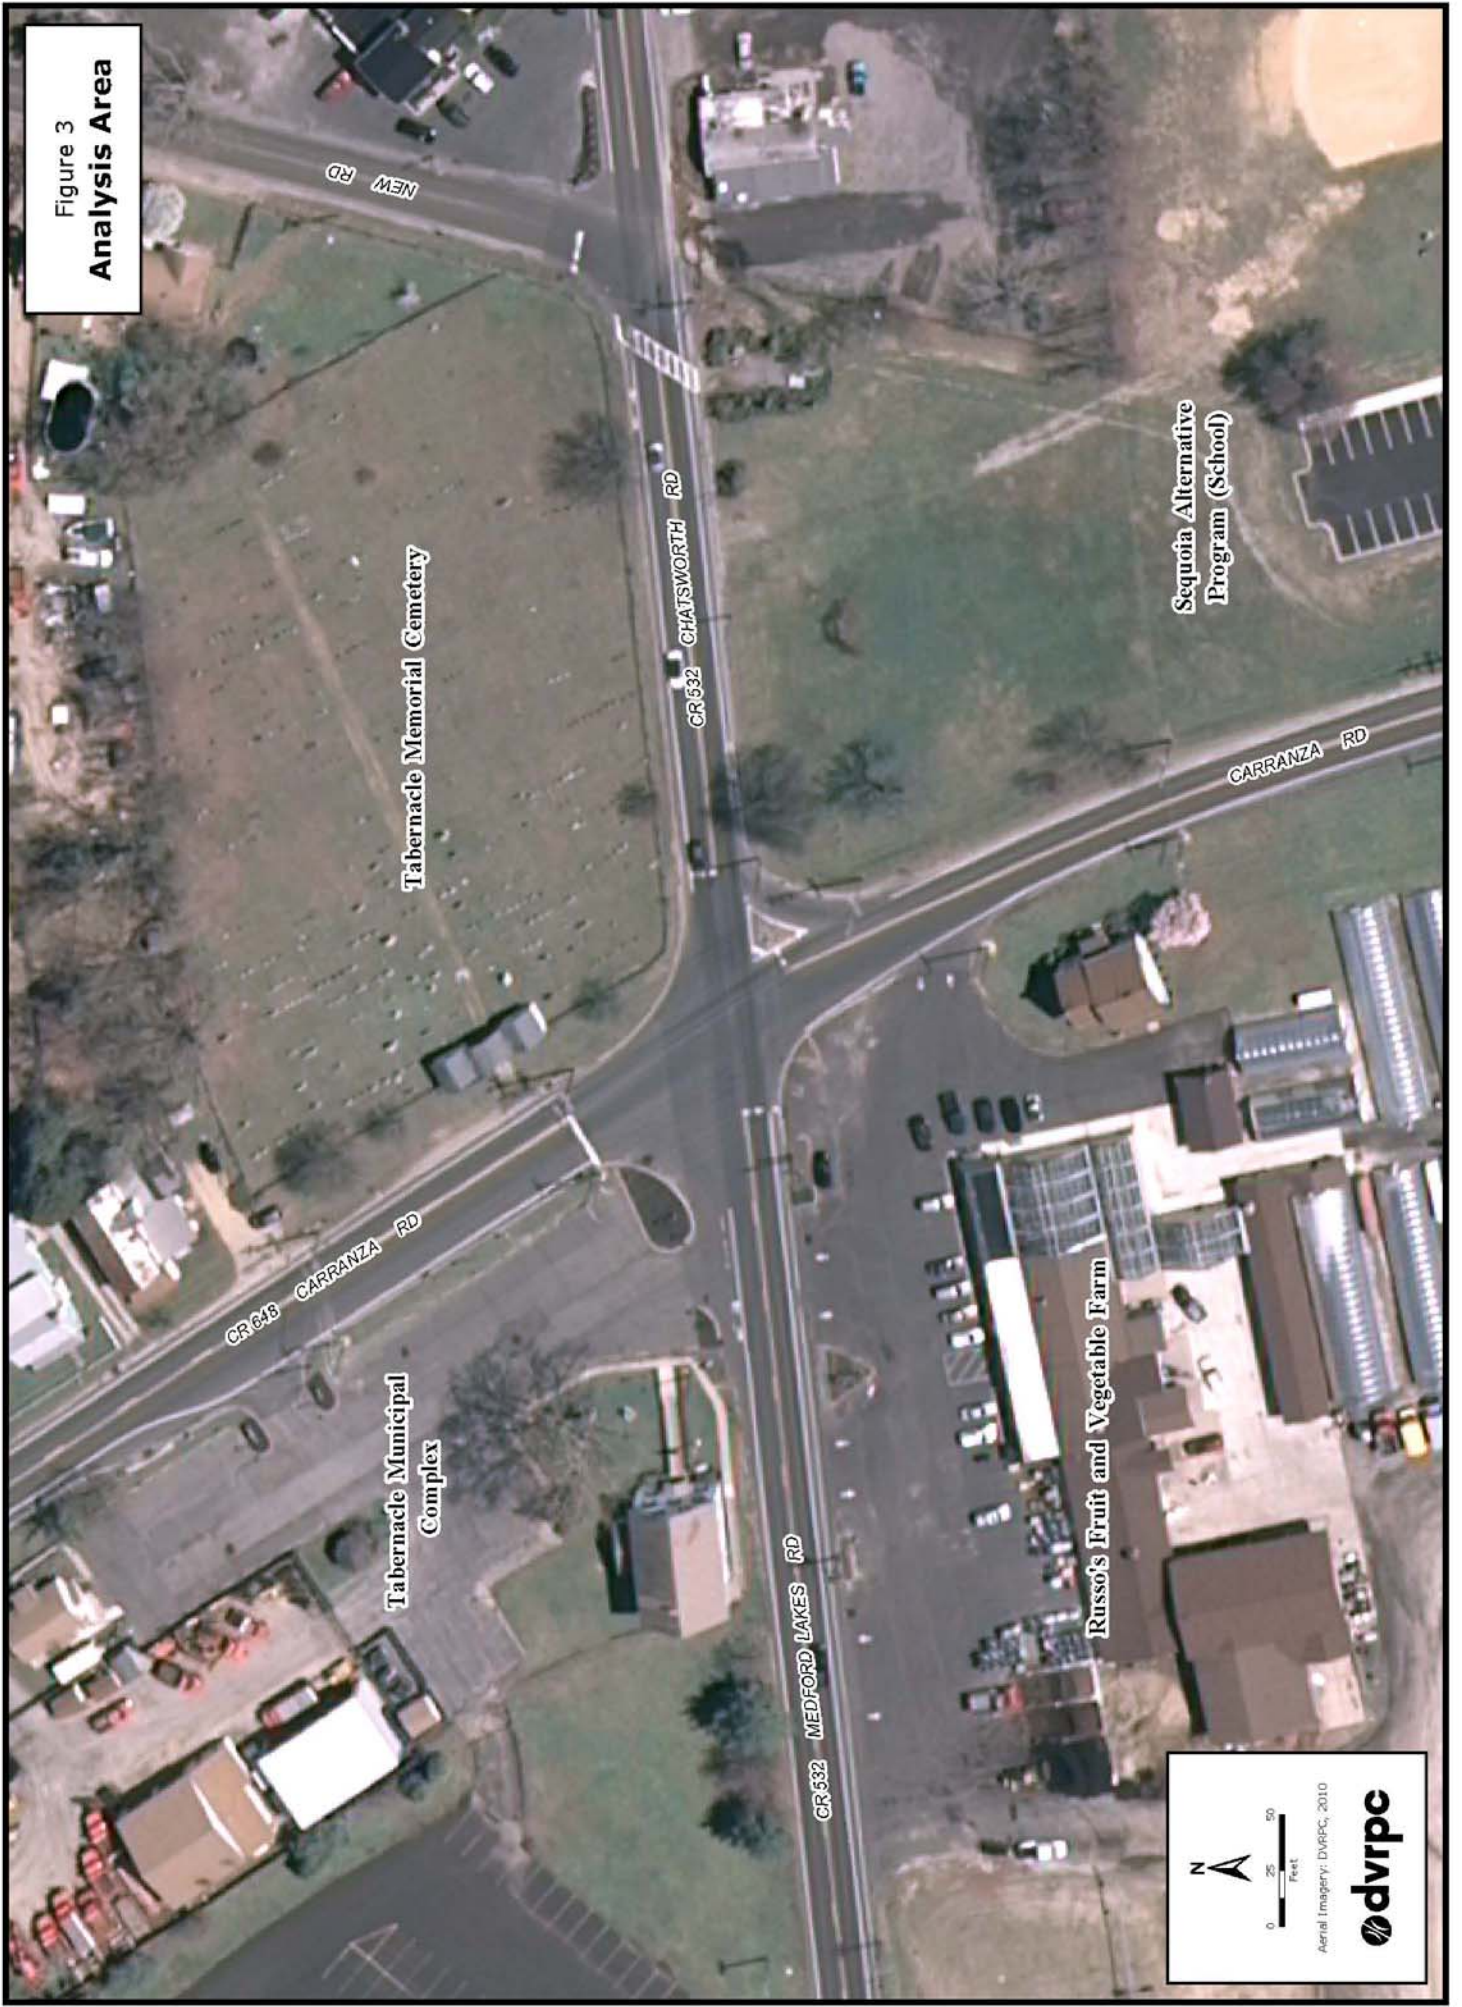
Figure 3
Analysis Area

The land use surrounding the immediate intersection is mixed use. As shown in [Figure 3](#), the Tabernacle Municipal Complex and Tabernacle Memorial Cemetery are located north of the intersection. Russo's Fruit and Vegetable Farm and the Sequoia Alternative Program School are located south of the intersection.

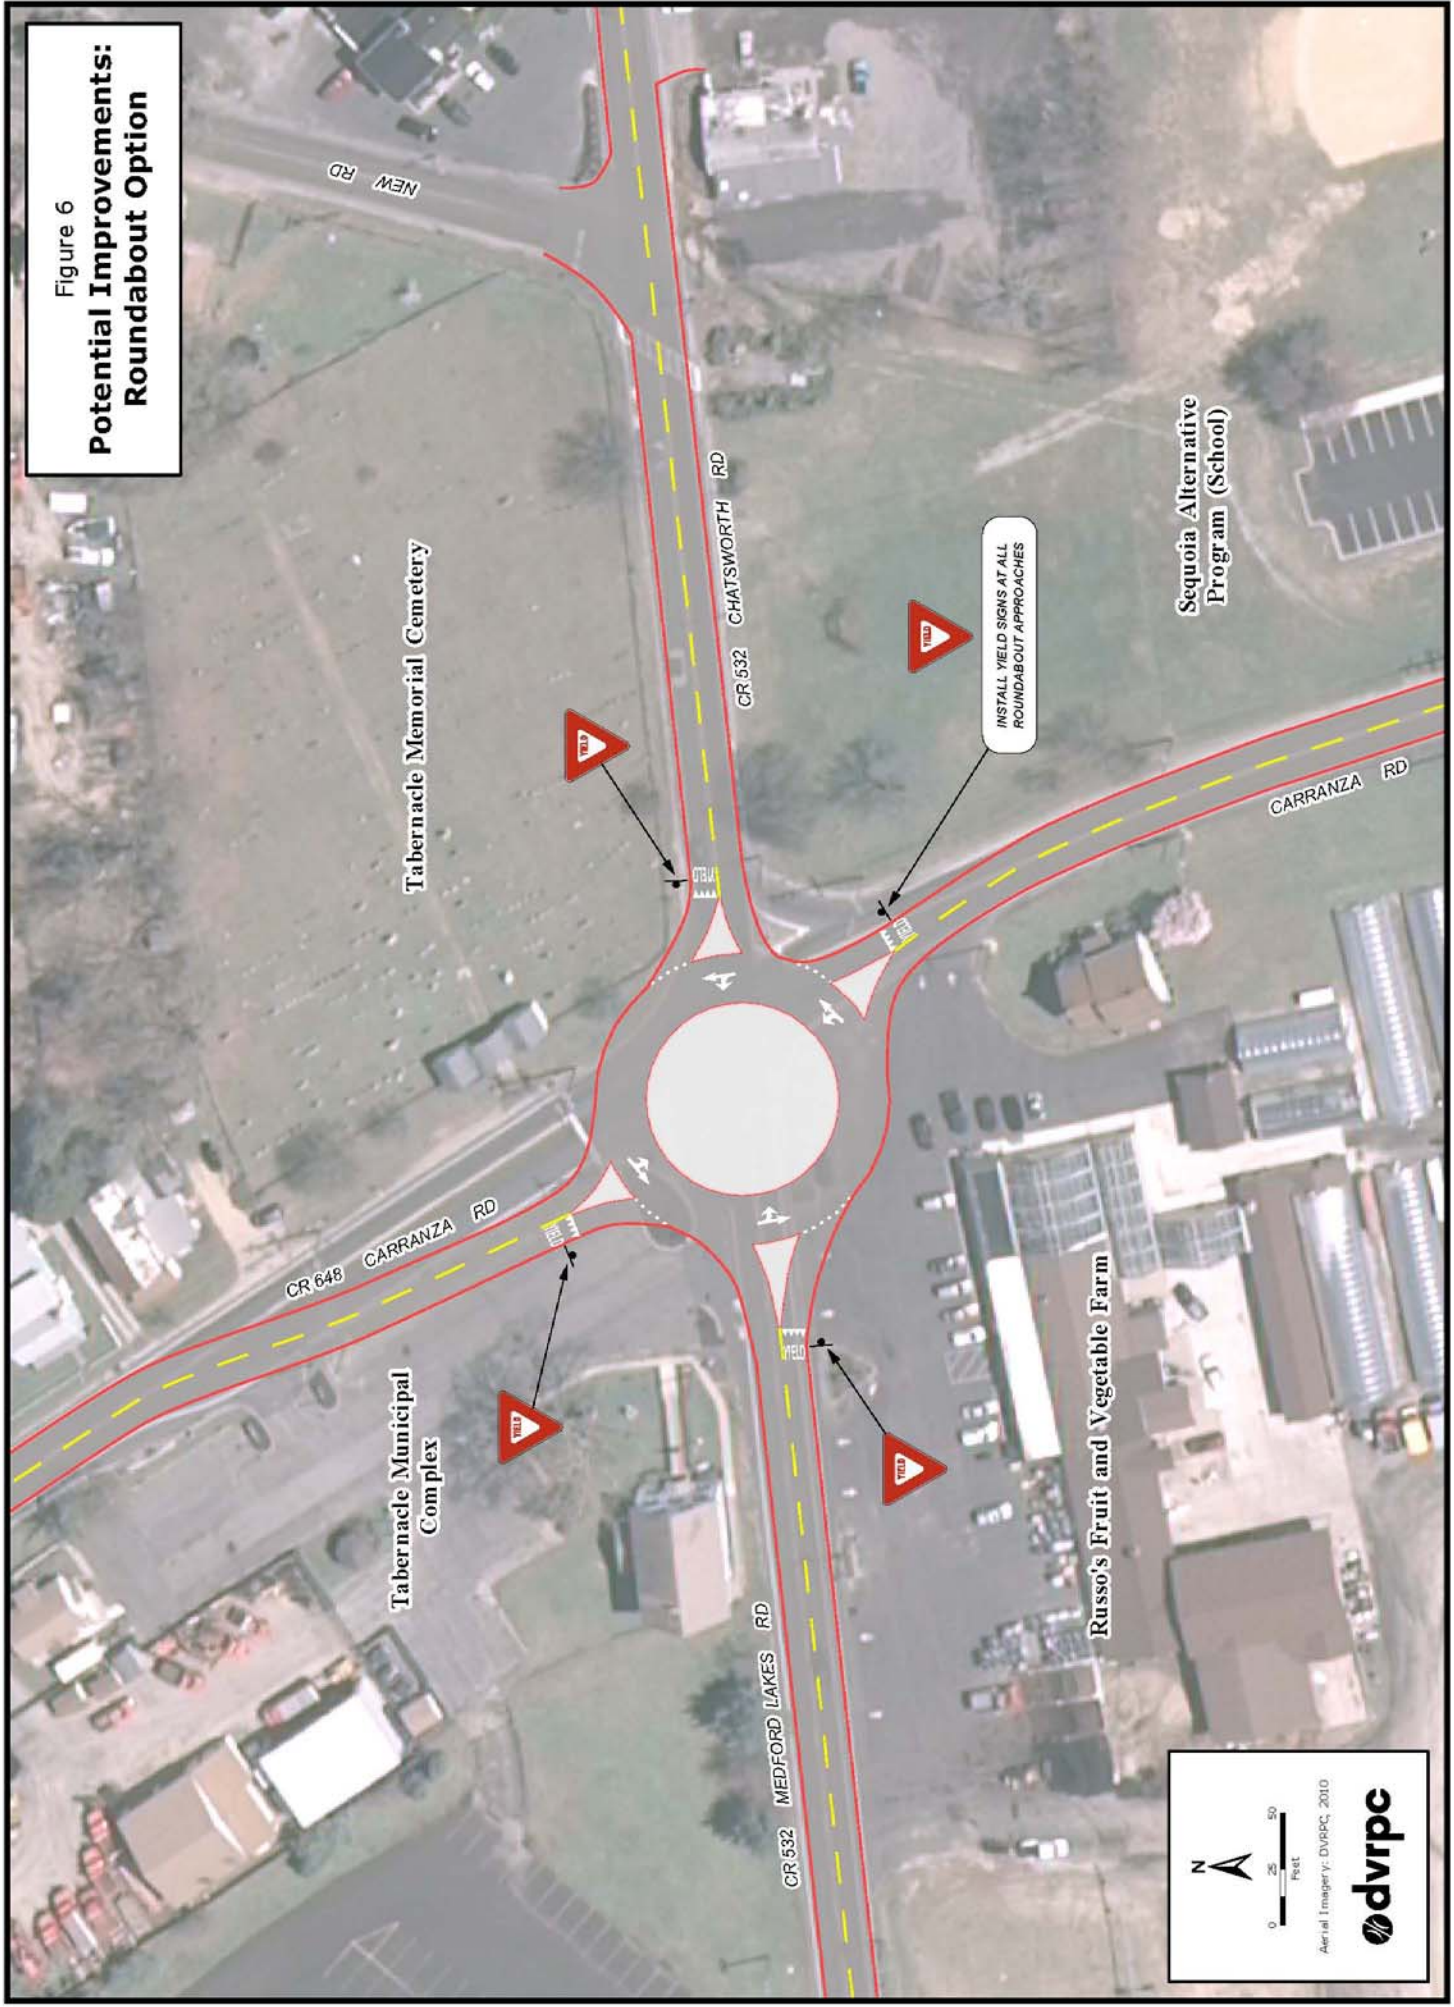
Figure 6

- ◆ Construct a single-lane roundabout.

Potential Improvements: Roundabout Option

- ◆ Given the skew layout of the intersection, there are limited options of where to place the roundabout. In order accommodate a roundabout at this location; ROW would need to be acquired from the Tabernacle Municipal Complex and Russo’s Fruit and Vegetable Farm. See [Figure 6](#).
- ◆ Officials from Tabernacle Township do not support the construction of a roundabout at the study intersection.
