BEDMINSTER AND HILLTOWN TOWNSHIPS, BUCKS COUNTY

# CONGESTION & CRASH

Analysis Program

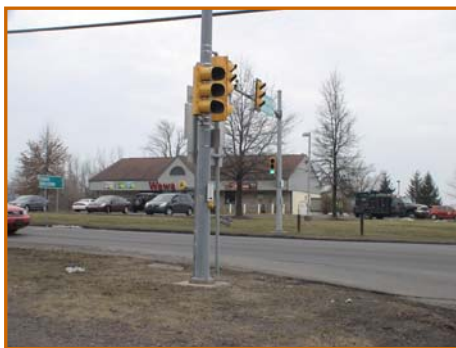
View of the Wawa Convenience Store  
(Source: DVRPC)

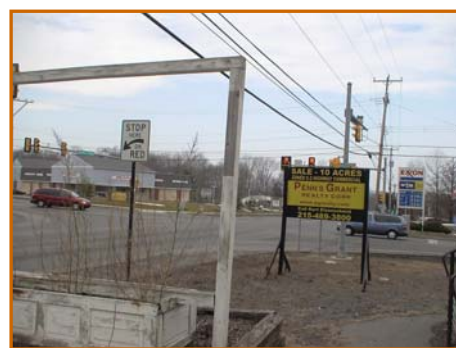
View of the vacant lot for sale, Exxon Gas Station and CVS Drugstore  
(Source: DVRPC)

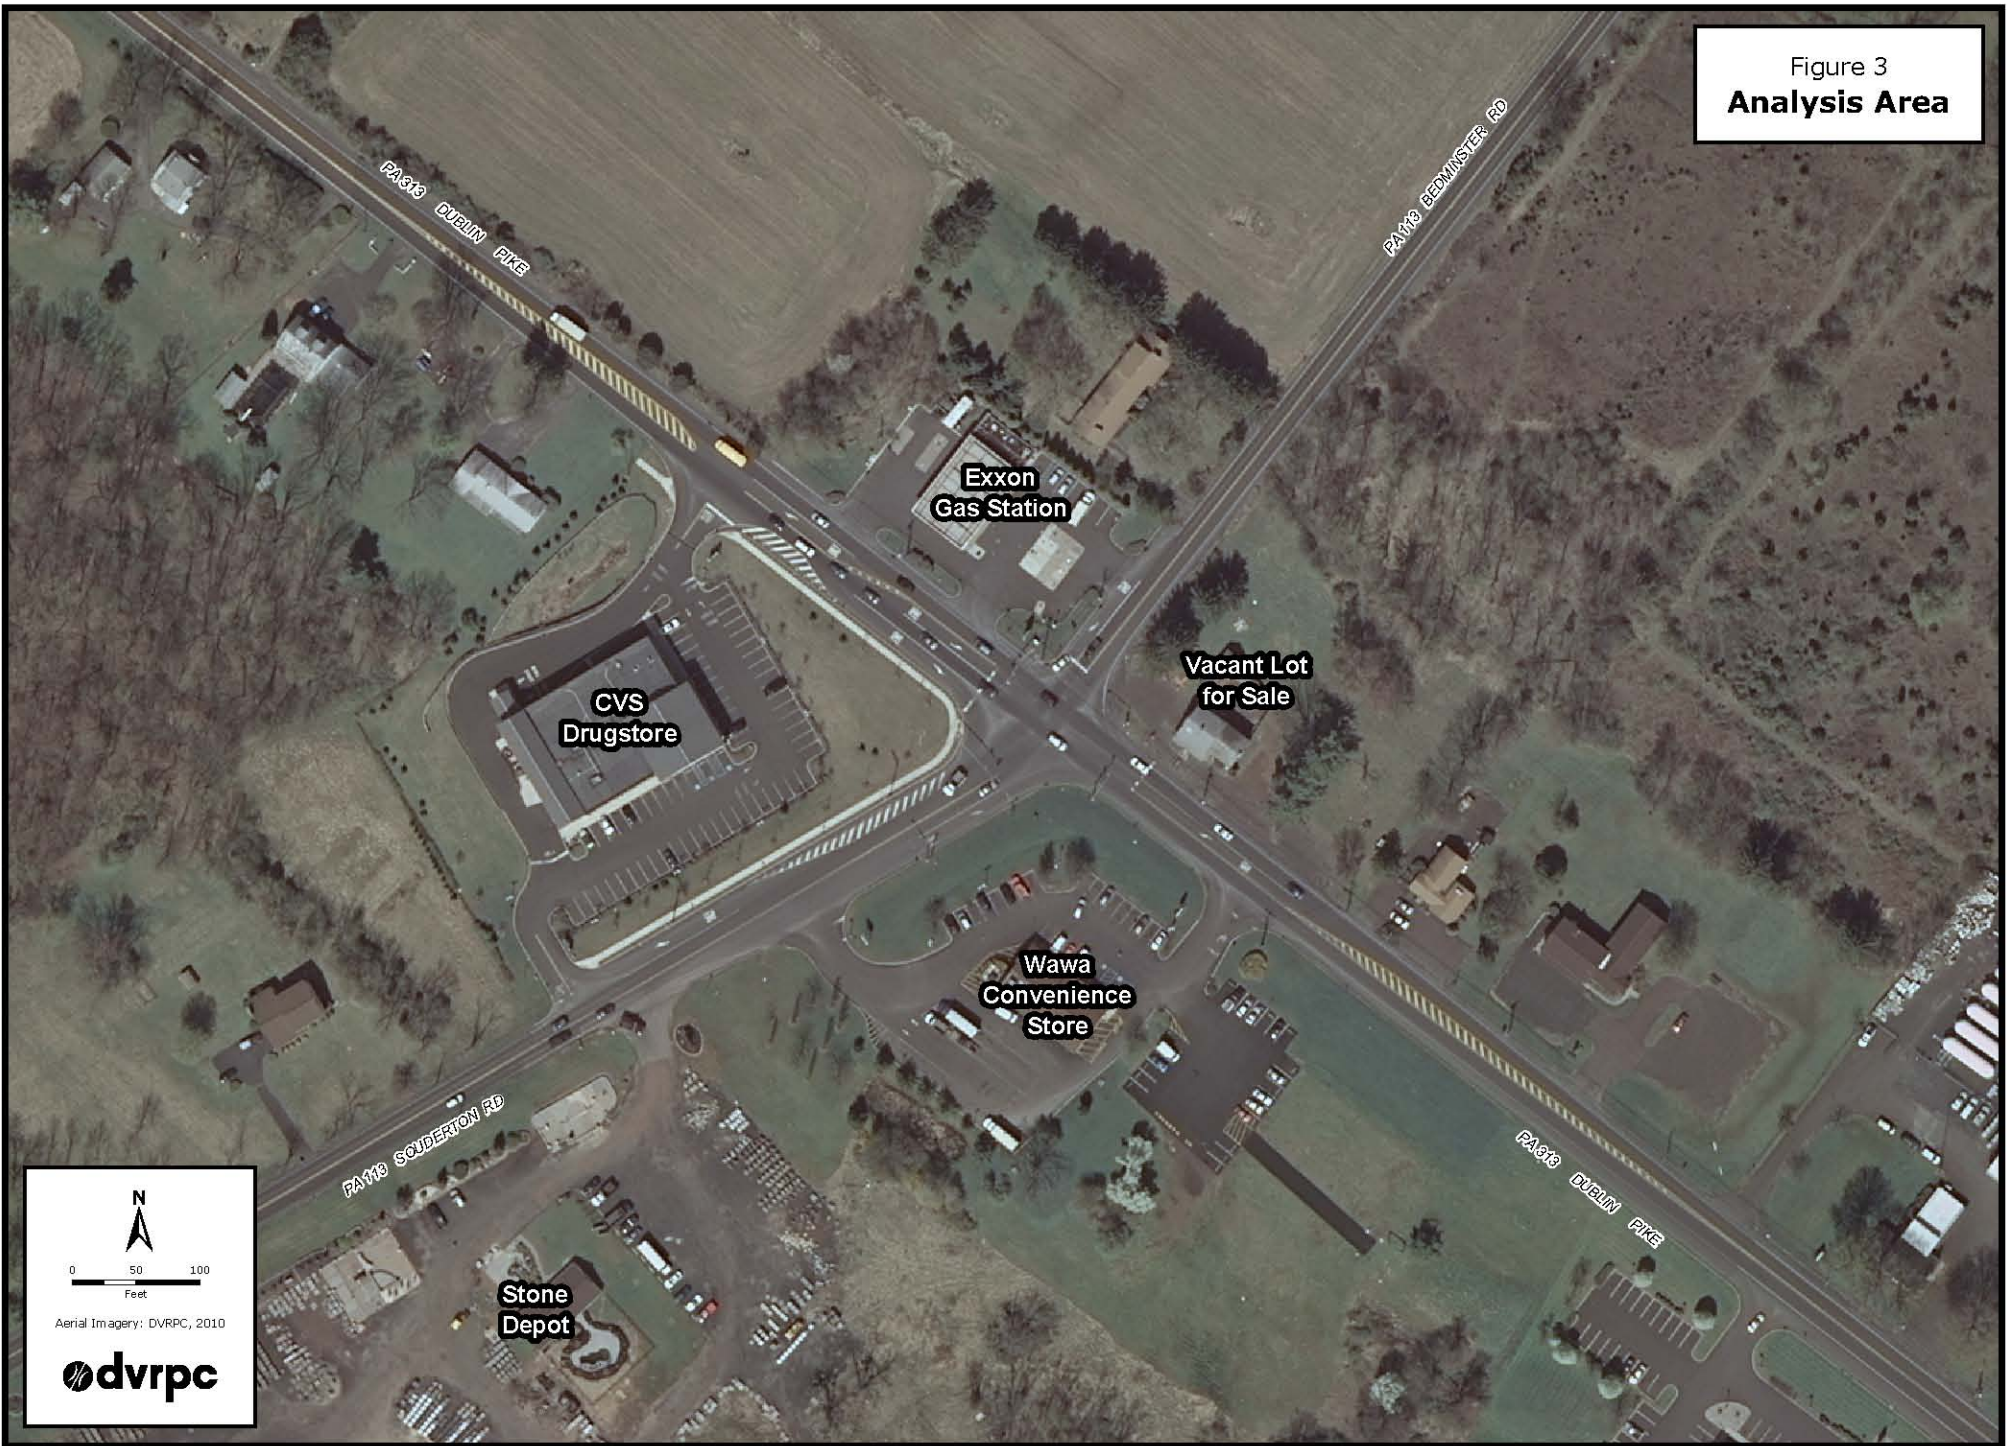
Figure 3  
Analysis Area

The land use surrounding the immediate intersection of SR 113 and SR 313 is commercial. As shown in **Figure 3**, a CVS Drugstore and Wawa Convenience Store are located south of the intersection. An Exxon Gas Station and vacant lot for sale (zoned commercial) are located north of the intersection. Less than half a mile north of the intersection is the Bedminster Crossing residential community. Stone Depot is located south of the intersection, behind the Wawa Convenience Store.

The focus of the study as shown in [Figures 1 and 3](#) is the intersection of SR 113 and SR 313. SR 113 provides access to Silverdale and Souderton and connects to key roads in north-central Bucks County, including SR 611 (Easton Road) and SR 309 (Bethlehem Pike). On a regional level, SR 313 is one of the main thoroughfares through Bucks County and connects to Doylestown and Quakertown. It also serves as the boundary between Hilltown and Bedminster townships.

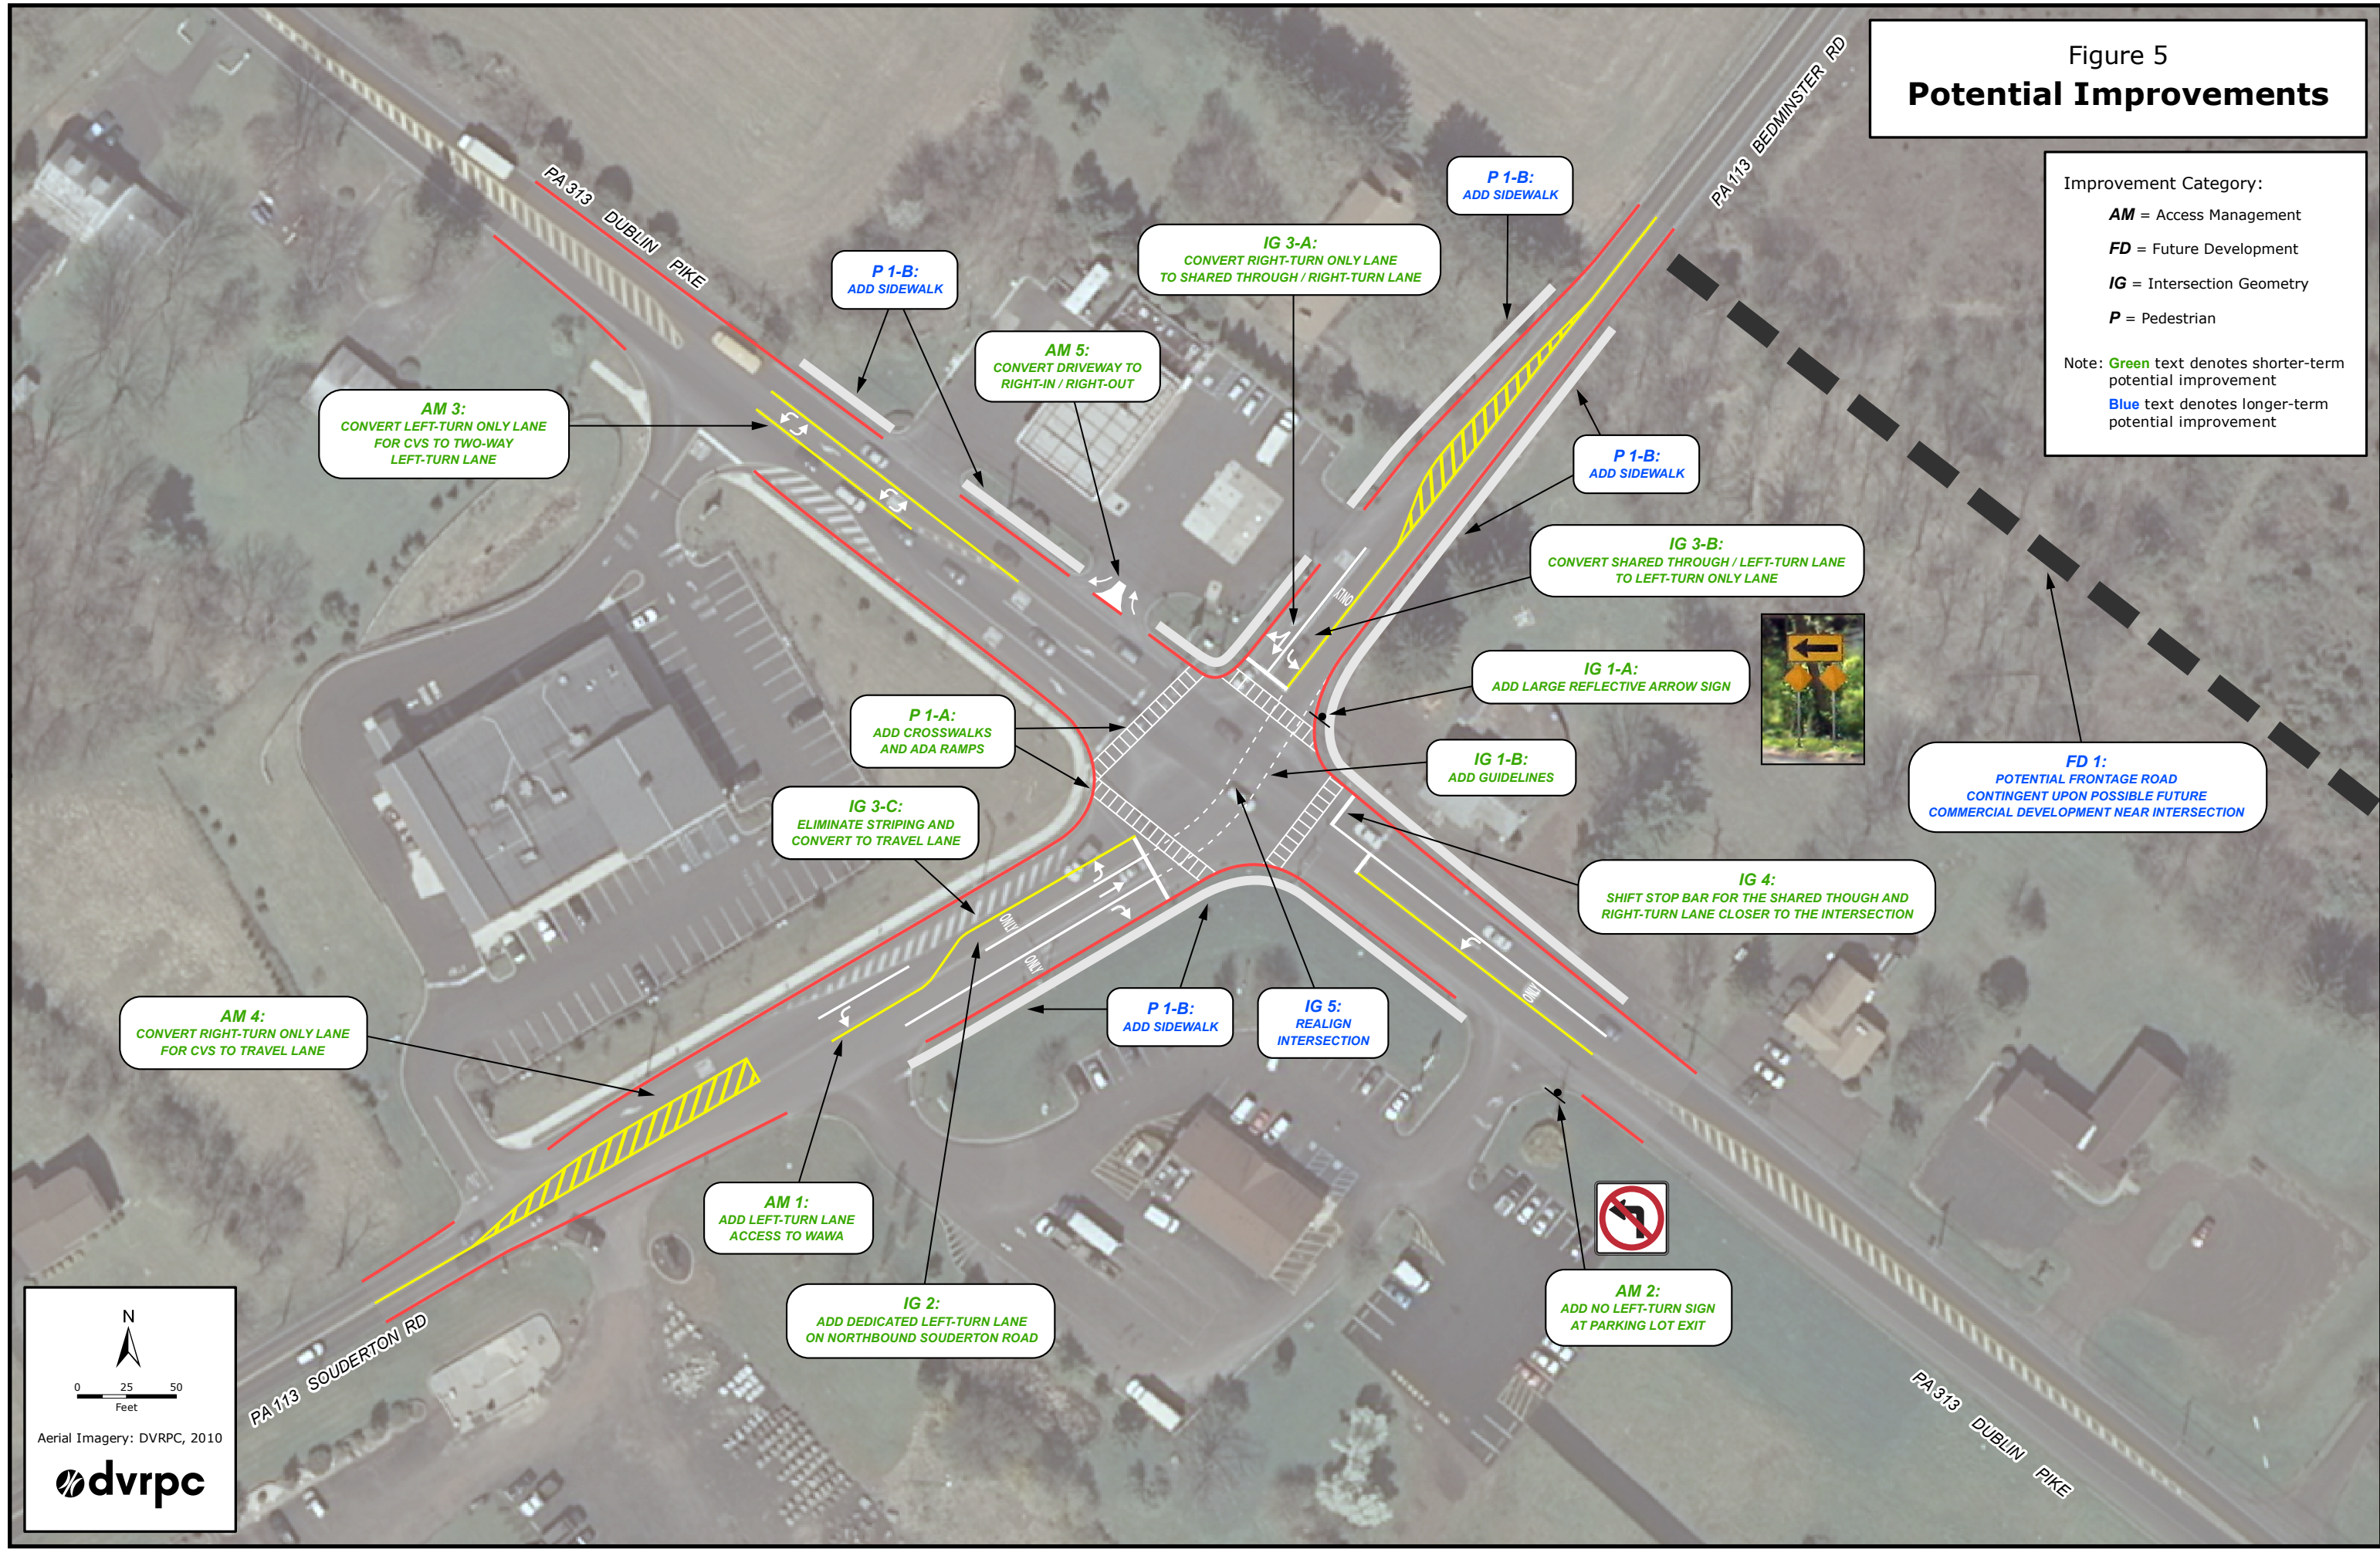
Improvement Category:  
**AM** = Access Management  
**FD** = Future Development  
**IG** = Intersection Geometry  
**P** = Pedestrian

Note: **Green** text denotes shorter-term potential improvement  
**Blue** text denotes longer-term potential improvement
