# Crash Data Review of Rail At-Grade Crossings in the Delaware Valley

October 2011

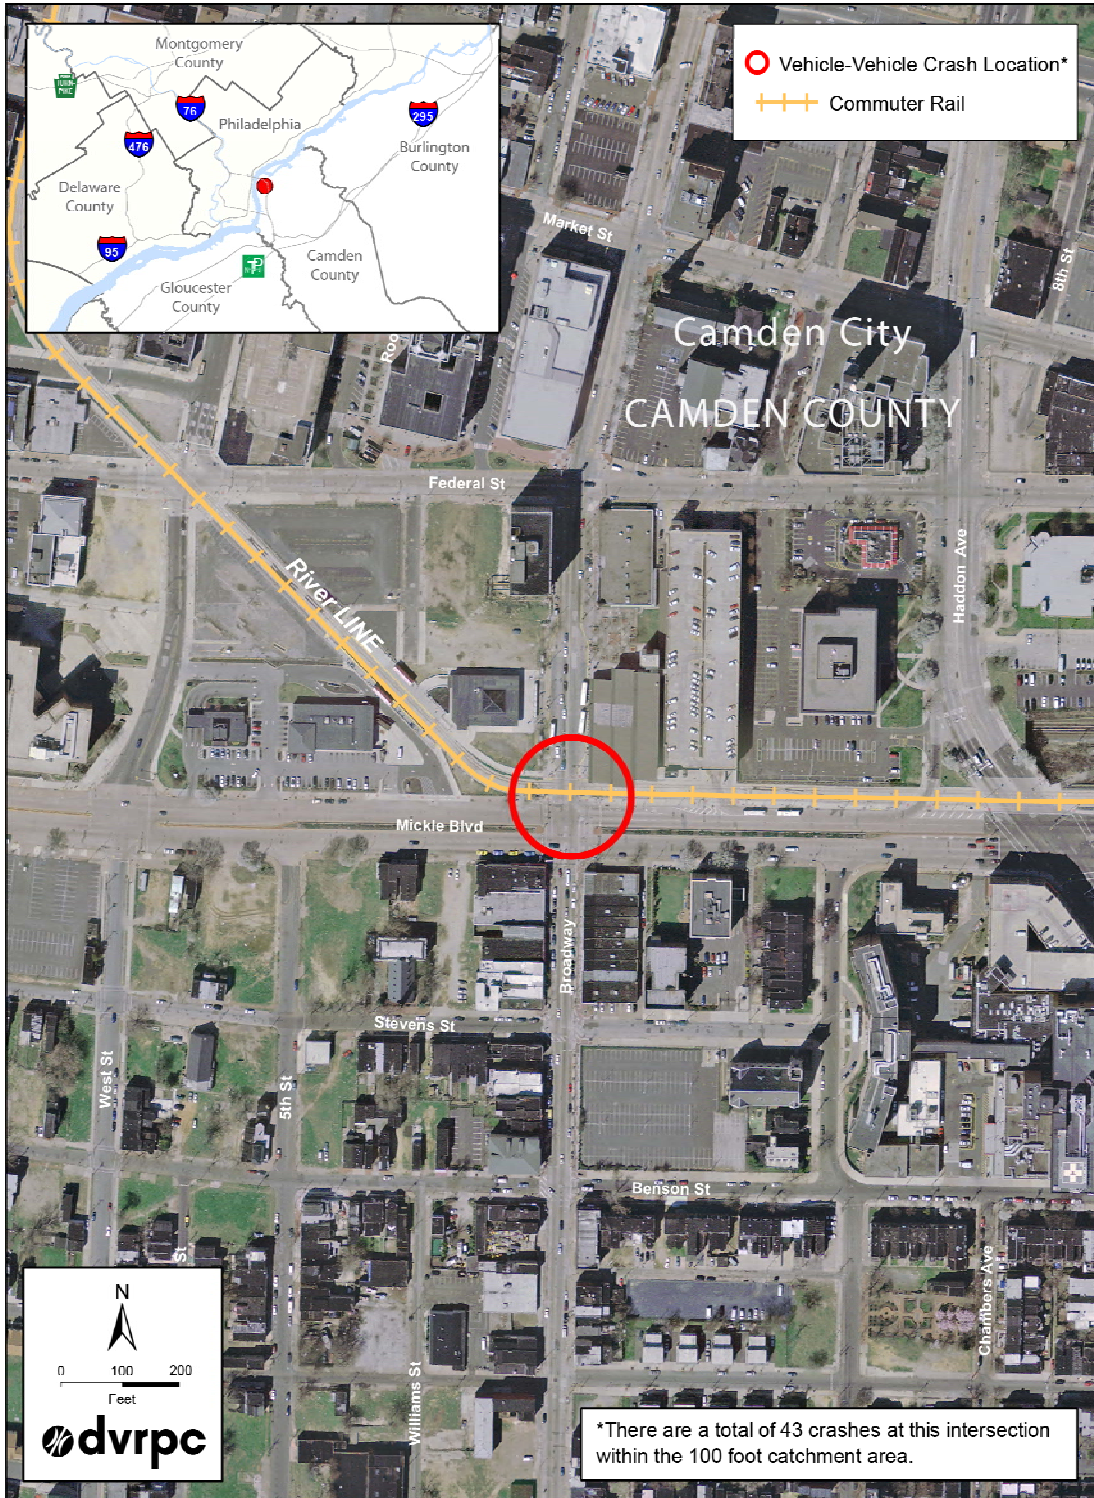
Figure 5: Highest Vehicle-Vehicle Crash Frequency Location in New Jersey

These crossings had, by far, the most crashes near them out of the nine-county region. Like Broadway, the Haddon Avenue crossing is directly north of the intersection of Haddon Avenue and Mickle Boulevard. The boulevard is six lanes plus a planted median that is about the width of a travel lane. Further review of these at-grade crossings is needed and appropriate safety improvements should be identified.
