US 202

SECTION: 200

TRANSPORTATION OPERATIONS AUDIT CHESTER COUNTY

DELAWARE VALLEY
dvrpc
REGIONAL
PLANNING COMMISSION

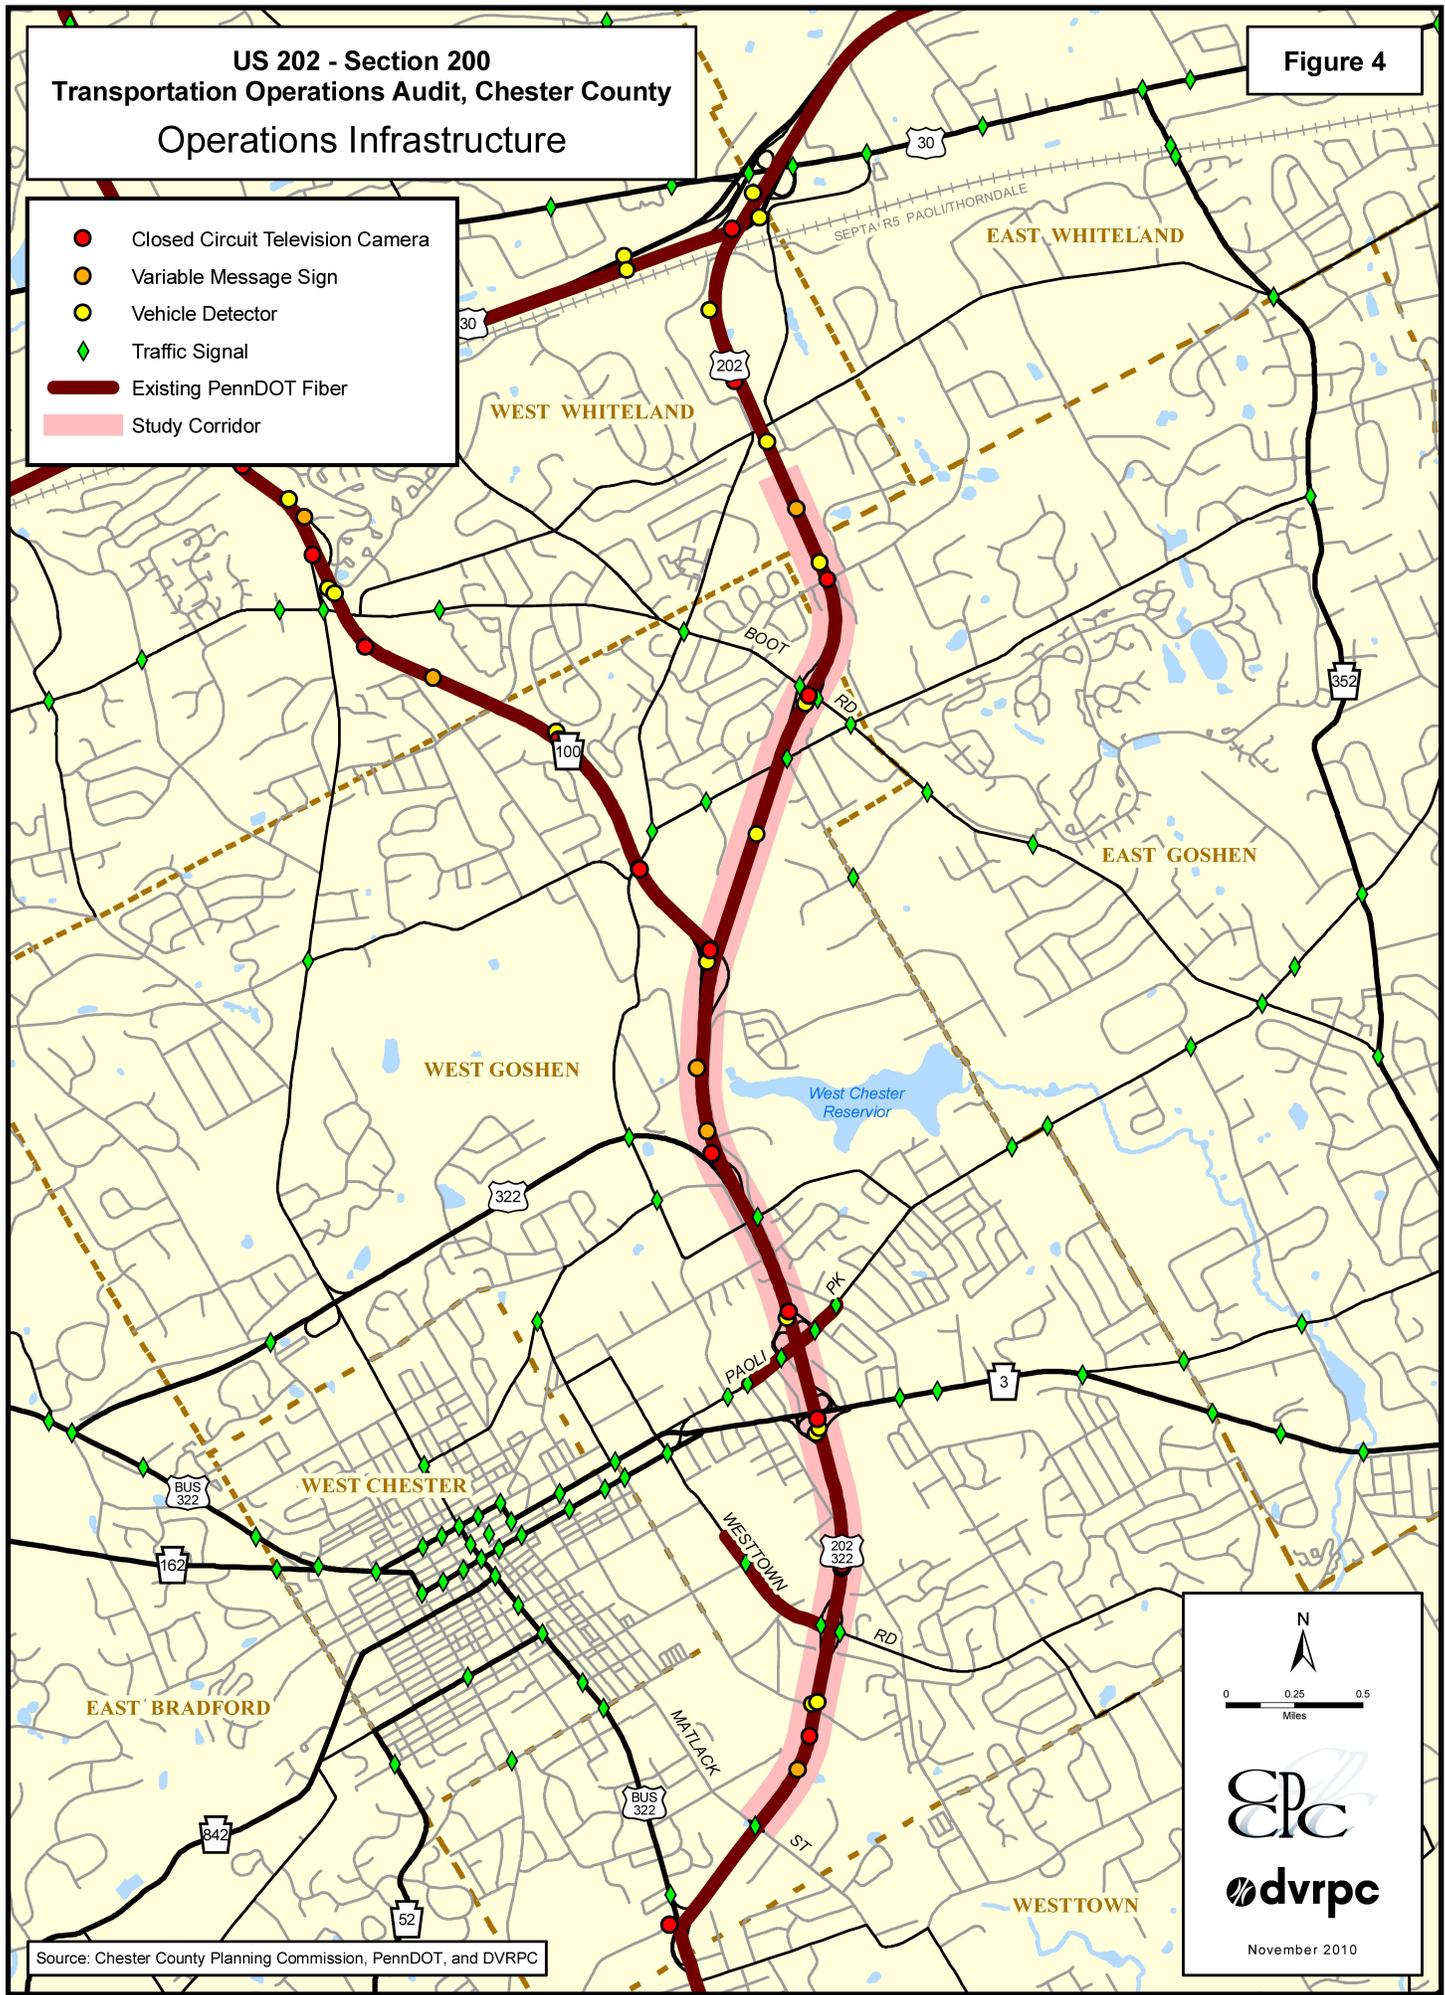
Figure 4

PennDOT has made significant investments in ITS devices along the US 202—Section 200 corridor. As **Figure 4** displays, there are a number of Closed Circuit Television cameras (CCTV) and Variable Message Sign (VMS). These devices are operated by PennDOT staff located at the Regional Traffic Management Center (RTMC) in King of Prussia and serving the five southeastern counties in Pennsylvania. The center is staffed 24 hours a day, seven days a week; operators utilize these technologies to monitor traffic conditions, assist in incident management, and disseminate traveler information to the public. In addition to CCTV and VMS, there are vehicle detectors along the roadside to help determine travel times which are posted on the VMS. Most of these devices are interconnected through a fiber optic network to allow communications with the RTMC.

- Closed Circuit Television Camera
- Variable Message Sign
- Vehicle Detector
- ◆ Traffic Signal
- Existing PennDOT Fiber
- Study Corridor

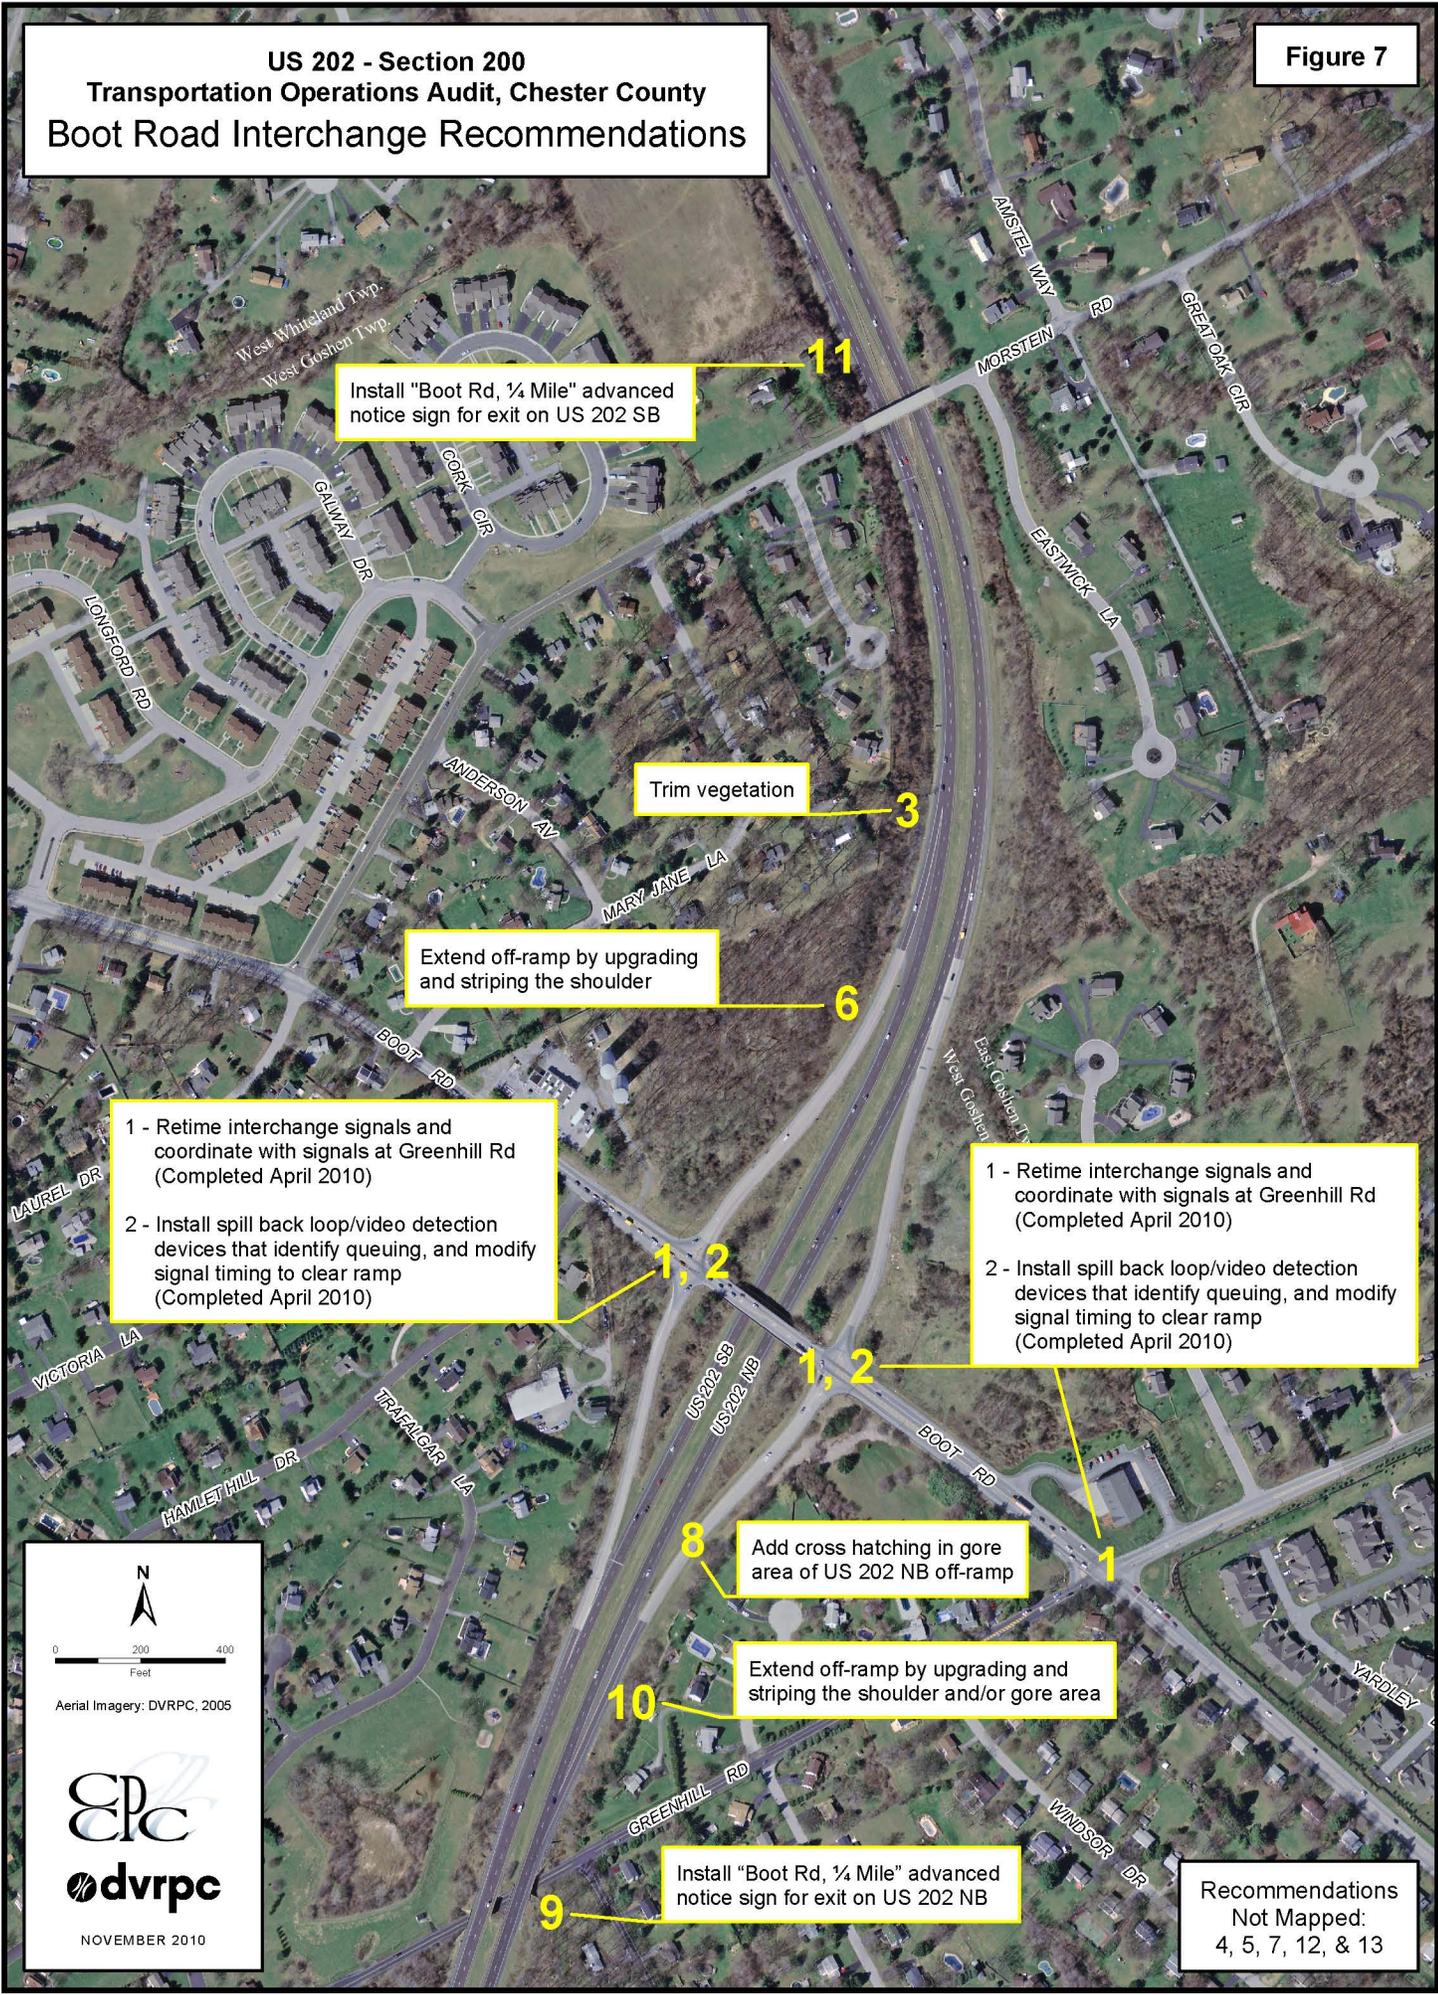
US 202 - Section 200
Transportation Operations Audit, Chester County
Boot Road Interchange Recommendations

Recommendations Not Mapped:
4, 5, 7, 12, & 13

Figure 7 displays the location of several recommendations from Table 6 on an aerial map.

Issues	Recommendations	Time-frame	Priority	Lead Agency
Safety issues at ramp intersections and queuing on US 202 Southbound off-ramp and mainline during AM peak due to substandard signal operations and existing lane configurations	1 — Retime interchange signals and coordinate with signals at Greenhill Road	Completed	Mid-April 2010	■ West Goshen Township
	2 — Install spill back loop/video detection devices that identify queuing, and modify signal timing to clear ramp	Completed	Mid-April 2010	■ West Goshen Township
	3 — Trim vegetation on approach to US 202 Southbound off-ramp	Short-term	High	■ PennDOT Maintenance
	4 — Monitor changes in traffic flow due to traffic signal improvements at interchange and Greenhill Road	Mid-term	High	■ Municipalities
	5 — Evaluate the incorporation of signals at Phoenixville Pike and Wilson Drive to signal system	Mid-term	High	■ Municipalities
	6 — Extend off-ramp by upgrading and striping the shoulder	Mid-term	Medium	■ PennDOT

7 — Study needs and opportunities of reducing congestion issues by reconfiguring the interchange	Long-term	Low	■ PennDOT
Insufficient signage, markings, and short deceleration lane for US 202 Northbound off-ramp	8 — Add cross hatching in gore area of Northbound off-ramp	Short-term	High	■ PennDOT Maintenance
	9 — Install "Boot Road, ¼ Mile" advanced notice sign for exit on US 202 Northbound	Short-term	High	■ PennDOT Maintenance
	10 — Extend off-ramp by upgrading and striping the shoulder and/or gore area	Mid-term	Medium	■ PennDOT Maintenance
Inadequate signage for US 202 Southbound off-ramp	11 — Install "Boot Road, ¼ Mile" advanced notice sign for exit on US 202 Southbound	Short-term	High	■ PennDOT Maintenance
Peak-hour commuter traffic creates congestion	12 — Based on analysis in the <i>US202/US 322 Interchange Completion Study</i> (DVRPC, Publication TM08009, 2008), pursue a Point-of-Access study to evaluate alternative access points for the proposed slip ramp connecting Ward Avenue to US 202 Northbound	Short-term	Medium	■ PennDOT ■ Municipalities

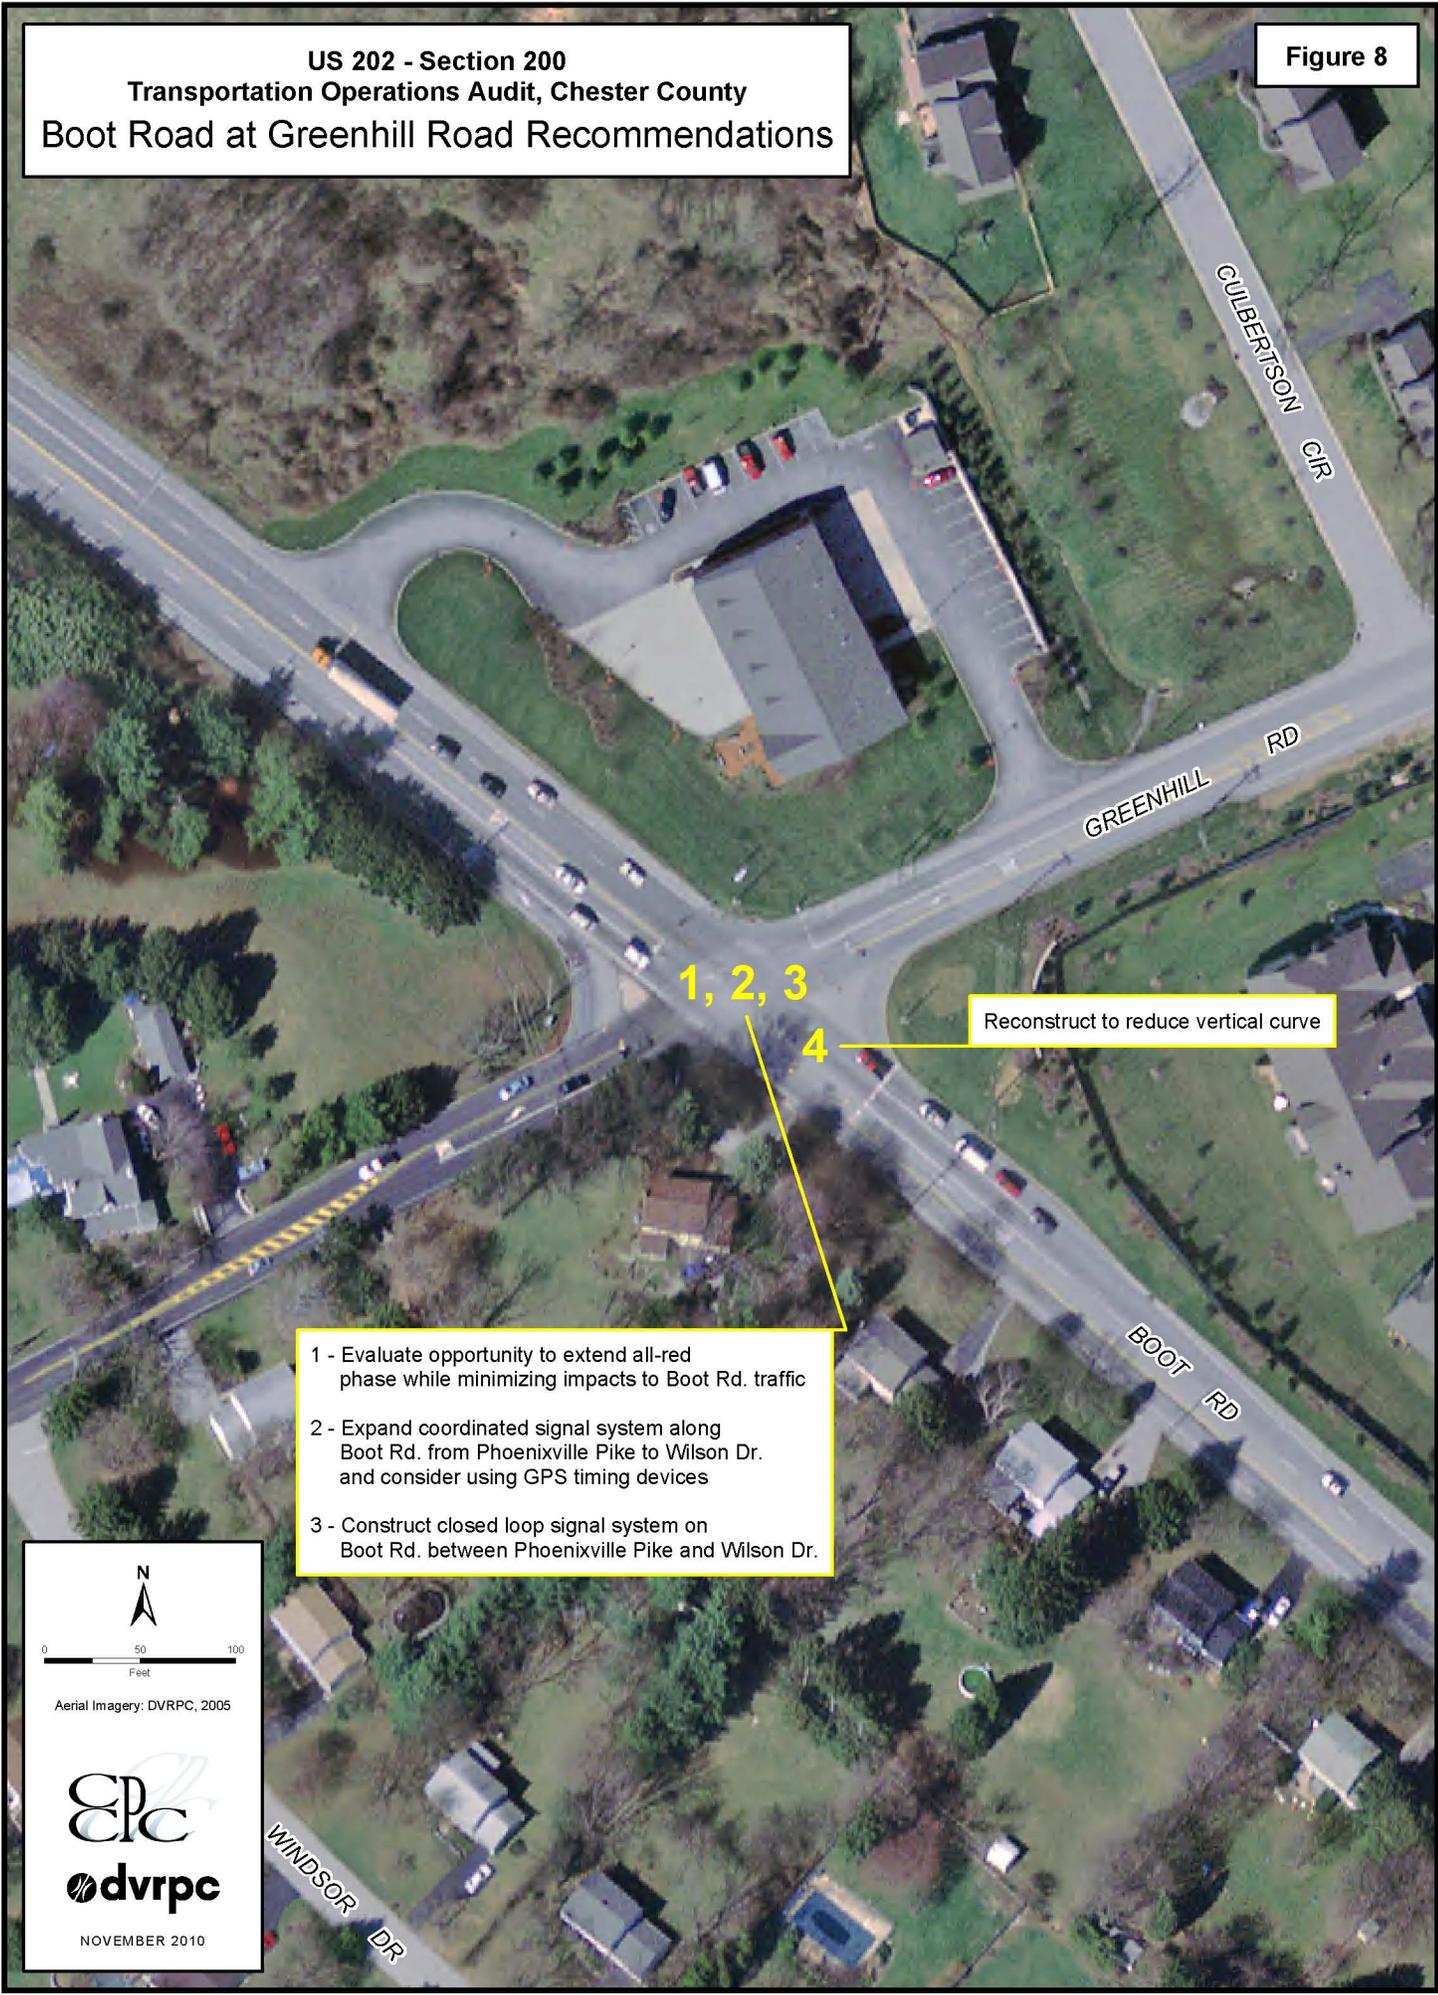
US 202 - Section 200
Transportation Operations Audit, Chester County
Boot Road at Greenhill Road Recommendations

1, 2, 3
4

Reconstruct to reduce vertical curve

Figure 8 displays the exact location of several recommendations from Table 7 on an aerial map.

Issues	Recommendations	Time - frame	Priority	Lead Agency
High number of crashes within the intersection due to heavy traffic volumes and turning movements	1 — Evaluate opportunity to extend all-red phase while minimizing impacts to Boot Road traffic	Short-term	Medium	<ul style="list-style-type: none"> ■ PennDOT ■ Municipalities
Wilson Drive signal not coordinated with Greenhill and US 202 interchange signals	2 — Expand coordinated signal system along Boot Road from Phoenixville Pike to Wilson Drive and consider using GPS timing devices	Mid-term	High	<ul style="list-style-type: none"> ■ PennDOT ■ Municipalities
	3 — Construct closed loop signal system on Boot Road between Phoenixville Pike and Wilson Drive	Long-term	Medium	<ul style="list-style-type: none"> ■ PennDOT ■ Municipalities
Steep slope limits visibility of oncoming traffic	4 — Reconstruct to reduce vertical curve	Long-term	Low	<ul style="list-style-type: none"> ■ PennDOT

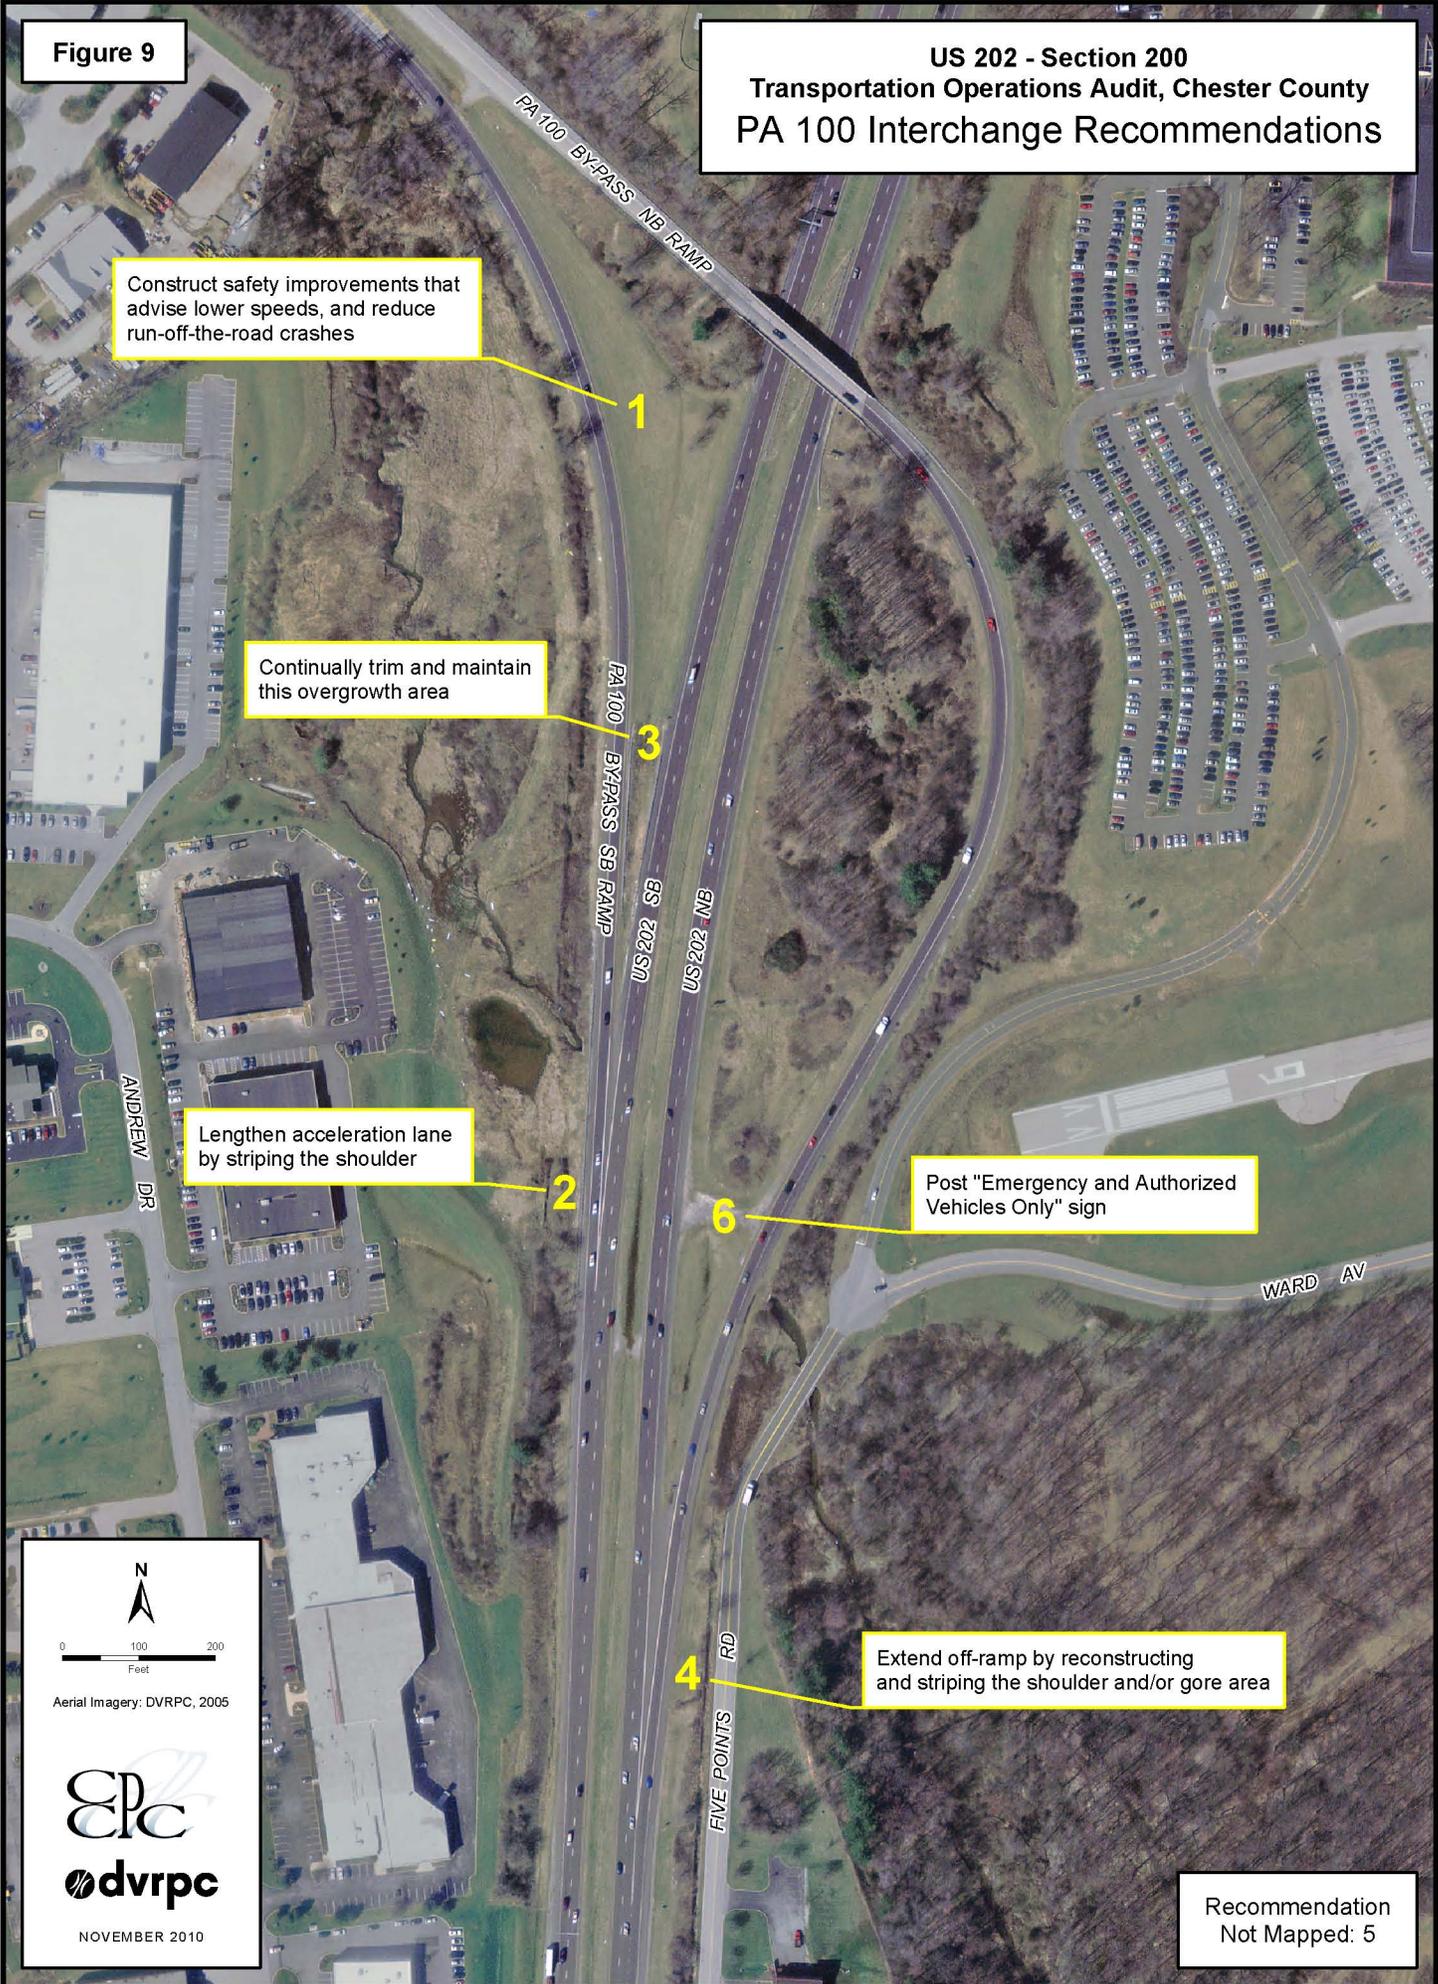
US 202 - Section 200
Transportation Operations Audit, Chester County
PA 100 Interchange Recommendations

Recommendation
Not Mapped: 5

Figure 9 displays the location of recommendations from Table 8 on an aerial map.

Issues	Recommendations	Time-frame	Priority	Lead Agency
<p>Safety issues due to the sharp curve of PA 100 Southbound ramp, high speeds entering curve, lack of delineation/signage, and roadway super elevation</p>	<p>1 — Construct safety improvements that advise lower speeds and reduce run-off-the-road crashes such as:</p> <ul style="list-style-type: none"> ■ Flexible post delineators ■ “Reduce Speed Ahead” advisory signs ■ Guardrail ■ Edge line rumble strips ■ Raised pavement markers ■ Chevrons ■ Reconstruct to reduce roadway superelevation 	<p>Short-term</p>	<p>High</p>	<ul style="list-style-type: none"> ■ PennDOT Maintenance
<p>Short merge lane from PA 100 Southbound to US 202</p>	<p>2 — Lengthen acceleration lane by striping the shoulder</p>	<p>Short-term</p>	<p>High</p>	<ul style="list-style-type: none"> ■ Recommended in ARRA project ■ PennDOT marked-up design plans to further investigate ■ Follow-up with PennDOT Traffic Unit is needed to determine if the shoulders can be reduced in width

Issues	Recommendations	Time-frame	Priority	Lead Agency
Short deceleration lane from US 202 Northbound to PA 100	4 — Extend off-ramp by reconstructing and striping the shoulder and/or gore area	Short-term	High	<ul style="list-style-type: none"> ■ Recommended in ARRA project ■ PennDOT marked-up design plans to further investigate ■ Follow-up with PennDOT Traffic Unit is needed to determine if the shoulders can be reduced in width
On US 202 Northbound, drivers have a tendency to make last-minute merges from the passing lane to the off-ramp for PA 100	5 — ARRA project may update signage. Change text on overhead sign from "202 North, King of Prussia" to "PA 100 North, Exit 7/8 mile"	Short-term	High	<ul style="list-style-type: none"> ■ Recommended in ARRA project ■ PennDOT made changes to signage design plans to accommodate request, but follow-up with Design Unit is needed to ensure structure designs support additional weight/wind loads

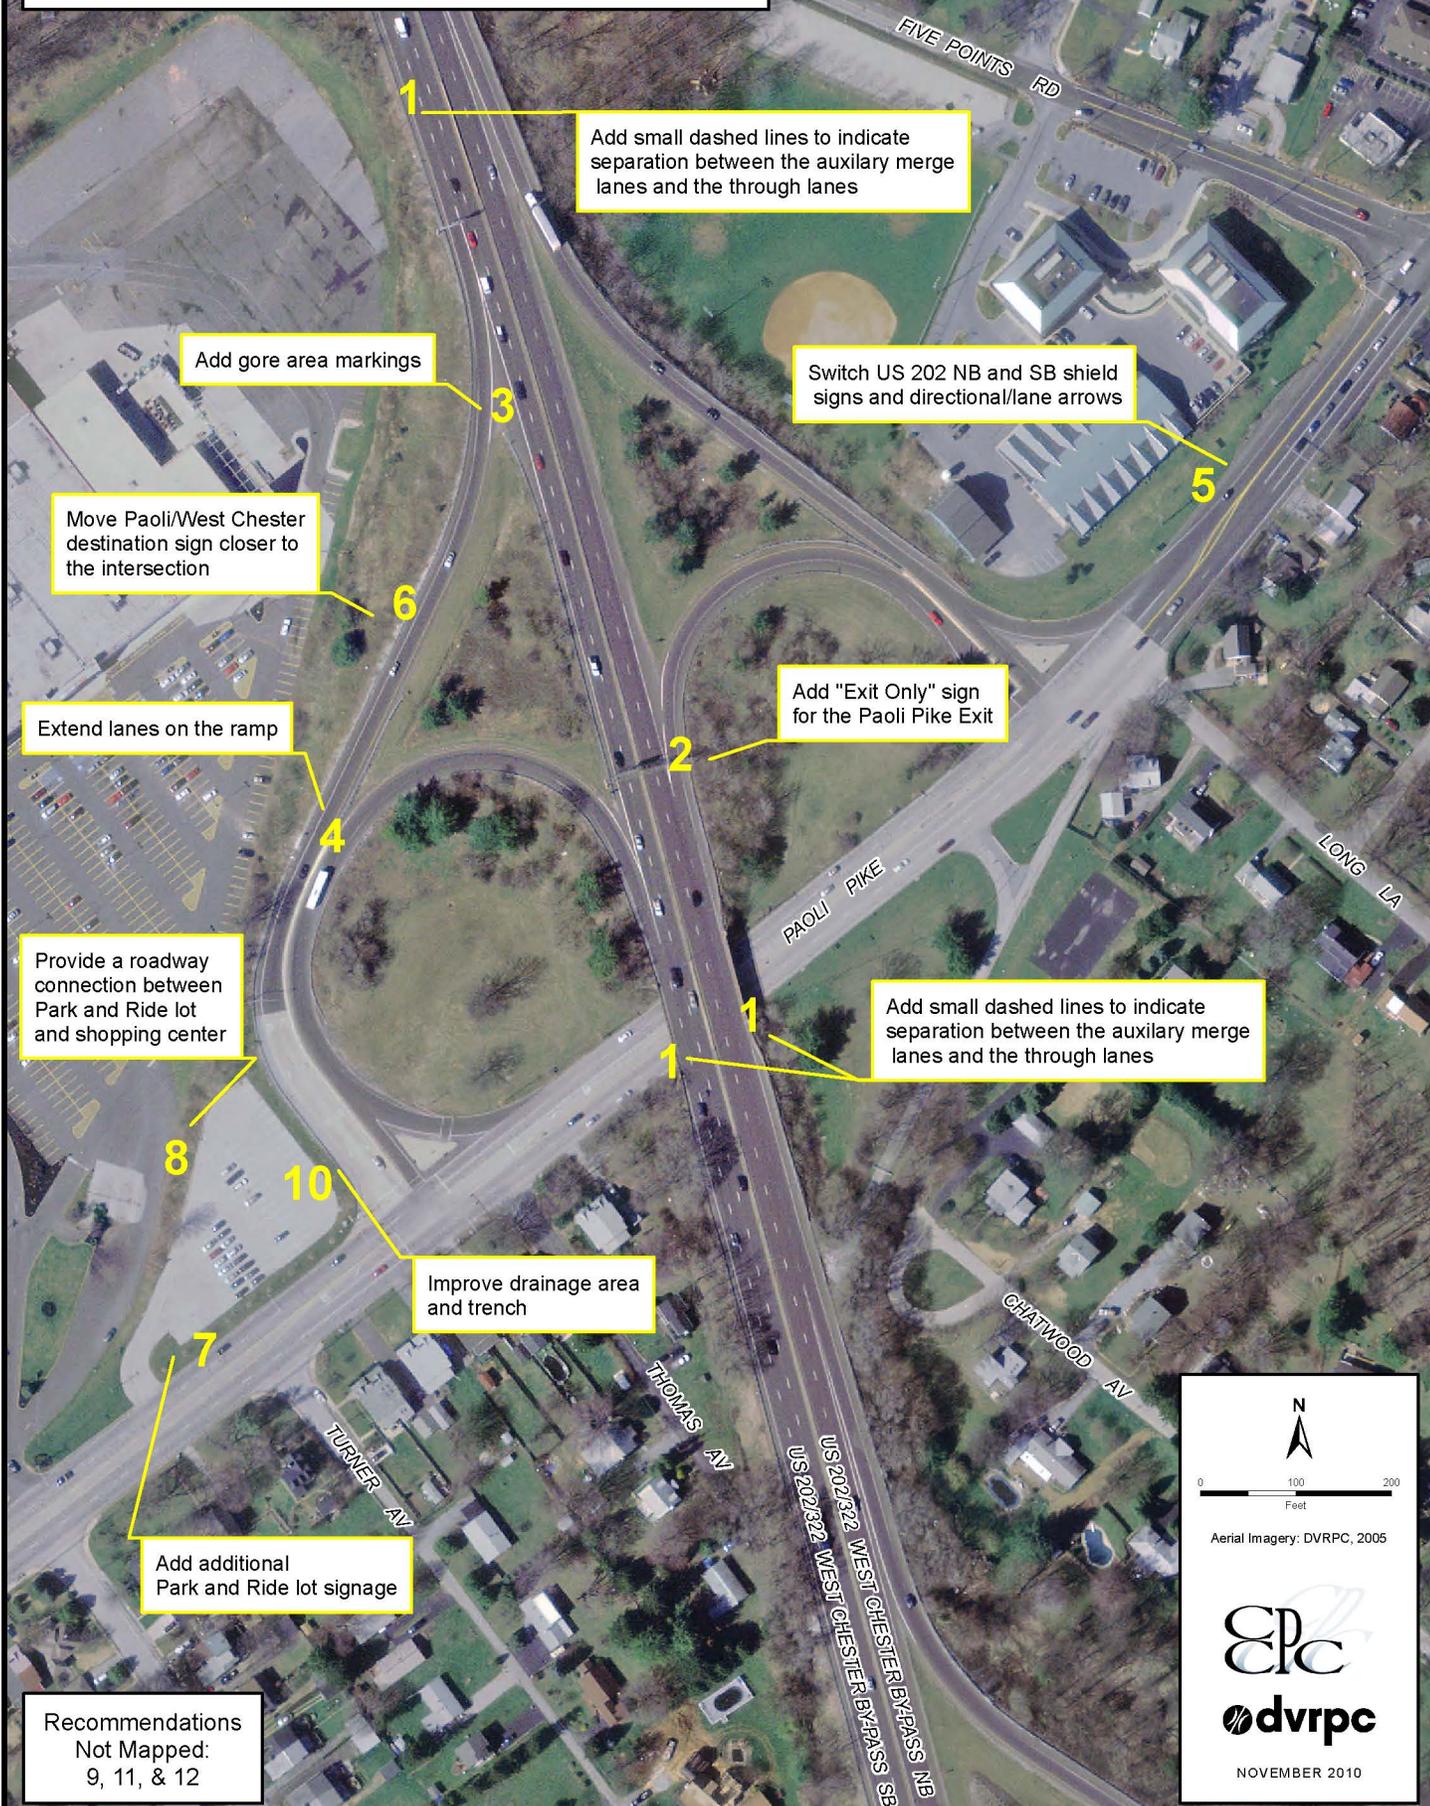
US 202 - Section 200 Transportation Operations Audit, Chester County Paoli Pike Interchange Recommendations

Recommendations
Not Mapped:
9, 11, & 12

Figure 11 displays the location of several recommendations from Table 10 on an aerial map.

Issues	Recommendations	Time-frame	Priority	Lead Agency
	1 — Add small dashed lines to indicate a separation between the auxiliary merge lanes and through travel lanes	Short-term	High	<ul style="list-style-type: none"> ■ Recommended in ARRA project ■ Follow-up needed
<p>There are complex merging areas on US 202 in both directions between interchanges:</p> <ul style="list-style-type: none"> ■ US 322 and Paoli Pike. ■ Paoli Pike and PA 3 <p>The shared merge lanes are sometimes used as through lanes.</p>	2 — Add "Exit Only" sign to Northbound US 202 over the deceleration lane for the Paoli Pike exit	Short-term	High	<ul style="list-style-type: none"> ■ Recommended in ARRA project ■ PennDOT made changes to signage design plans, but follow-up with Design Unit is needed to ensure structure designs support additional weight/wind loads
Delineation of US 202 Southbound off-ramp gore area is unclear	3 — Add gore area markings	Short-term	High	<ul style="list-style-type: none"> ■ Recommended in ARRA project ■ Follow-up needed

Excessive queuing on US 202 Southbound off-ramp	4 — Extend turning lanes on the ramp	Short-term	Medium	<ul style="list-style-type: none"> ■ PennDOT
Inaccurate directional signs and improperly placed destination signs are confusing. Sign clutter near the interchange is distracting.	5 — Switch route signs and directional/lane arrows for Northbound and Southbound US 202 on Paoli Pike	Short-term	Low	<ul style="list-style-type: none"> ■ PennDOT Maintenance
	6 — Move the Paoli/West Chester destination sign on US 202 Southbound off-ramp closer to Paoli Pike intersection	Short-term	Low	<ul style="list-style-type: none"> ■ PennDOT Maintenance
Park and Ride lot underutilized	7 — Additional signage may be provided as part of the US 202 Section 320 project.	Short-term	Medium	<ul style="list-style-type: none"> ■ PennDOT
	8 — Provide a roadway connection with the lot to the West Goshen Shopping Center parking lot to improve access and provide a safe exit, especially for vehicles heading east on Paoli Pike	Long-term	Low	<ul style="list-style-type: none"> ■ PennDOT ■ Shopping Center Management

Issues	Recommendations	Time-frame	Priority	Lead Agency
Incomplete system of sidewalks limits pedestrian mobility	9 — Develop and implement a pedestrian/bicycle improvement project to provide infrastructure along Paoli Pike to West Chester	Mid-term	High	<ul style="list-style-type: none"> ■ PennDOT ■ Municipalities
During rainy conditions, the right-turn lane is flooded on the US 202 Southbound off-ramp.	10 — Improve drainage area and trench between park and ride lot and US 202 Southbound off-ramp.	Mid-term	Medium	<ul style="list-style-type: none"> ■ PennDOT
Insufficient public transit infrastructure to support transit demand	11 — Support transit recommendations from <i>Boosting The Bus: Better Transit Integration Along West Chester Pike</i> (DVRPC, Pub # 10033) which suggests strategies to improve the attractiveness, speed, and cost effectiveness of bus service along West Chester Pike including transit signal priority, bus stop consolidation, limited station stops, far-side bus stops, and enhanced passenger information.	Mid-term	High	<ul style="list-style-type: none"> ■ SEPTA ■ PennDOT ■ Municipalities

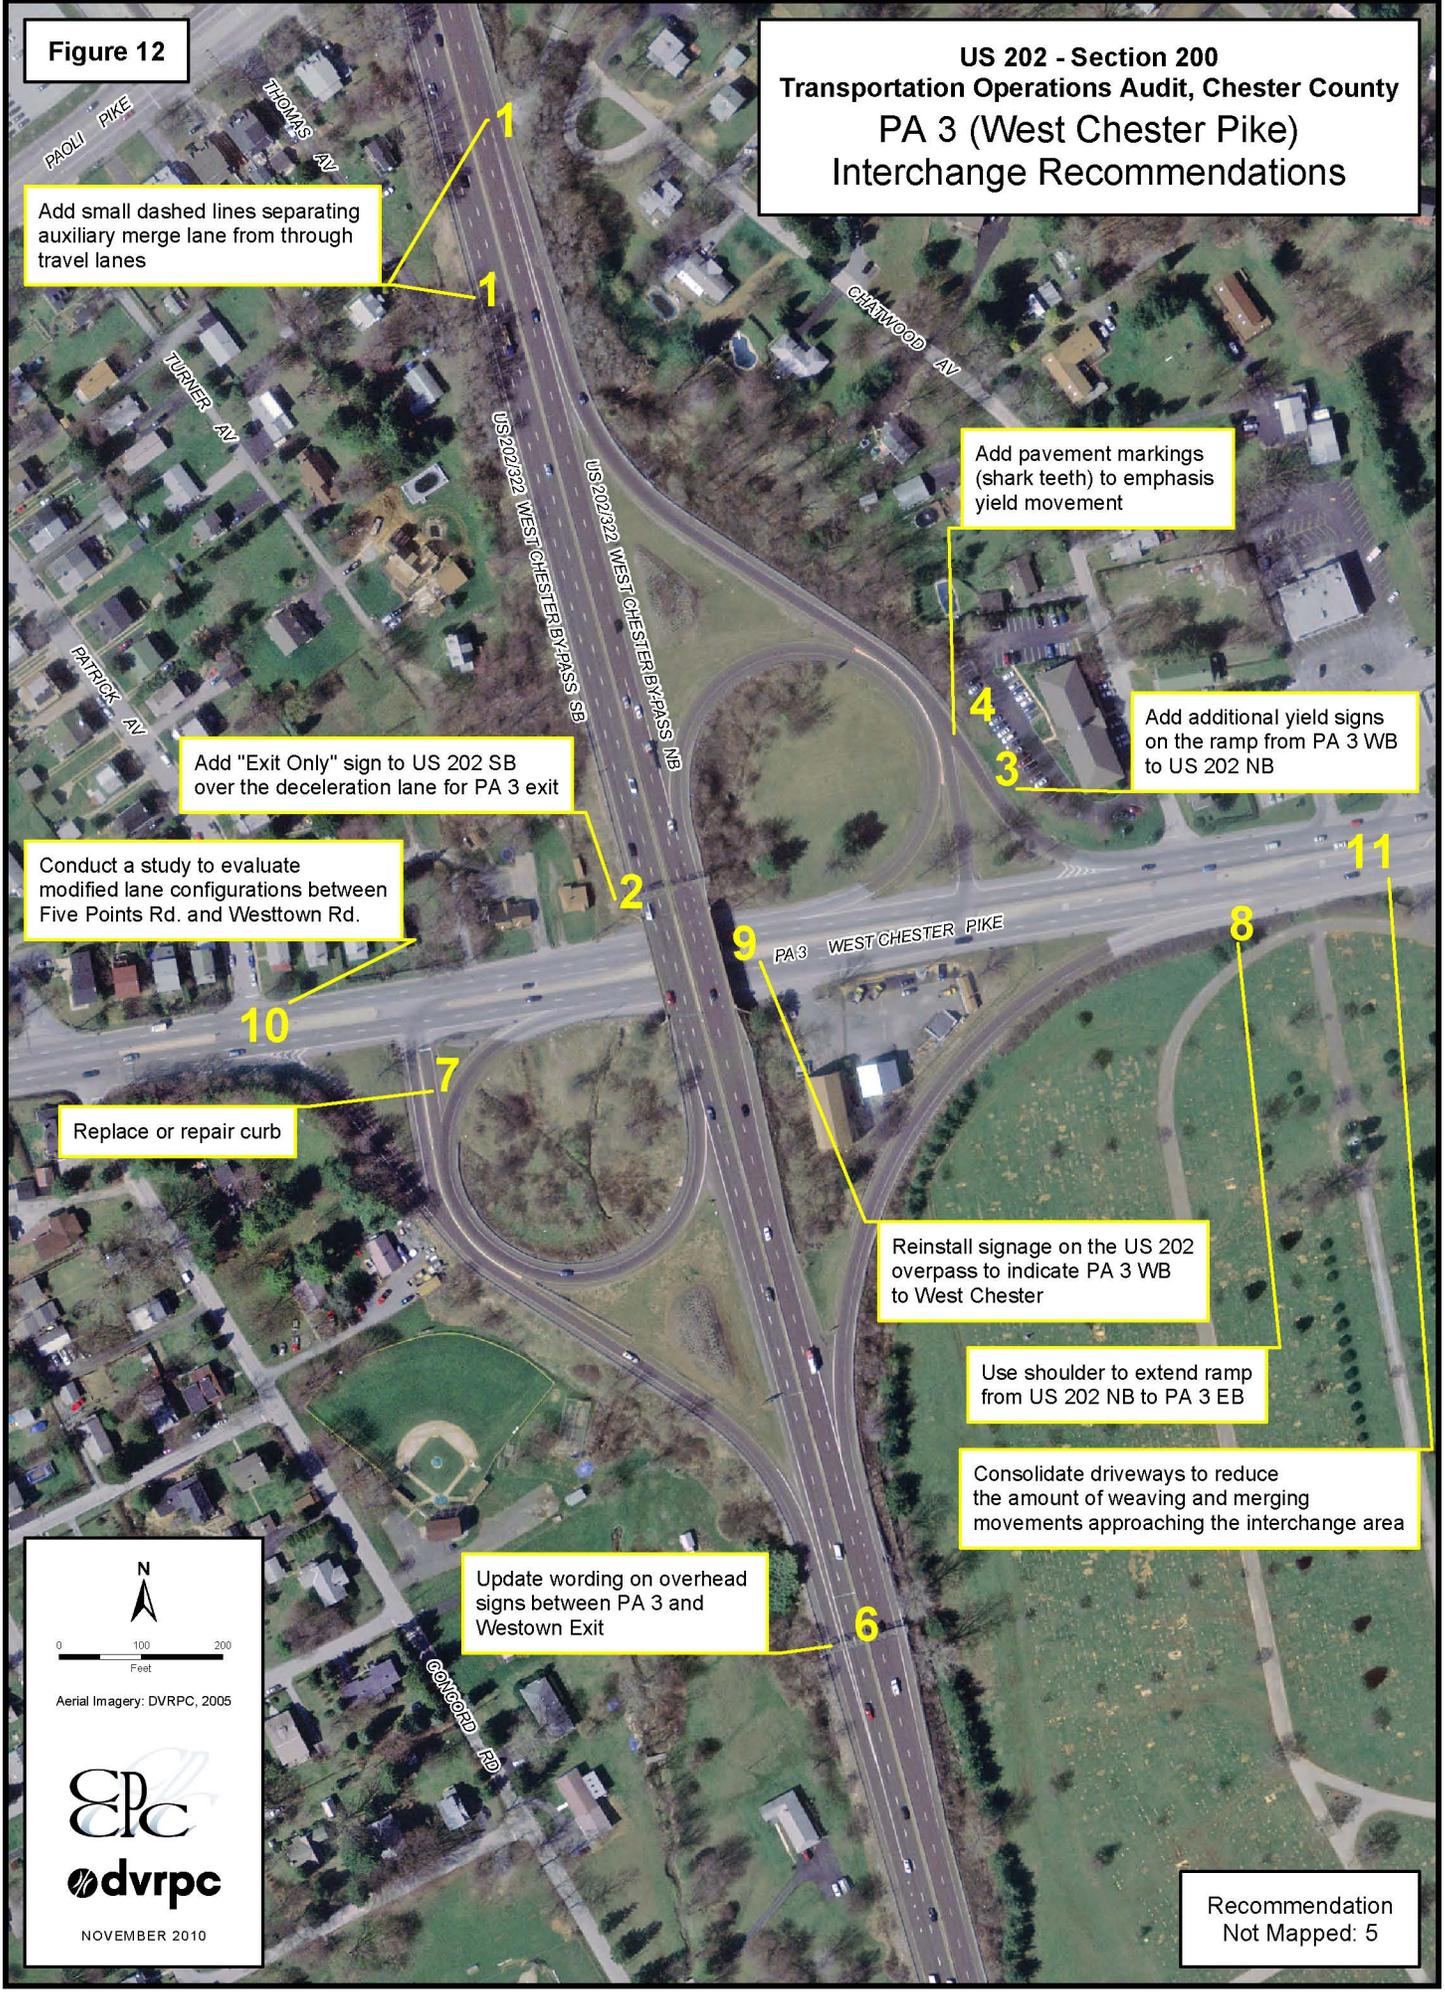
US 202 - Section 200
Transportation Operations Audit, Chester County
PA 3 (West Chester Pike)
Interchange Recommendations

Replace or repair curb

Recommendation
Not Mapped: 5

Table 11: PA 3 (West Chester Pike) Interchange Recommendations

Issues	Recommendations	Time-frame	Priority	Lead Agency
Complex merging area between Paoli Pike and PA 3 on US 202 in both directions. The shared merge lanes are sometimes used as through travel lanes.	1 — Add small dashed lines separating auxiliary merge lane from through travel lanes	Short-term	High	<ul style="list-style-type: none"> Recommended in ARRA project Follow Up Needed
	2 — Add "Exit Only" sign to US 202 Southbound over the deceleration lane for PA 3 exit	Short-term	High	<ul style="list-style-type: none"> Recommended in ARRA project PennDOT made changes to signage design plans, but follow-up with Design Unit is needed to ensure structure designs support additional weight/wind loads
Conflict areas at merge for the ramp from PA 3 to Northbound US 202. Although PA 3 Eastbound movement has more traffic, this movement currently must yield to PA 3 Westbound	3 — Add additional yield signs on the ramp from PA 3 Westbound to US 202 Northbound	Short-term	Medium	<ul style="list-style-type: none"> PennDOT Maintenance ordered additional signage for this location Follow Up Needed

4 — Add pavement markings (shark teeth) to emphasize yield movement	Short-term	Medium	<ul style="list-style-type: none"> PennDOT Maintenance
There are no bicycle or pedestrian facilities	5 — Develop a bicycle and pedestrian improvement plan to identify and develop safe facilities to connect the West Goshen Town Center, West Goshen Shopping Center, and West Chester	Mid-term	Medium	<ul style="list-style-type: none"> PennDOT Municipalities
Overhead signs between Westtown Road and PA 3 exits are faded and outdated	6 — Replace and update wording on overhead signs between Westtown Road and PA 3 exits	Short-term	High	<ul style="list-style-type: none"> Recommended in ARRA project
The mountable curb on US 202 Southbound on/off-ramp is deteriorated	7 — Replace or repair curb	Short-term	High	<ul style="list-style-type: none"> Recommended in ARRA project
Short merge lane from US 202 Northbound off-ramp to PA 3	8 — Use shoulder to extend ramp from US 202 Northbound to PA 3 Eastbound	Mid-term	Low	<ul style="list-style-type: none"> PennDOT

Issues	Recommendations	Time-frame	Priority	Lead Agency
No directional signs to West Chester currently exist on the overpass	9 — Reinstall signage on the US 202 overpass to indicate PA 3 Westbound to West Chester	Mid-term	Low	■ PennDOT Maintenance
Vehicular movements generated by businesses along PA 3 Westbound create conflict points in the interchange area. The median along PA 3 restricts many left turns onto PA 3 Eastbound and drivers often use the intersection at the interchange to make a U-turn.	10 — Conduct a study to evaluate modified lane configurations, including a potential road diet between Five Points Road and Westtown Road to reduce conflict points, calm traffic, and accommodate bicyclists and pedestrians	Mid-term	Medium	■ PennDOT ■ West Goshen Township ■ CCPC
	11 — Consolidate driveways to reduce the amount of weaving and merging movements approaching the interchange area	Long-term	Low	■ West Goshen Township ■ Local businesses
