US 202

SECTION: 200

TRANSPORTATION OPERATIONS AUDIT CHESTER COUNTY

DELAWARE VALLEY
dvrpc
REGIONAL
PLANNING COMMISSION

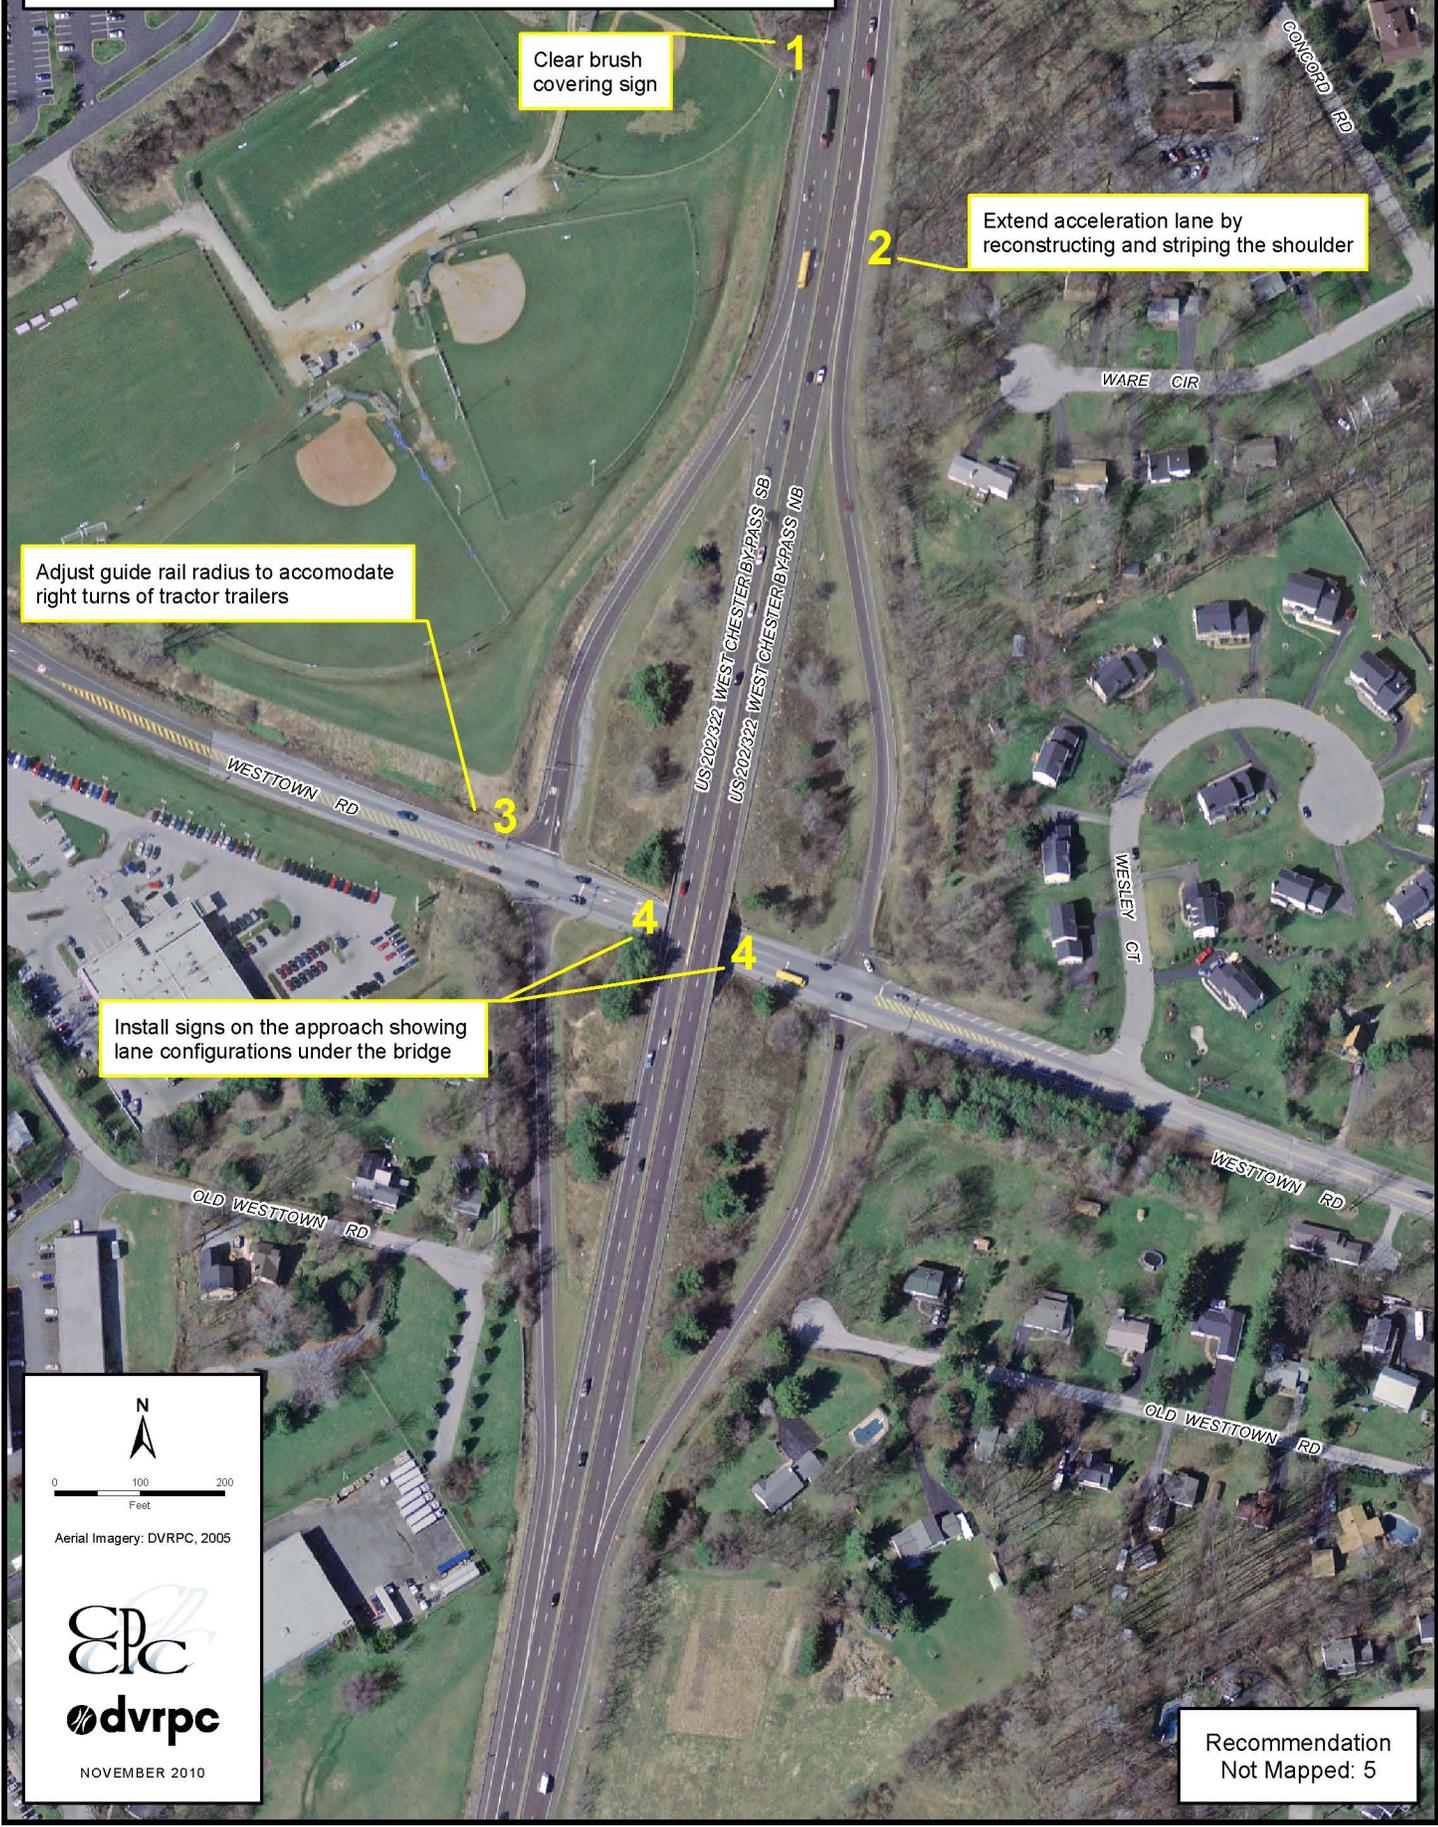
Figure 13

US 202 - Section 200 Transportation Operations Audit, Chester County Westtown Road Interchange Recommendations

Adjust guide rail radius to accommodate right turns of tractor trailers

Clear brush covering sign

Recommendation Not Mapped: 5

Issues	Recommendations	Time-frame	Priority	Lead Agency
US 202 Southbound to Westtown Road exit sign covered by brush	1 — Clear brush covering the sign	Short-term	High	■ PennDOT Maintenance
Short acceleration lane from Westtown Road to US 202 Northbound	2 — Extend acceleration lane by reconstructing and striping the shoulder	Completed	Fall 2010	■ Recommended in ARRA project
At the bottom of the US 202 Southbound off-ramp, guide rail is frequently damaged by truck traffic making right turns	3 — Adjust guide rail radius for right turns of tractor trailers	Completed	Fall 2010	■ Recommended in ARRA project
The Westtown Road left turn lanes to US 202 are difficult to see	4 — Install a signs on the approach to the intersection that shows the lane configuration under the bridge	Mid-term	Low	■ PennDOT Maintenance
Proposed Wyeth development may increase traffic using this interchange	5 — Institute multi-municipal coordination of plan review and mitigation of impacts through the development process	Short-term	High	■ PennDOT ■ Municipalities

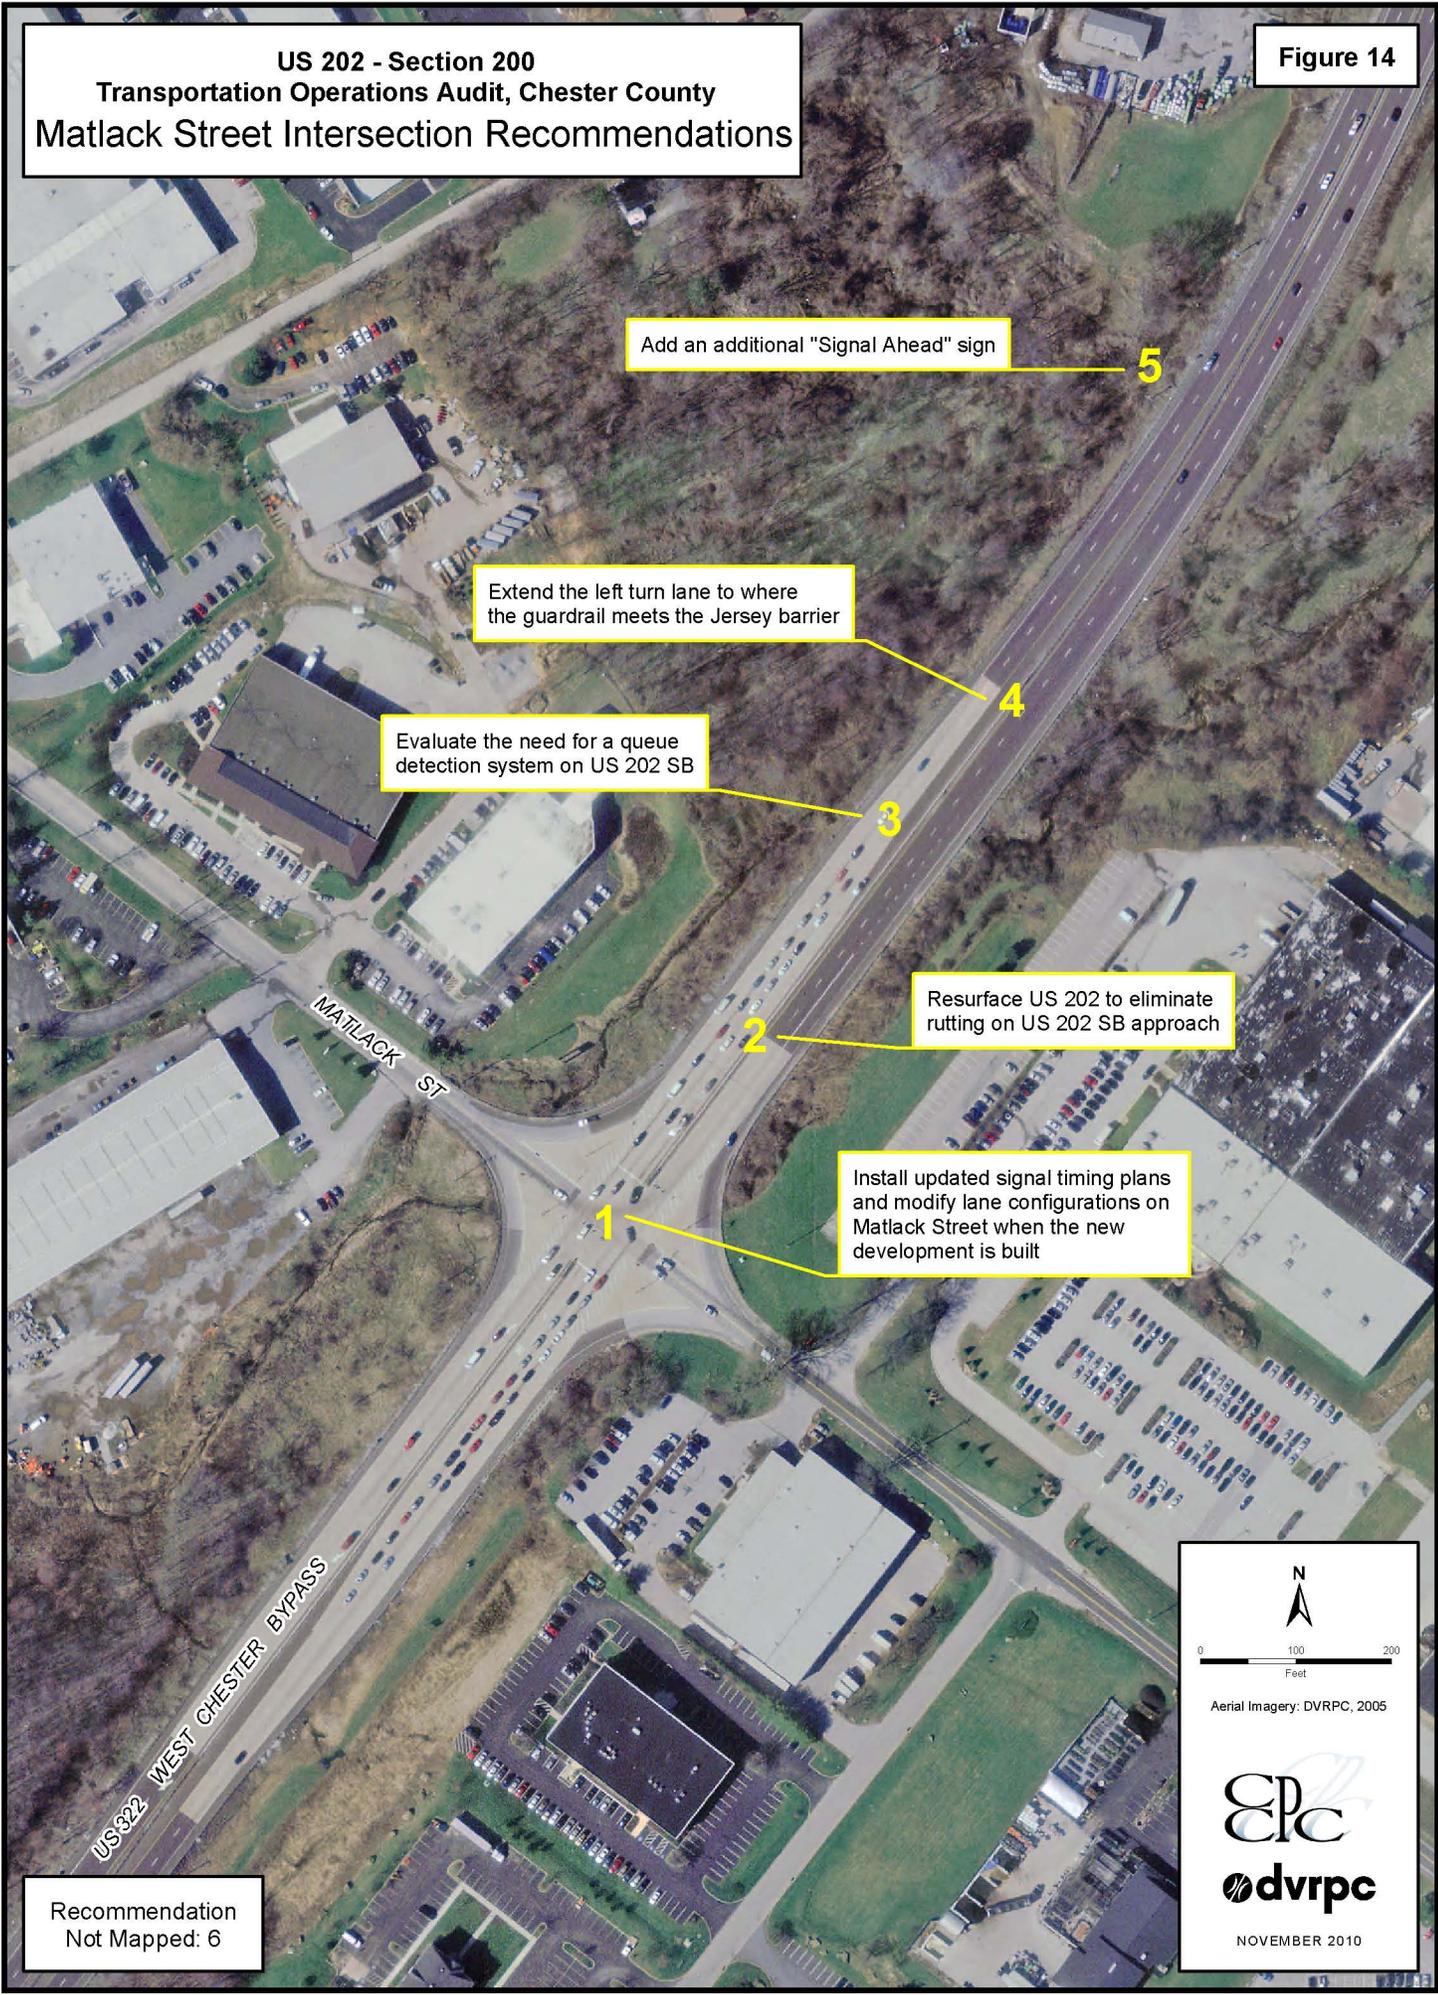
US 202 - Section 200
Transportation Operations Audit, Chester County
Matlack Street Intersection Recommendations

Add an additional "Signal Ahead" sign **5**

Extend the left turn lane to where the guardrail meets the Jersey barrier **4**

Recommendation
Not Mapped: 6

Figure 14 displays the location of several recommendations from Table 13 on an aerial map.

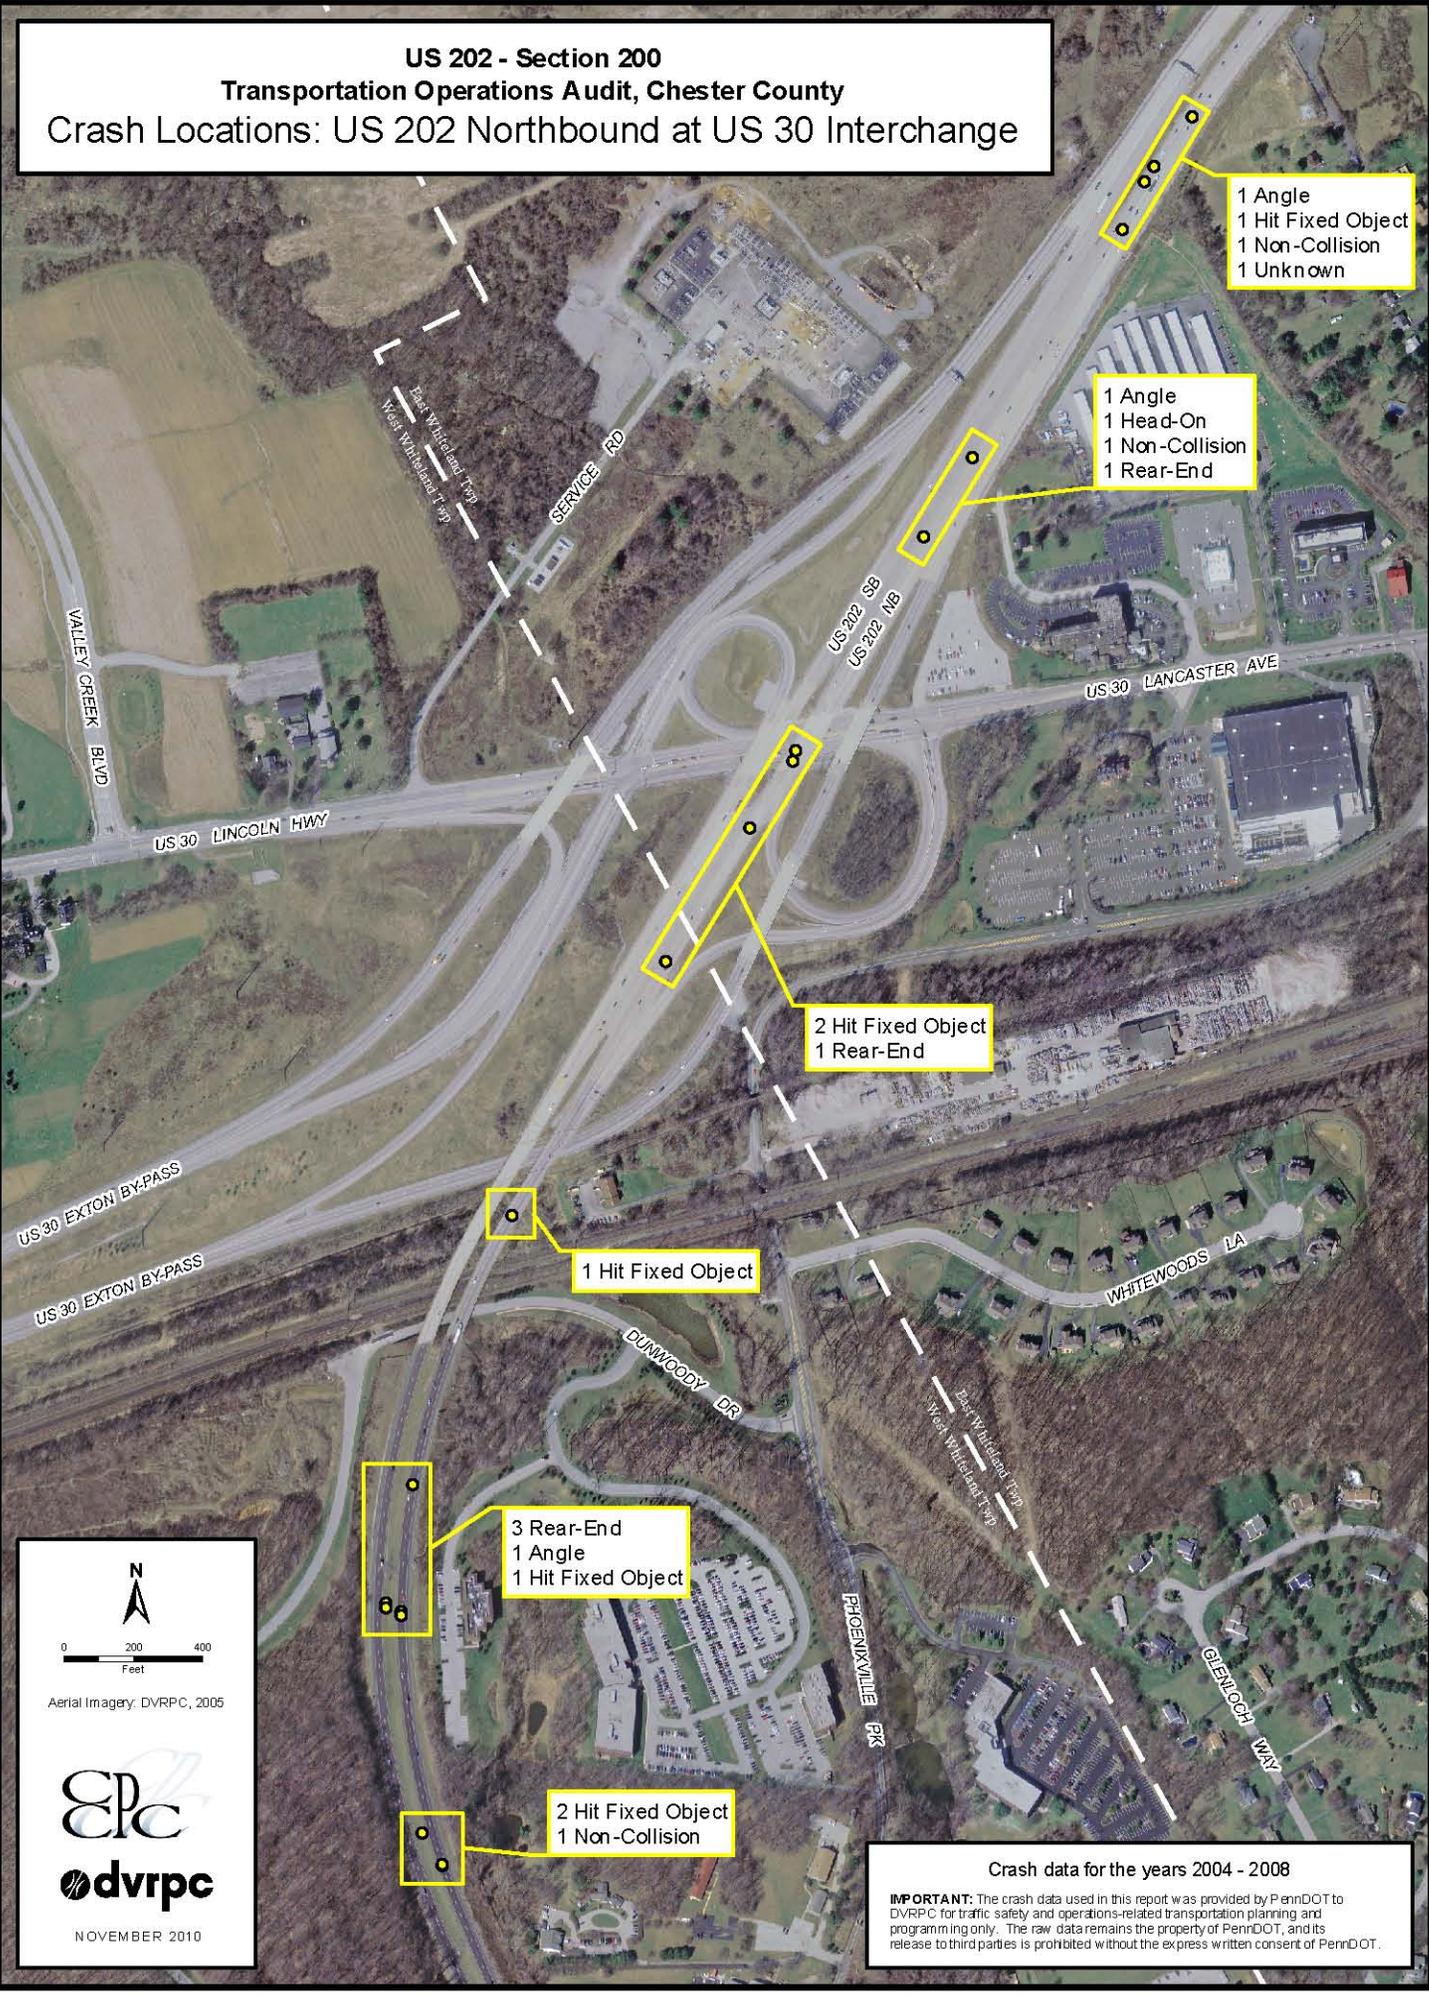
US 202 - Section 200
Transportation Operations Audit, Chester County
Crash Locations: US 202 Northbound at US 30 Interchange

1 Angle
 1 Hit Fixed Object
 1 Non-Collision
 1 Unknown

1 Angle
 1 Head-On
 1 Non-Collision
 1 Rear-End

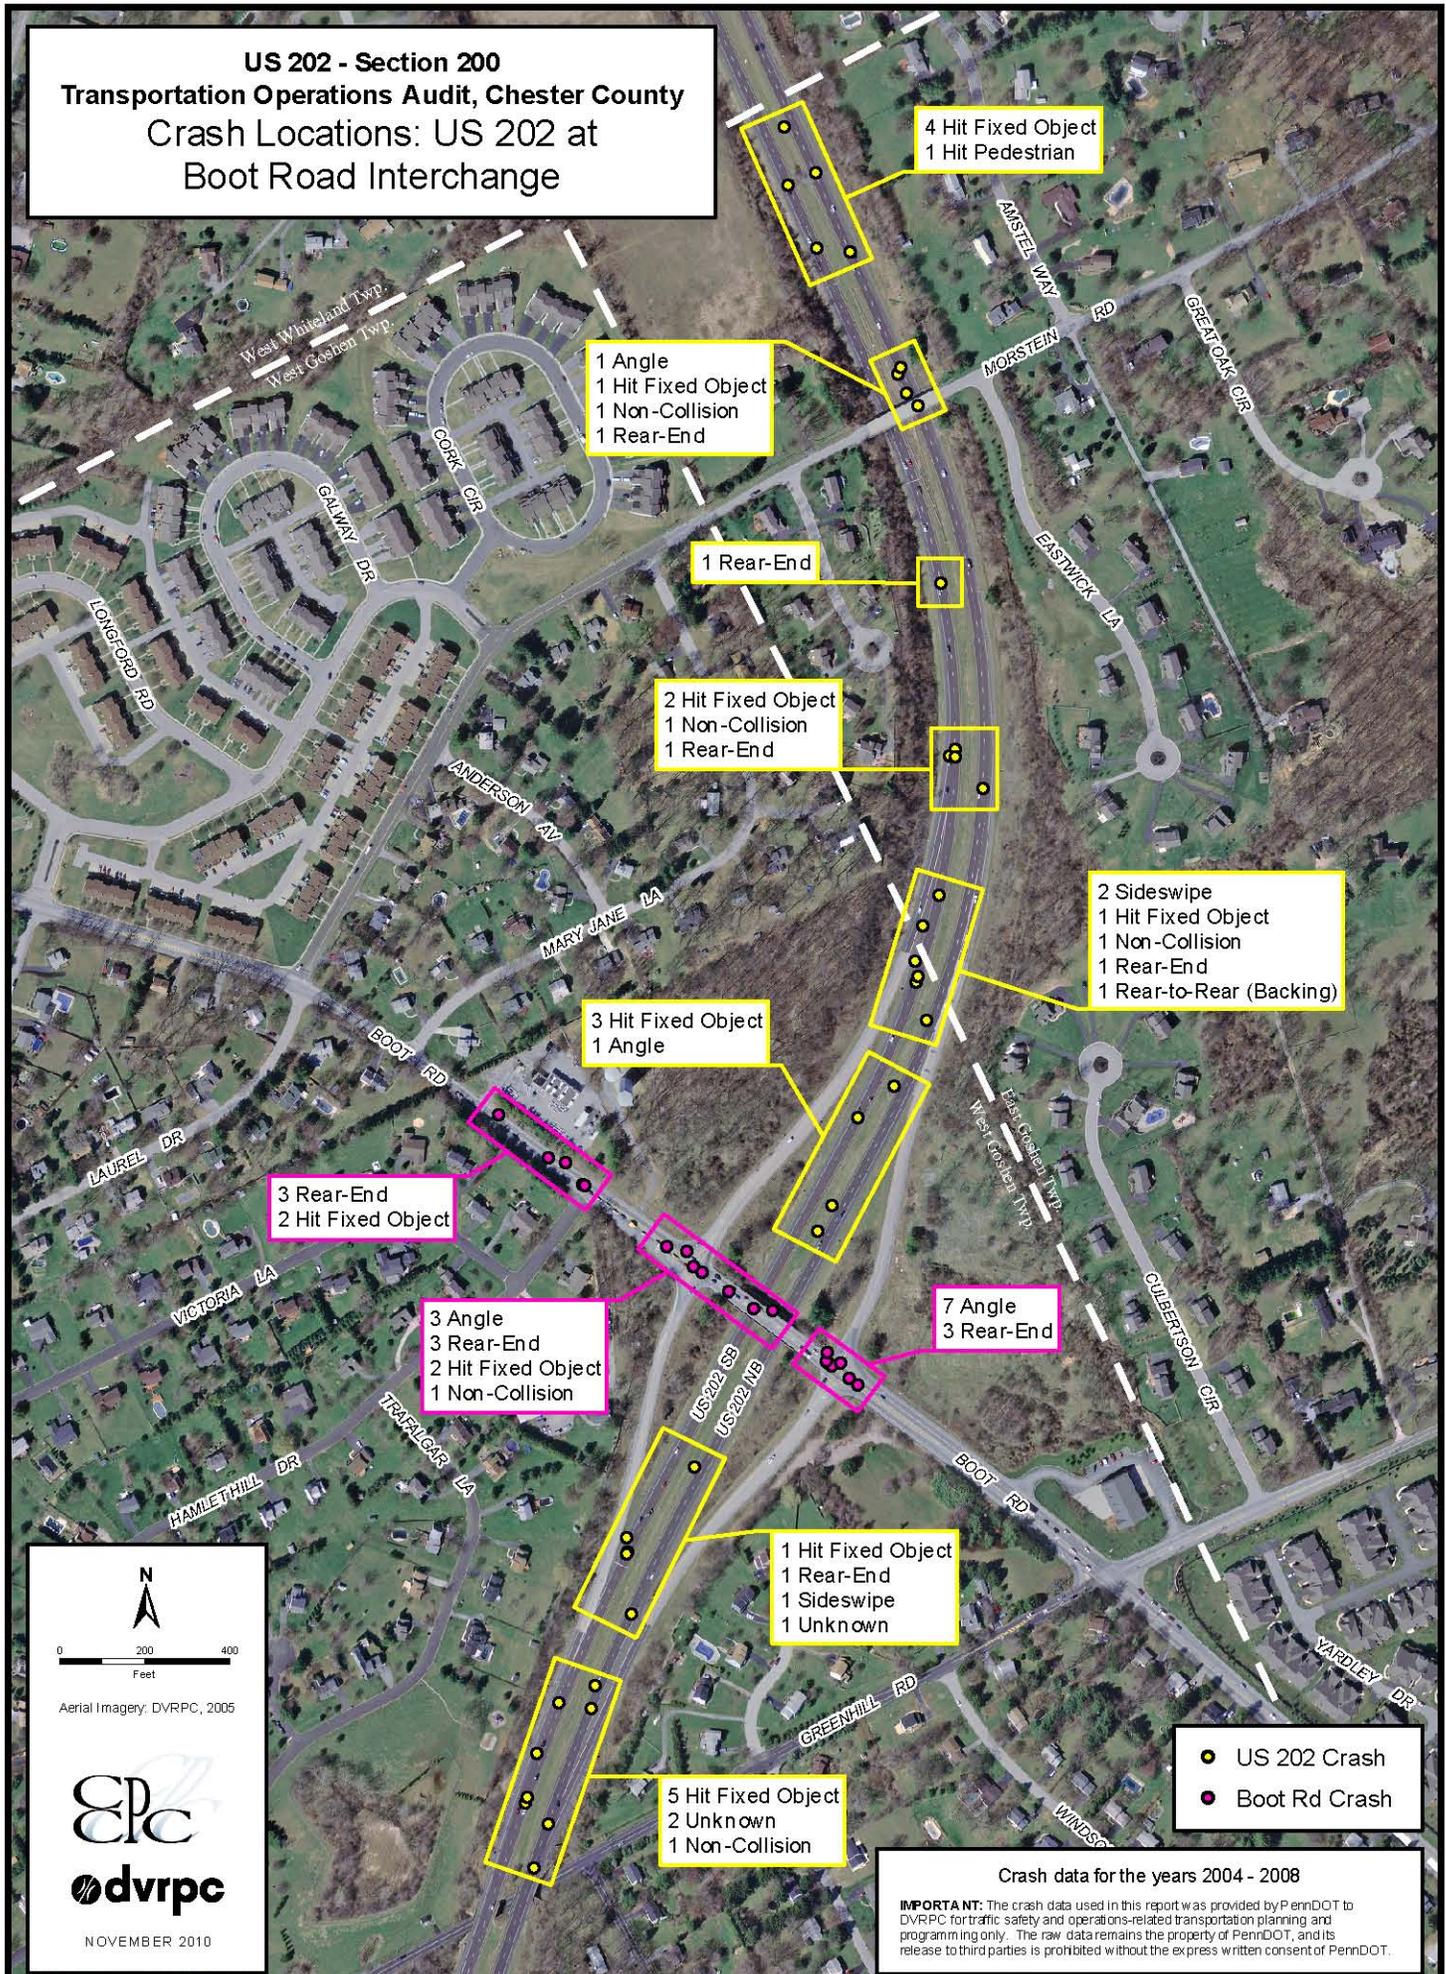
US 202 - Section 200
Transportation Operations Audit, Chester County
Crash Locations: US 202 at
Boot Road Interchange

4 Hit Fixed Object
1 Hit Pedestrian

1 Angle
1 Hit Fixed Object
1 Non-Collision
1 Rear-End

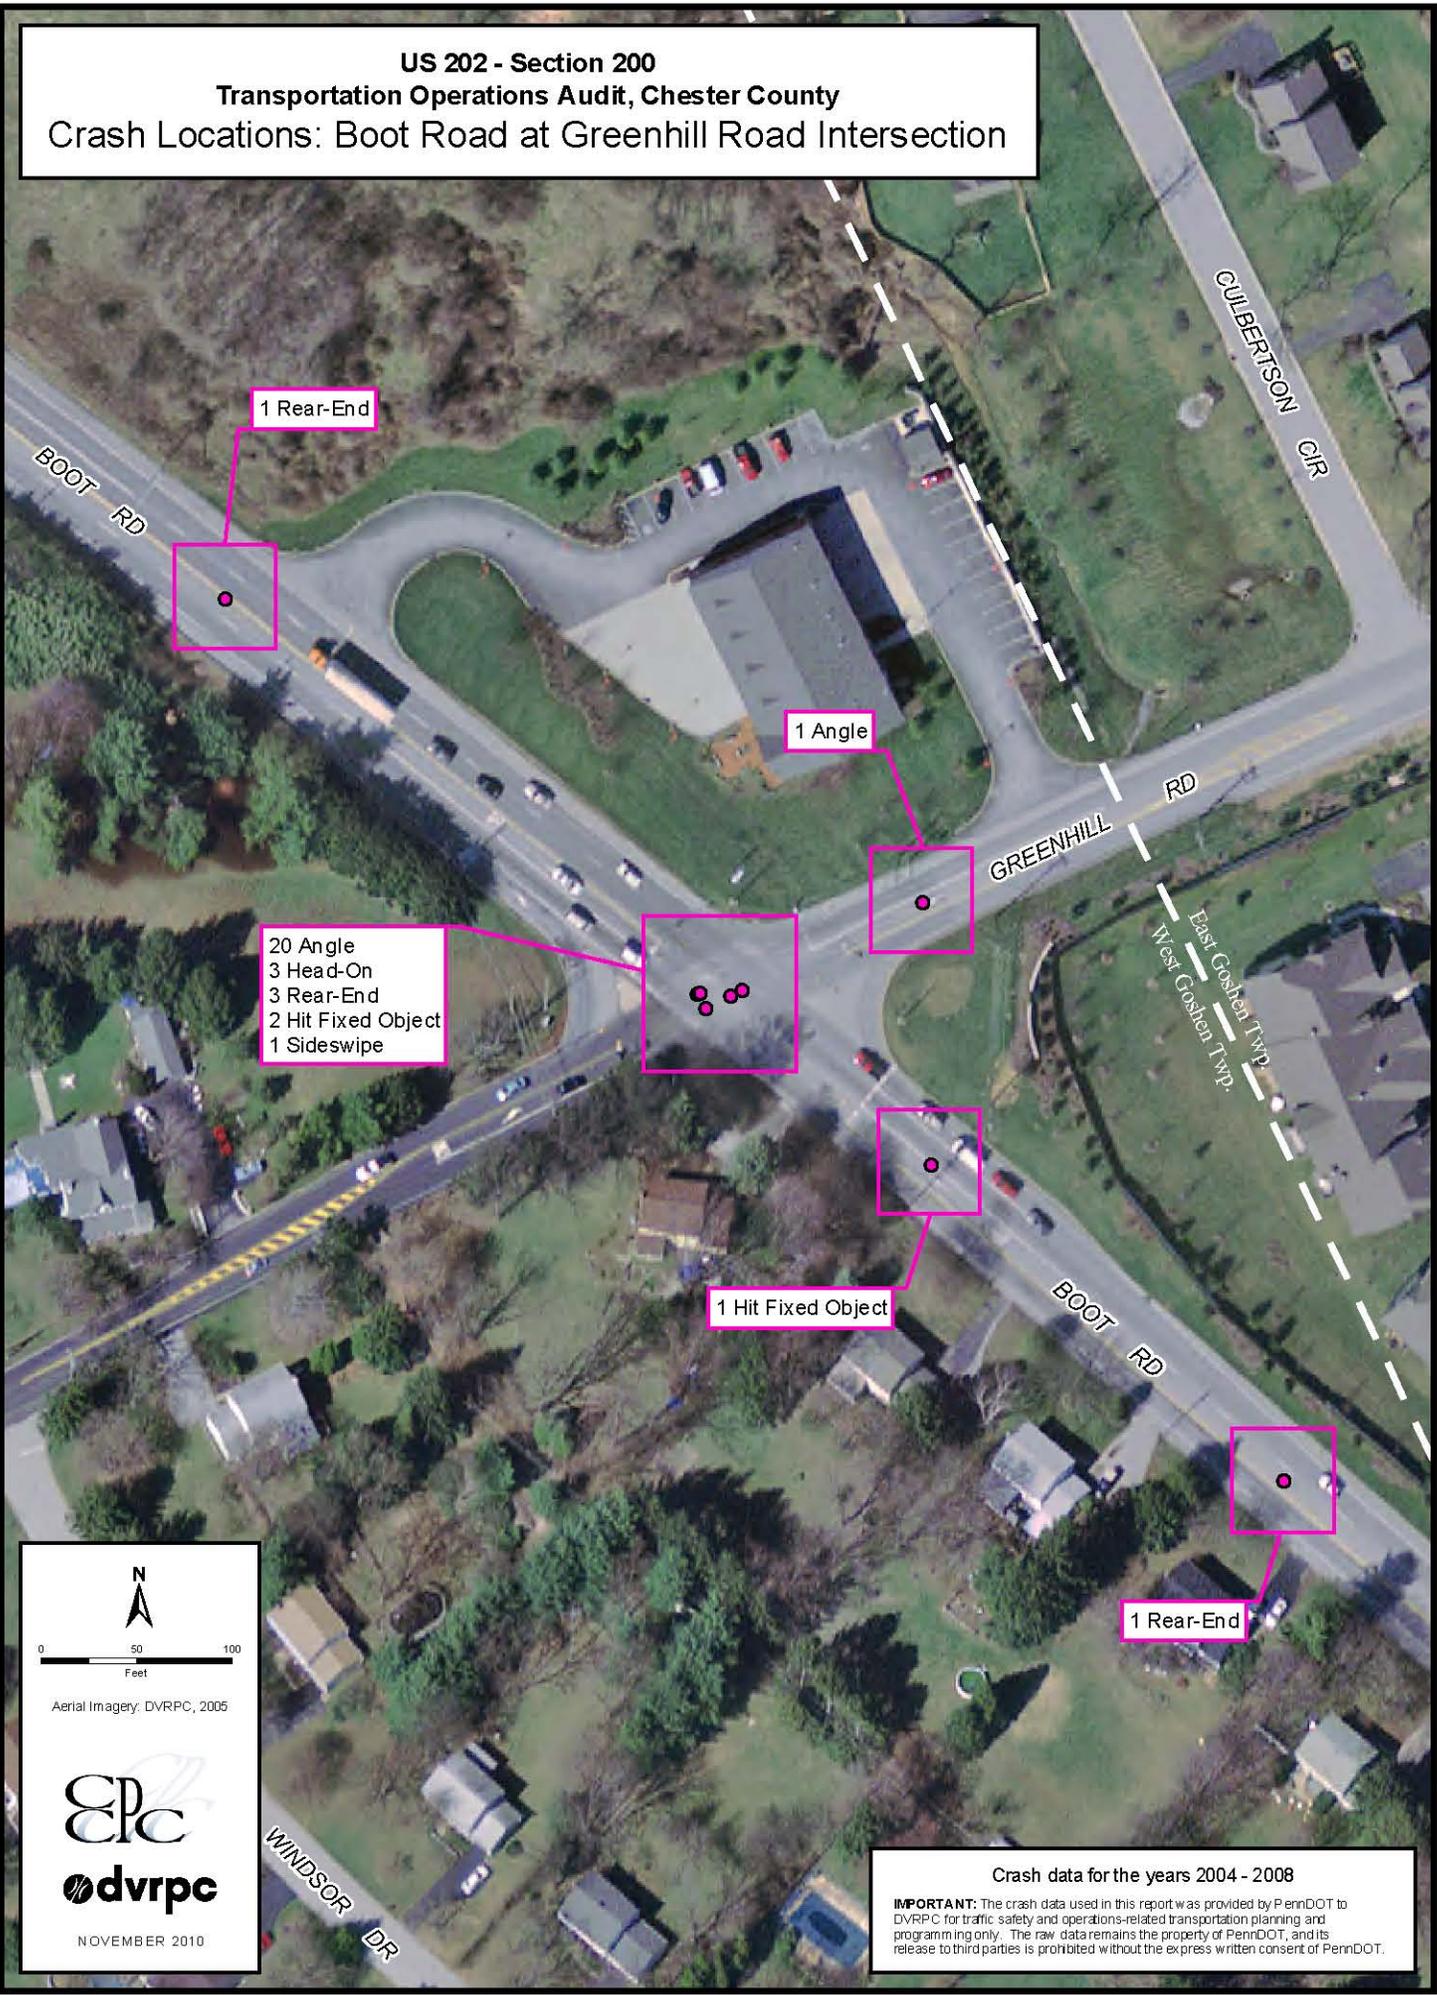
US 202 - Section 200
Transportation Operations Audit, Chester County
Crash Locations: Boot Road at Greenhill Road Intersection

1 Rear-End

1 Angle

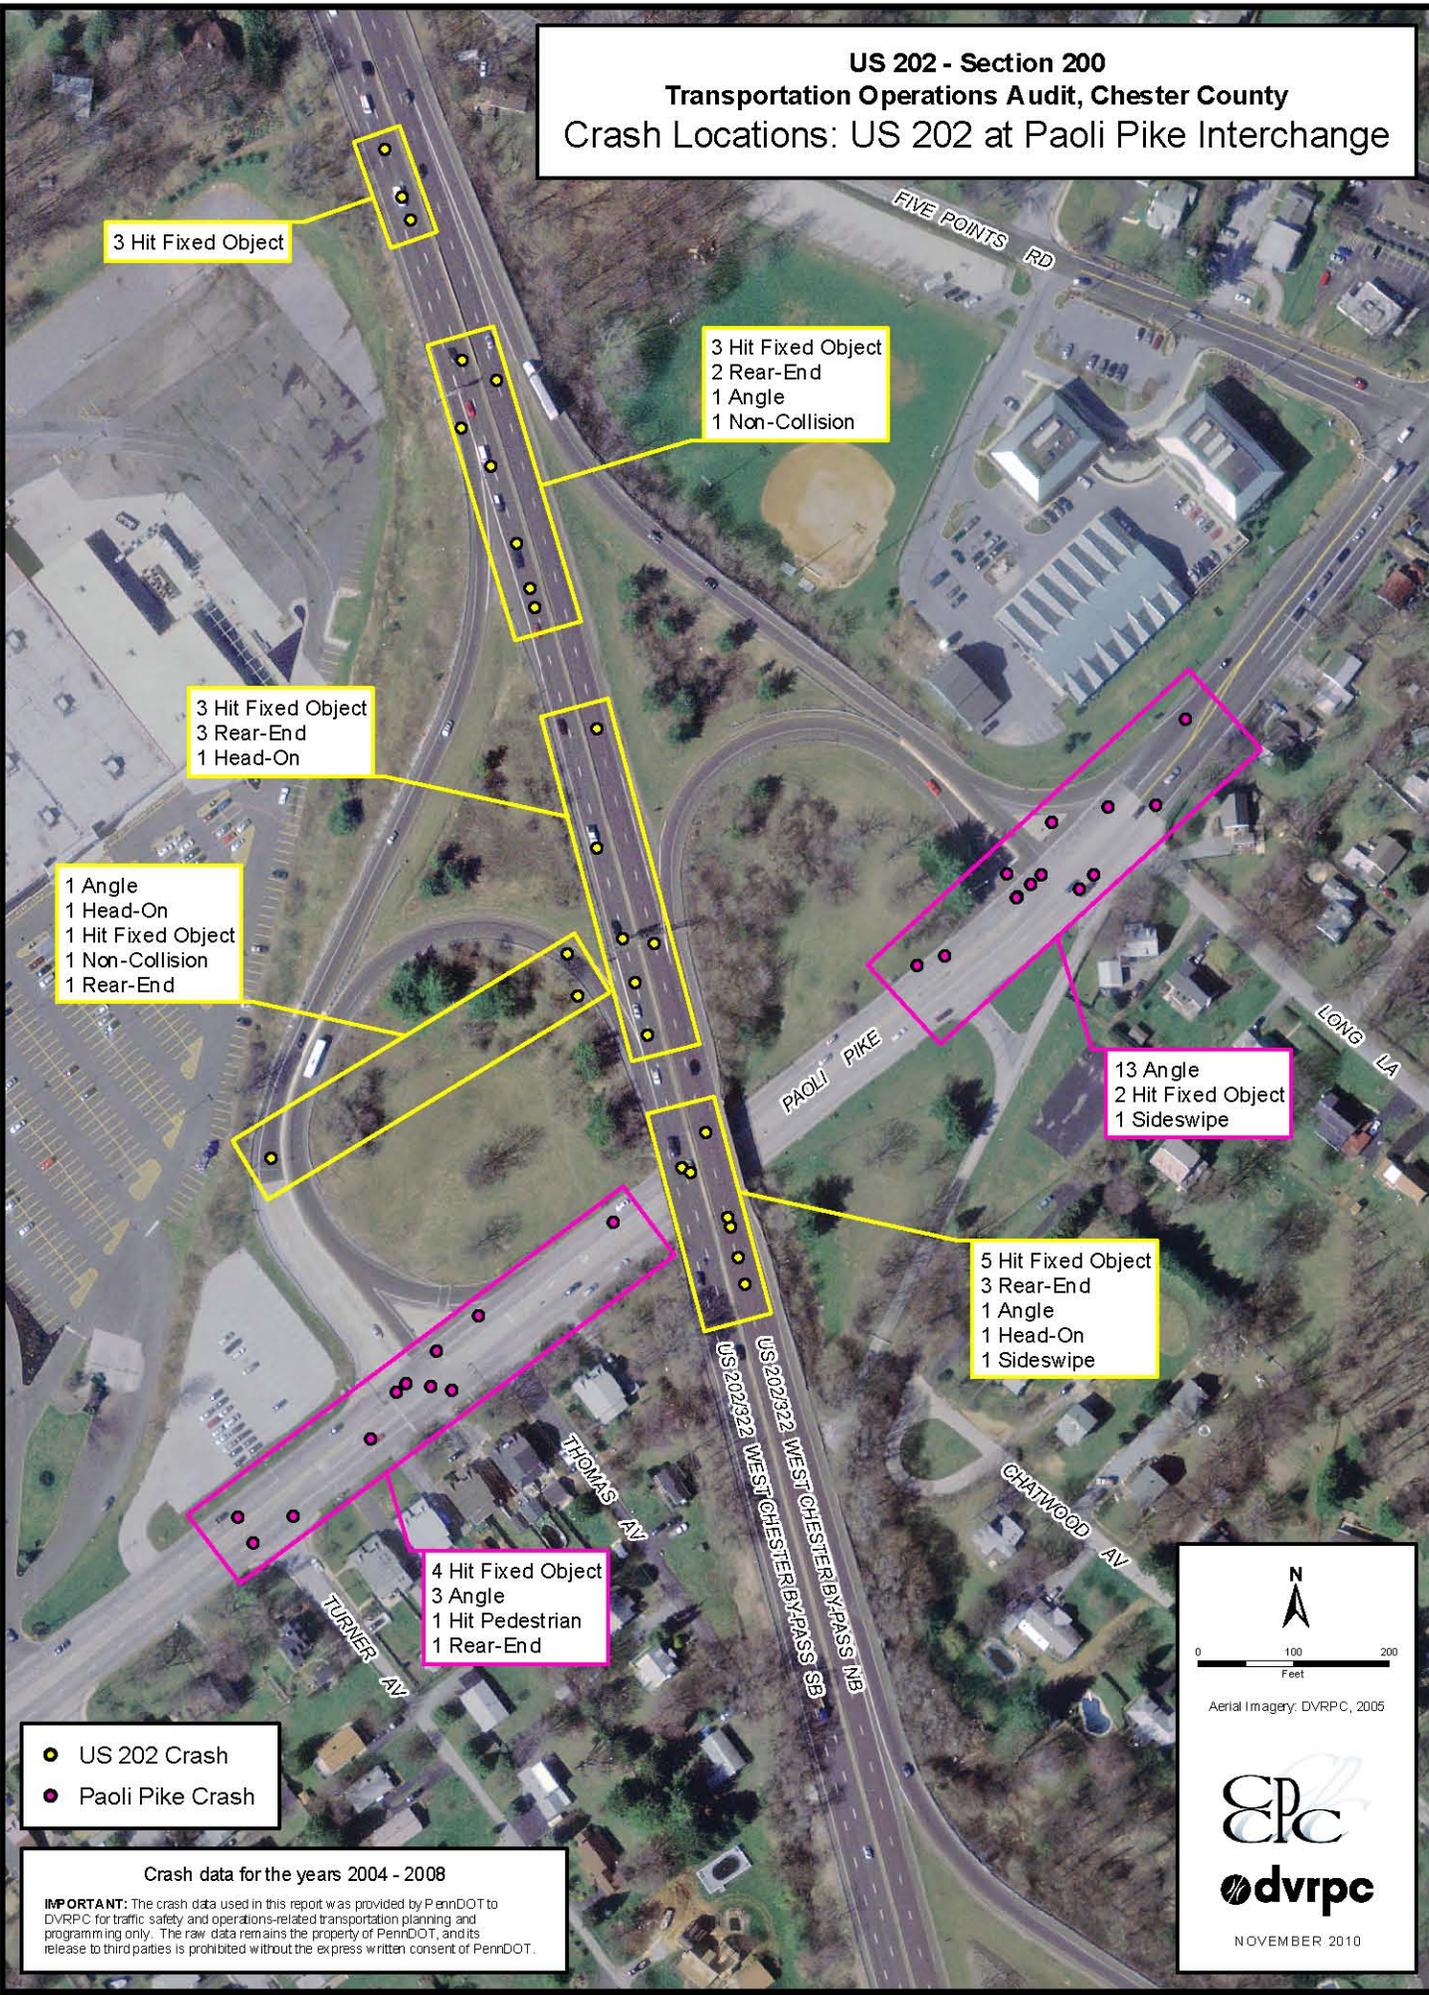
US 202 - Section 200
Transportation Operations Audit, Chester County
Crash Locations: US 202 at Paoli Pike Interchange

3 Hit Fixed Object

3 Hit Fixed Object
 2 Rear-End
 1 Angle
 1 Non-Collision

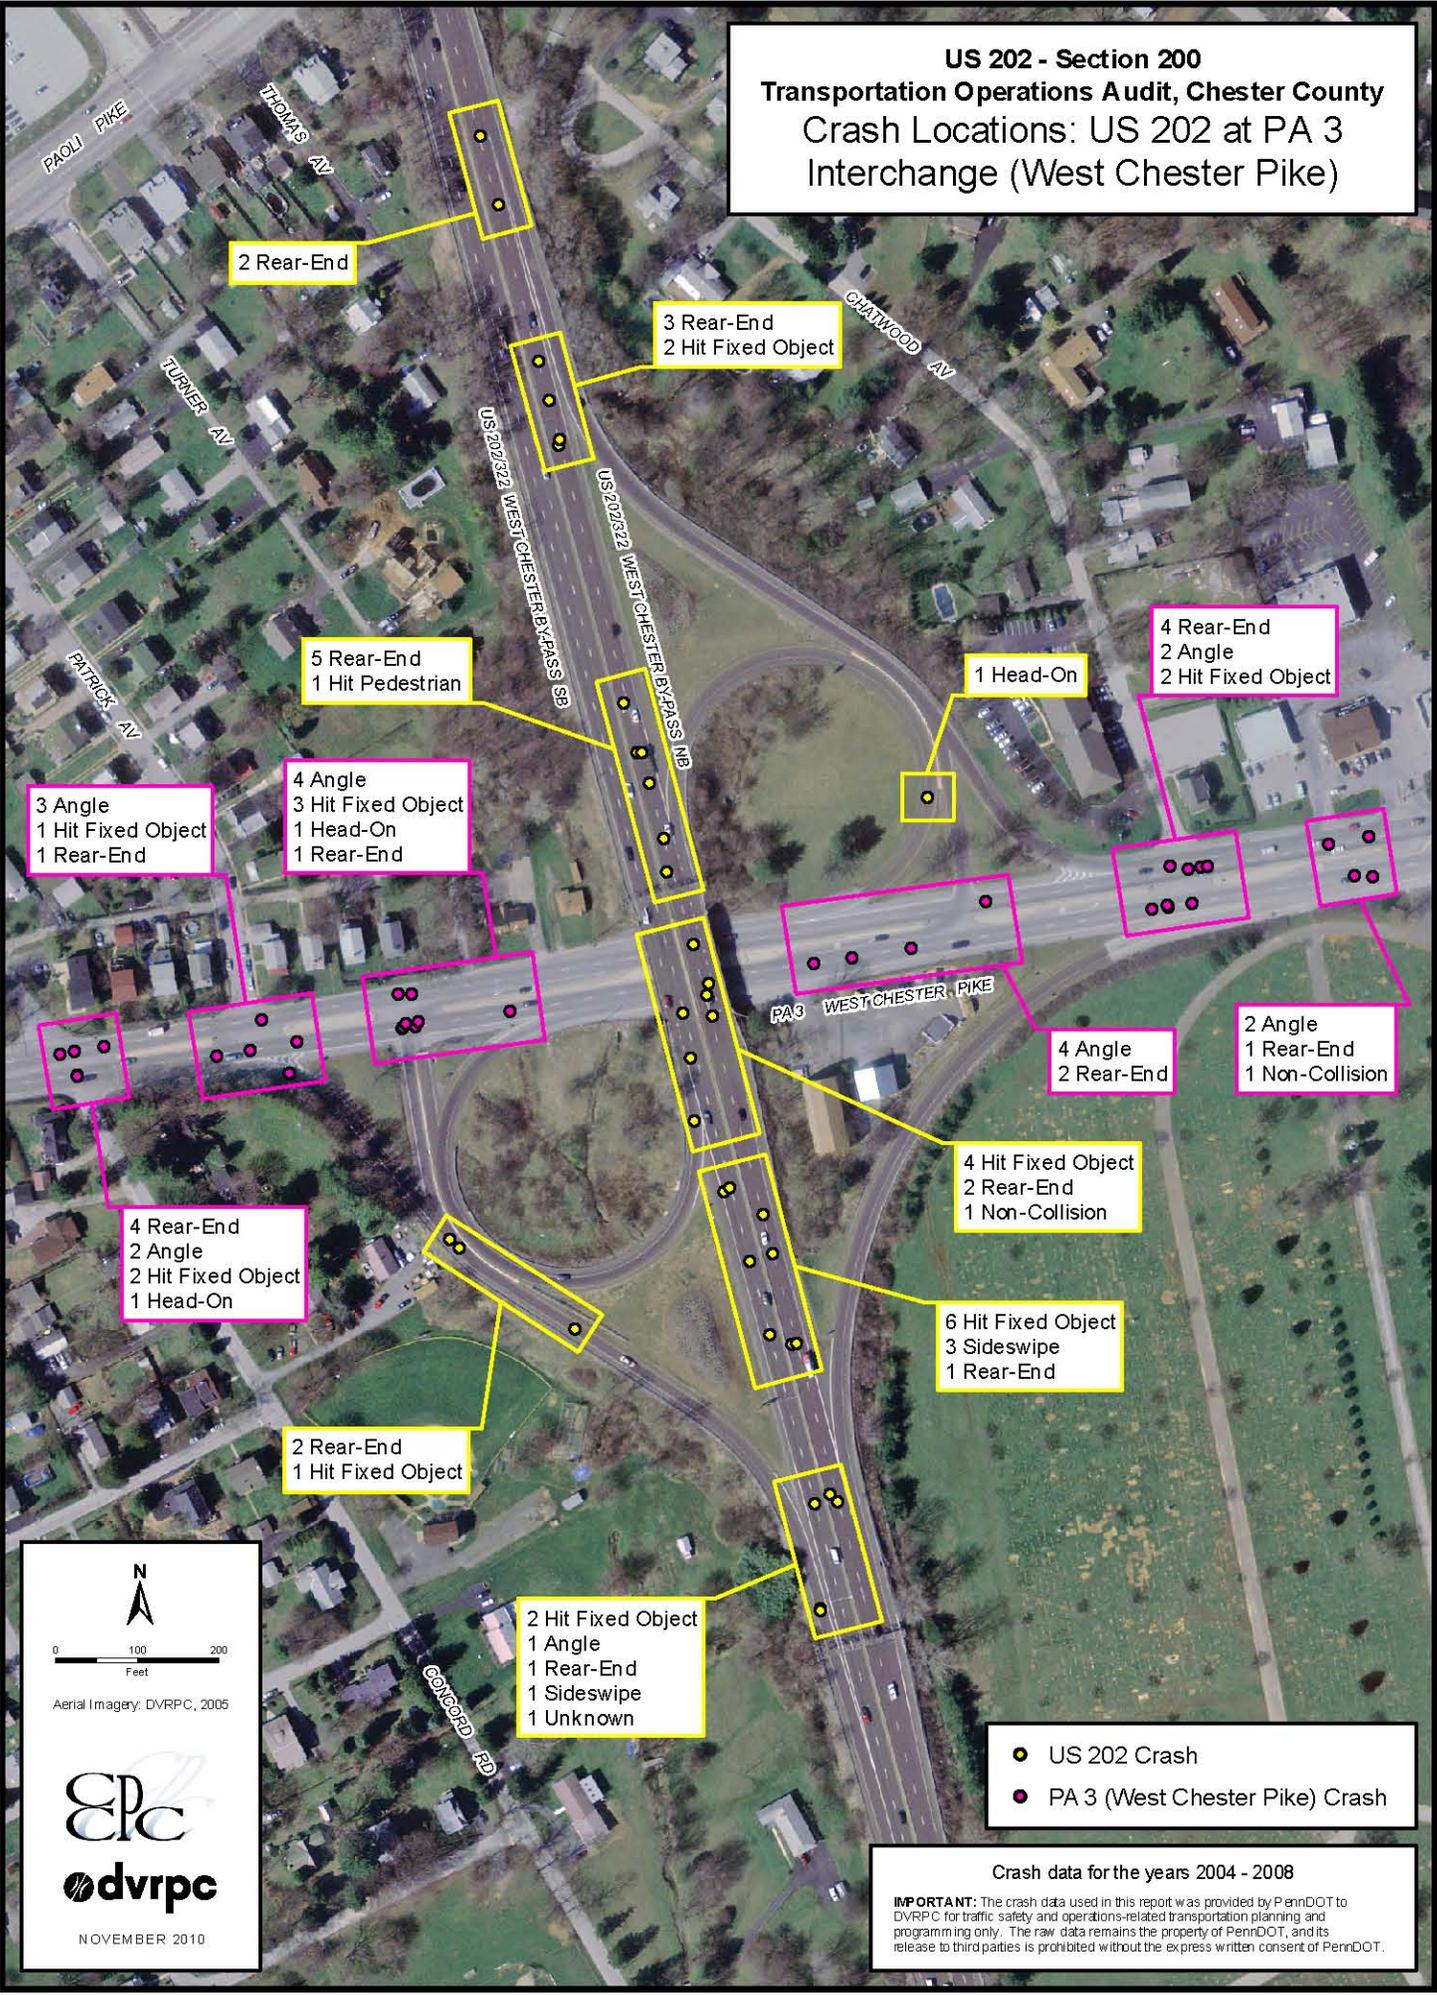
US 202 - Section 200
Transportation Operations Audit, Chester County
Crash Locations: US 202 at PA 3
Interchange (West Chester Pike)

2 Rear-End

3 Rear-End
2 Hit Fixed Object
