DELAWARE VALLEY
dvrpc
REGIONAL
PLANNING COMMISSION

LAWRENCE & WEST WINDSOR TOWNSHIPS, MERCER COUNTY

CONGESTION & CRASH

site
Analysis
Program

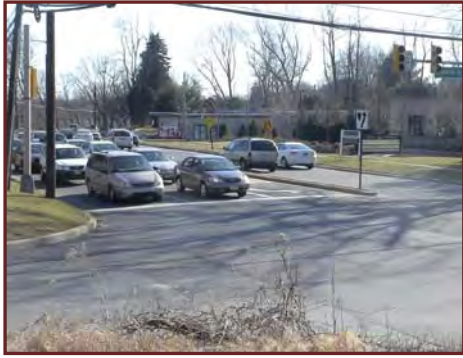
View of northbound approach.
Source: DVRPC, 2012.

Quakerbridge Road is classified as an urban minor arterial. As shown in the photographs of each leg on the next page, the southbound Quakerbridge Road approach contains one dedicated left-turn lane, two through lanes, and one channelized right-turn lane. The southbound approach is on a down slope from the bridge. The northbound approach contains one dedicated left-turn lane, one through lane, and one shared through and right-turn lane. Village Road and Lawrence Square Boulevard are classified as urban collector and urban local roadways, respectively. On Village Road, the roadway widens from one lane to form one dedicated left-turn and one shared through and right-turn lane. The lane configuration on Lawrence Square Boulevard, a private roadway to the Lawrence Square Village housing development, consists of one dedicated left-turn lane and one shared through and right-turn lane. This intersection is signalized.

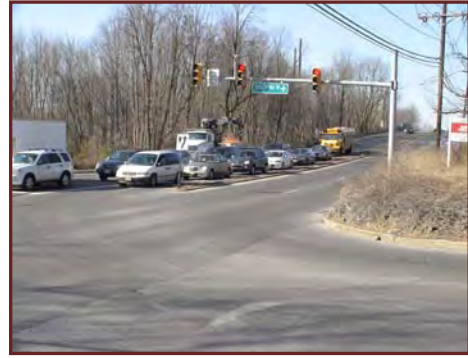
View of southbound approach.
Source: DVRPC, 2012.

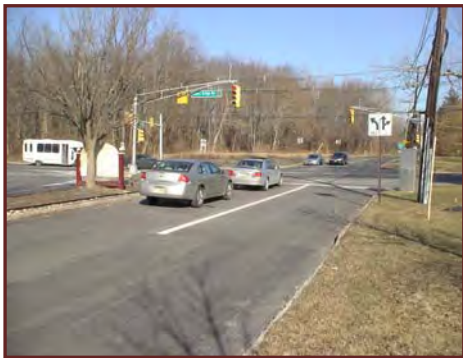
Eastbound view from Lawrence
Square Boulevard.
Source: DVRPC, 2012.

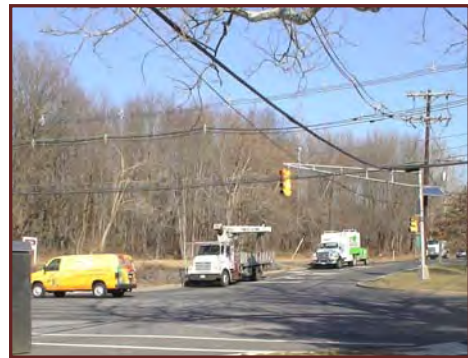
View of Village Road.
Source: DVRPC, 2012.

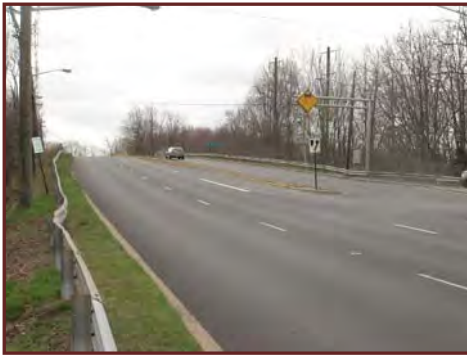
View of northbound approach.
Source: DVRPC, 2012.

Lawrence Station Road is classified as an urban minor arterial. The eastbound approach is stop controlled and forms a T-intersection with Quakerbridge Road. It contains one dedicated left-turn lane and one channelized right-turn lane. The northbound Quakerbridge Road approach has one left-turn lane and two through lanes. The southbound Quakerbridge Road approach contains two through lanes and one channelized right-turn lane.

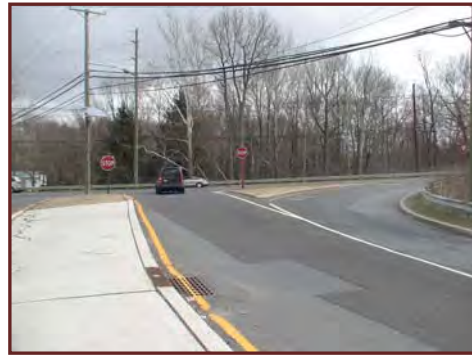
View from Lawrence Station Road.
Source: DVRPC, 2012.

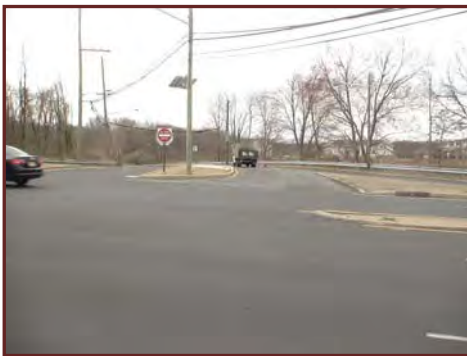
Westbound view of Lawrence Station Road.
Source: DVRPC, 2012.

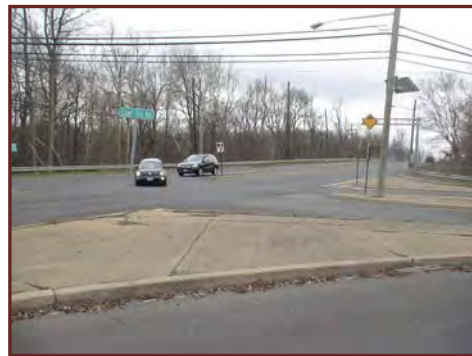
View of northbound vehicle turning left onto Lawrence Station Road.
Source: DVRPC, 2012.

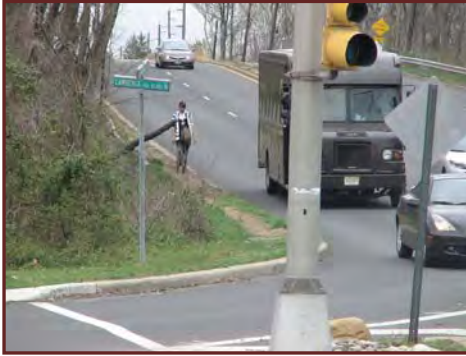
View of pedestrian walking narrow path along westside Quakerbridge Road. Source: DVRPC, 2012.

Pedestrian activity is evident in the study area. During field visits, pedestrians were observed walking the narrow cow path worn in the grass along the west side of Quakerbridge Road. These observations were confirmed by township officials at the kick-off meeting. Residents living in the Lawrence Square Village community often walk along Quakerbridge Road to travel to Quakerbridge Village Commons and other shopping centers, north of Lawrence Station Road.

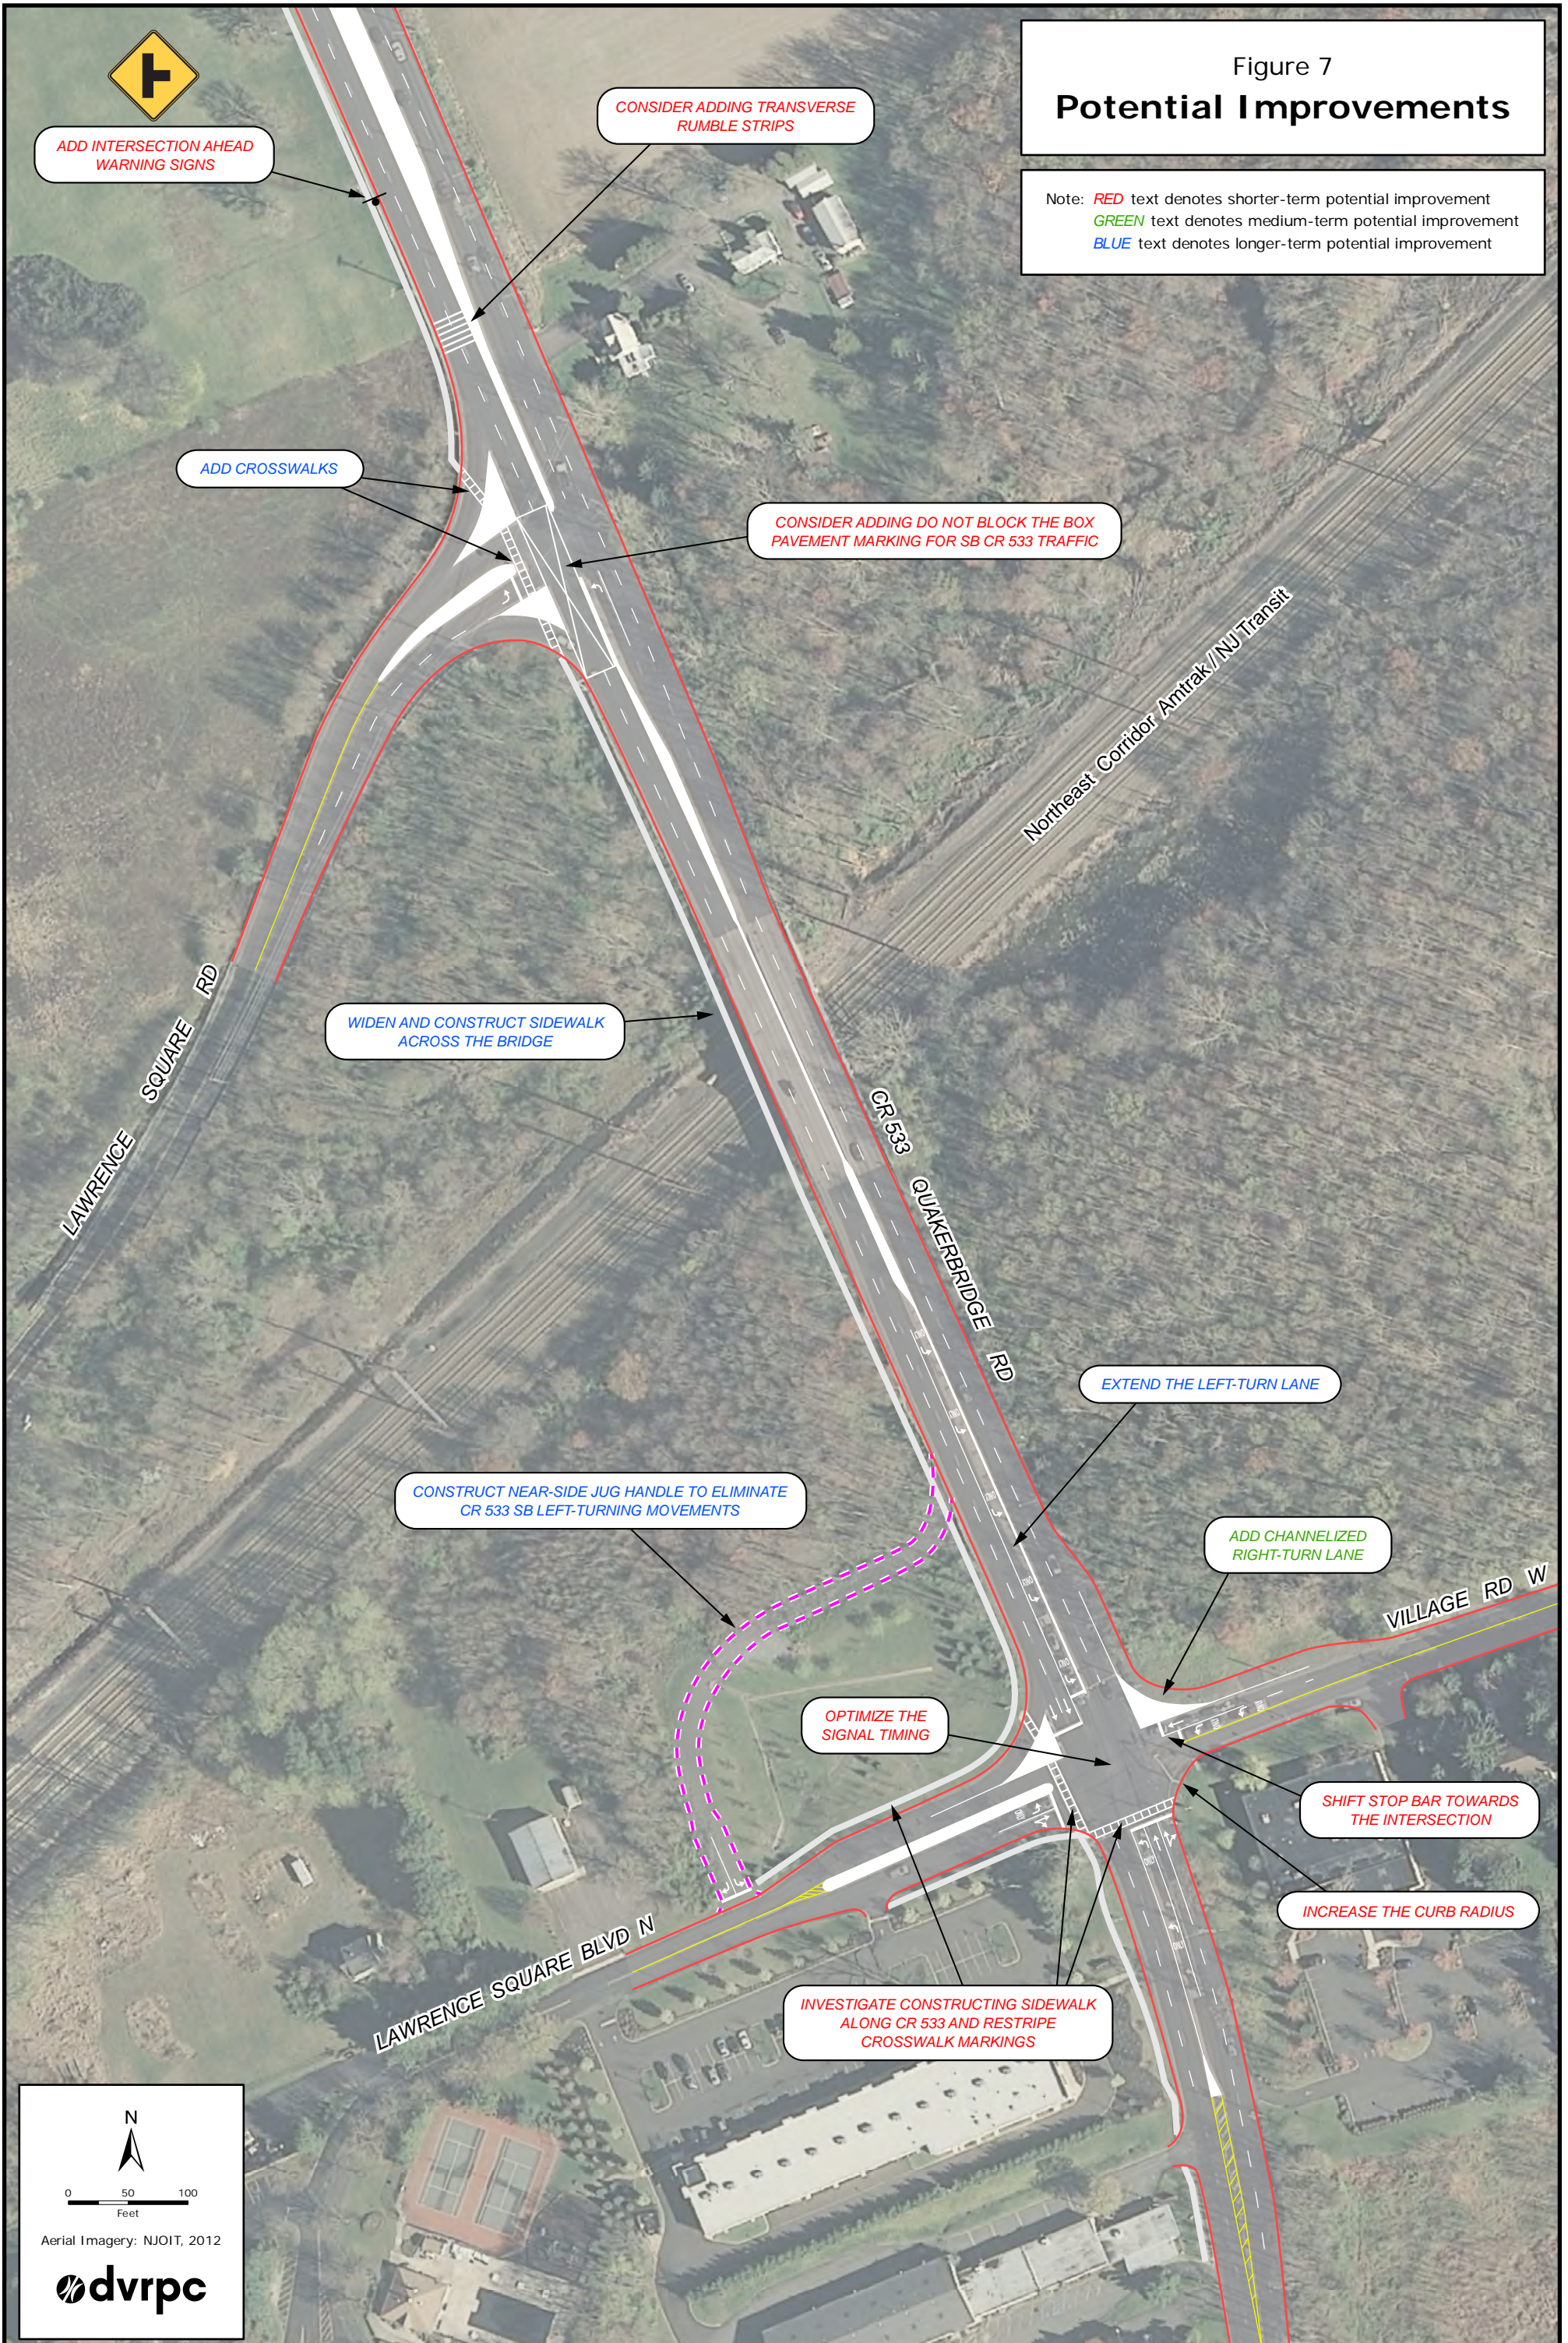
Potential Improvements

Note: **RED** text denotes shorter-term potential improvement
GREEN text denotes medium-term potential improvement
BLUE text denotes longer-term potential improvement

ADD INTERSECTION AHEAD WARNING SIGNS

CONSIDER ADDING TRANSVERSE RUMBLE STRIPS
