DELAWARE VALLEY
dvrpc
REGIONAL
PLANNING COMMISSION

FEBRUARY 2014

CHARLESTOWN TOWNSHIP, CHESTER COUNTY

CONGESTION & CRASH

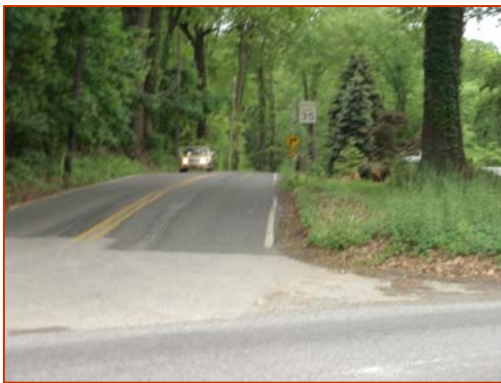
View facing Pikeland Road approach. Source: DVRPC, 2012.

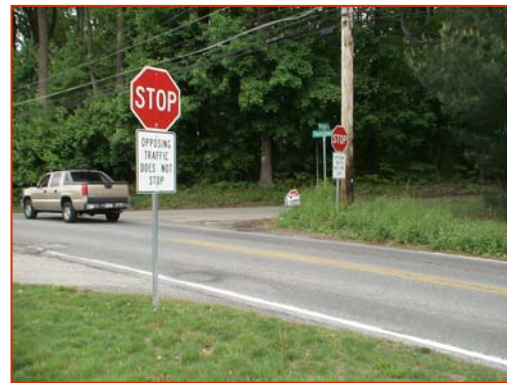
View of Charlestown Road southbound approach. Source: DVRPC, 2012.

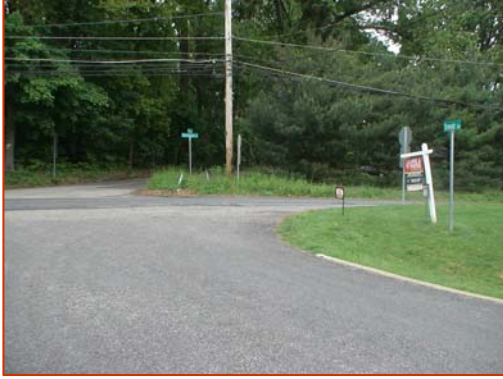
View from Trevor Lane approach. Source: DVRPC, 2012.

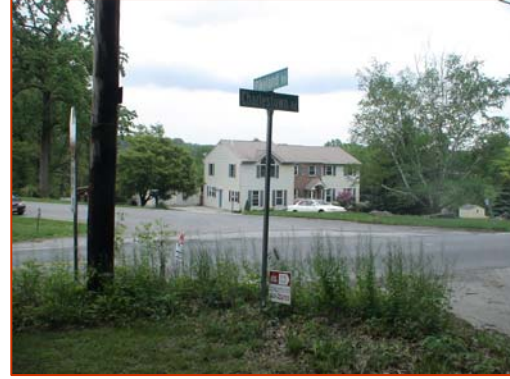
View of intersection from the northwest quadrant. Source: DVRPC, 2012.

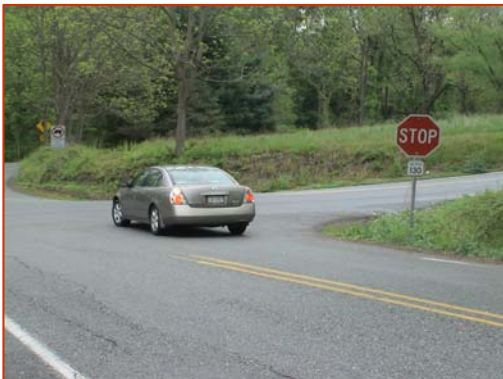
Eastbound view of Hollow Road approach. Source: DVRPC, 2012.

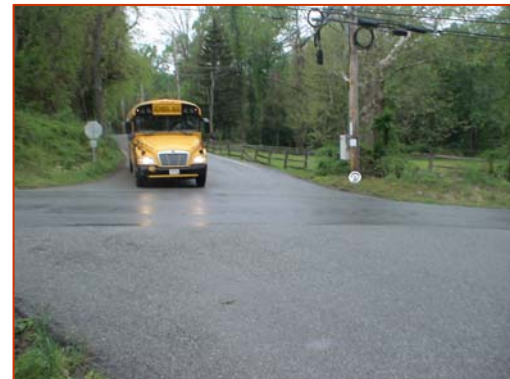
Westbound view of Hollow Road approach. Source: DVRPC, 2012.

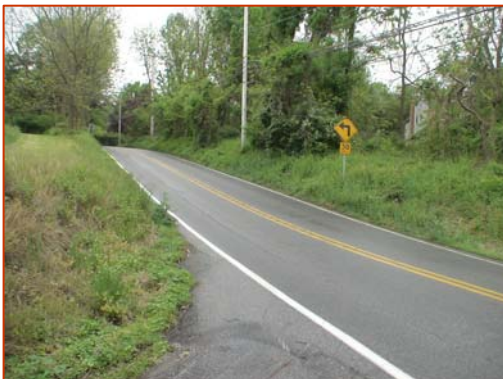
Southbound view of Charlestown Road at Hollow Road. Source: DVRPC, 2012.

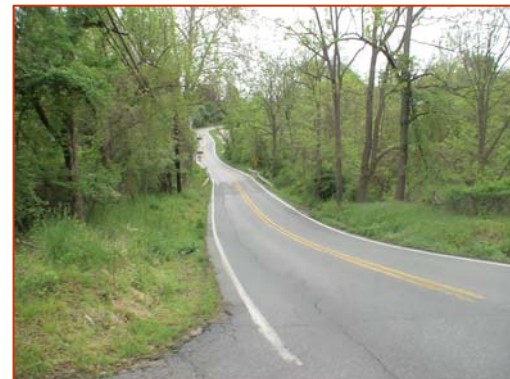
Northbound view of Charlestown Road at Hollow Road. Source: DVRPC, 2012.

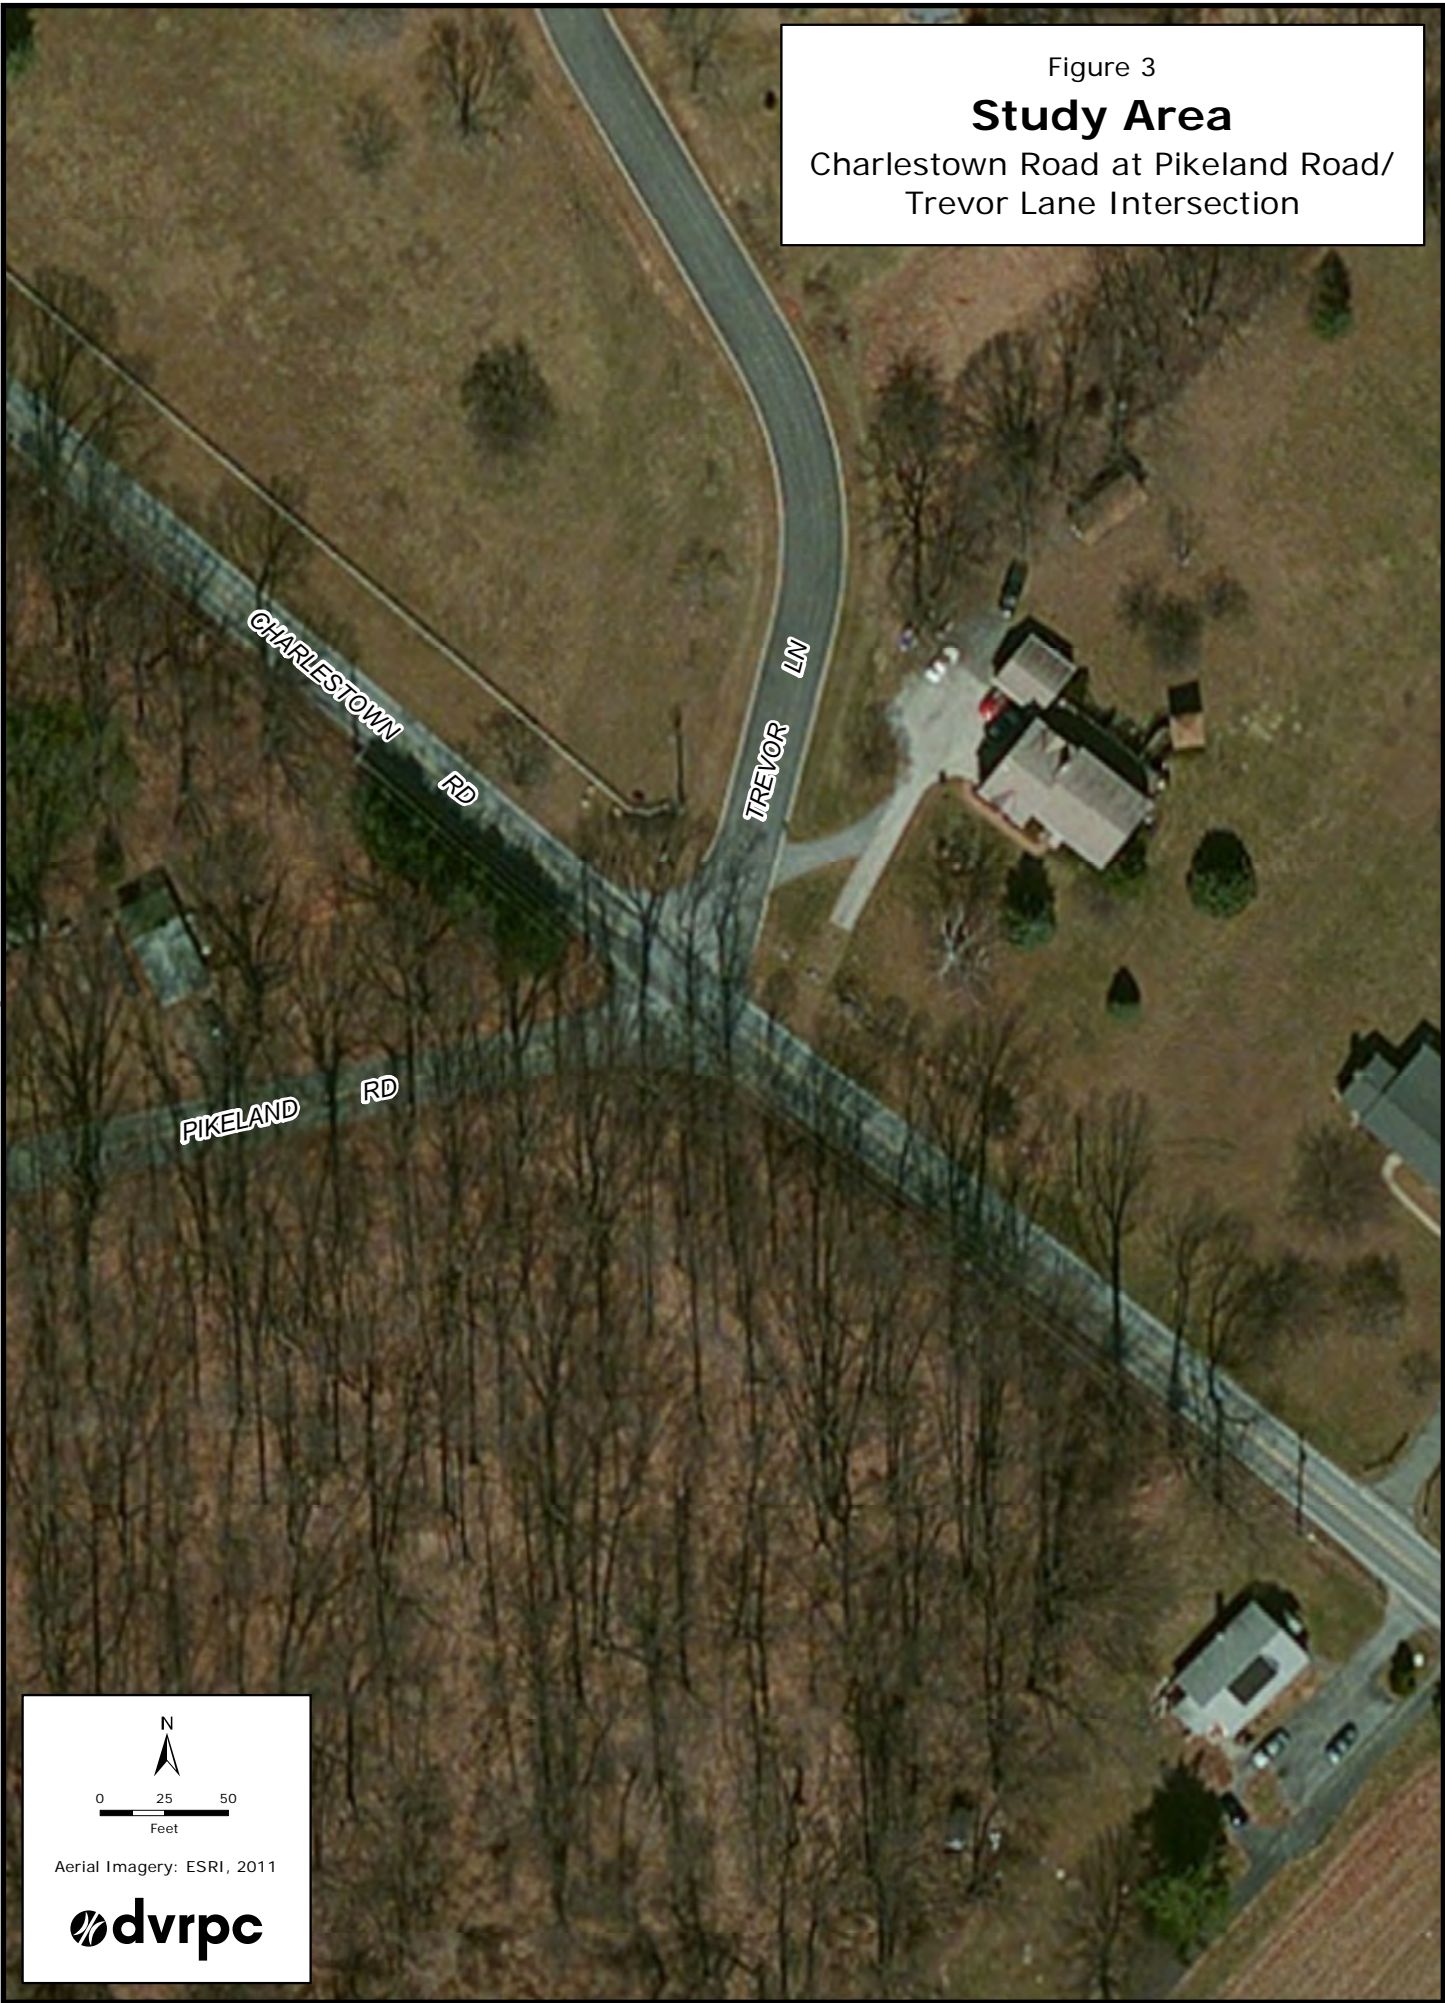
Figure 3
Study Area
Charlestown Road at Pikeland Road/
Trevor Lane Intersection

The land use surrounding the immediate intersection is wooded and low-density residential development. [Figure 3](#) on page 13 is an aerial view of the intersection. Homes located in the Ashford subdivision occupy the east side of the intersection. The west side of the intersection is wooded.

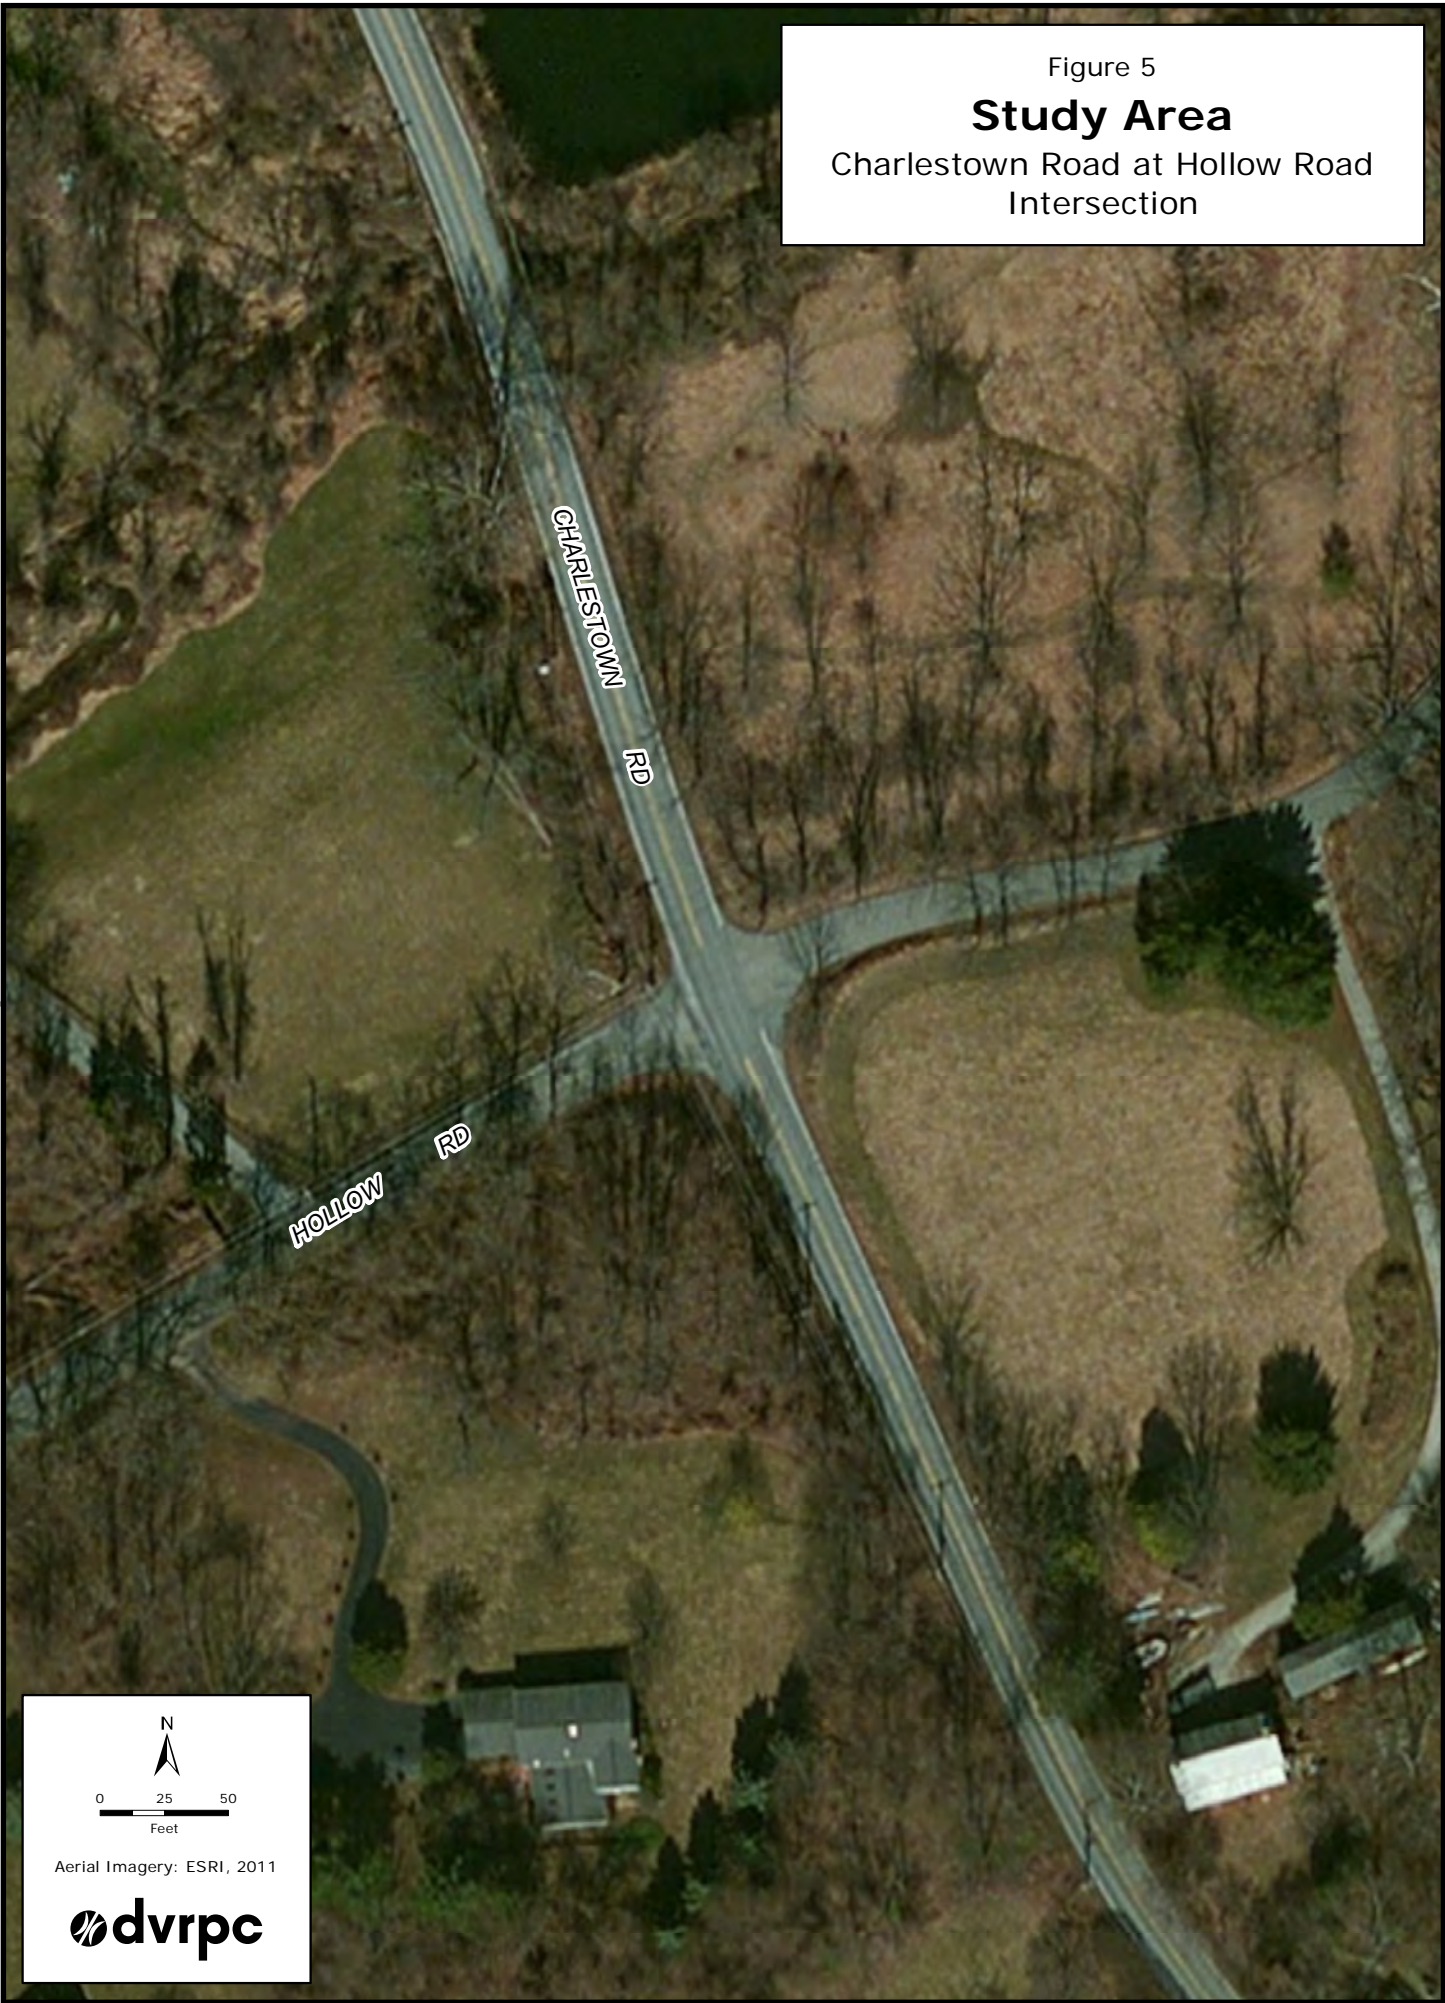
Figure 5
Study Area
Charlestown Road at Hollow Road
Intersection

The land use surrounding the immediate intersection is wooded and low-density residential development. [Figure 5](#) on page 18 is an aerial view of the intersection. Homes are located on the south side and in the northwest quadrant of the intersection. The northeast quadrant of the intersection is wooded.

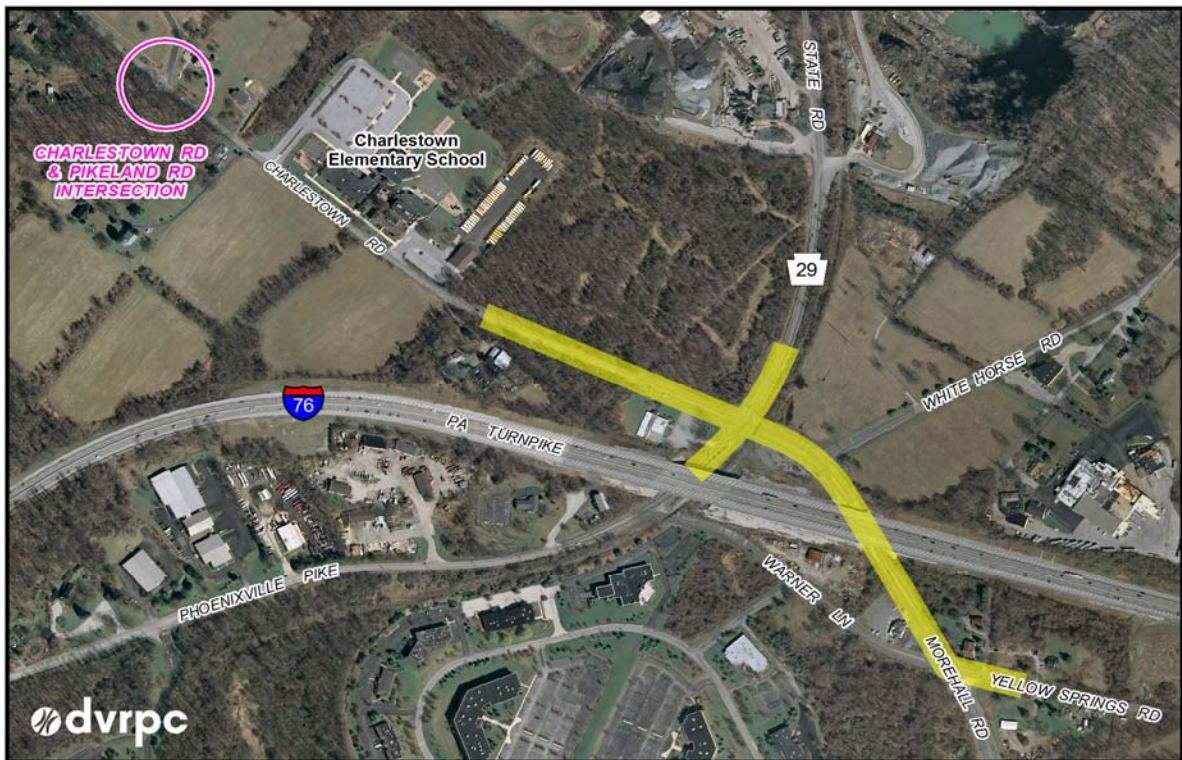
Figure 9: PA 29 Project Limits

PennDOT is undertaking a construction project in the vicinity of PA 29 (Morehall Road) near the Pennsylvania Turnpike. A part of this project includes widening Charlestown Road from Phoenixville Pike to just south of Charlestown Elementary School. See [Figure 9](#). This widening lies southeast of the Charlestown Road and Pikeland Road/Trevor Lane intersection.

At the follow-up meeting held on June 27, 2012, advisory committee members discussed the option of talking with PennDOT officials to consider extending the PA 29 construction project limits to include traffic safety improvements at the Charlestown Road and Pikeland Road/Trevor Lane intersection. This option would fund and implement many of the strategies referenced above in [Table 5](#).

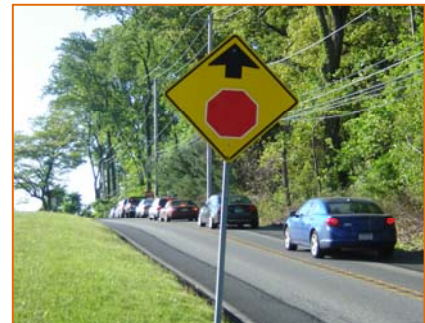
Morning southbound view of traffic back-up.
(Source: DVRPC, 2012.)

Under this scenario, the overall LOS and vehicle delay in the morning and afternoon peak period is A. Due to the removal of the stop sign, the average driver in the AM peak would experience 13 seconds less delay along the southbound approach. Southbound vehicles would no longer stop, so they would travel at free-flow speeds. As indicated in [Table 6](#), delays have been reduced from 15 to two seconds in the morning and from eight to one second in the afternoon. Delays in the morning on the eastbound approach increased slightly by two seconds, but remained the same in the afternoon. The northbound approach LOS remains at LOS A.
