Philadelphia Street Tree Survey: South Philadelphia and Whitman

January 2013

Abstract: This report documents the process and results from the street tree survey conducted by DVPRC during the summer of 2012.

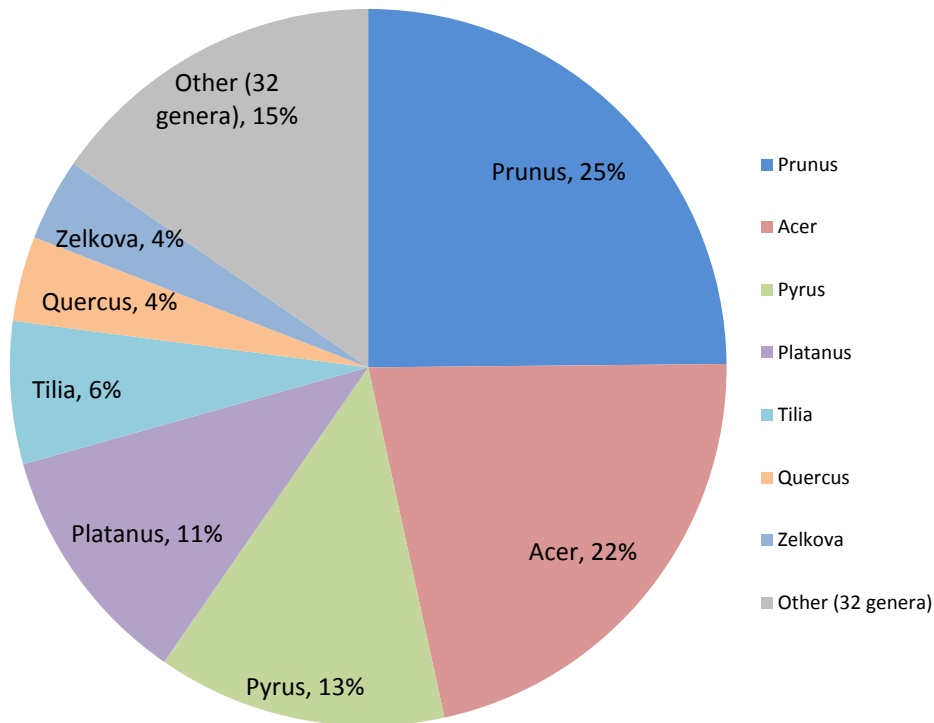
Figure 2: Distribution of Trees by Genus

Prunus and Acer were the two dominant genera of trees in the survey area, making up 25% and 22% of all trees, respectively. There were 12 species of Prunus that were found, with the vast majority being Sweet Cherry (*Prunus avium*). Ten species of Acer were recorded, with Norway Maple (*Acer platinoides*) being dominant. The median DBH was 6.75" for Prunus trees and 7.75" for Acer trees. The size distribution of these two genera was roughly similar, with a drop-off in population for trees larger than 12" DBH.

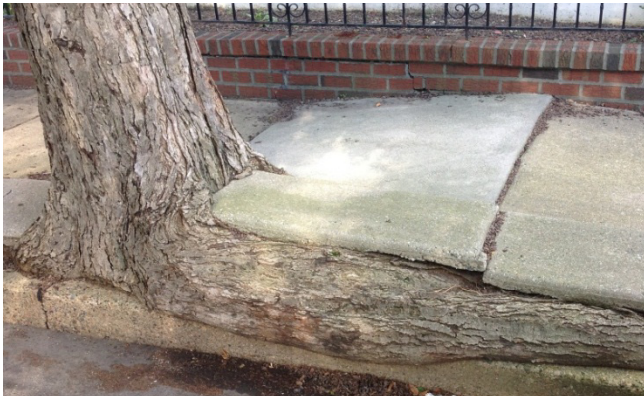
Roots outgrow a small pit cut.

Larger pit cuts where possible would be beneficial to the health of trees while reducing sidewalk damage. Many tree pits are smaller than the Philadelphia Parks & Recreation standard 3'x3' plot size. Some tree pits with trees had even been covered with concrete or asphalt to the base of the trunk. Where possible, pits should be enlarged to provide trees with the proper amount of soil, water, air, and ability to grow unhindered. Insufficient tree pits lead to more severe effects of drought, nutrient deficiencies, and damage to the tree, sidewalk, and underground pipes.

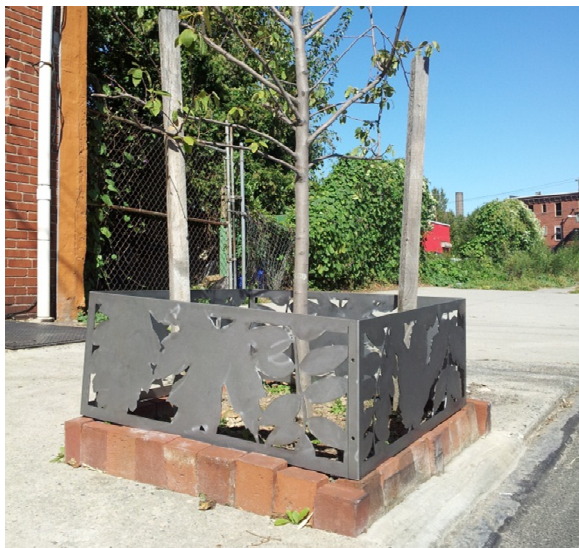
A tree guard protects trees from the urban environment.

Tree guards, or fences, installed around trees would help protect trees in a number of ways, especially new trees. These guards should be constructed at the perimeter of the pit, not directly against the trunks, to allow healthy tree growth. Tree guards can protect against vehicular damage from opening doors, parking impact, and accidents. They can also discourage pet waste. Tree guards would also prevent bikes from being locked to trees, an all-too-common occurrence. These would also provide a barrier against pedestrians accidentally walking into trees and could discourage children from breaking branches.

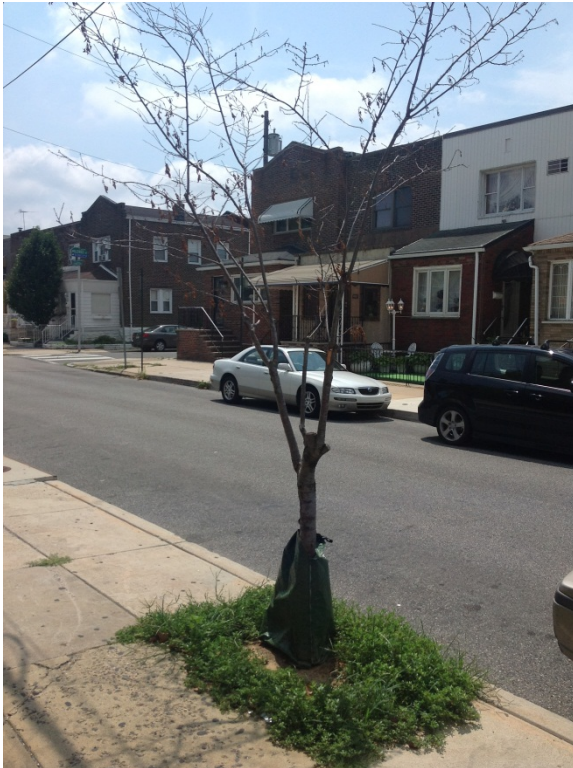
Over-pruning can cause twig dieback.

Pruning around overhead wires is a cause for concern in the study area. The quality of the pruning work appears to be destructive to many trees. Many pruning cuts are made in a way that prevents the tree from healing its wounds properly, which may increase susceptibility to pests and disease. The current practices observed remove far too many branches at once and prune more of the canopy than is necessary to protect the overhead wires. In particular, older, more substantial trees such as London Planes have great difficulty with such severe pruning cuts. For trees under overhead wires, greater care should be taken to prune them when they are smaller so they can be trained to grow around the wires. Evidence of older successful pruning jobs was found around Marconi Plaza on 13th Street.

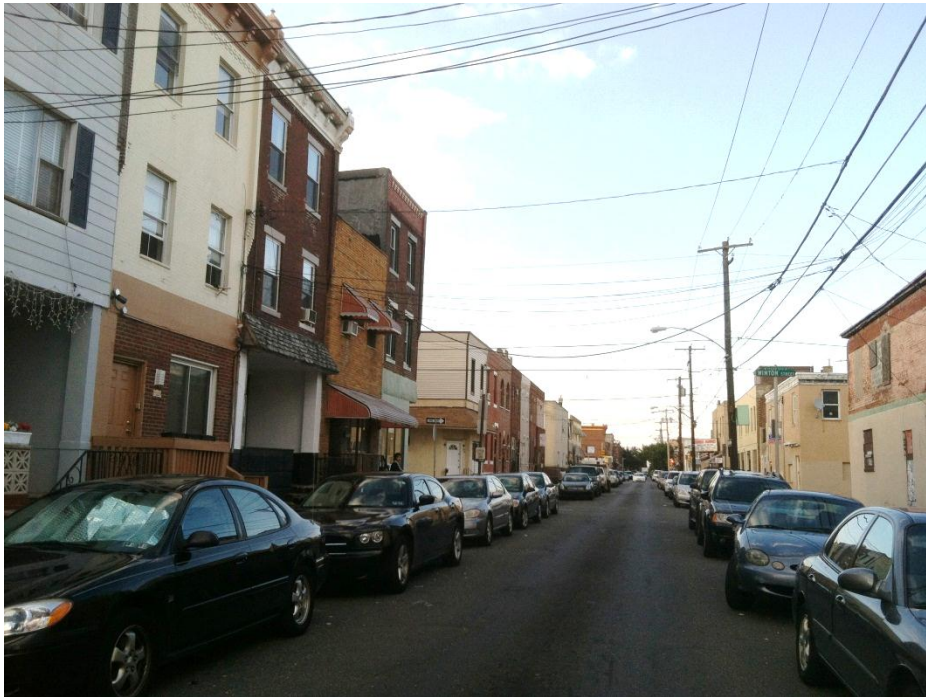
Many blocks in the study area completely lack trees, like 10th Street shown here.

Streets entirely lacking trees were located throughout, but were found primarily in the center and in some eastern portions of the study area. Wider, more heavily used corridors would benefit most from new trees. These corridors include tree-deficient portions of Snyder Street, Moyamensing Avenue, Wolf Street, Ritner Street, Porter Street, and Shunk Street. Frequent driveways and garages, commercial signage, and overhead wires make Oregon Avenue a difficult corridor for tree plantings. North-south corridors with high priority for tree plantings include portions of South Broad Street, 13th Street, 12th Street, 10th Street, 8th Street, 7th Street, 6th Street, 5th Street, 4th Street, and 3rd Street.

These more prominent streets are less likely to have underground utilities and more likely to have wider sidewalks that can better accommodate tree pits. Corridor streets also tend to have less shade cover from buildings. As wider streets, they are also responsible for larger volumes of stormwater runoff. Corridor streets serve as main arteries for residents and nonresidents, and improving the streetscape aesthetics through tree plantings will add to the quality of life of the entire neighborhood. Many of these streets lead to parks, and tree-lined streets will increase the feeling of connectivity between these parks and the surrounding neighborhood.
