# Nether Providence Township Energy Assessment Report

## Township Administration Building

214 Sykes Road, Rose Valley, PA 19086

APRIL 2016

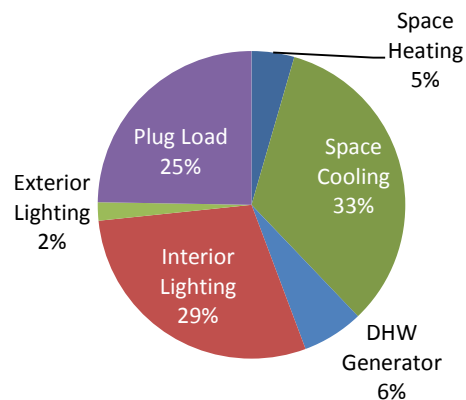
**Figure 3:** Electricity End Uses

- One hundred percent of natural gas is used for heating.
- One-third of electricity is used for space cooling, and interior lighting uses an additional 29 percent. PES estimated that space heaters use 5 percent of the electric load, costing more than \$600 per year. Figure 3 shows all electricity end uses; Figure 4 shows the spike in wintertime electricity use (December, January, February) due to space heaters.

**Notes:** Plug load = computers, desk lamps, printers, faxes, copiers vending machines, other plug load. **Source:** Practical Energy Solutions for DVRPC 2014

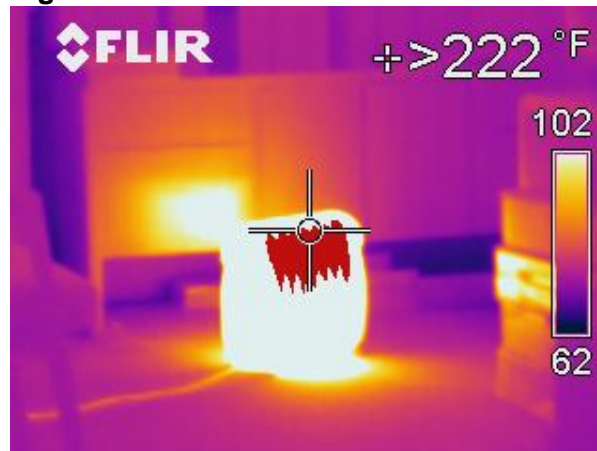
**Figure 6: South Wall Cold Air Infiltration**

Infrared imaging also indicated significant cold air infiltration along the back and southern walls of the first-floor office space, suggesting insufficient wall insulation. Figure 6 below is an infrared image showing the temperature differential in the first-floor office space, despite the use of a space heater.

- Back and southern walls. Consider improving insulation along these walls. Contractor evaluation and quotation are recommended.
- Teller window. Consider a more effective, easily removable air barrier for the teller window. This can be made from insulating materials purchased at the local hardware store.

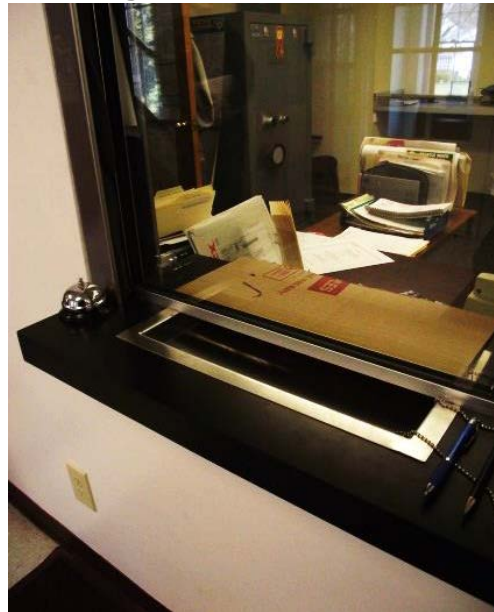
**Figure 7:** Teller Window

PES also noted substantial cold air flow through the front teller window, despite attempts to block it with cardboard, as shown in Figure 7 below.
