Towamencin Township Energy Assessment Report

Township Administration Building

1090 Troxel Road, Lansdale, PA 19446

Practical Energy Solutions of West Chester, PA

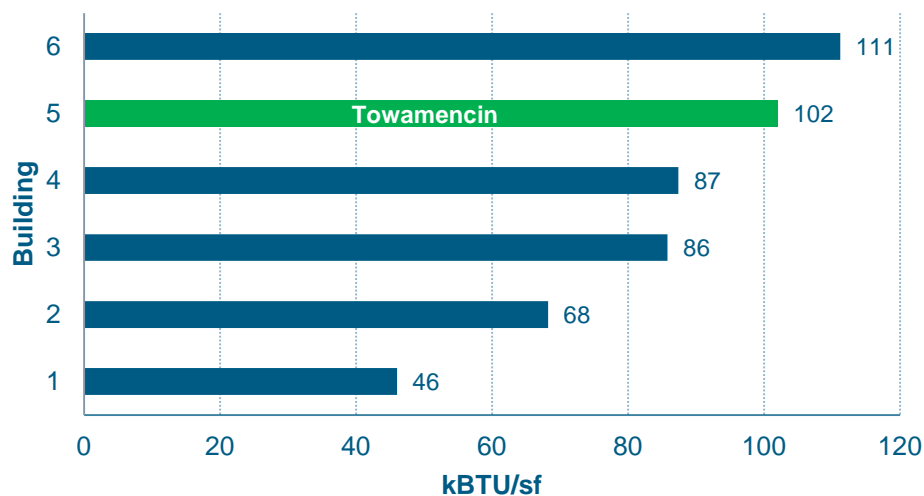
Figure 1: EUI Scores for Local Municipal Administration Facilities

The facility's estimated energy use intensity (EUI)—a measure of total energy use per square foot—is 102, which is on the high end of EUI scores for similar local facilities, as shown in Figure 1 below.

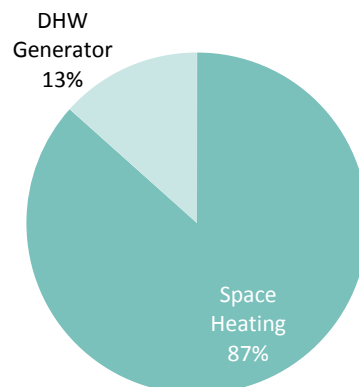
Figure 3: Natural Gas End Uses

- Eighty-seven percent of natural gas is used for space heating; the remainder is used for domestic hot water (DHW), as shown in Figure 3 below.

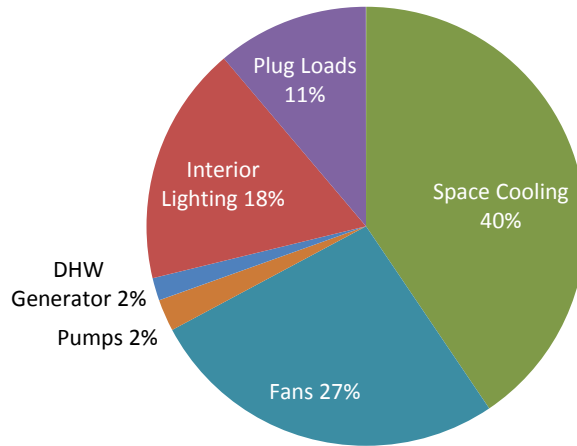
Figure 4: Electricity End Uses

- Figure 4 shows all electricity end uses. Space cooling uses the most electricity. Ventilation fans use approximately 27 percent of electricity, and interior lighting uses just 18 percent.

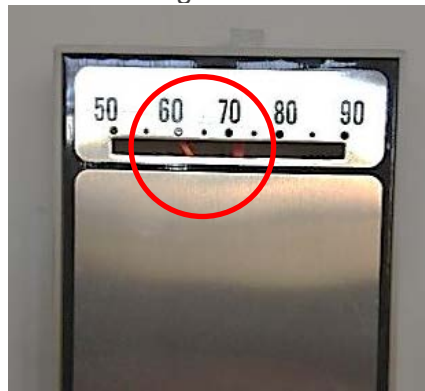
- Digital, nonprogrammable thermostats control the air handlers for both cooling and heating. Since the thermostats are not programmable, the air handlers cannot be consistently set back during evenings and weekends, resulting in unnecessary heating, ventilation, and energy use during unoccupied times.
- The perimeter hot water baseboards are controlled primarily by many individual manual thermostats located in nearly every room. Many of these thermostats, and possibly the valves and actuators as well, appear to be malfunctioning. During the site visit, some radiators were not heating despite high thermostat settings, while others were heating despite low settings. For example, PES noted one thermostat set to 72°F, but the ambient temperature reading was 60°F, as shown in Figure 5. There were similar incongruities throughout the facility.

Figure 5: Malfunctioning Manual Baseboard Thermostat

To address the malfunctioning radiators, PES recommends evaluating all valves, actuators, and wiring and replacing all faulty components. The contractor should also confirm that the transformer is working properly. Once functionality is restored, all manual thermostats should be replaced with digital programmable thermostats with locking covers, and the thermostats should be programmed carefully so they operate as intended—that is, as supplements to the AHUs on cold winter days and in the mornings, when needed to bring the building temperature to the occupied setpoint. Table 2 shows a programming recommendation.

- Evaluate all valves, actuators, and wiring to ensure functionality. If needed, ensure functionality of transformer;
- Replace all faulty valves, actuators, and wiring;
- Replace all manual thermostats with *digital programmable thermostats with locking covers* (n = 24). Ensure that all AHUs also have digital programmable thermostats with locking covers;
- Schedule all programmable thermostats carefully. The intent of the hot-water radiators is to complement the air handling units (AHUs), which act as the primary heat source for the core of the building. The radiators provide supplementary heat on cold days when the AHUs cannot keep up with heating demands and in the mornings when needed to bring the temperature up to setpoint. Therefore, the baseboard thermostats should be set at temperatures below those of the AHUs, using an approach similar to the following:

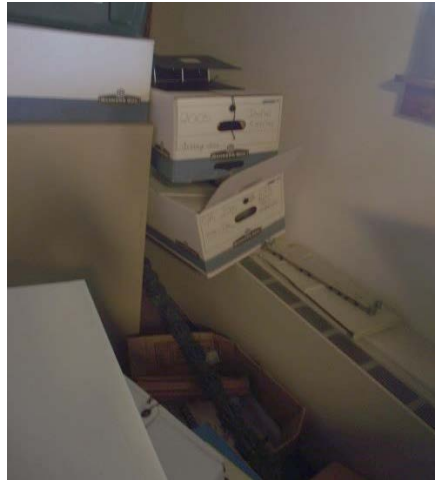
PES recommends against storing boxes on top of the radiators, as shown in Figure 6 below. This is a safety and fire hazard and inhibits proper operation of the heating system.

Figure 6: Improper Storage of Boxes

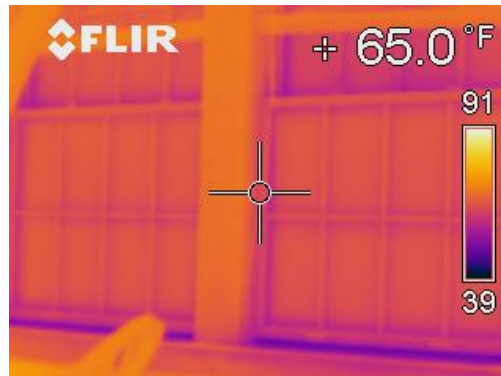
Windows in private offices are double-pane, ½" insulated units with wood frames that have good thermal insulation properties. However, many of the windows in the private offices do not close tightly, if at all. This allows unconditioned outside air to enter the building and increases heating and cooling costs. Figure 7 below shows an infrared image captured during PES' site visit. The temperature measured using an infrared camera in the circle centered in the photo is 65°F, while the temperature at the bottom seal of the window measures closer to 40°F, indicating significant air infiltration. This is the primary building envelope concern from an energy standpoint.

Figure 7: Second-Floor Office Windows, with insufficient closure and cold air infiltration

Towamencin Township should rehang all malfunctioning windows or install storm windows on all wood-framed windows to significantly reduce infiltration. The existing windows appear to be compatible with exterior storms, which may be available from the window manufacturer for a substantially lower price than a third-party interior storm window. If not, interior storm windows are available from several manufacturers and are highly configurable for window size and operability.
