Delaware Valley
Regional Planning
Commission

JUNE 2007

CONESTOGA ROAD

Road Safety Audit

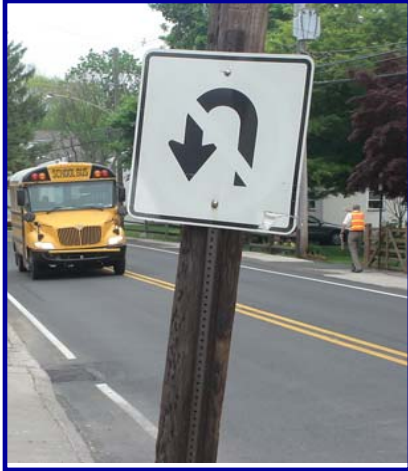
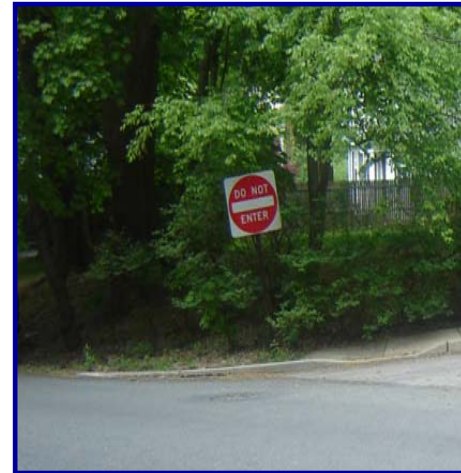
SIGNAGE

ISSUES	RECOMMENDATIONS	LEVEL OF EFFORT REQUIRED	POTENTIAL SAFETY BENEFITS
<p><i>Signage</i></p> <ul style="list-style-type: none"> ○ Street signs are not mounted on break-away post assembly and do not have reflectivity ○ Many of the yellow warning signs are faded ○ Many signs along the corridor are too low ○ Sign visibility is hampered due to foliage and setback at intersections ○ “Conestoga Road” signs are missing from many intersections ○ Pedestrian signs are missing at crosswalks ○ Inconsistency in the placement of curve warning signs and advisory speed limit signs 	<ul style="list-style-type: none"> ○ Upgrade signs and posts to conform to official MUTCD requirement. Realign signs to make them visible to motorists ○ Upgrade signs ○ The bottom of the signs should be 7’-0” from the ground. ○ Trim trees and bushes and place street name signs on existing mast arms as appropriate (require amendment to permit from PennDOT) ○ Add “Conestoga Rd” sign on side roads ○ Add pedestrian signs at crosswalks ○ Maintain consistency in the placement of curve warning signs (advance warning and advisory speed limit) <p><i>Conduct a complete sign inventory of corridor-wide signage and upgrade, add and remove signs as appropriate</i></p>	<p>Low</p> <p>Low</p> <p>Low</p> <p>Low</p> <p>Low</p> <p>Low</p> <p>Low</p> <p>Medium</p>	<p>High</p> <p>High</p> <p>High</p> <p>High</p> <p>High</p> <p>High</p> <p>High</p> <p>High</p>

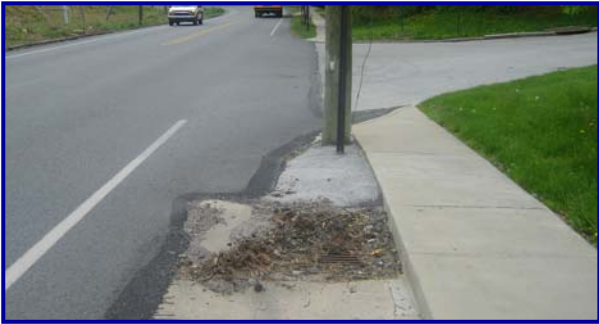
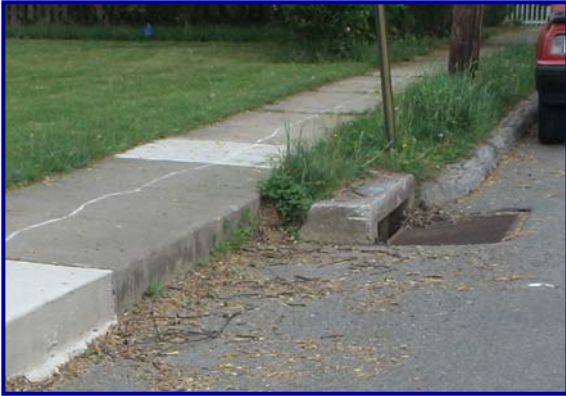
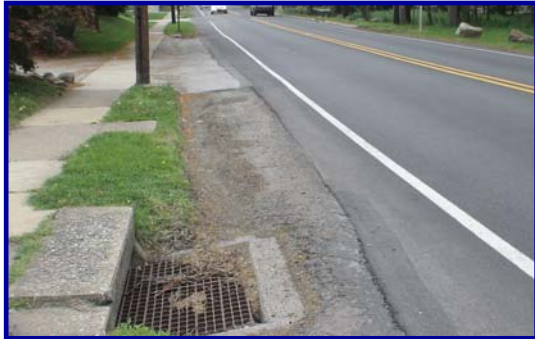
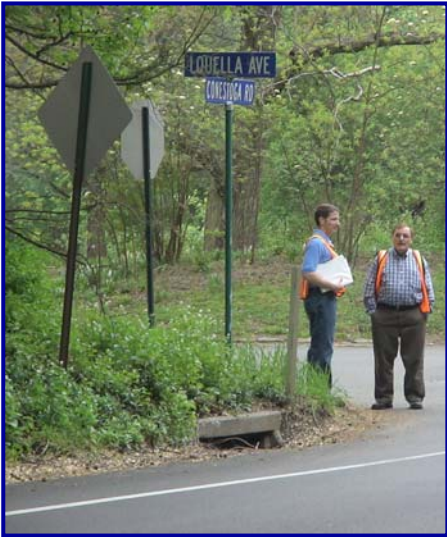
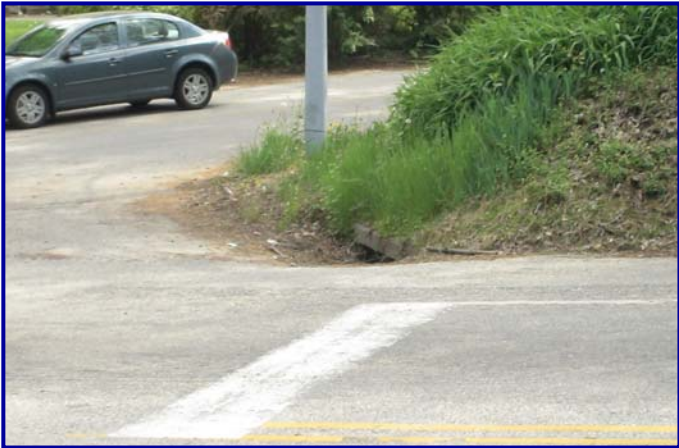
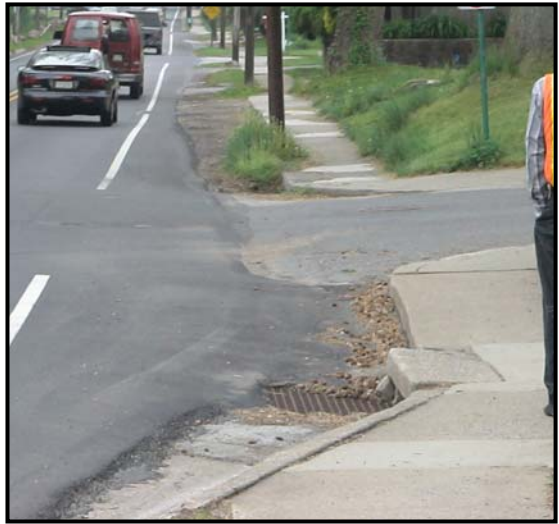
INLETS

<u>CORRIDOR WIDE ISSUES</u>	<u>Solution</u>	<u>Decision</u> <u>Agree/Reject</u>	<u>Planned</u> <u>Completion Date</u>	<u>Comments</u>
<p><i>Drainage</i></p> <ul style="list-style-type: none"> ○ Inlets top units present a hazard to all road users. Inlet blunt curb ends are unprotected and numerous inlet top units are not flush with pavement gutter line. Some inlet grates are also rotted. ○ Grates/Inlets are clogged 	<ul style="list-style-type: none"> ○ Replace inlet top units and address untreated inlet blunt curb ends. Install inlet top units flush with roadway gutter line. ○ Unclog drainage grates/inlets 			
<p><i>Crosswalks</i></p> <ul style="list-style-type: none"> ○ Faded and hardly visible ○ Inconsistent style of crosswalk ○ Missing crosswalk ahead signs and yield to pedestrian signs in crosswalk ○ Long crosswalks due to skewed intersections 	<ul style="list-style-type: none"> ○ Re-stripe crosswalks along the corridor ○ Install same crosswalk style at all locations ○ Install signs as appropriate ○ Reduce the skew to as close as 90 degrees ○ Utilize bulb-outs to shorten crossing distance and increase the visibility of pedestrians visibility at key locations

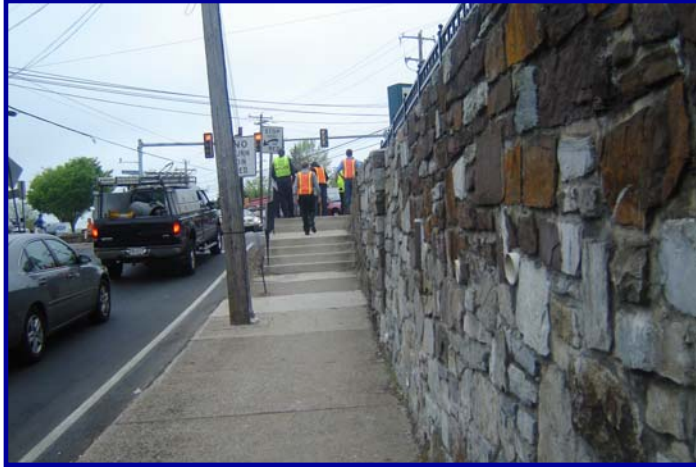
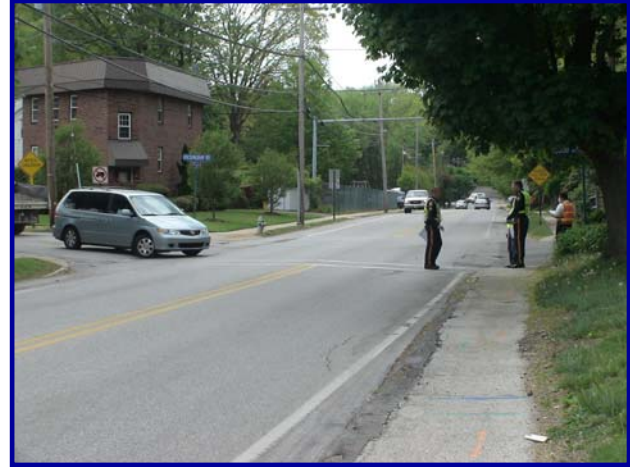
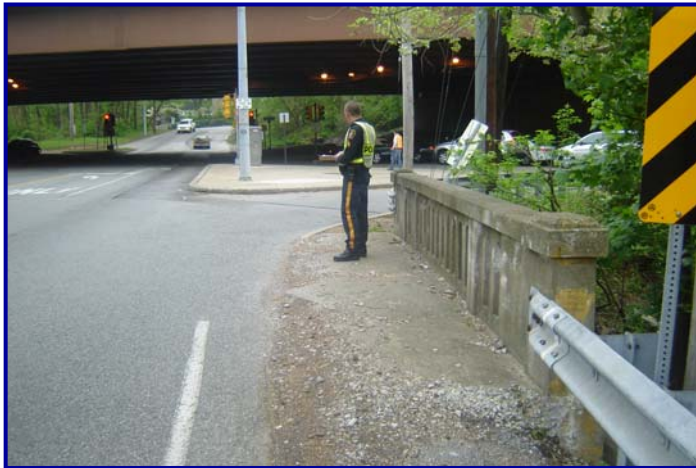
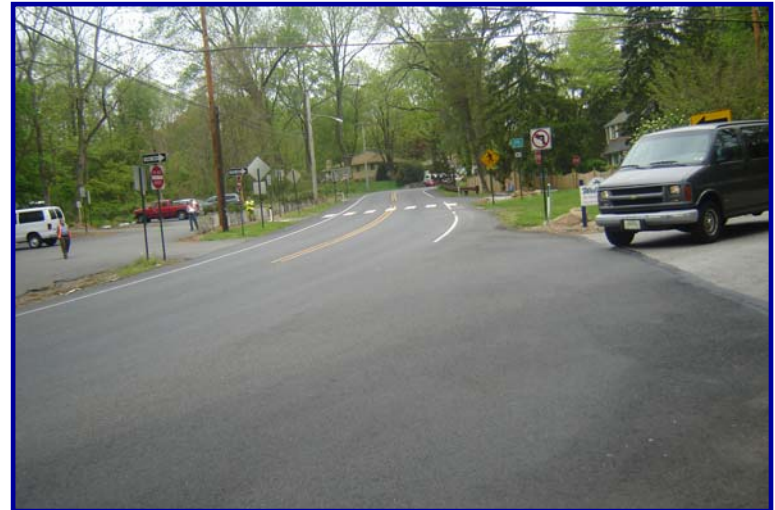
PEDESTRIAN AMENITIES

<p><i>Sidewalks</i></p> <ul style="list-style-type: none"> ○ Inconsistent width ○ Sidewalk missing in several areas ○ Sidewalk in poor condition (uneven, cracks, vegetation) 	<ul style="list-style-type: none"> ○ Upgrade and install sidewalks as appropriate with curb. ○ Upgrade curb ramps and install truncated domes
