# LEVITTOWN PARKWAY

ROAD SAFETY AUDIT

DECEMBER 2010

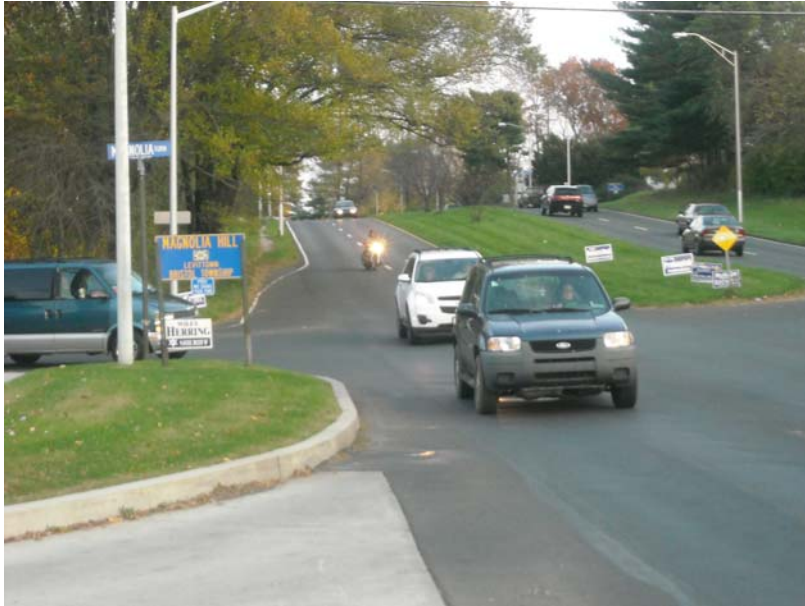
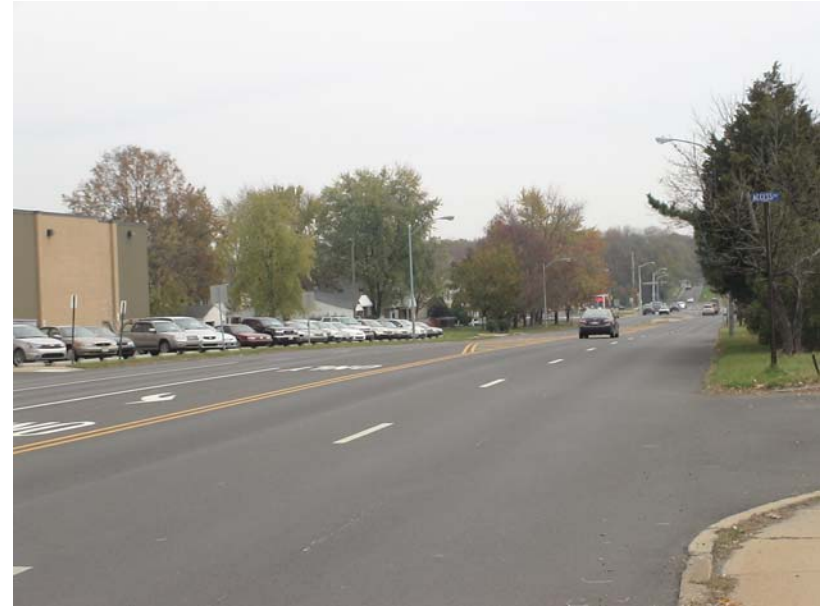
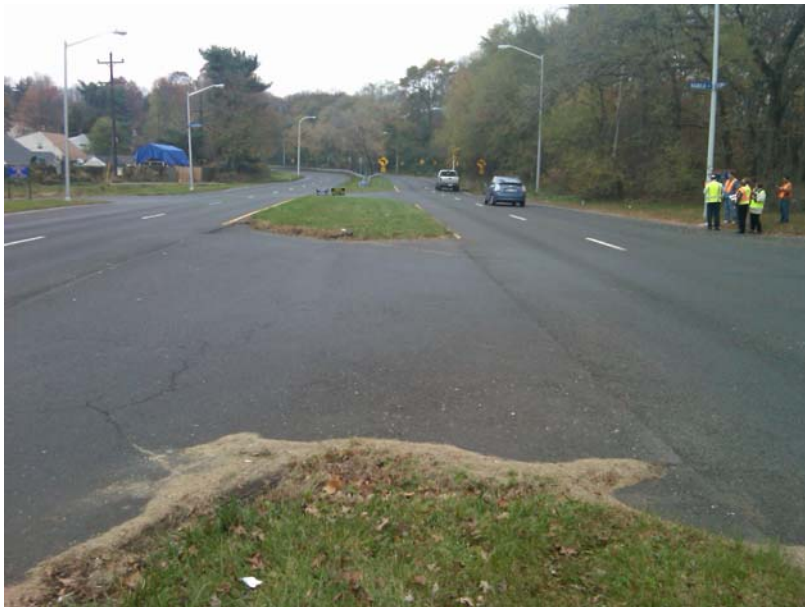
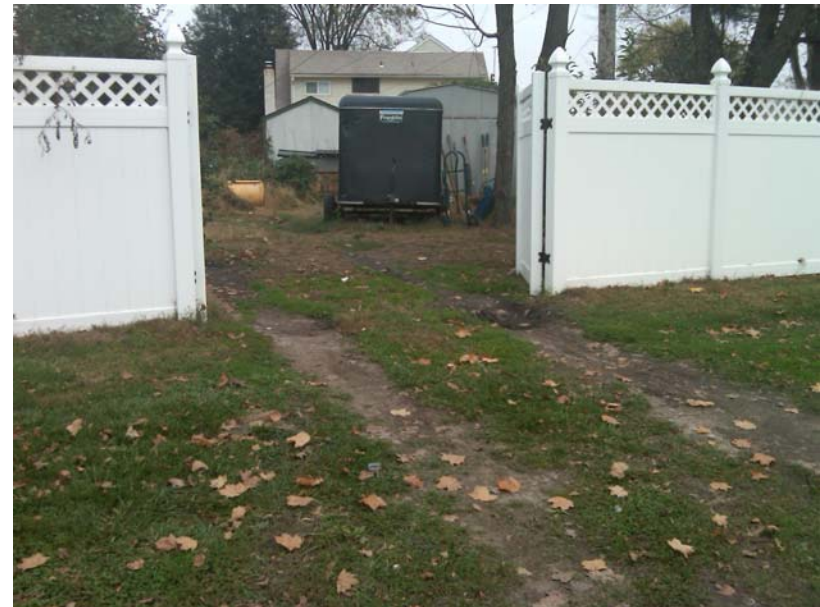
# Access Management

to complete a left turn into a neighborhood side street. The reverse movement is just as common as drivers exit the neighborhoods to access the far side of the Parkway, using these openings as a staging area while they wait for a gap in oncoming traffic. These openings are problematic by design as they are closely spaced, frequent, and lead to compromised sight distance when two or more drivers occupy them at the same time. The group observed that not all of these openings may be necessary, as some are duplicative. It was clear that this entire section of the study corridor needs careful thought and would benefit from a collaborative effort between local leaders and PennDOT in developing an access management plan.

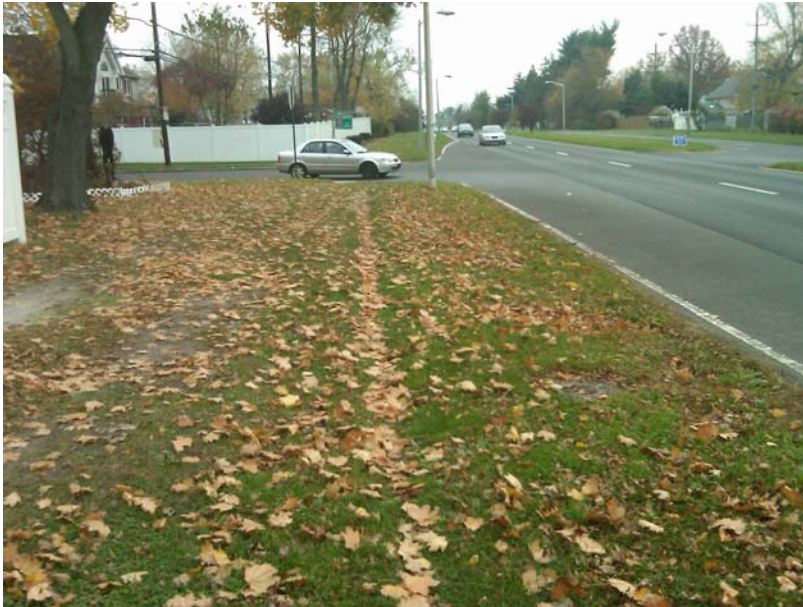
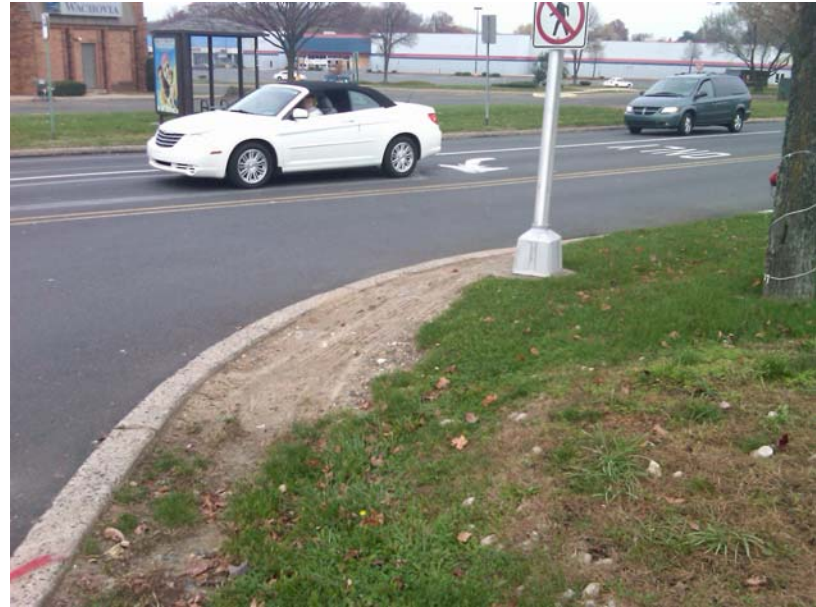
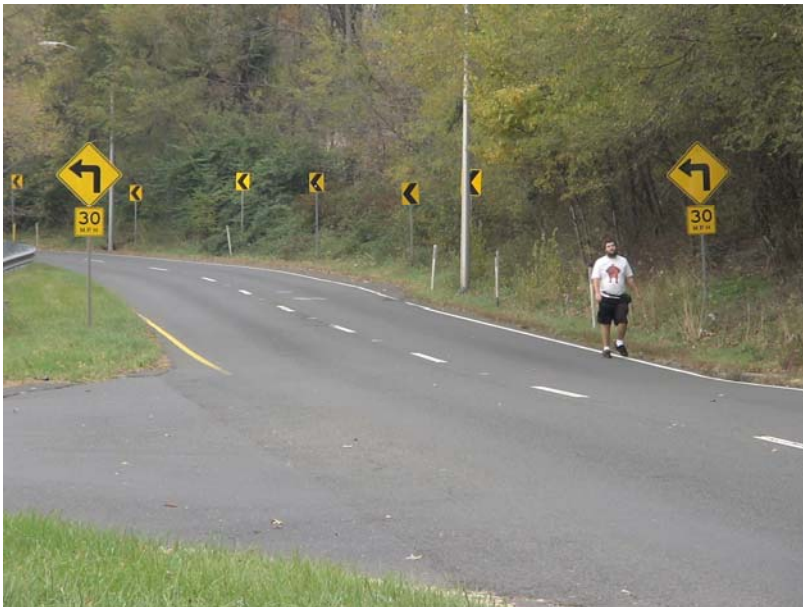
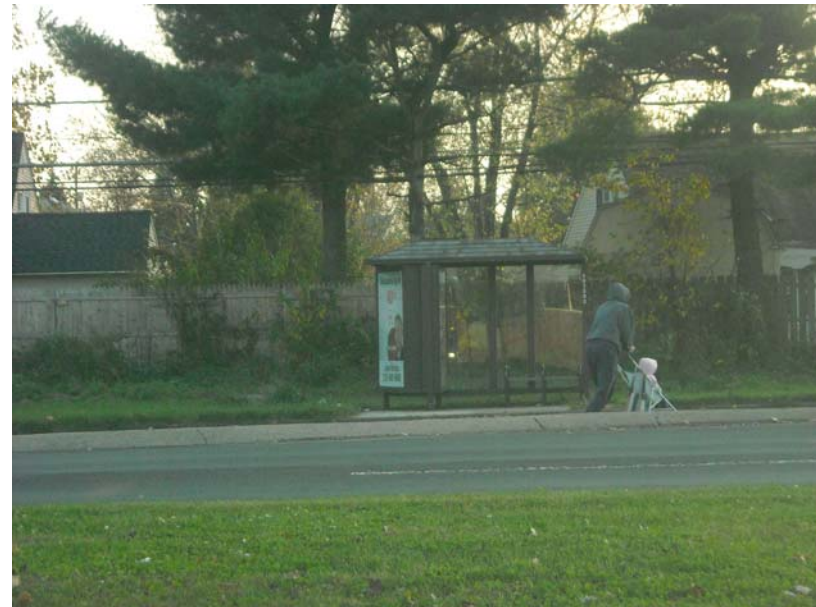
# Pedestrian Environment

Another identified corridor-wide problem was the lack of adequate and continuous sidewalks throughout the study section. Although they can be found in several locations, consistent sidewalk design and continuity are lacking. Similarly, accommodations for bicyclists are nearly non-existent. Though the roadway does not provide enough width to add a bike lane under the current configuration, a road diet, if deemed appropriate, would provide the needed width while calming traffic through the corridor. This idea was explored by the committee as a long-term strategy for consideration. A more attainable short-term alternative to accommodating bicyclists would be a multi-use bike route using existing parallel streets through the adjacent neighborhoods designated with signs and possibly striping.

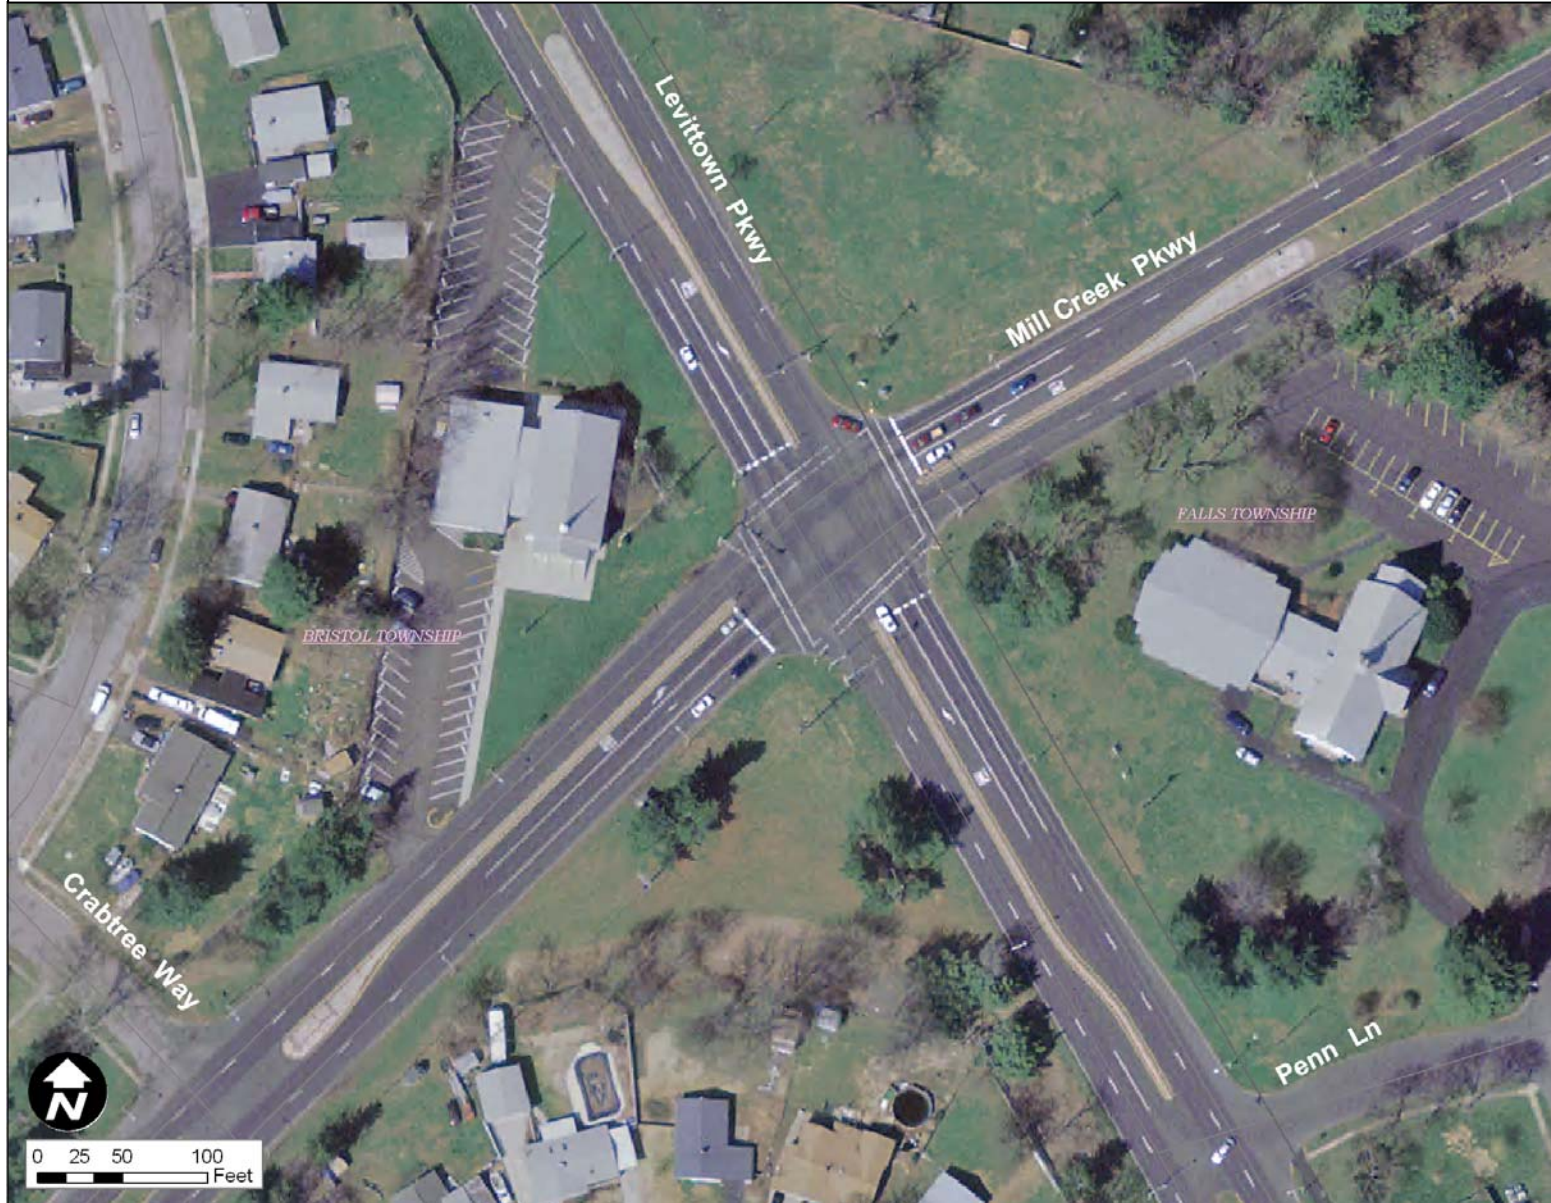
**1. Levittown Parkway (SR 2051) at Mill Creek Parkway**  
 Segment 20/2090 to Segment 21/2096

COLLISION TYPE	
Angle	7
Rear-end	1
Left Turn Involved (Angle)	1
Hit Fixed Object	1
Hit Pedestrian (Angle)	1
<b>Total</b>	<b>11</b>
SEVERITY COUNT (people)	
Fatalities	2
Major	0
Moderate	1
Minor	4
Unk Severity	11
Unk If Injured	0
<b>Total</b>	<b>18</b>

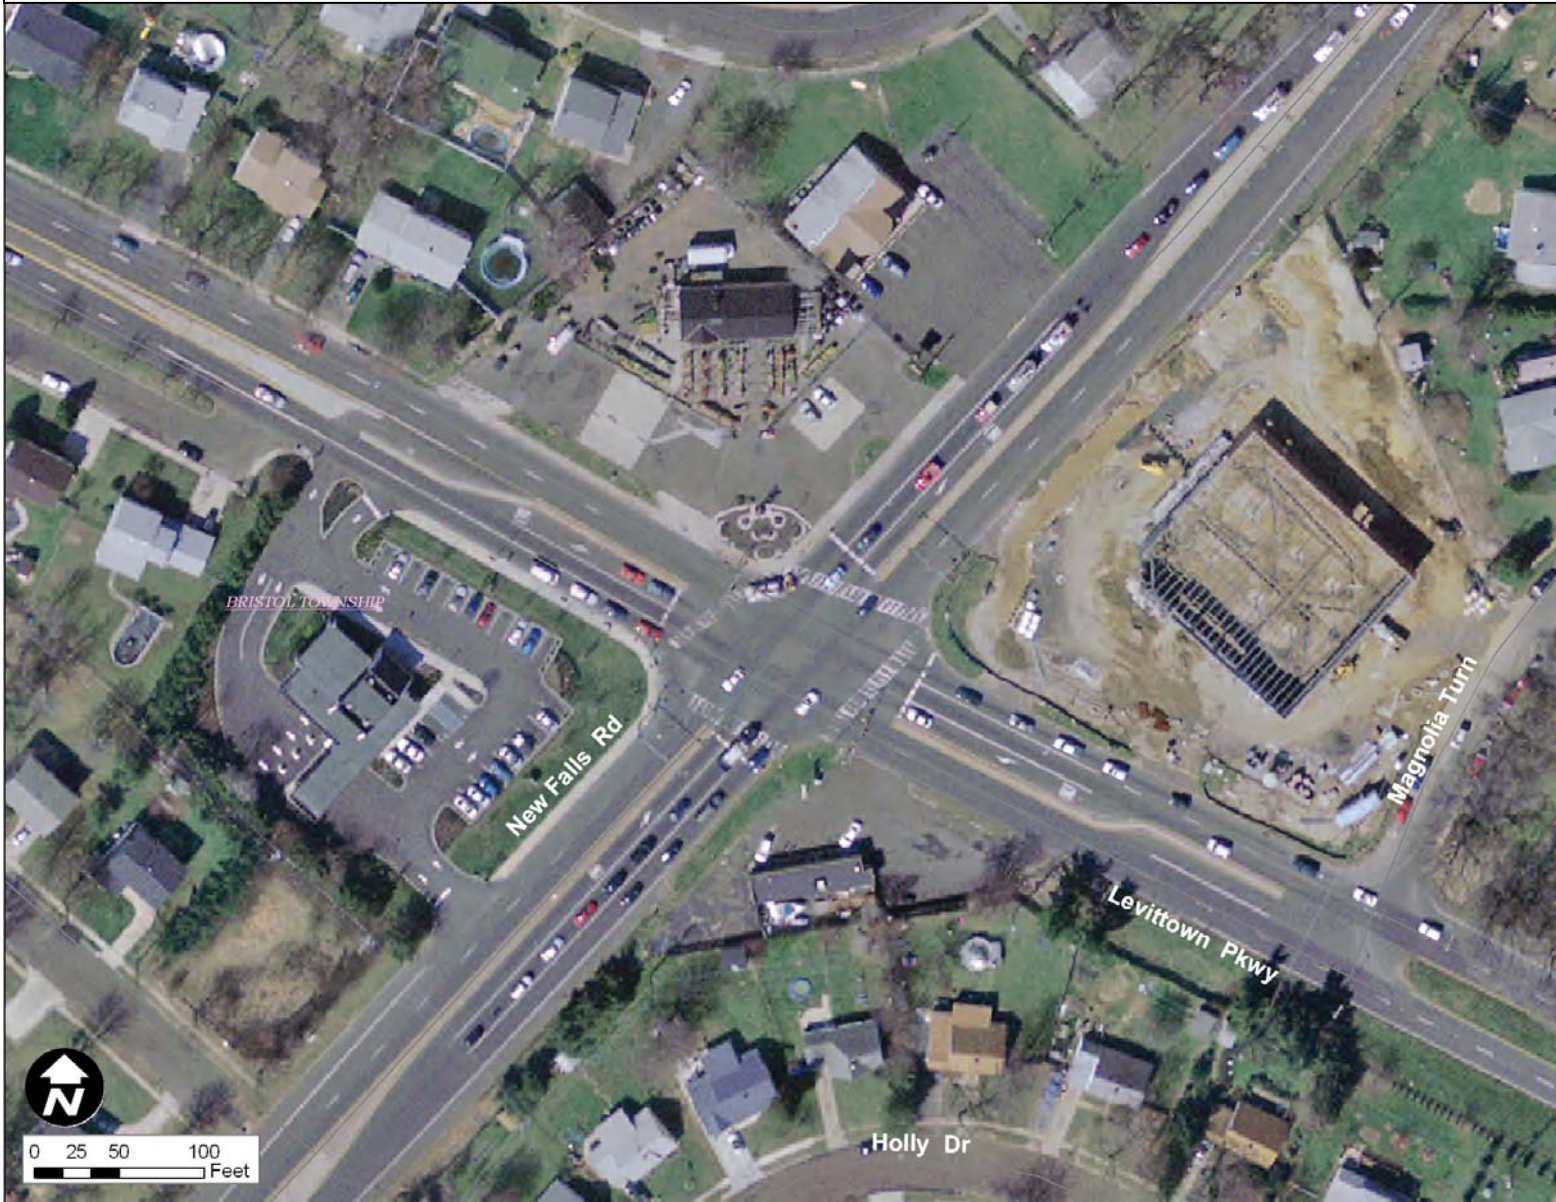
**2. Levittown Parkway (SR 2051) at New Falls Road**  
 Segment 50/0 to Segment 51/0

COLLISION TYPE	
Angle	5
Rear-end	5
Hit Fixed Object	3
<b>Total</b>	<b>13</b>
SEVERITY COUNT (people)	
Fatalities	0
Major	1
Moderate	0
Minor	6
Unk Severity	5
Unk If Injured	0
<b>Total</b>	<b>12</b>

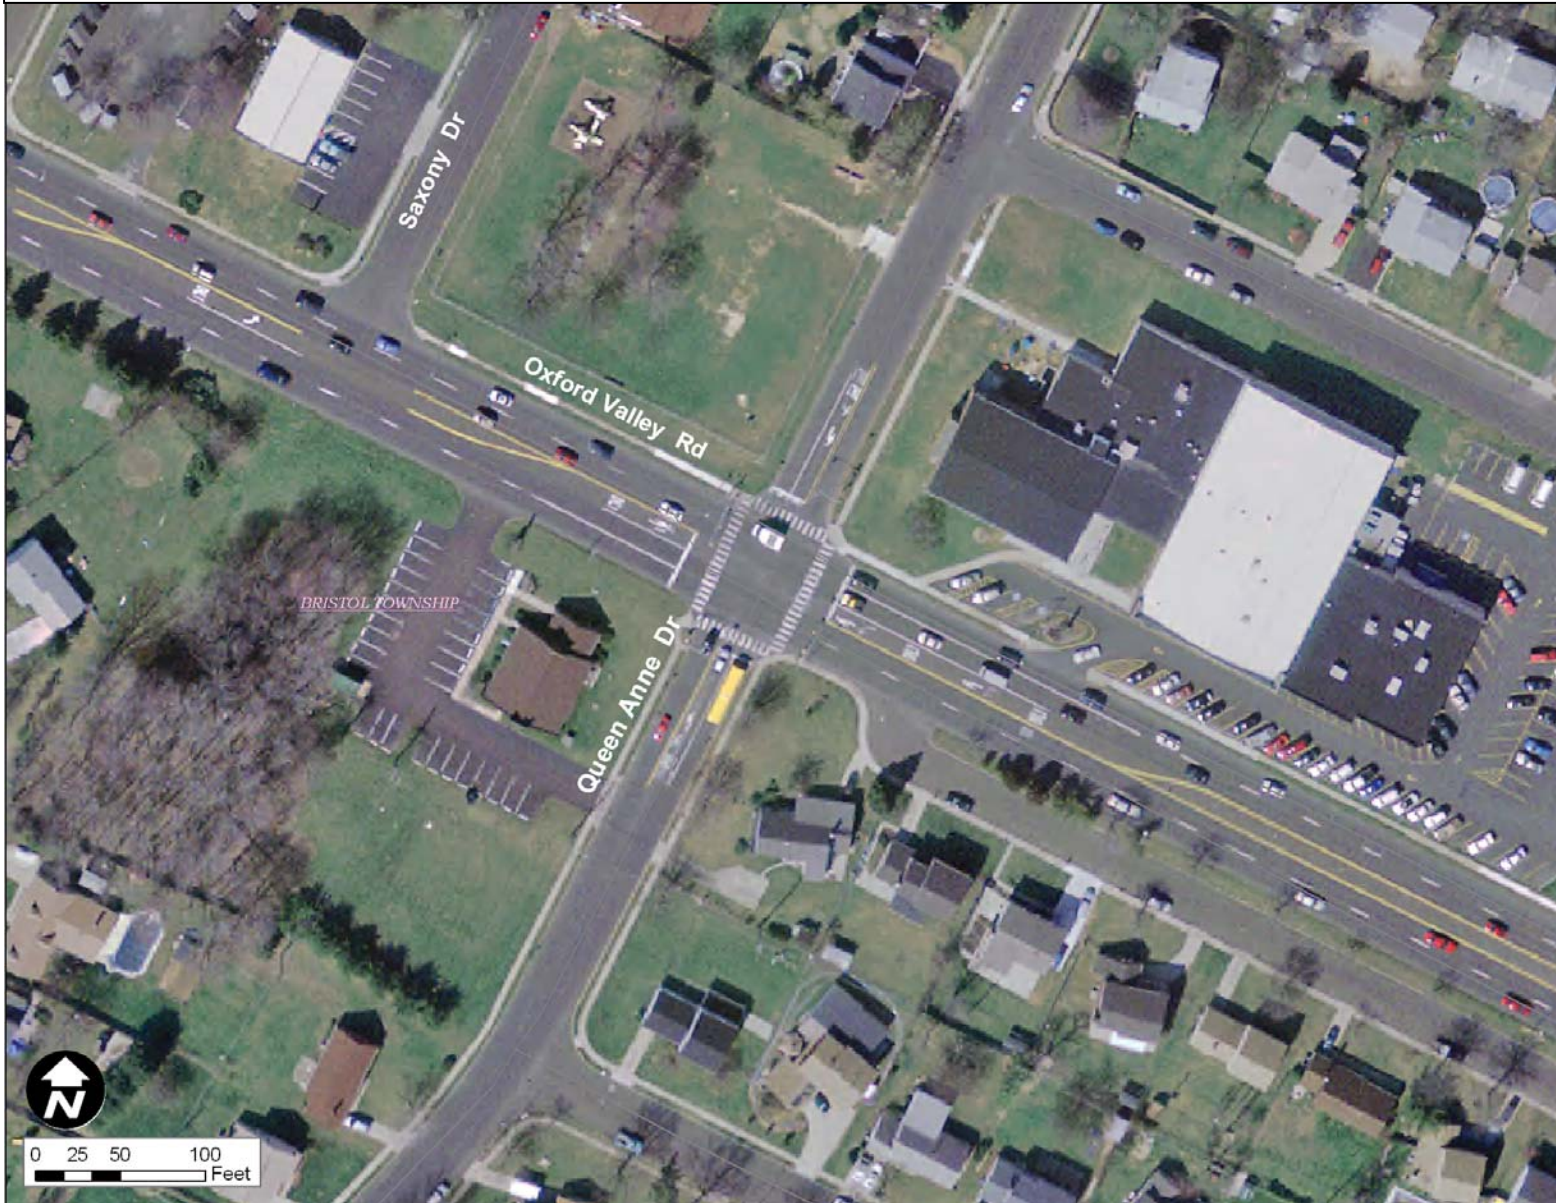
**3. Levittown Parkway (SR 2051) at Queen Anne Dr**  
 Segment 50/1015 to Segment 60/0000

COLLISION TYPE	
Rear-end	8
Angle	6
Left Turn Involved (Angle)	2
Left Turn Involved (Head-on)	1
Bike (Head-on)	1
Bike (Angle)	1
<b>Total</b>	<b>19</b>
SEVERITY COUNT (people)	
Fatalities	0
Major	1
Moderate	2
Minor	10
Unk Severity	11
Unk If Injured	0
<b>Total</b>	<b>24</b>

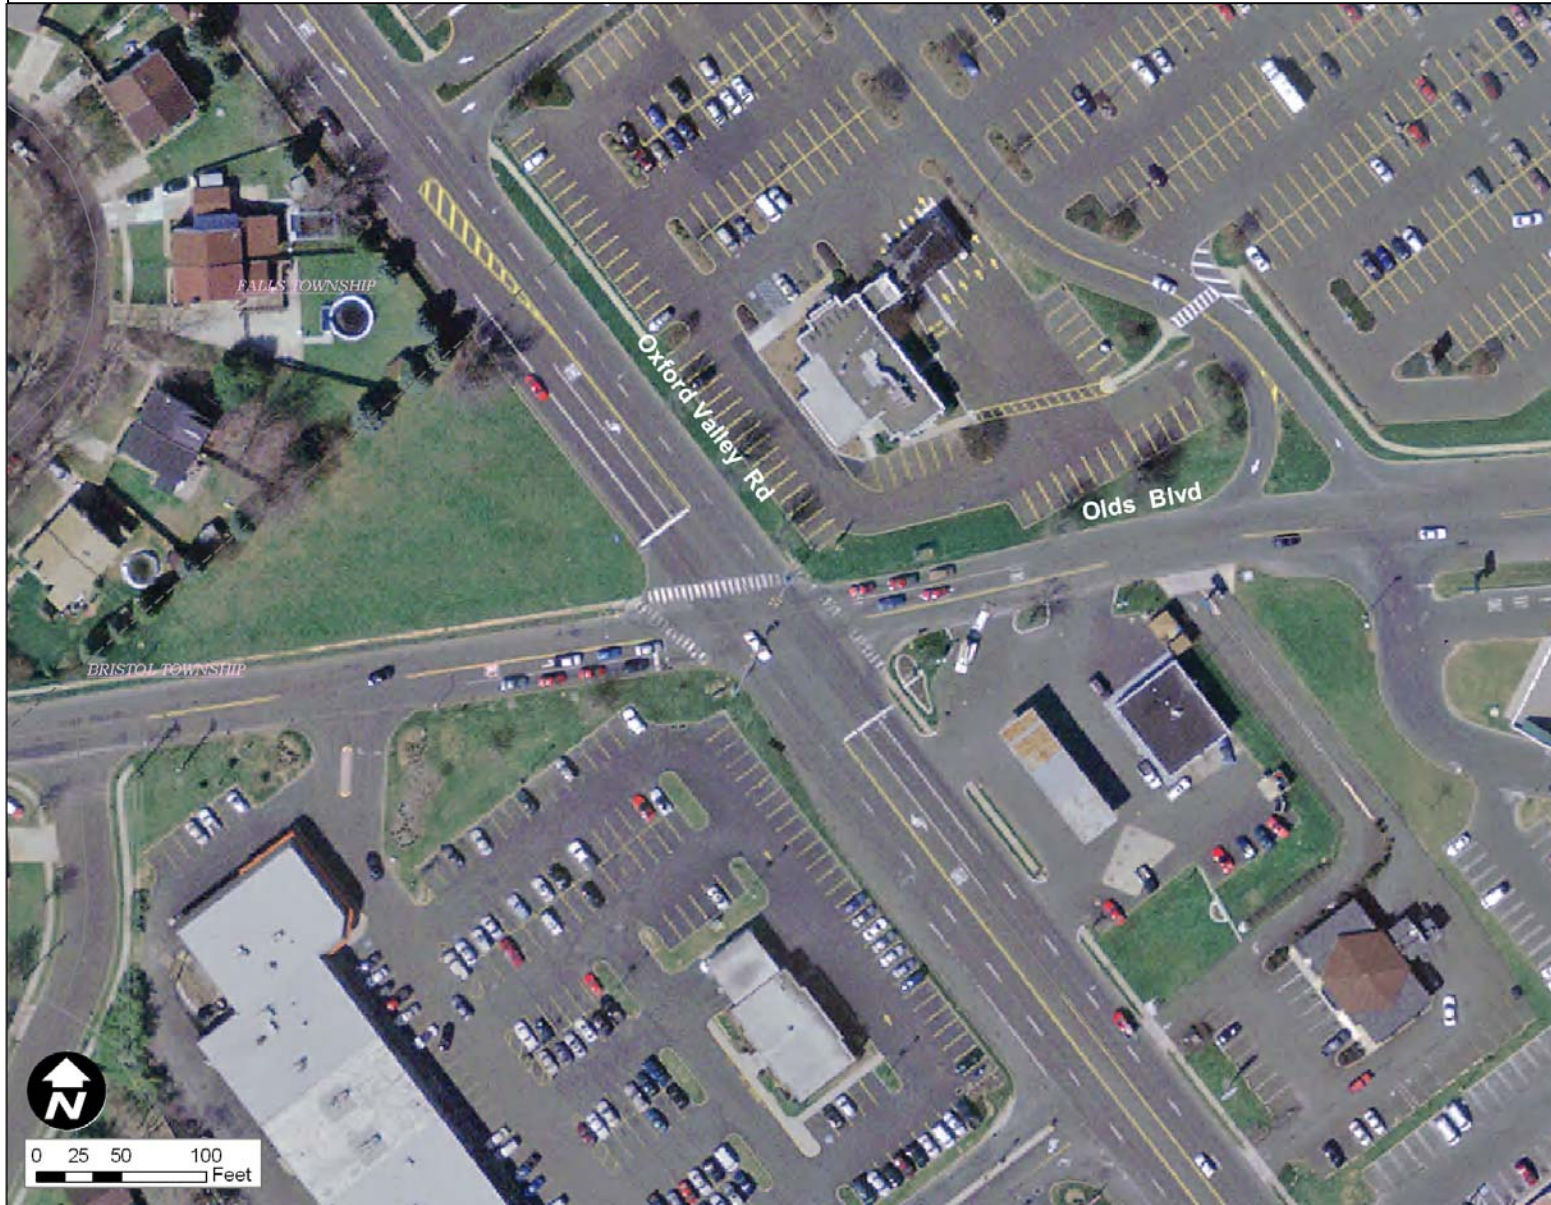
**4. Levittown Parkway (SR 2051) at Olds Blvd**  
 Segment 60/1858 to Segment 61/1926

COLLISION TYPE	
Angle	10
Rear-end	4
Left Turn Involved (Angle)	2
<b>Total</b>	<b>16</b>
SEVERITY COUNT (people)	
Fatalities	0
Major	1
Moderate	1
Minor	7
Unk Severity	13
Unk If Injured	0
<b>Total</b>	<b>22</b>

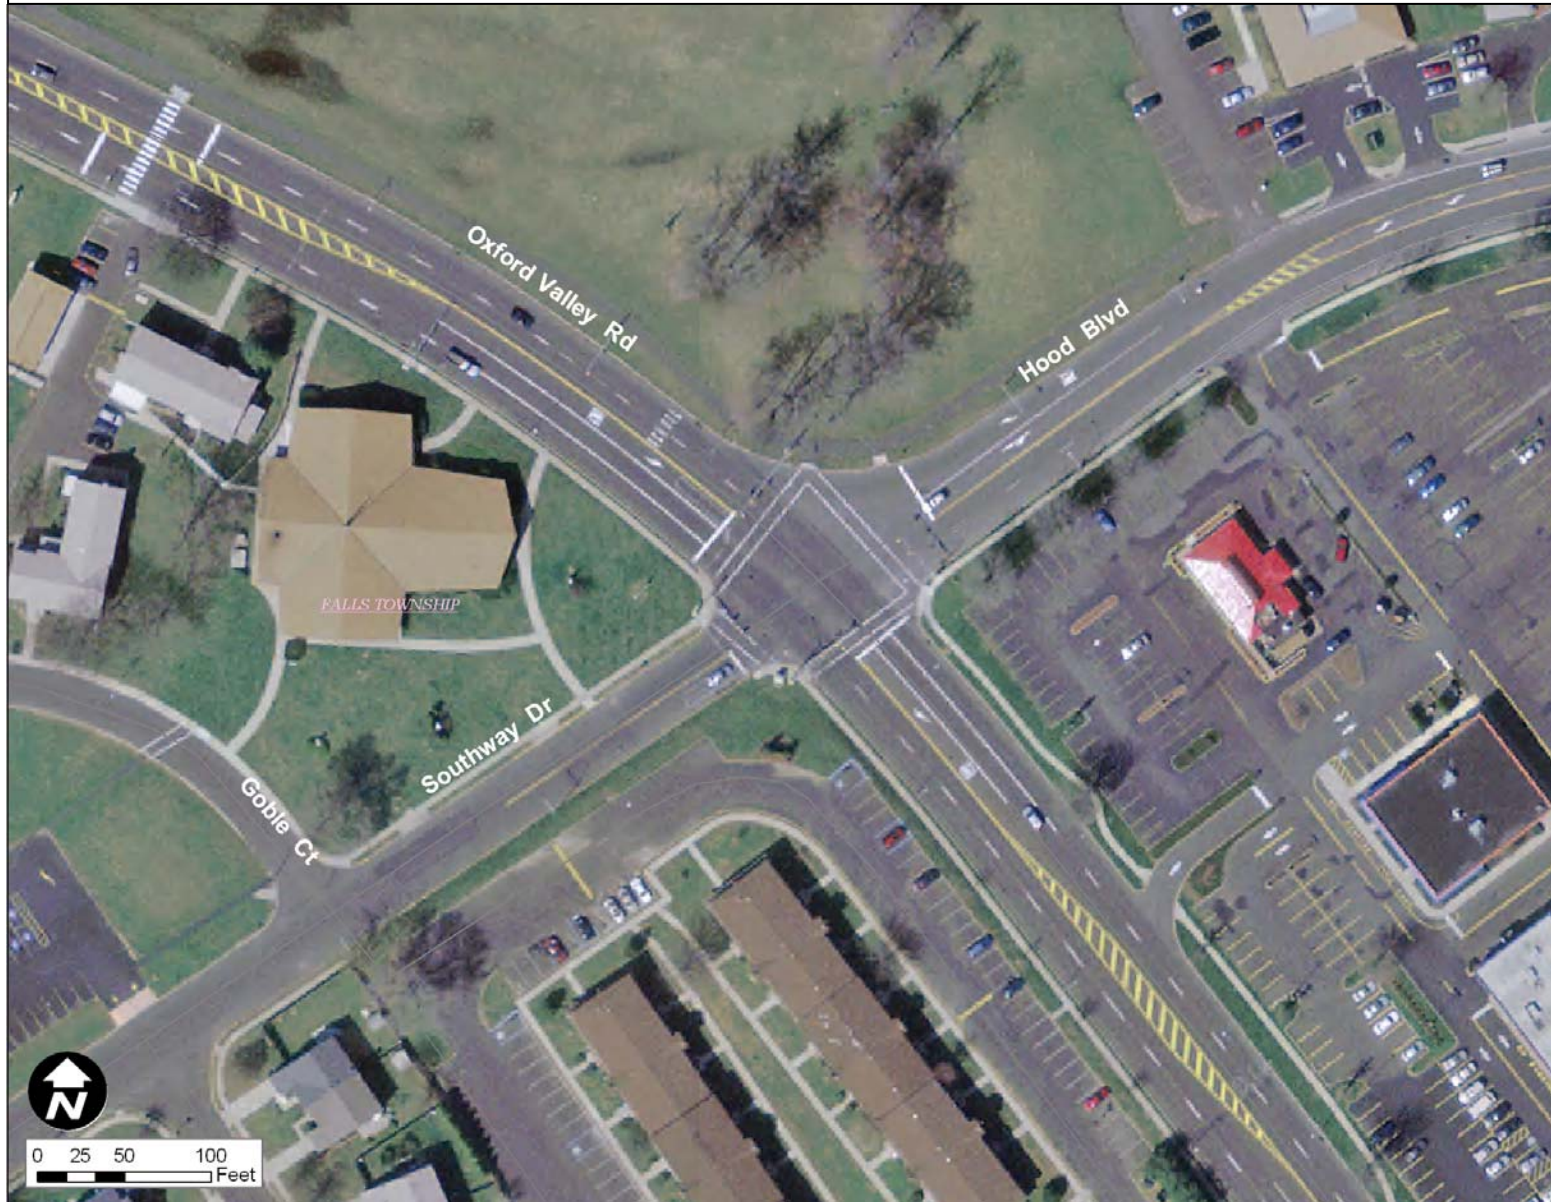
**5. Levittown Parkway (SR 2051) at Southway Dr / Hood Blvd**  
 Segment 60/3334 to Segment 61/3245

COLLISION TYPE	
Angle	5
Rear-end	4
SD Sideswipe	1
Left Turn Involved (Angle)	3
Right Turn Involved (Angle)	1
<b>Total</b>	<b>14</b>
SEVERITY COUNT (people)	
Fatalities	0
Major	0
Moderate	2
Minor	3
Unk Severity	5
Unk If Injured	1
<b>Total</b>	<b>11</b>
