Delaware Valley
Regional Planning
Commission

DECEMBER 2008

PA 10

Road Safety Audit

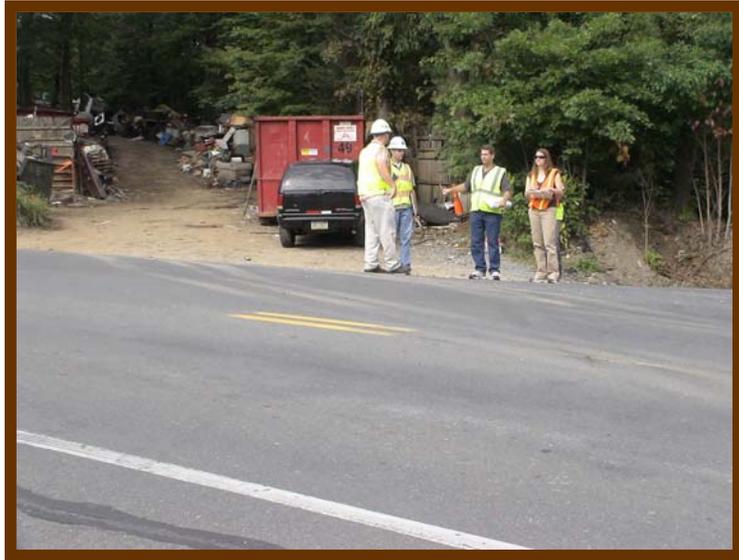
Scrapyard entrance on PA 10 next to Shirktown Road

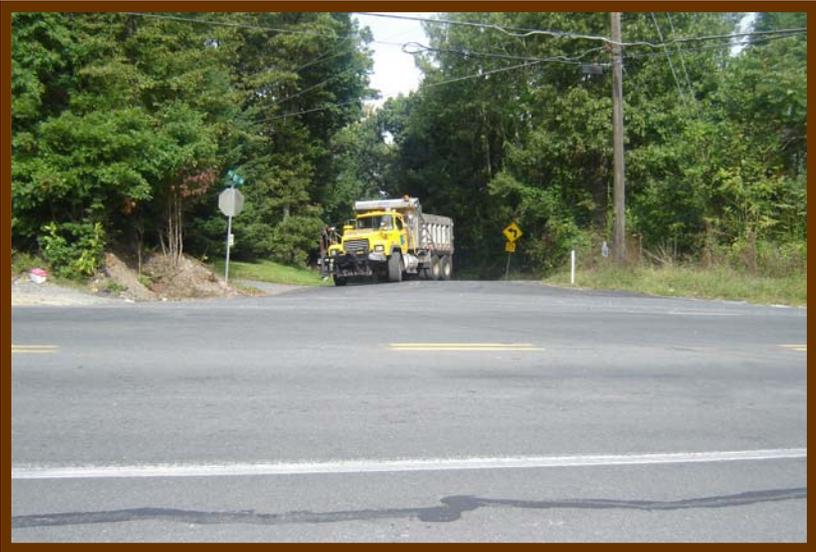
The skewed Shirktown Road approach to PA 10

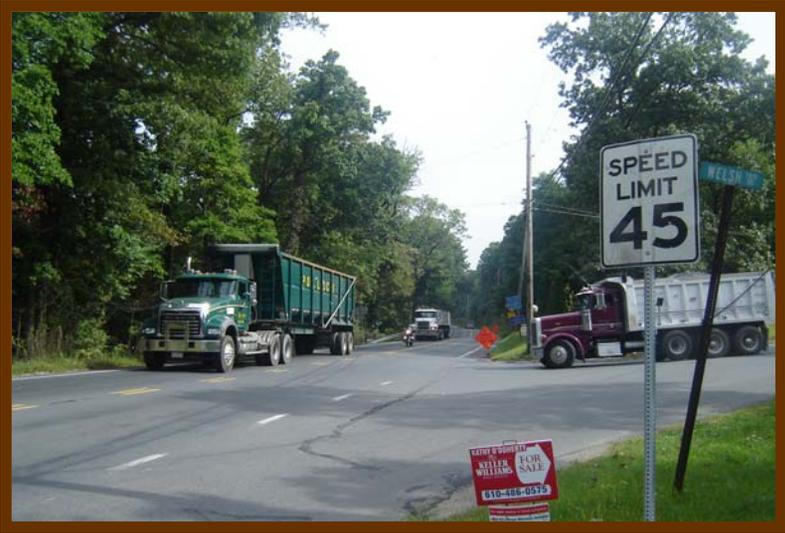
Welsh Road approach to PA 10

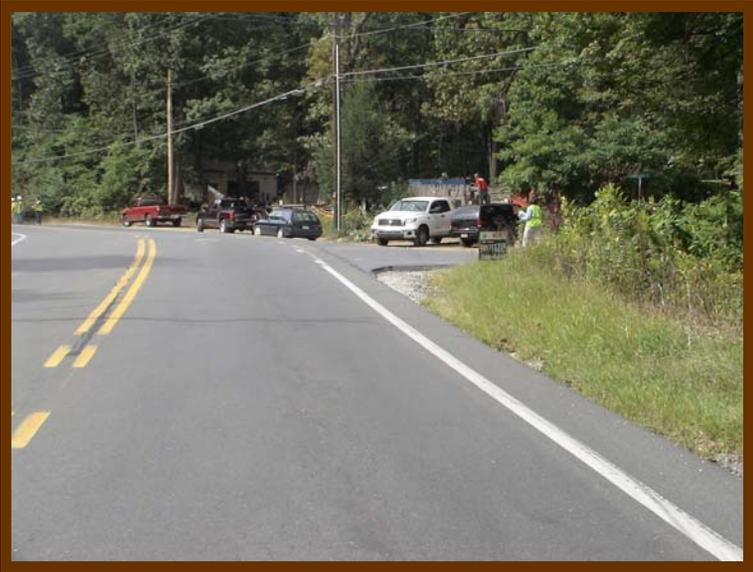
Scrapyard access and Shirktown Road located on a curve on PA 10

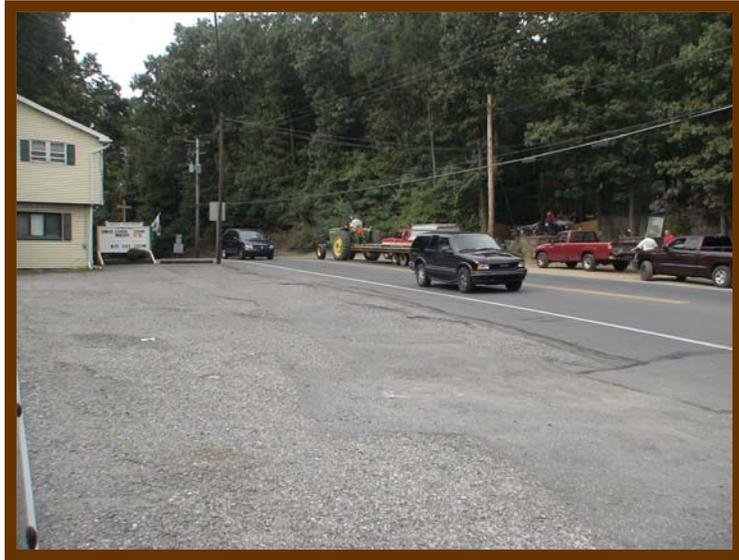
Open access and edge drop off at the church parking lot on the northbound side of PA 10

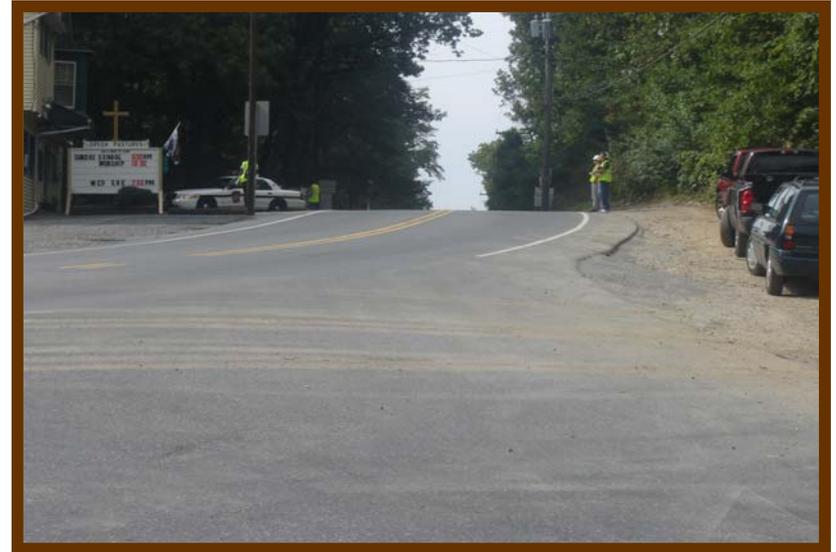
Edge drop off adjacent to Scrap yard entrance on PA 10. This area is usually used for parking by patrons

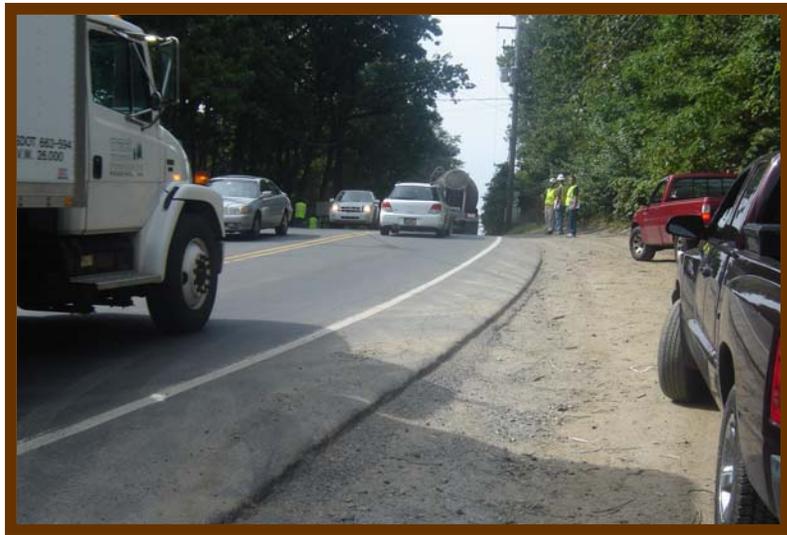
Edge drop off south of Shirktown Road on PA 10.

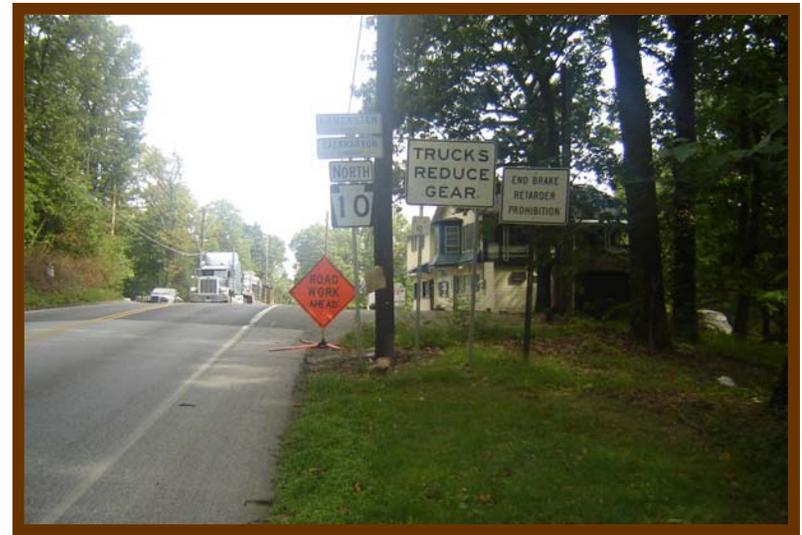
Crest approaching Shirktown Road traveling north on PA 10

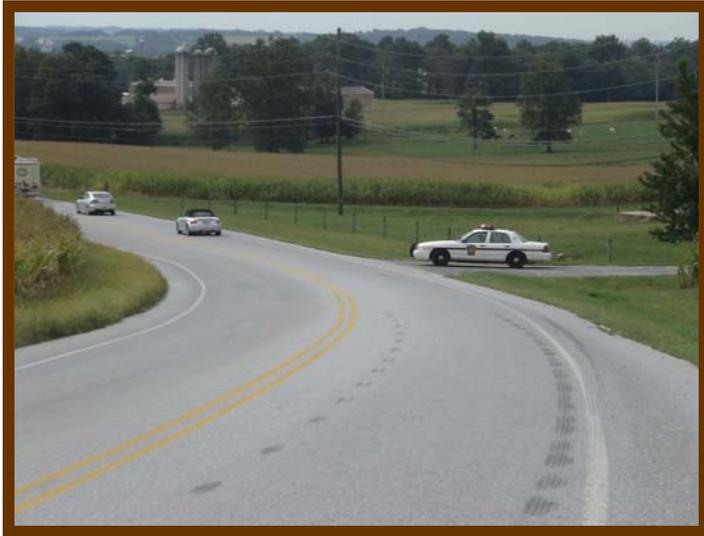
Reservoir Road/PA 10 skewed intersection, located on a curve

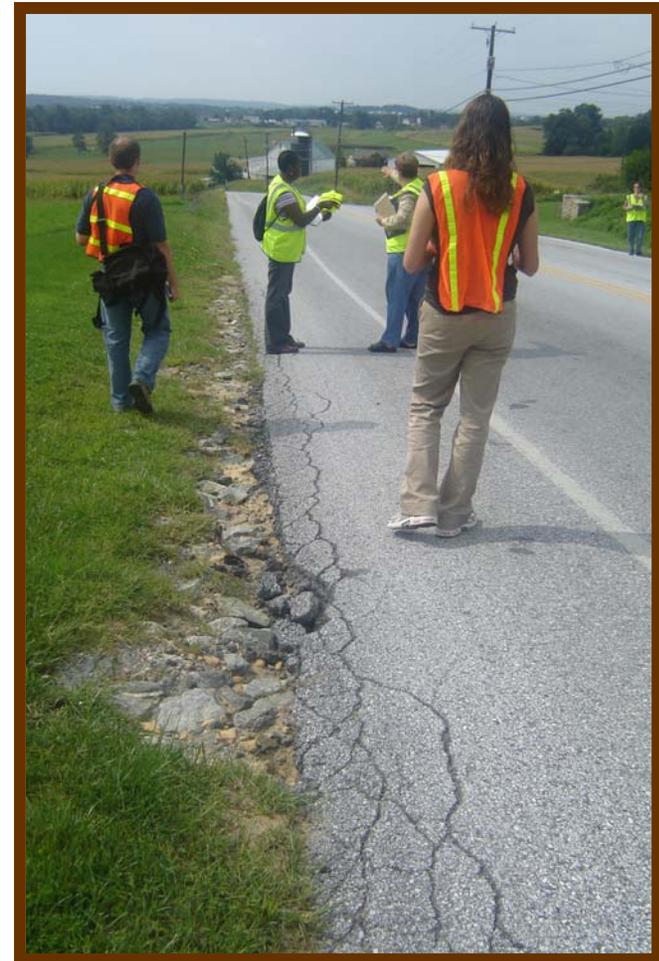
Evidence of drainage problems on eastside of PA 10, north of Reservoir Road

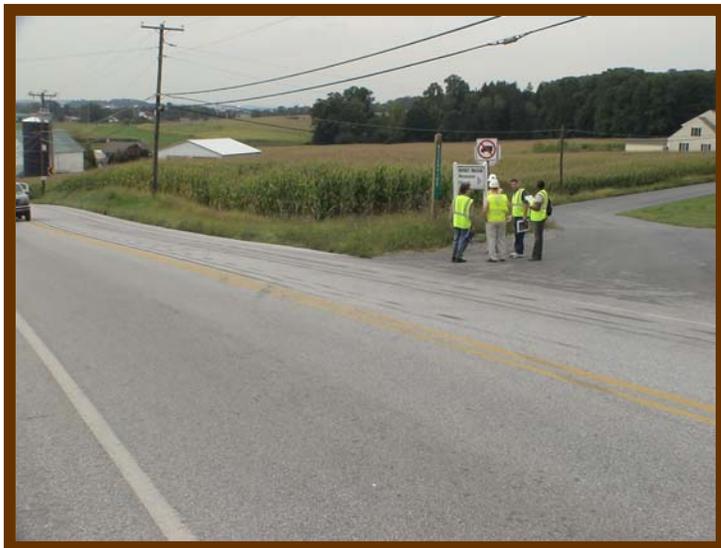
No pavement marking visible on Reservoir Road

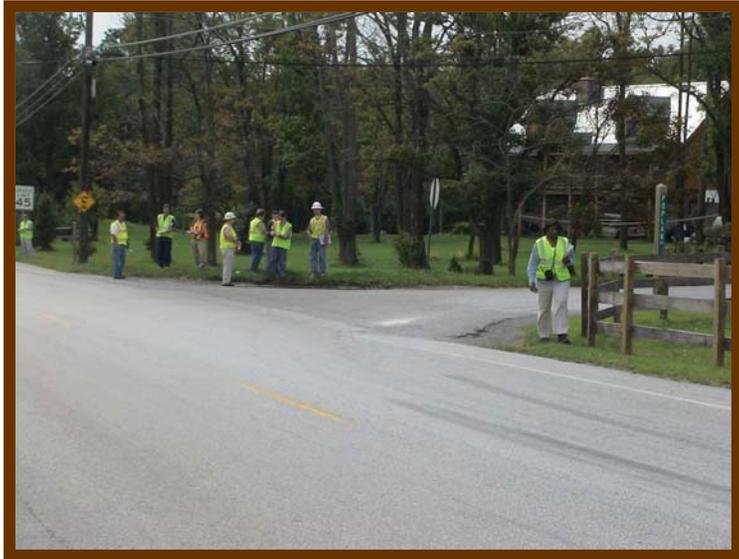
Pavement marking on PA 10 continues through the intersection at Poplar Road

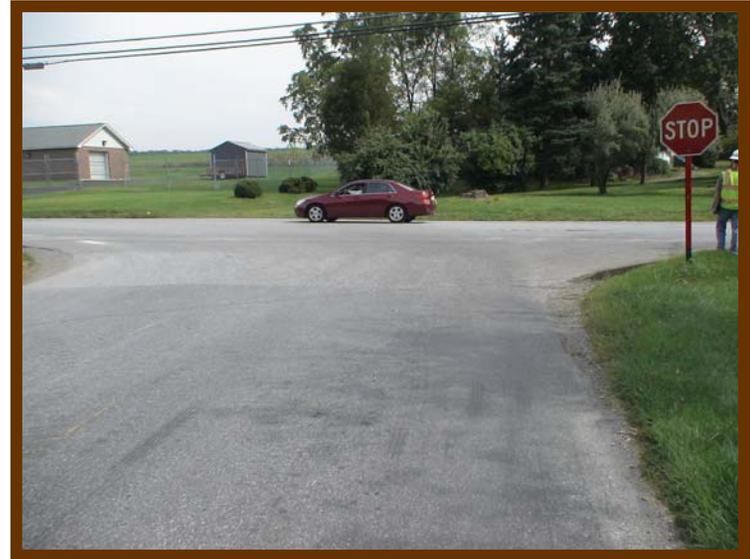
Faded pavement markings on Poplar Road. "Stop" sign is mounted too low

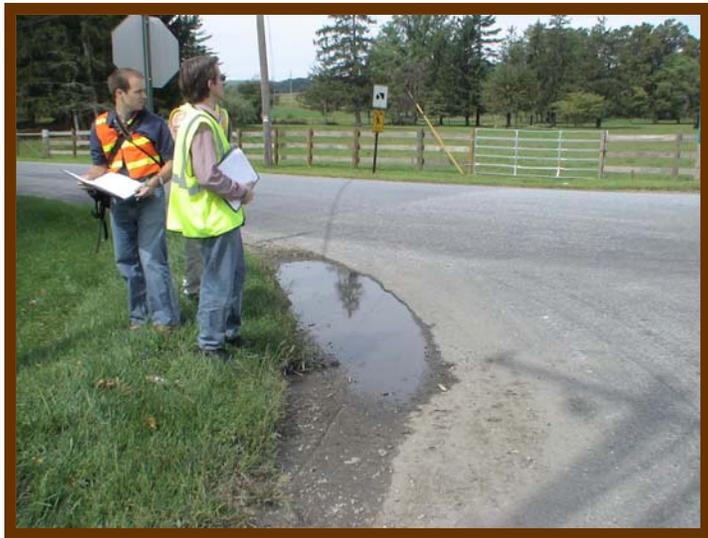
Water pooling on the corner of Poplar Road

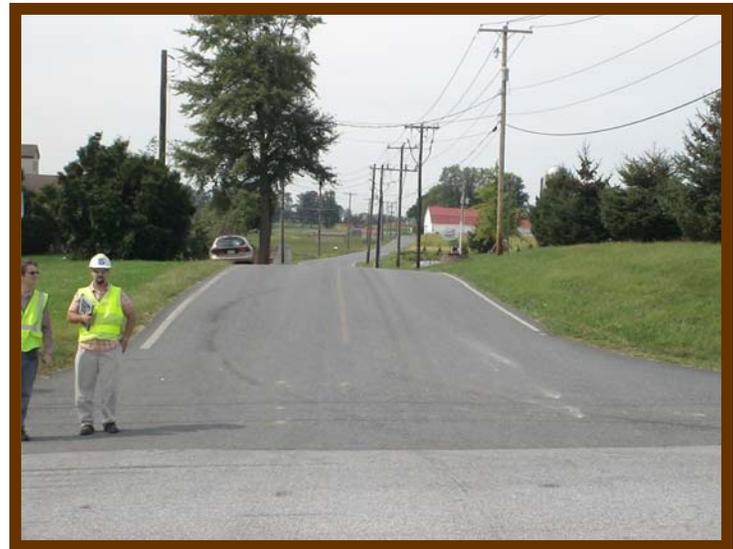
Faded pavement markings at Todd Road.

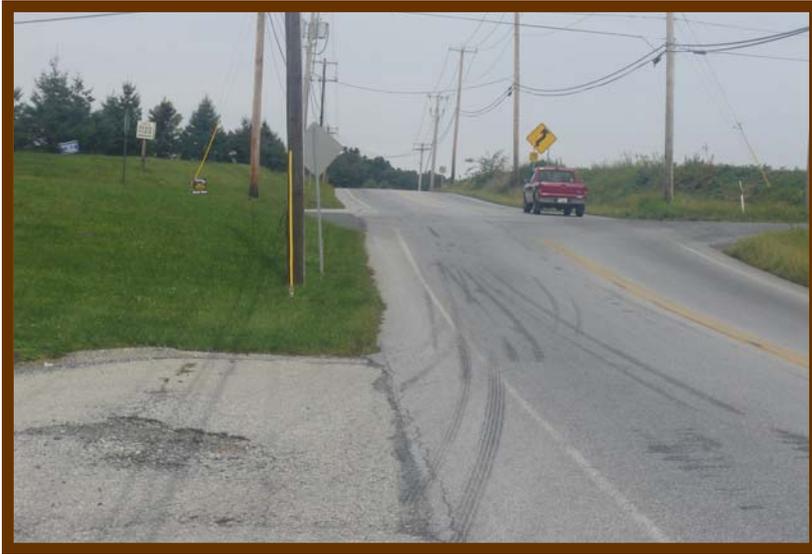
Todd Road intersection located on a grade. Limited sight distance for Todd Road traffic for southbound PA 10 traffic

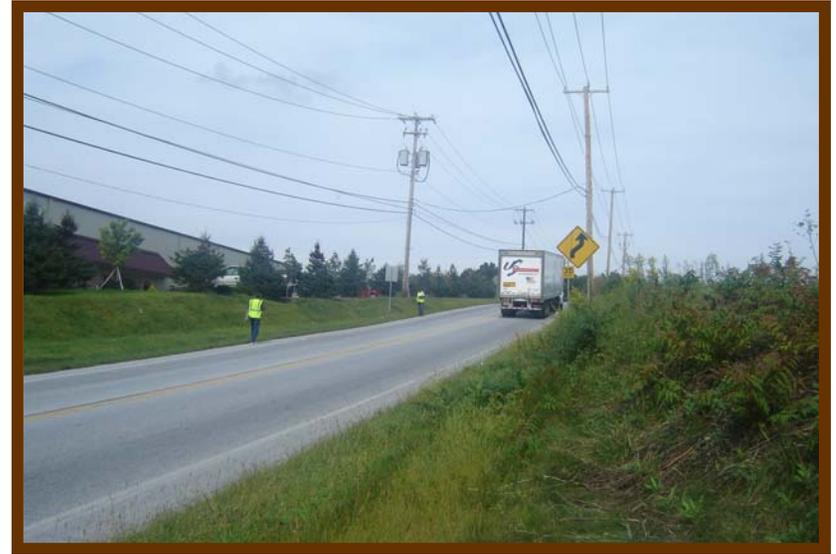
Grade north of the Todd Road intersection

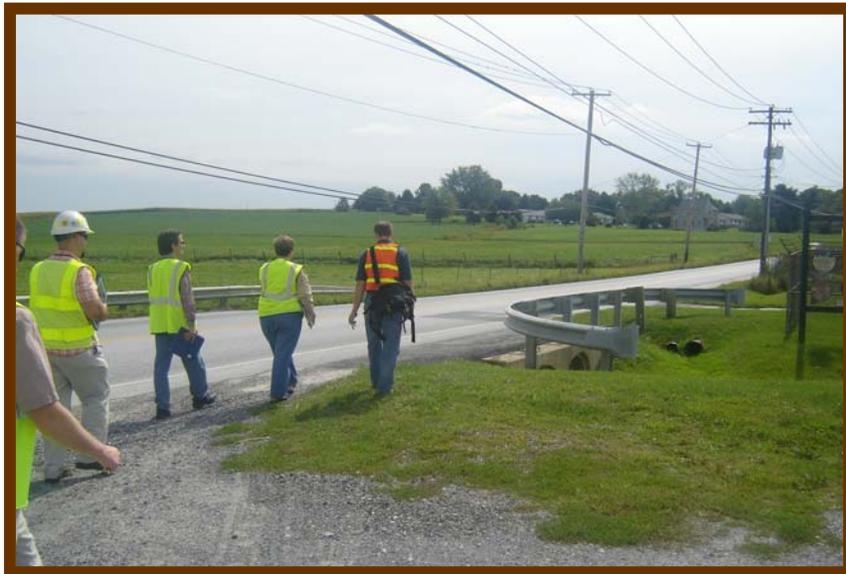
Guide rail just south of the Todd Road intersection protecting the drainage pipes

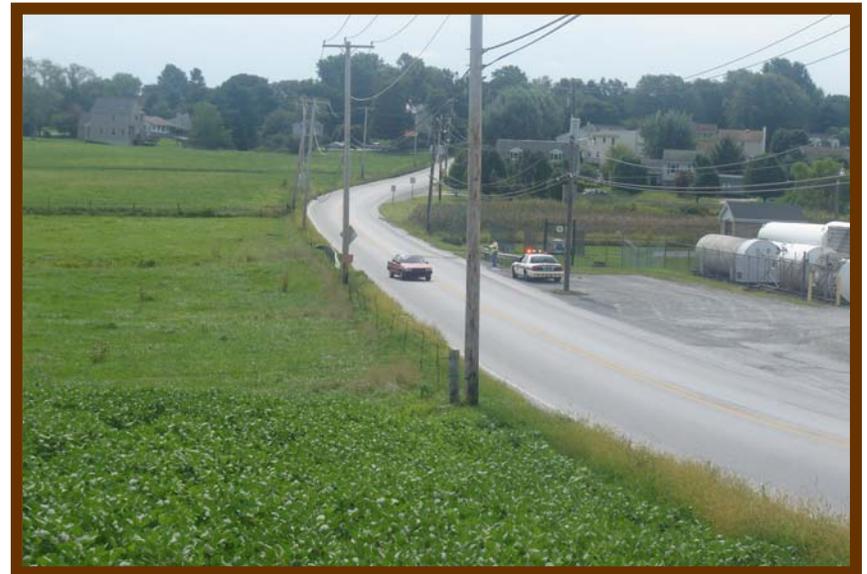
Open access to business located on the southwest corner of Todd Road intersection

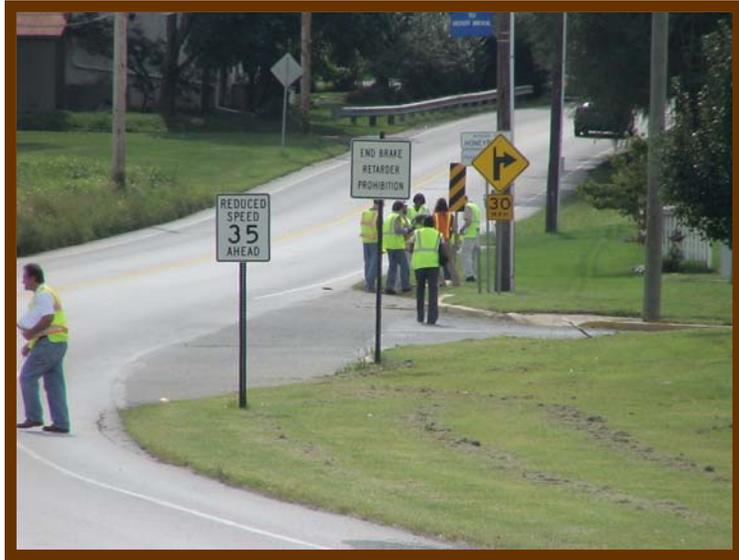
Sign clutter at Wawassan Drive.

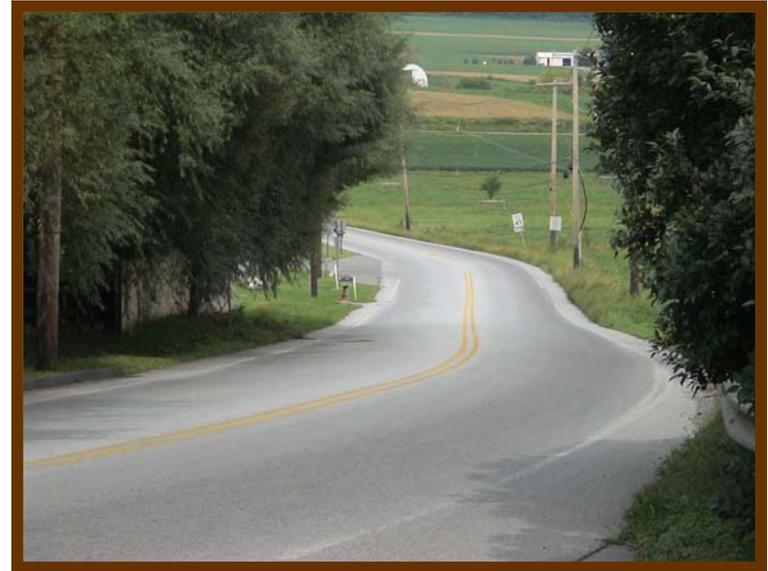
Trees overhang the roadway north of Water Street

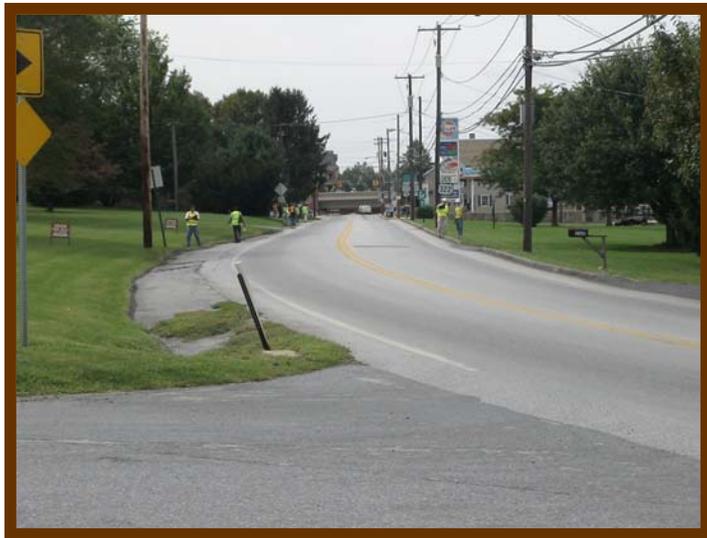
Sign post with no sign on the corner of Water Street

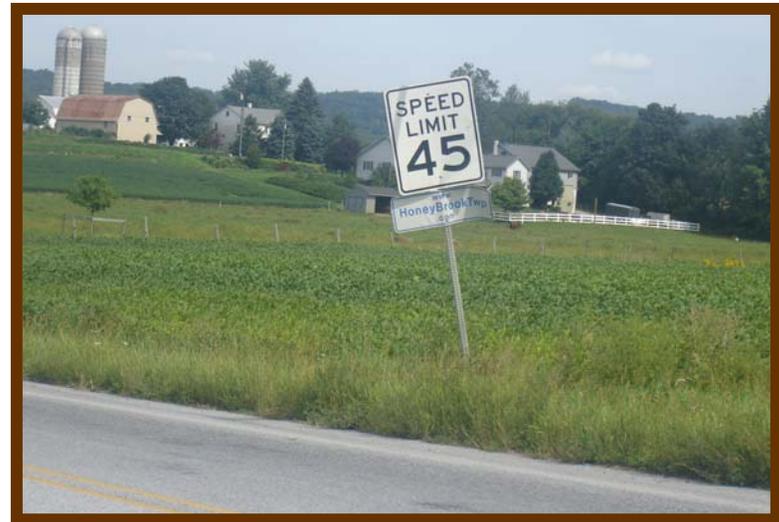
Damaged sign opposite Wawassan Drive

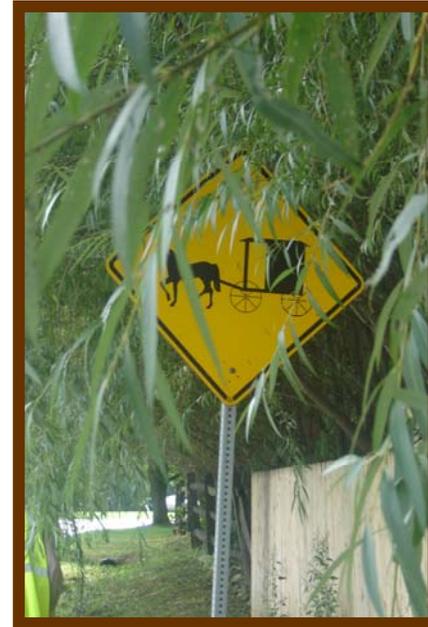
Sign blocked by tree branches south of Wawassan Drive

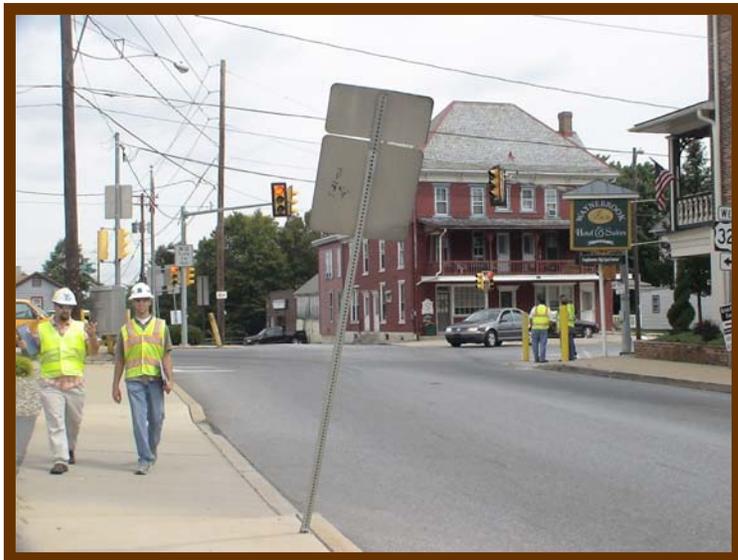
Sign leaning in the travel way south of the US 322 intersection on the southbound side of PA 10

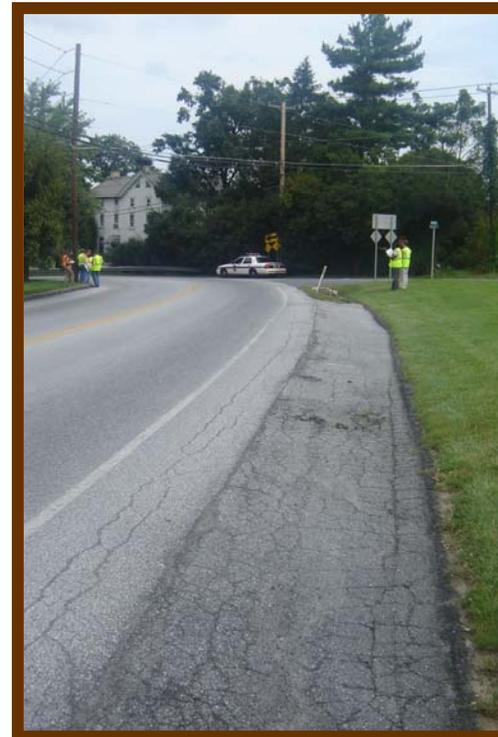
Evident of drainage problems on eastside of PA 10, south of Water Street

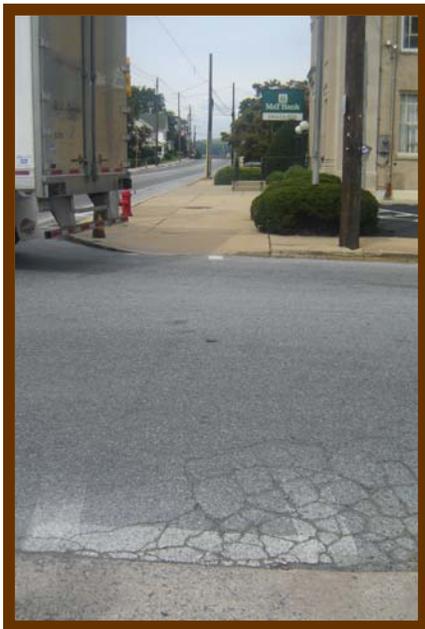
Pavement markings are faded at the US 322/PA 10 intersection

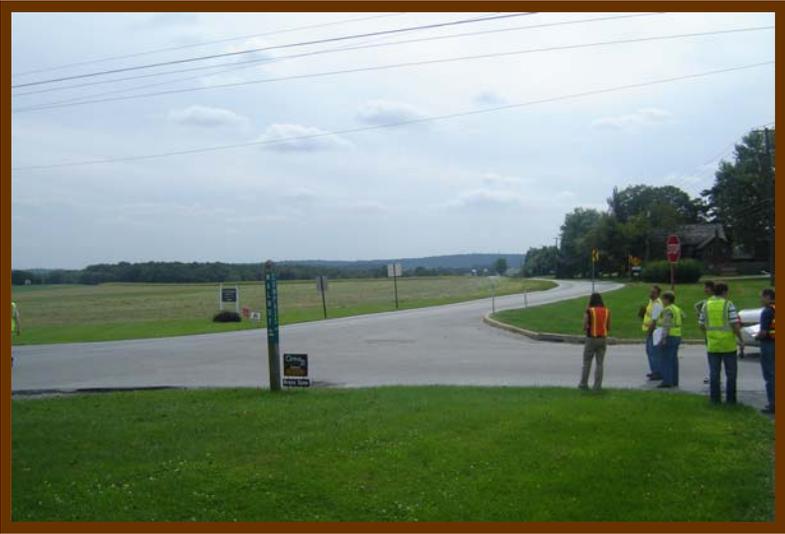
Open land on the southeast corner of Walnut Road intersection is site of proposed housing development

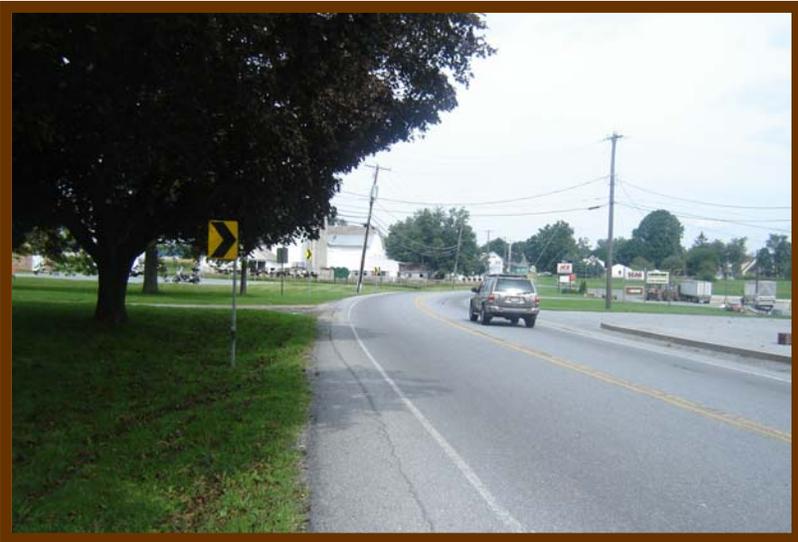
Curve north of the Walnut Road intersection

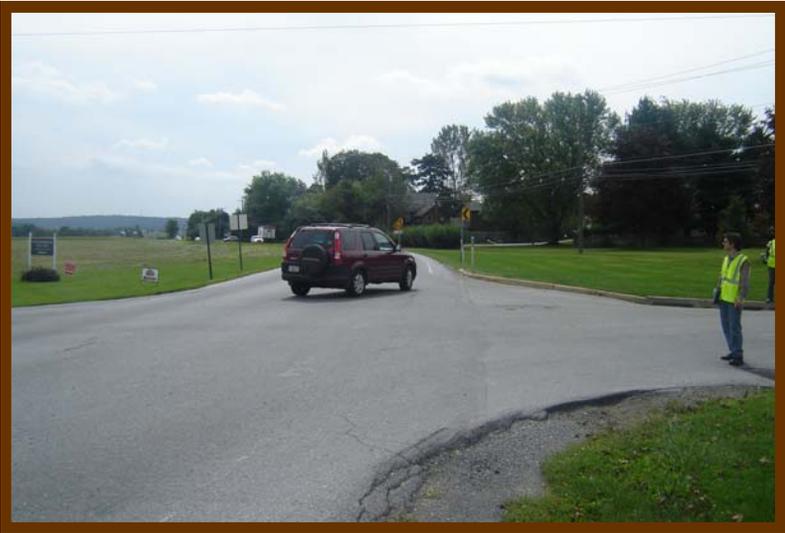
Edge drop off at the northwest corner of the Walnut Road intersection

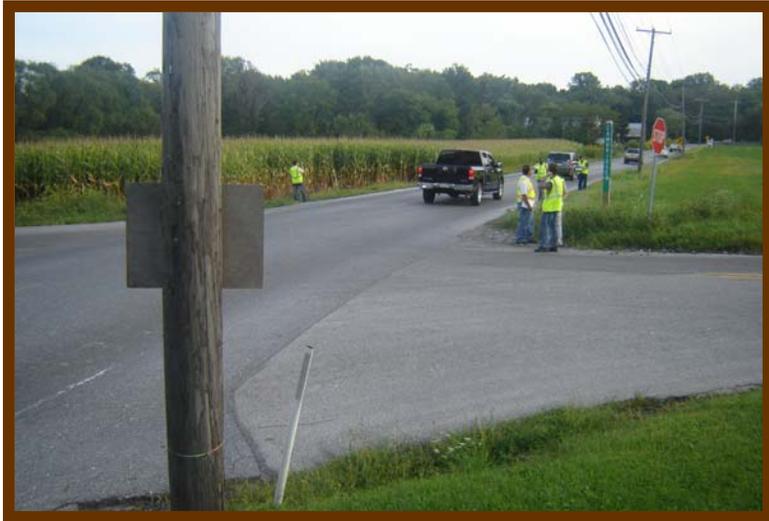
On the northeast corner of the Cambridge Road intersection – hole marked by delineator. There are no stop bars on Cambridge Road approaches

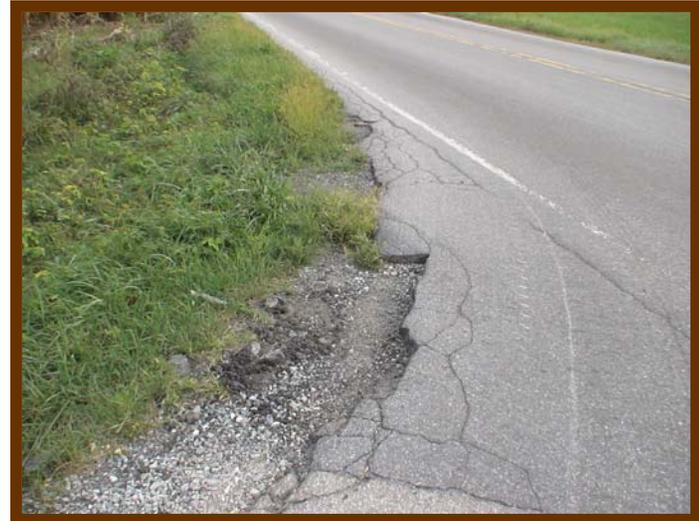
On the northwest corner of the Cambridge Road intersection the pavement is breaking away, maybe indicative of a drainage problem

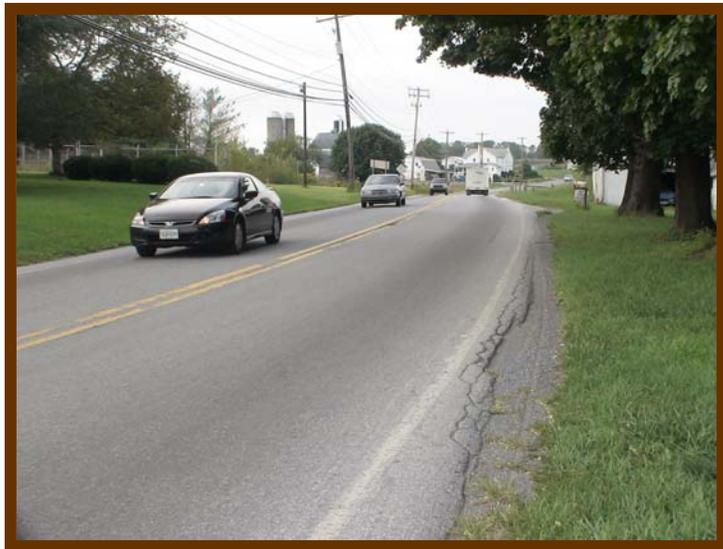
Shoulder breaking away north of the PA 10/Cambridge Road intersection. Pavement markings are fading

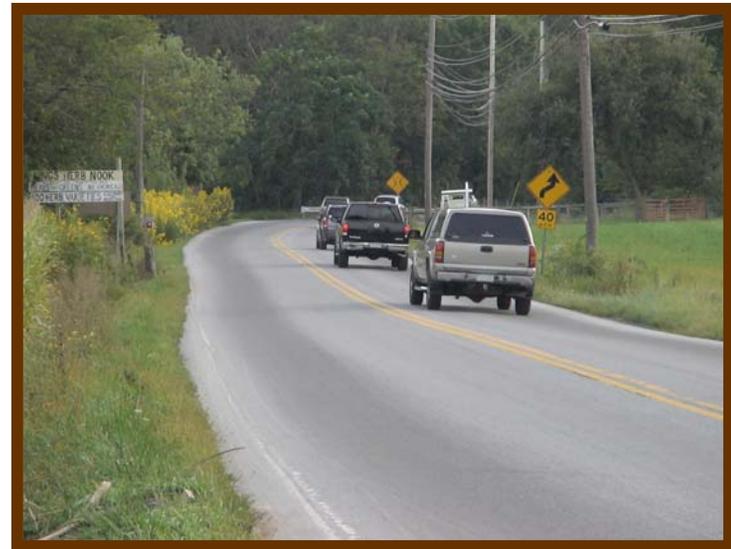
South of the PA 10/Cambridge Road intersection, shoulders are narrow and pavement markings are faded

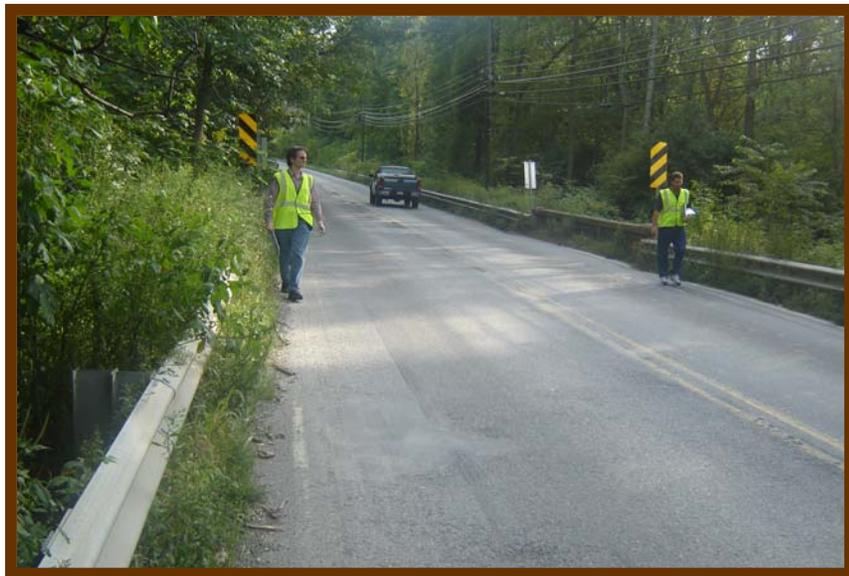
Narrow bridge south of the PA 10/Cambridge Road intersection, guide rail is too low and lacks delineation.

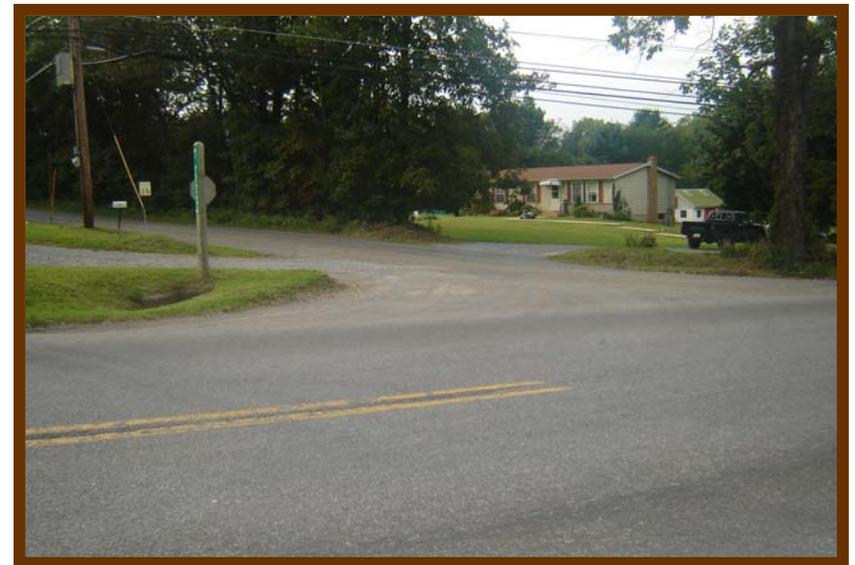
Unprotected U-shaped culvert on the southwest corner of the Mt Pleasant Road intersection

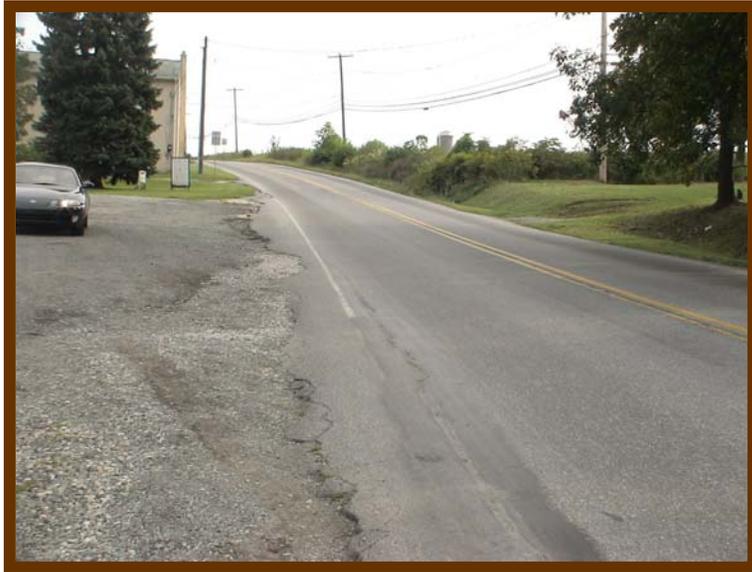
Open access area with edge drop off opposite Mount Pleasant Road on the northbound side of PA 10

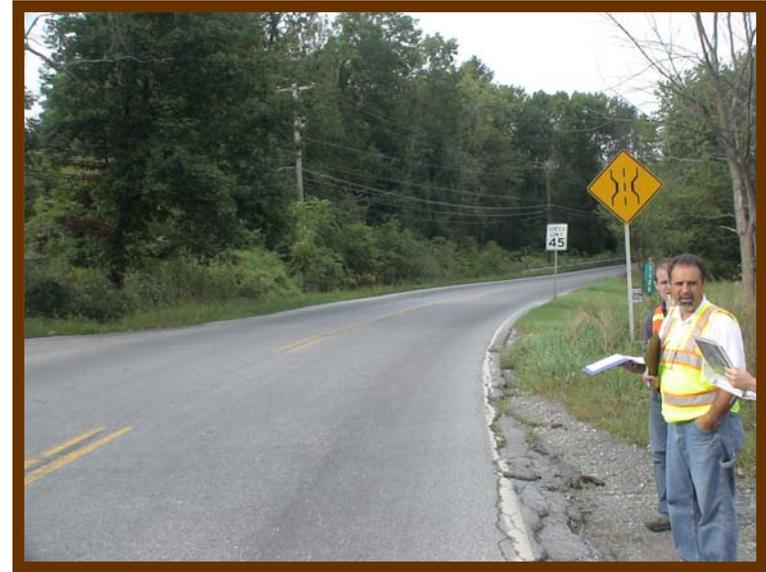
Shoulder breaking away opposite Mount Pleasant Road on the northbound side of PA 10

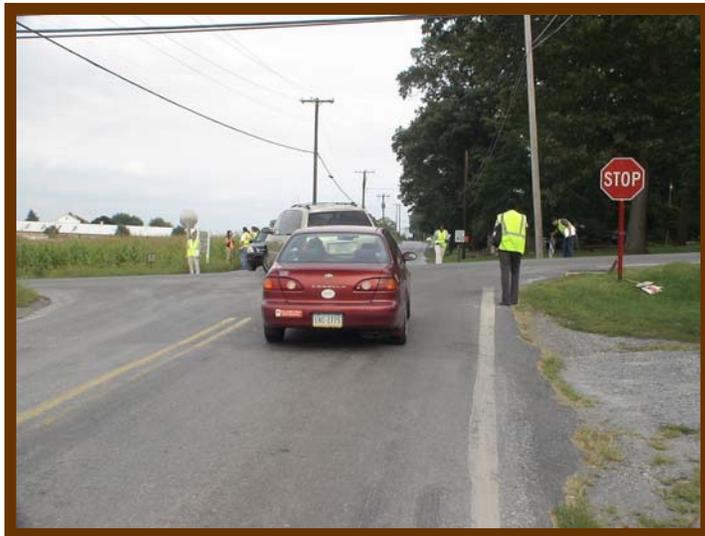
Beaver Dam Road eastbound approach to PA 10. "Stop" sign is mounted too low

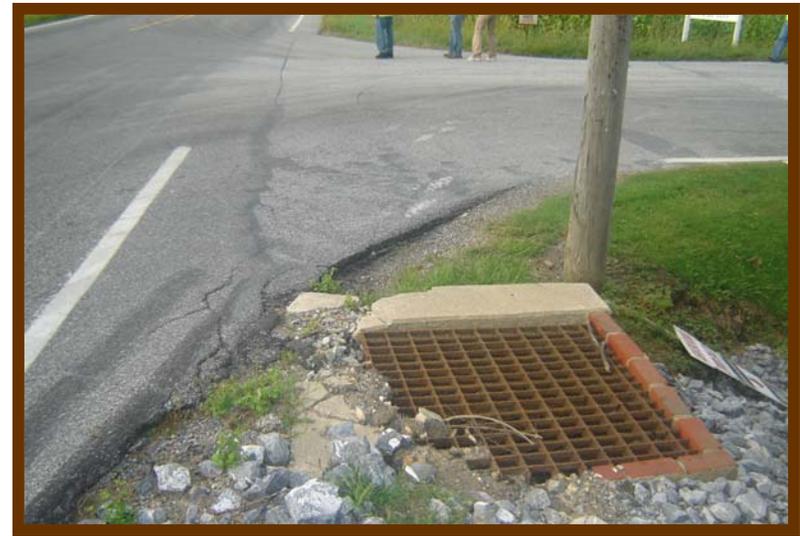
Edge drop off, headwall and grate presents safety issues at the Beaver Dam Road intersection

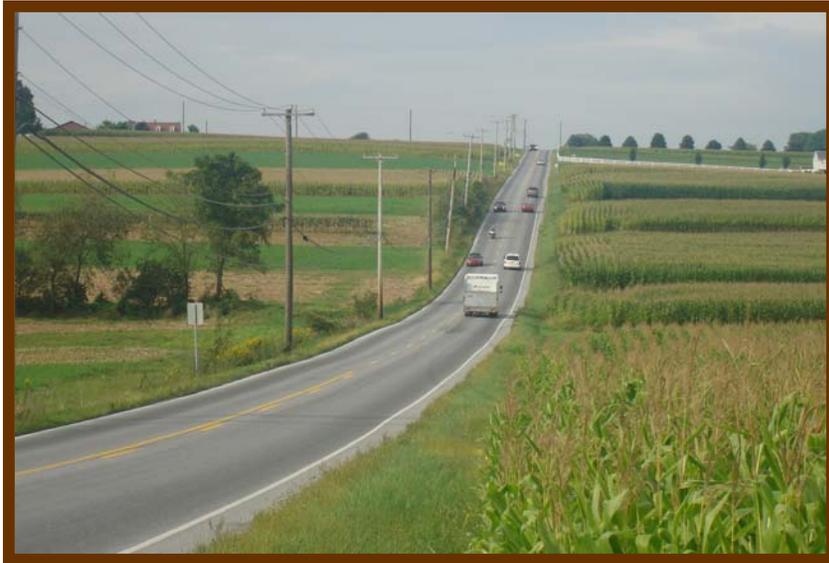
Grade north of the Beaver Dam Road intersection encourage higher speeds towards the intersection

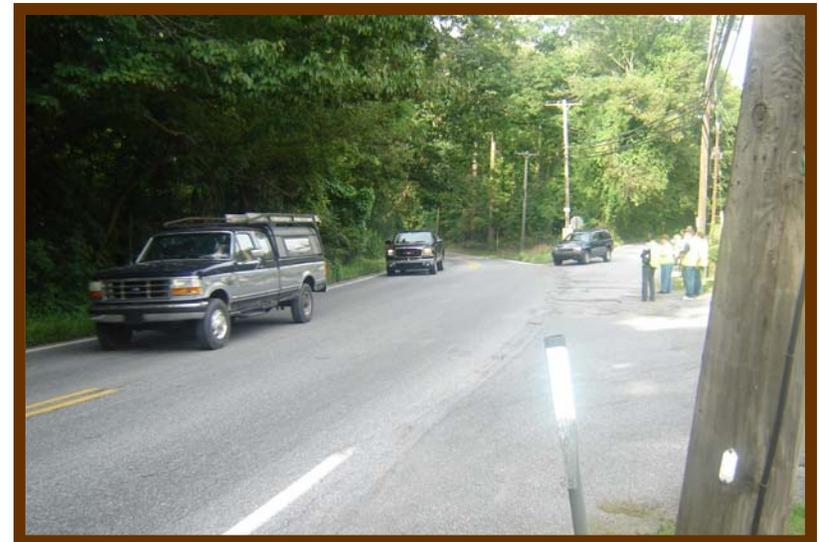
PA 10 at the Michael Road and Hill Road intersection. The curve limits sight distance

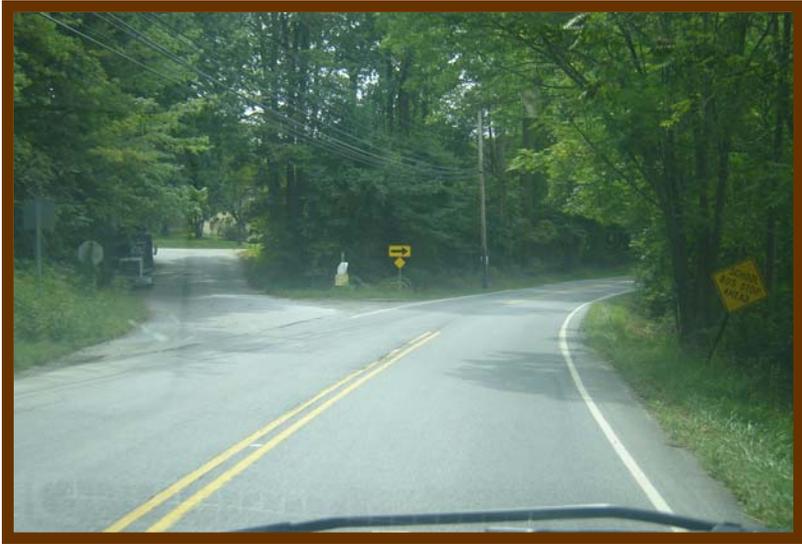
PA 10 southbound approach to the north leg of Hill Road intersection

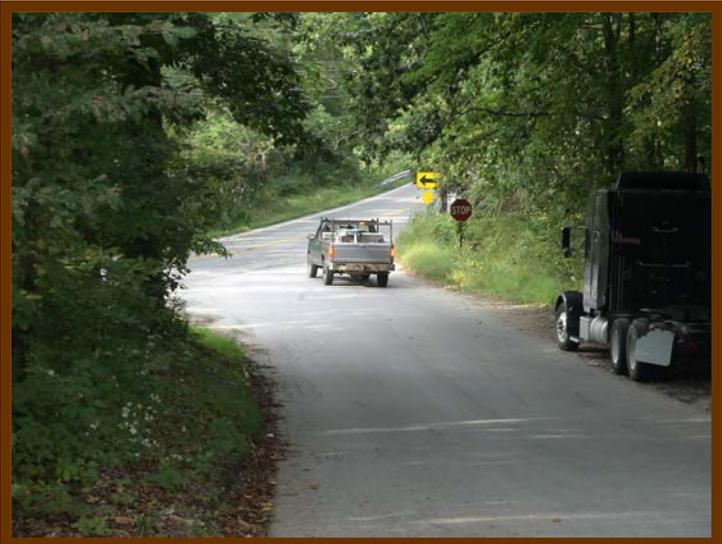
North leg of Hill Road approach to PA 10

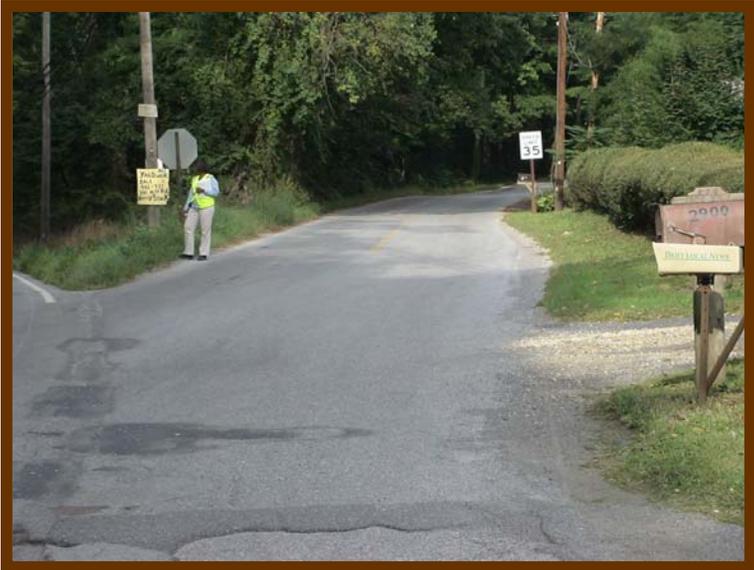
South leg of Hill Road approach to PA 10

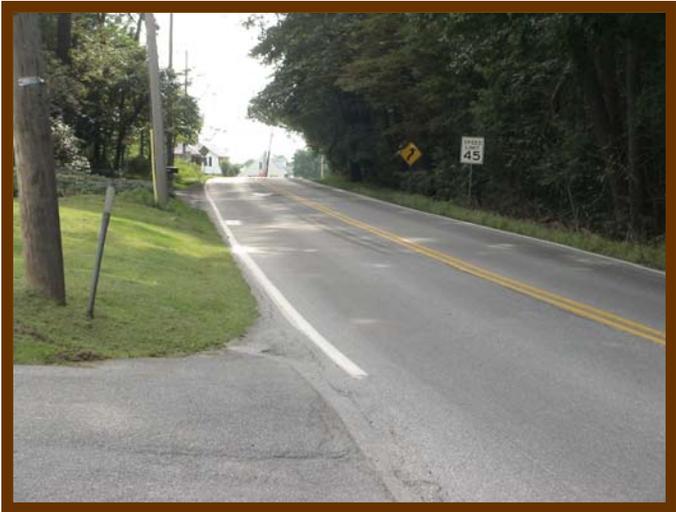
Grade and curve south of Hill Road

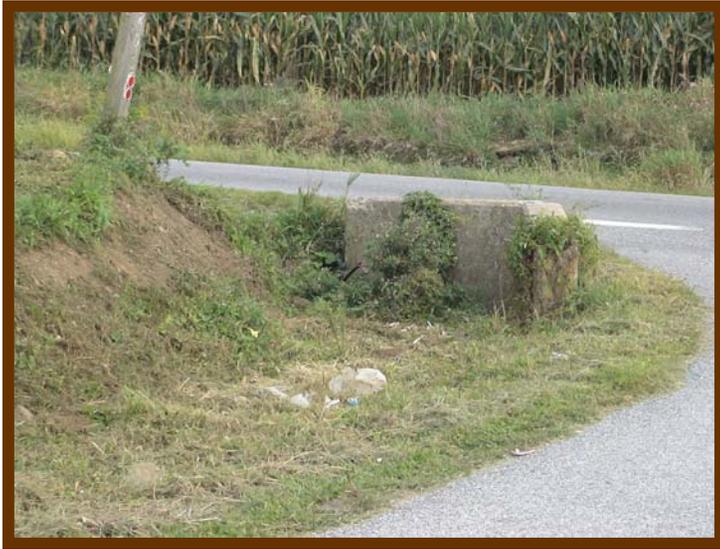
Drop off with exposed headwall on the northwest corner of Lammey Road

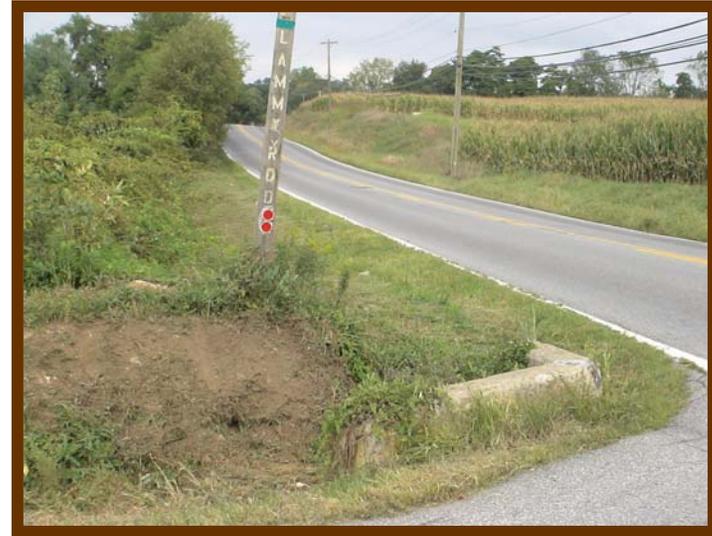
Compromised sight distance from Lammey Road by the crest of the hill to the north

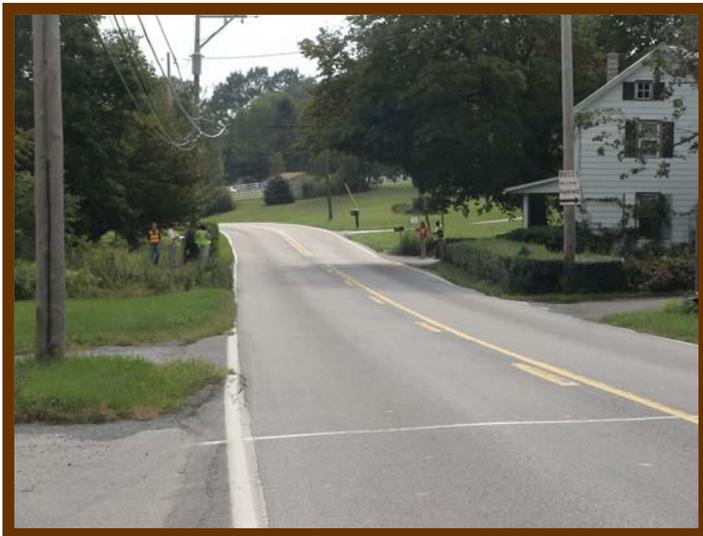
Offset intersections of Caton and Cains Roads. Shoulders are very narrow and sight distance is compromised by the curve to the south

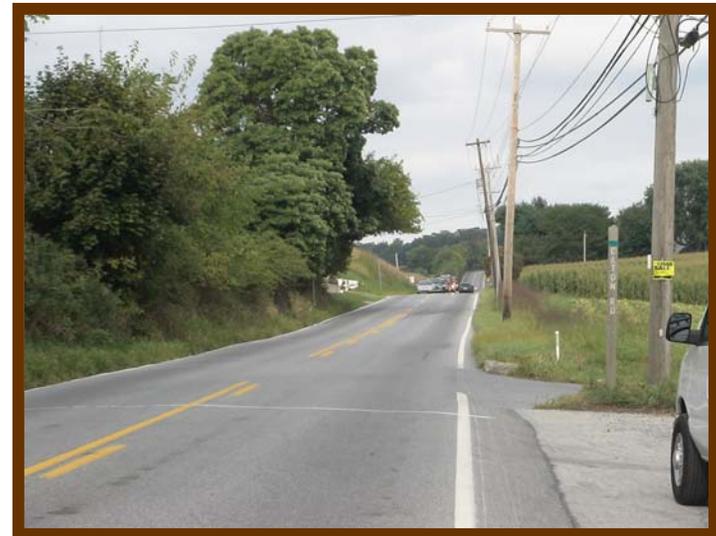
Passing zone goes through the intersection at Caton Road

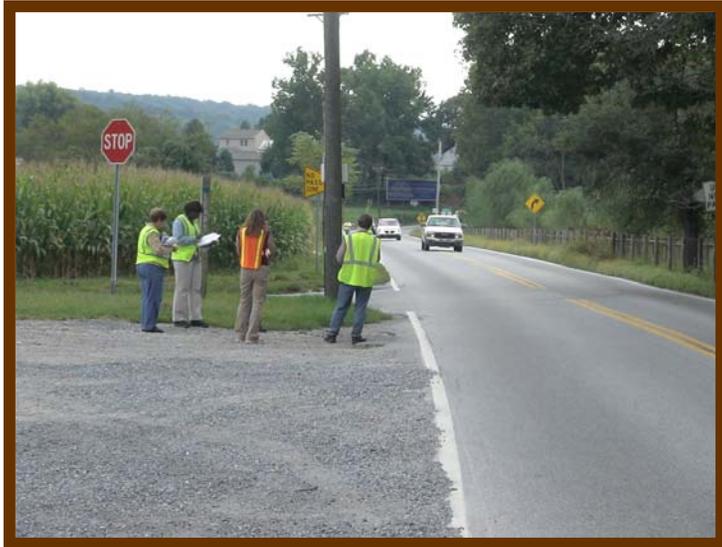
No access control at the School House Bar at Leary Road intersection. Corn field limits sight distance on the southeast corner

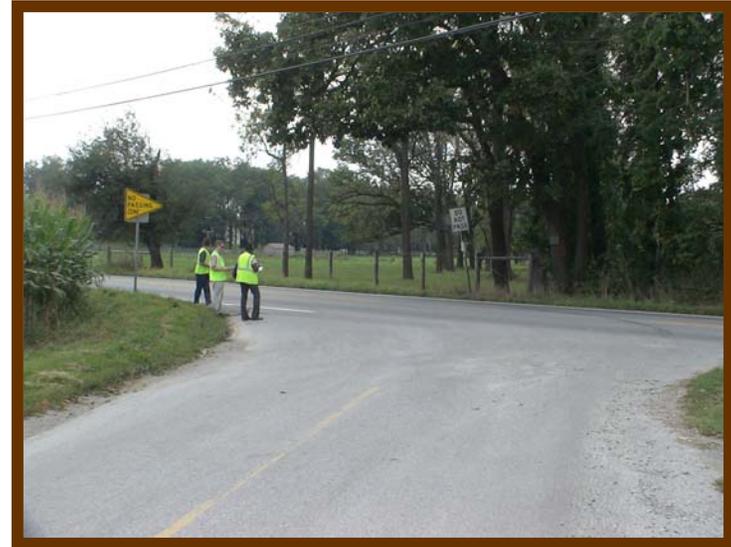
Pavement markings faded at the Leary Road approach to PA 10

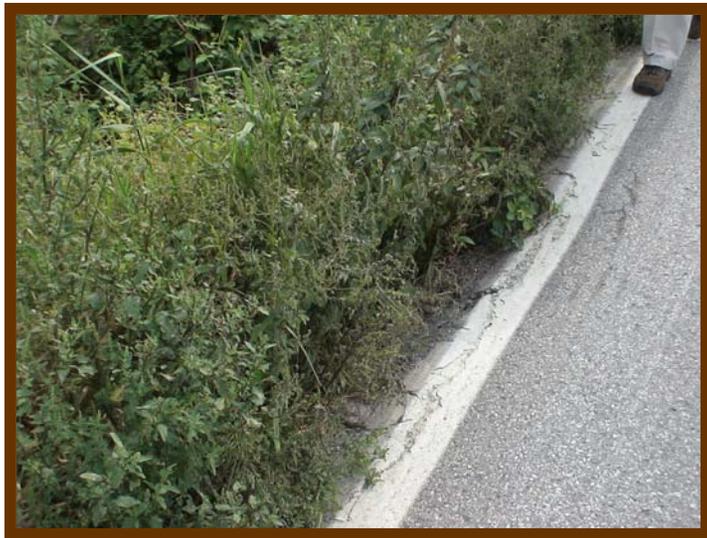
Vegetation overgrown on the shoulder of PA 10 between PA 340 and Leary Road
