Delaware Valley
Regional Planning
Commission

DECEMBER 2008

PA 10

Road Safety Audit

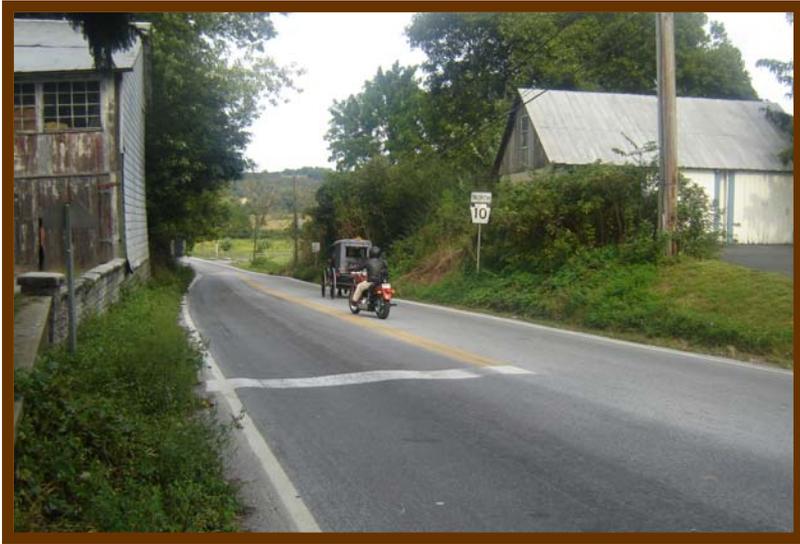
Pavement rutting at the southbound approach of the intersection with PA 340

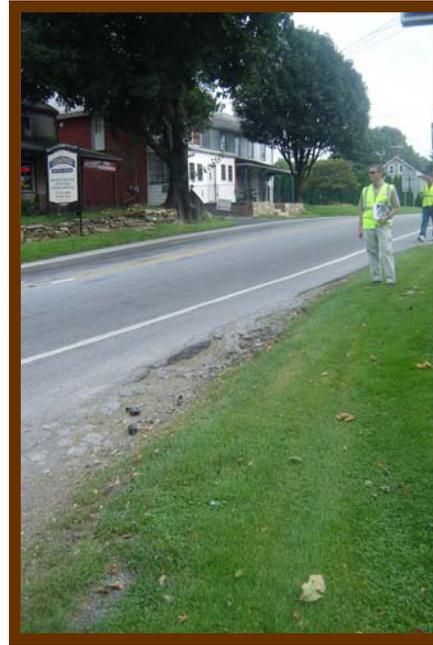
Pavement crumbling in front of the Turkey Hill Store – could signify a drainage problem

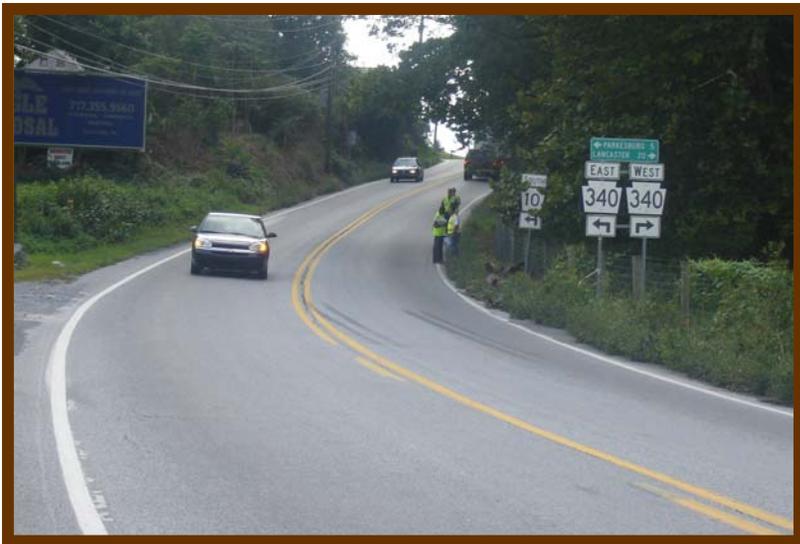
Many signs and sign posts at the southbound PA 10 approach of the intersection with PA 340

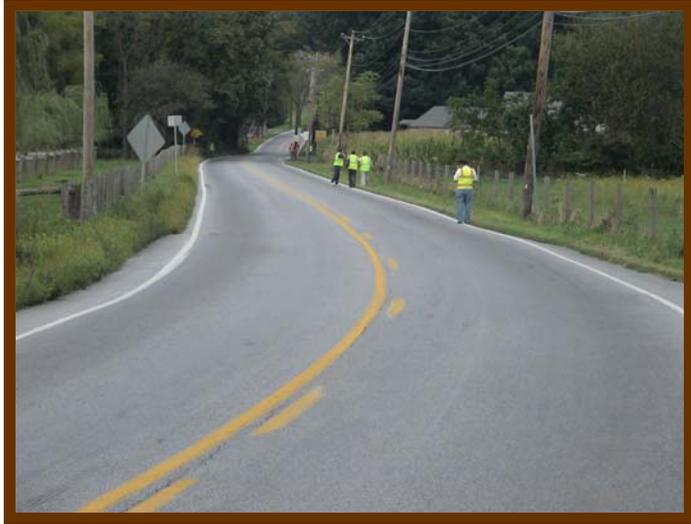
Passing zone north of the PA 10/PA 340 signalized intersection

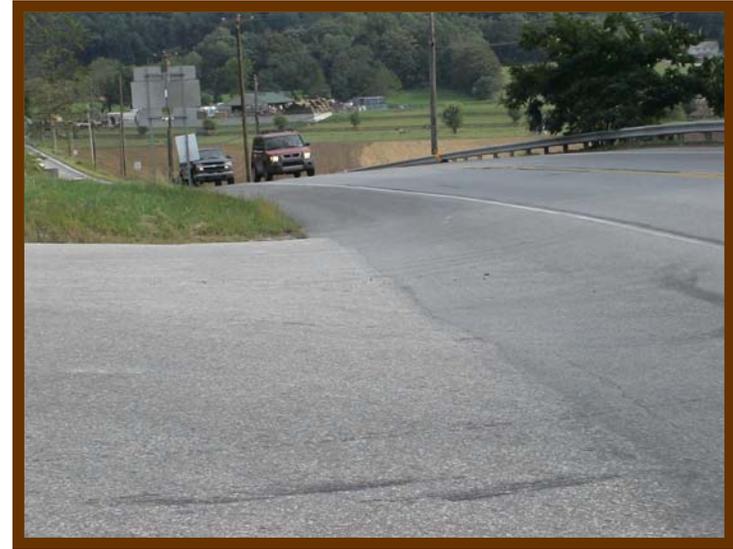
Compromised sight distance at the PA 10/PA 340 unsignalized intersection for traffic entering PA 10

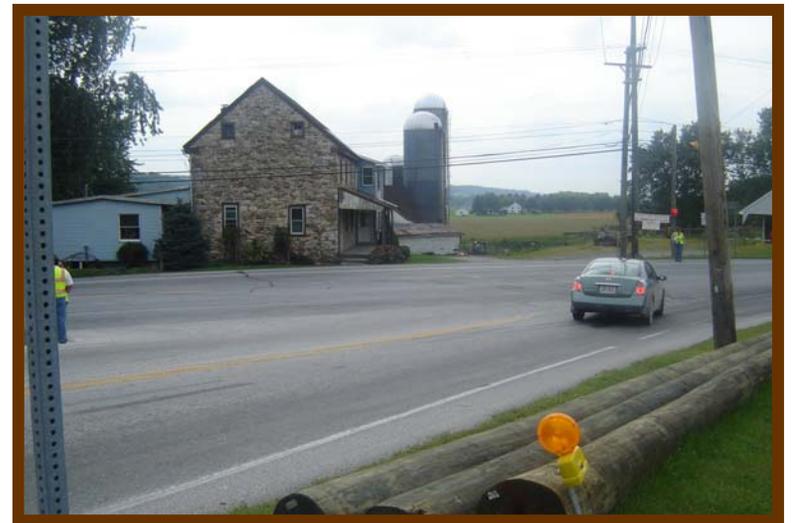
PA 340 approach to the PA 10/PA 340 unsignalized intersection. There is no stop bar. The intersection is skewed. PA 340 slopes towards PA 10

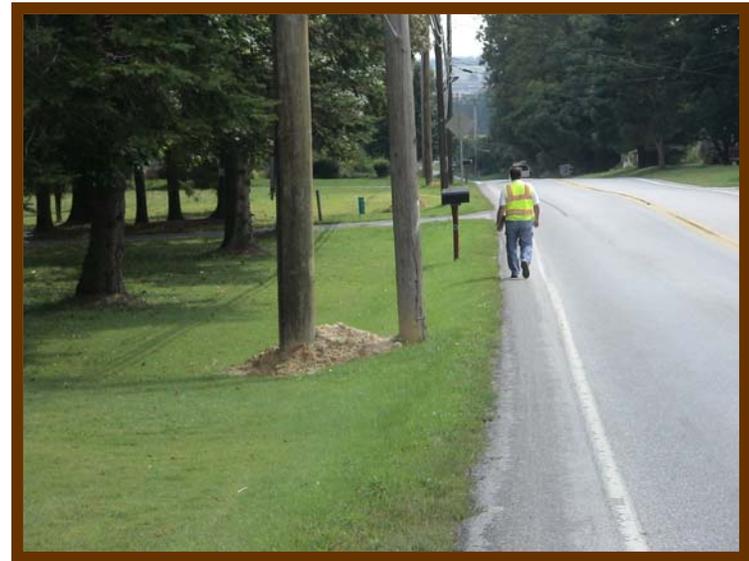
Several driveways access PA 10 between
Compass Road and Beacon Light Road/Quarry
Road

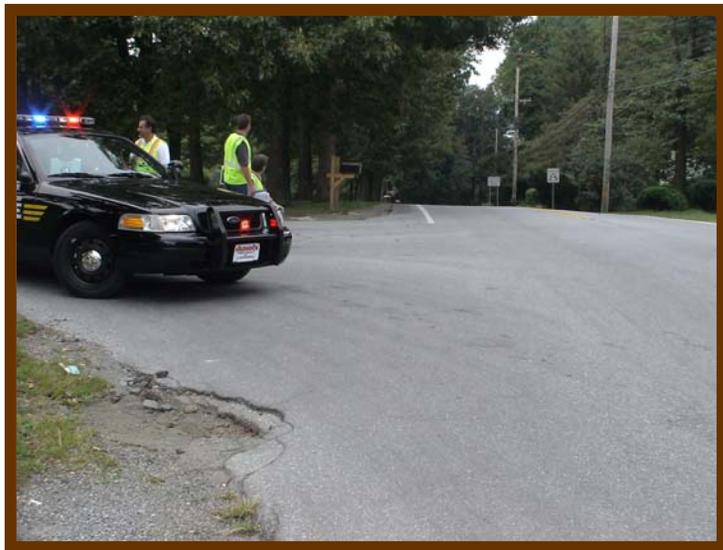
Compromised sight distance for Quarry Road
traffic at PA 10 to the north

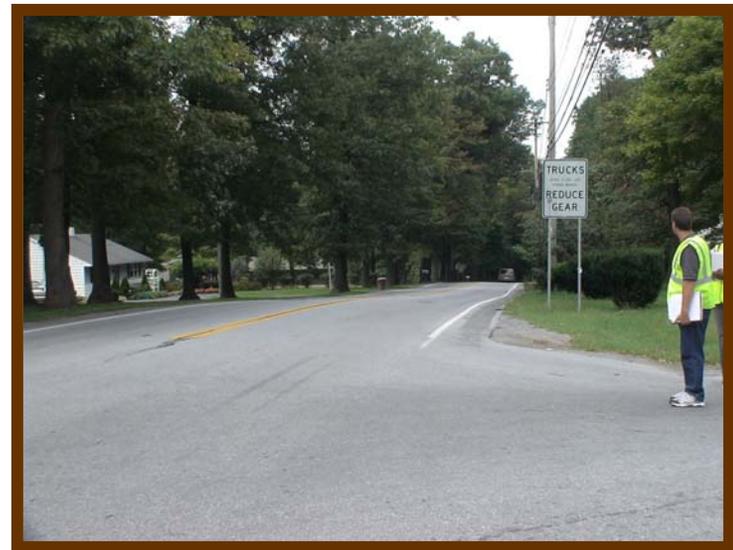
Compromised sight distance for Beacon Light
Road traffic at PA 10 to the north

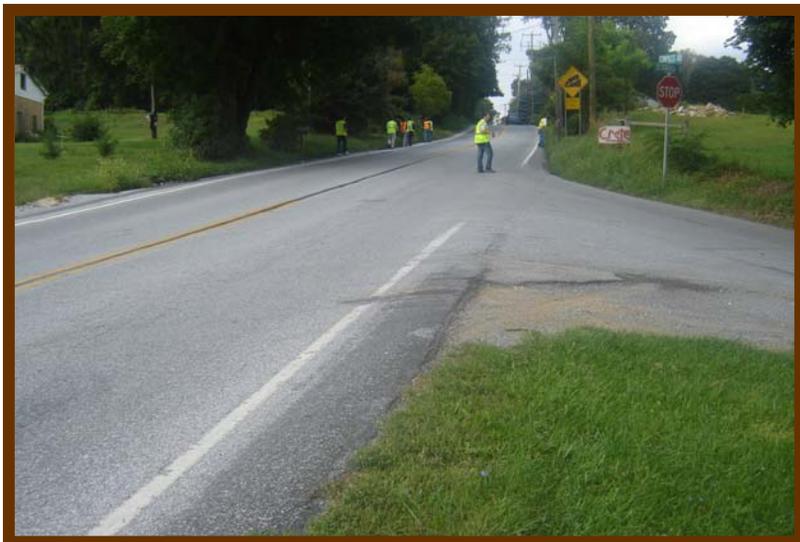
Crest of the hill to the north compromised sight distance for Compass Road traffic entering PA 10

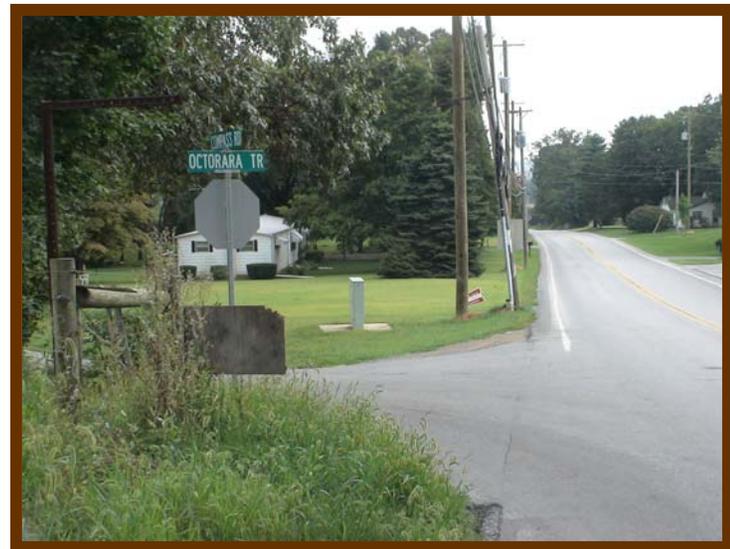
Utility poles in the clear zone

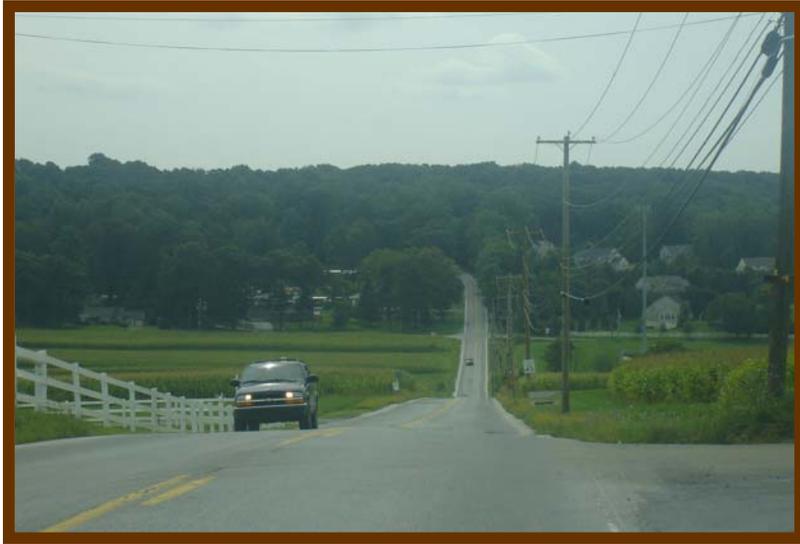
Passing zone continues through the intersection. Undulating roadway compromised sight distance for traffic entering PA 10 from Beaver Dam Road

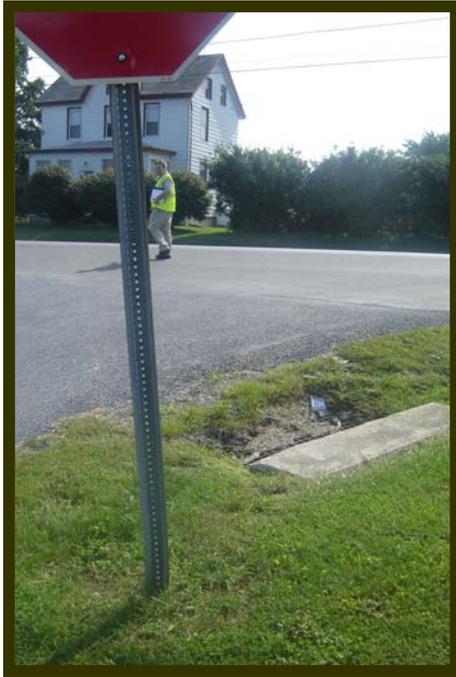
Stop sign at
Catamount Road is
too low

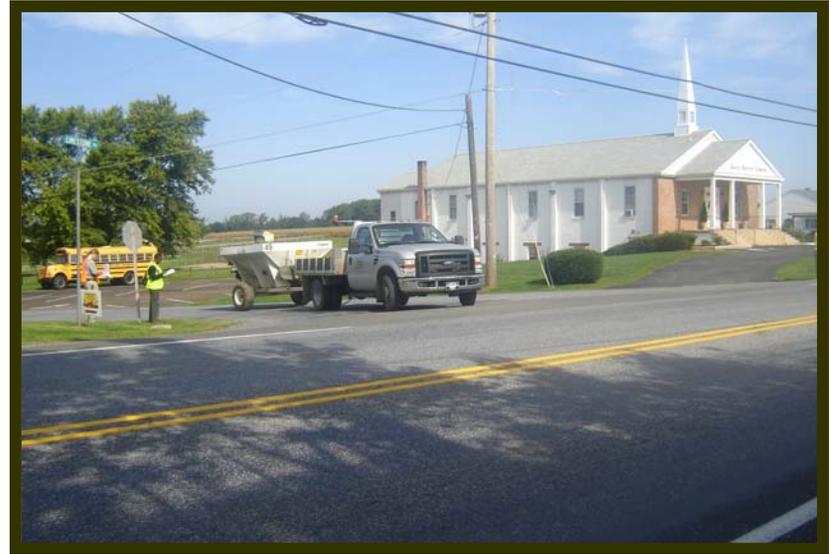
Catamount Road, pavement markings do not
indicate intersection

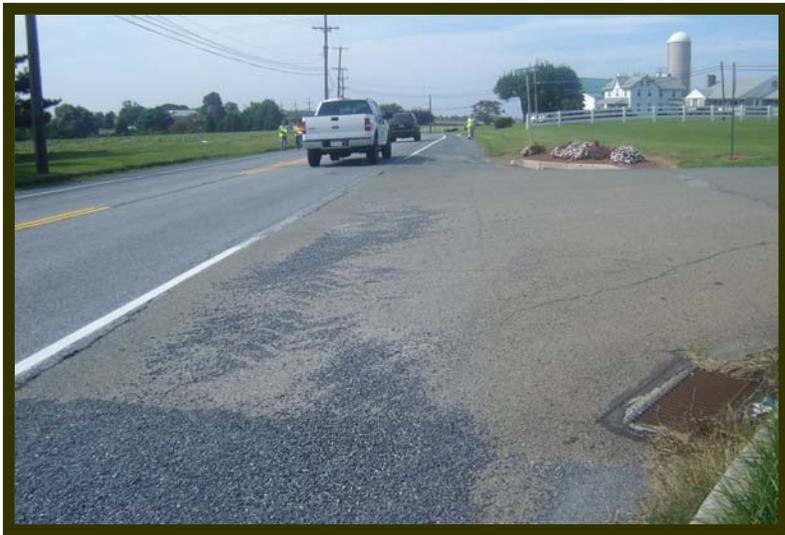
Pavement marking at the intersection of Old
Limestone Road does not indicate intersection

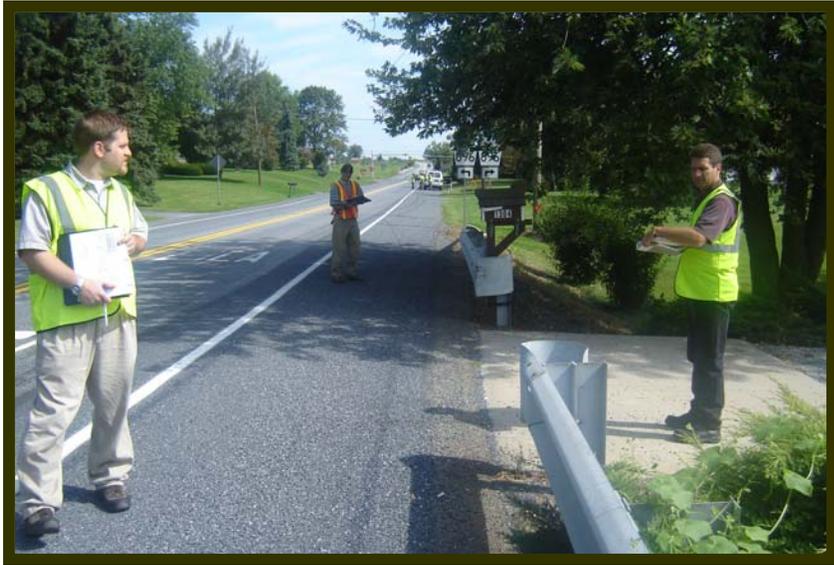
Guide rail with two blunt ends for driveway on northbound side of PA 10

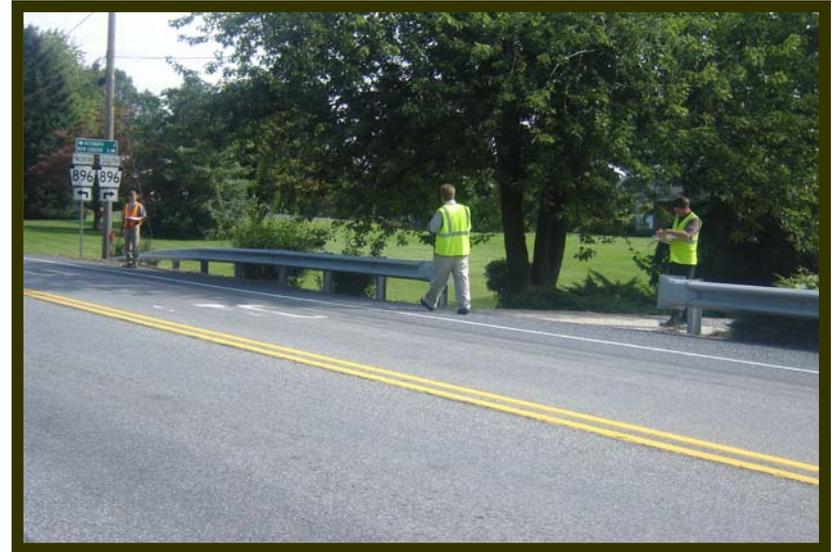
Guide rail with two blunt ends for driveway, second string of guide rail is ineffective

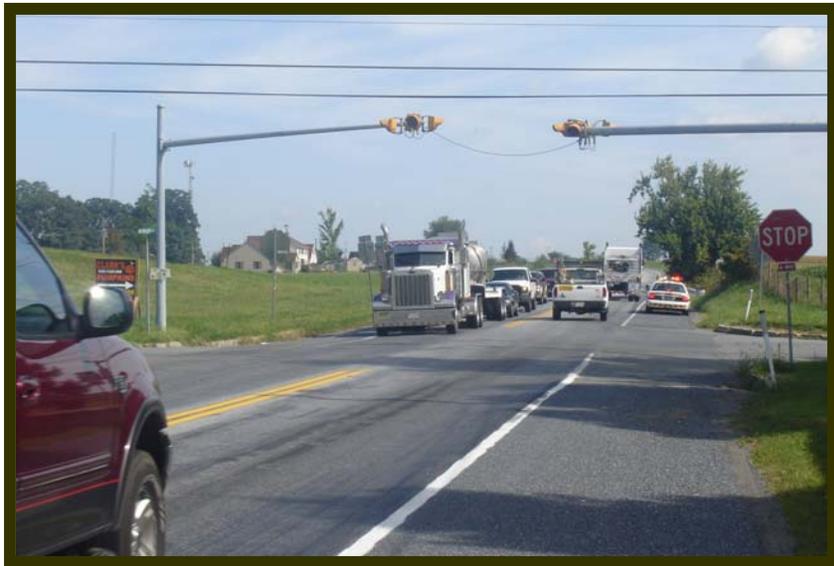
PA 10 pavement rutted at the PA 896 approach

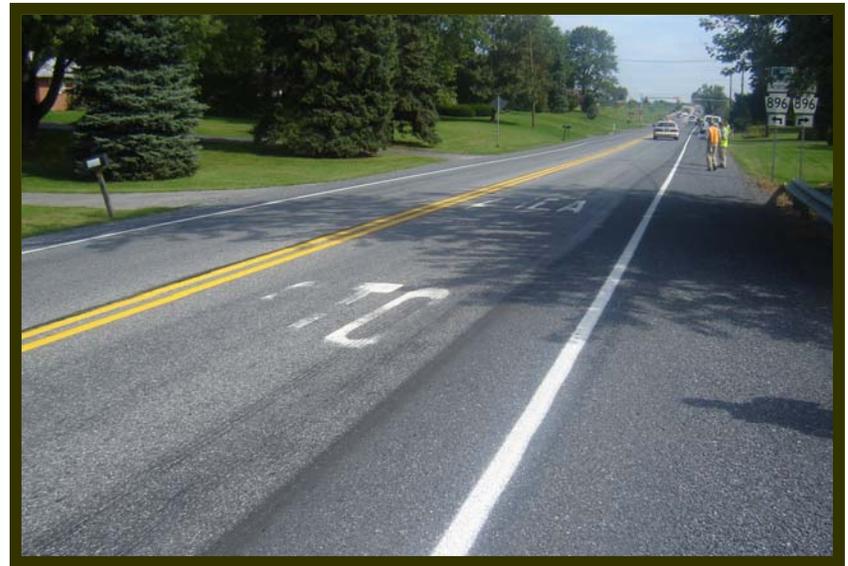
"Stop Ahead" legend faded at the northbound approach of PA 896

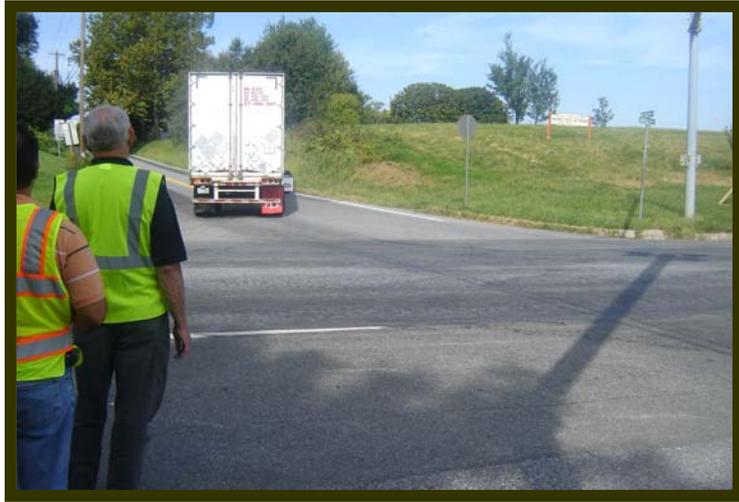
Tight turning radii at the intersection of PA 10/PA 896

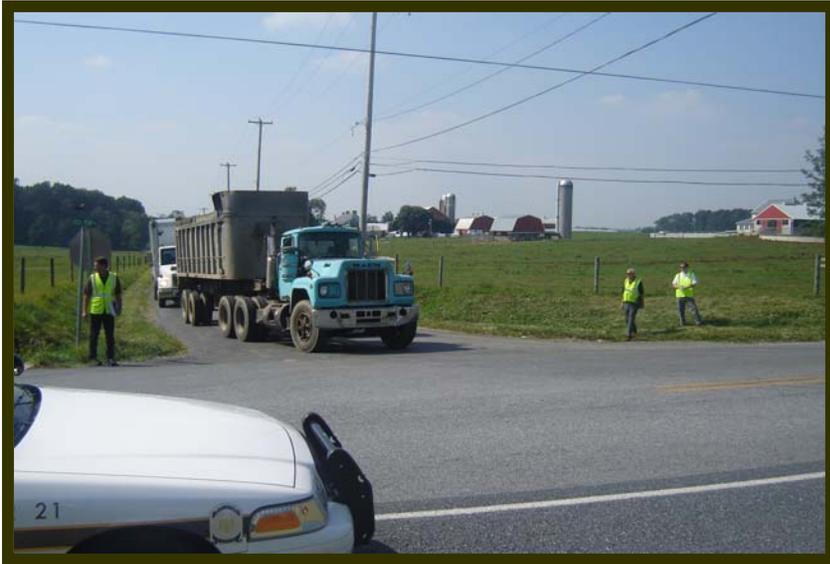
Tight intersection radii at High Point Road makes it difficult for turns at the intersection

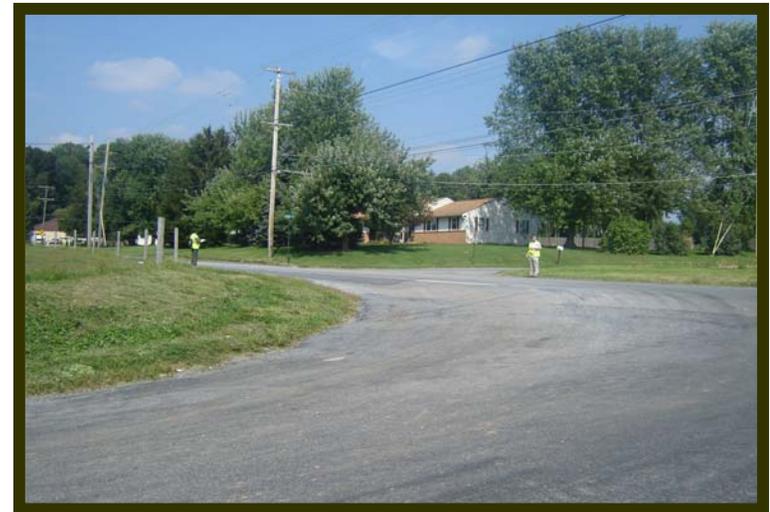
High Point Road approach to PA 10 is steep and abrupt

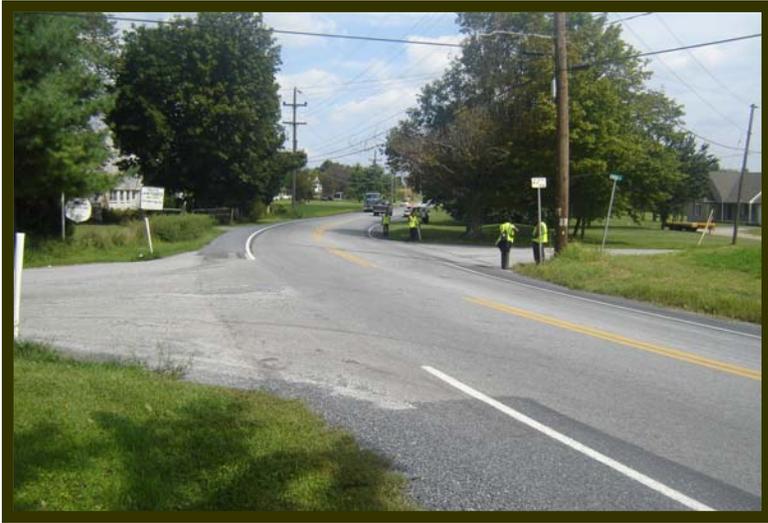
Ewing Road and Edenton Road – offset intersections on the curve

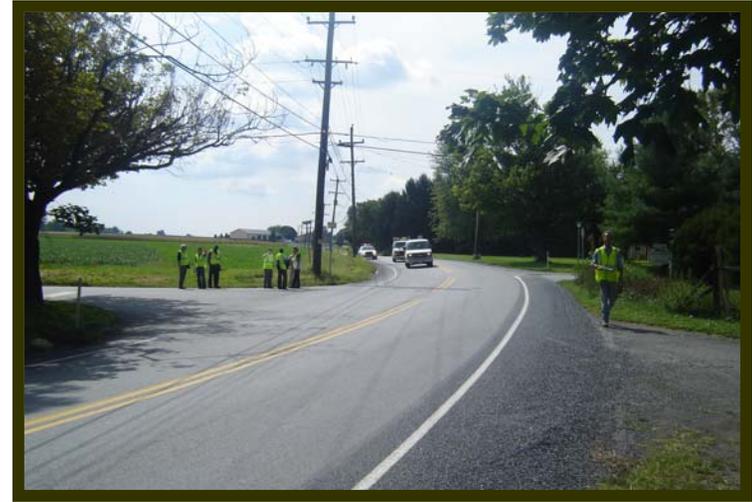
Ewing Road and Edenton Road – limited sight distance looking south

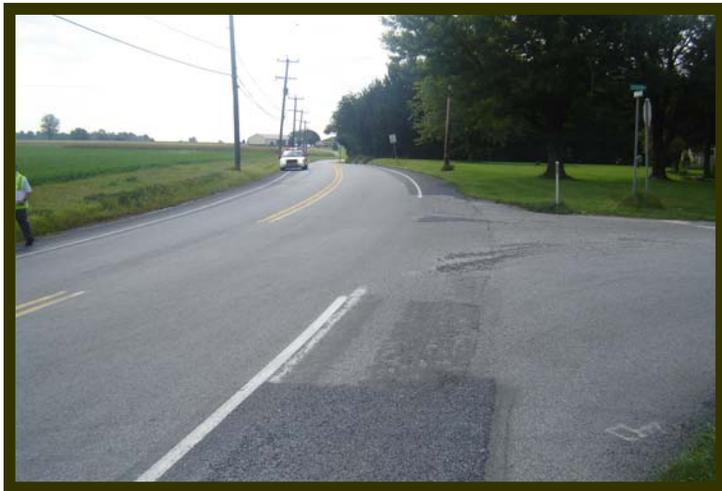
Ewing Road approach to PA 10

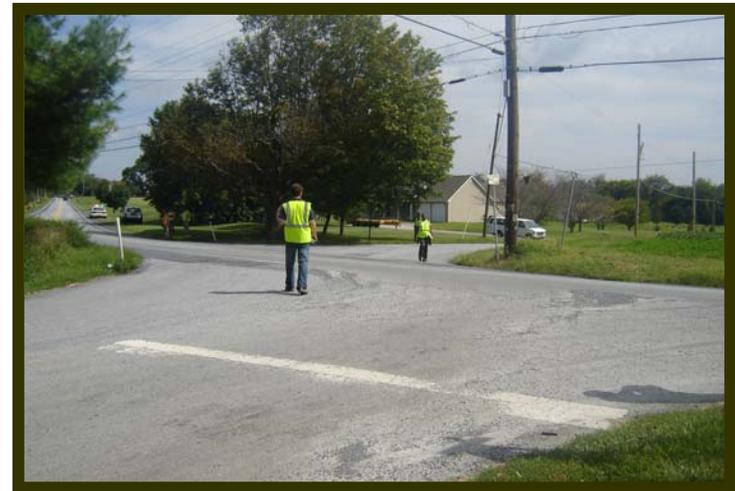
Edenton Road approach to PA 10

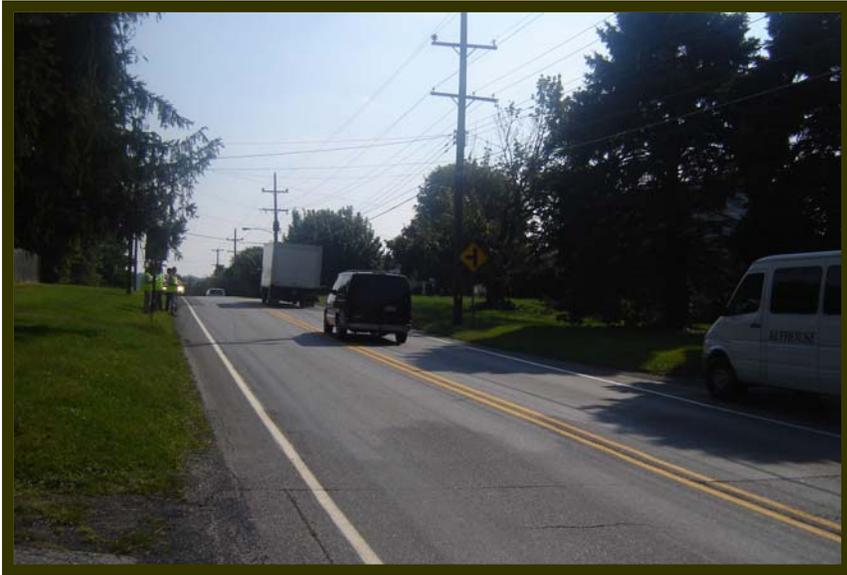
Blind crest approaching Highview Drive

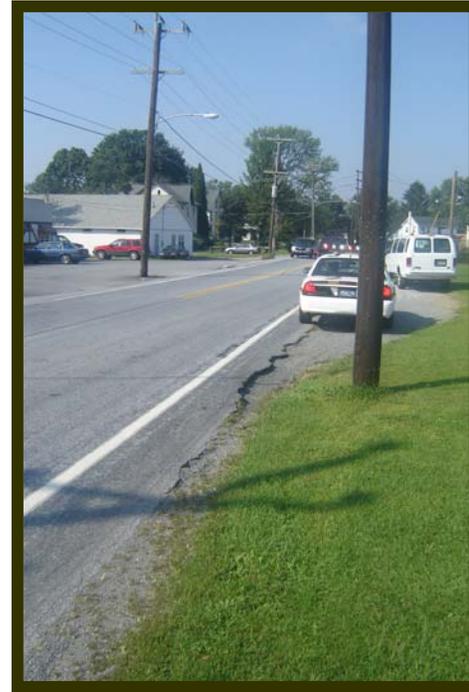
Edge drop off opposite
Glenville Road on the
northbound side of PA
10

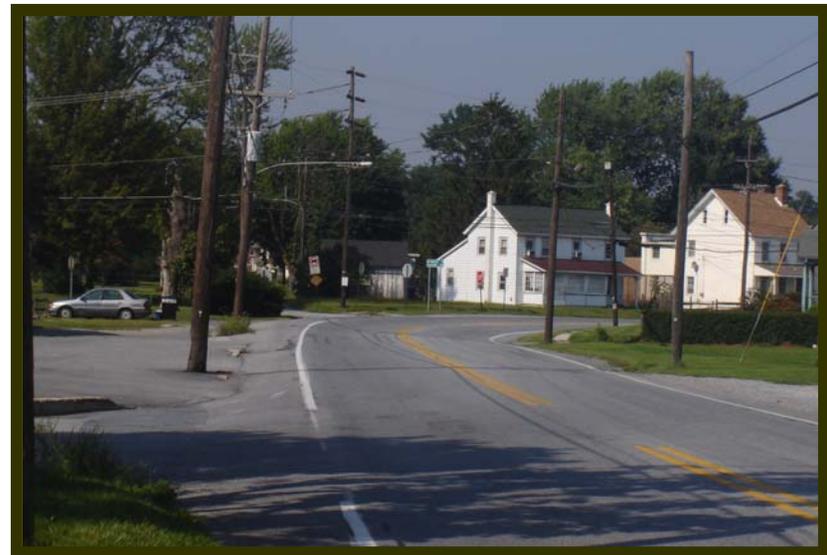
Open access for the businesses on the corner of
Glenville Road and PA 10. Curve is super-elevated

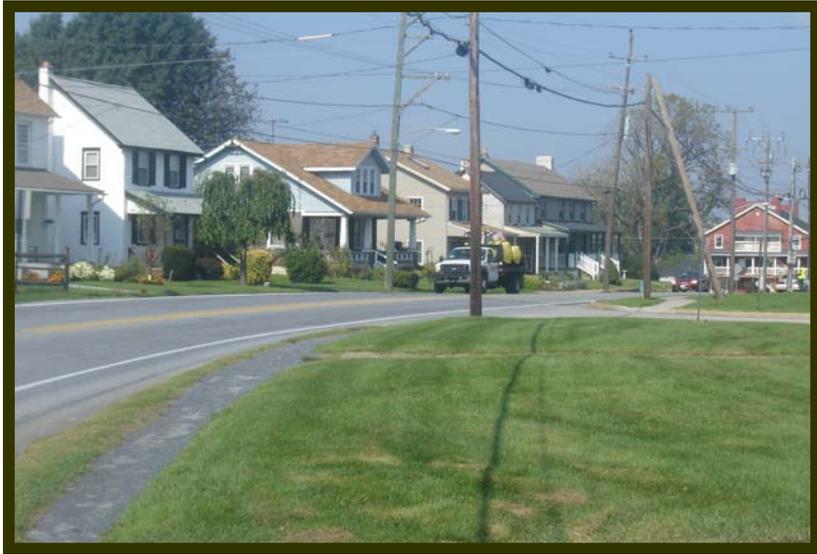
No curb or sidewalk on the northbound side of PA 10 north of Church Road

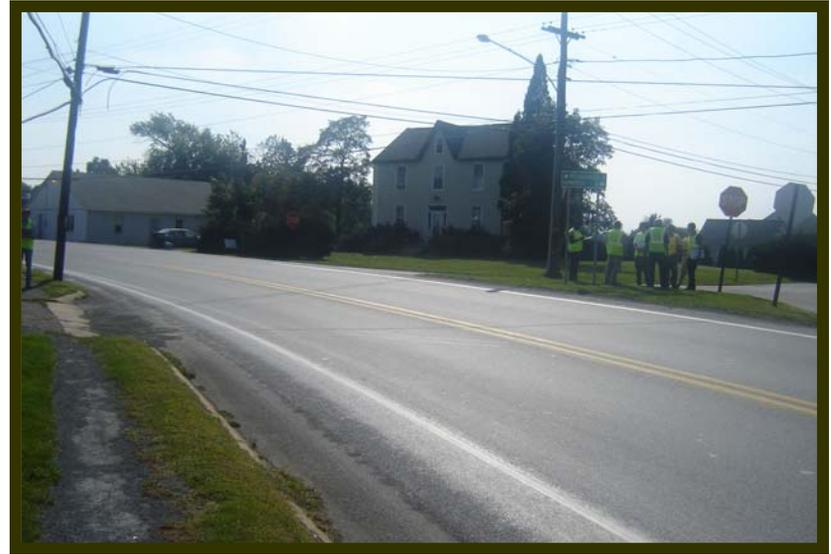
PA 10 slopes to the inside of the curve at the Church Road intersection on PA 10

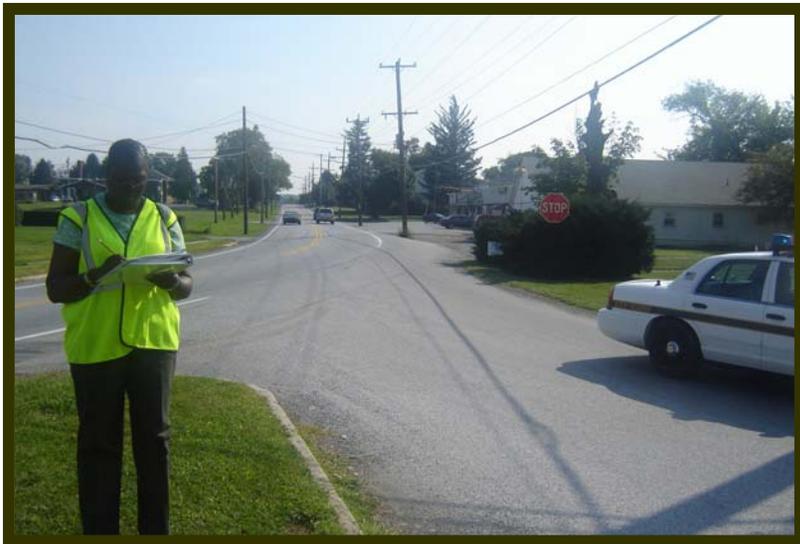
Skewed alignment of Church Road at PA 10. "Stop" sign is too low and covered in the trees.

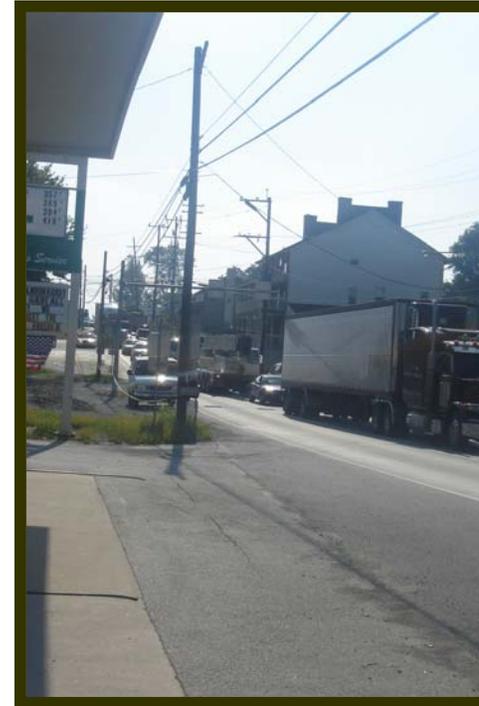
Gas station access at the northbound approach of the PA 10/PA 41 intersection

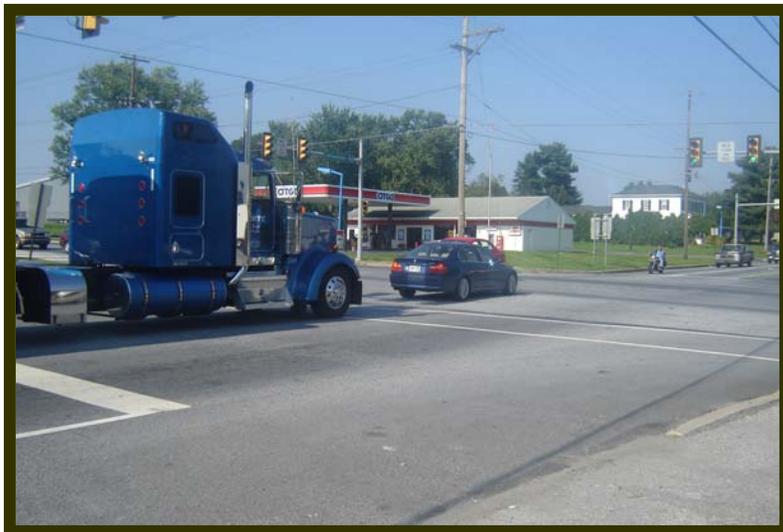
Traffic signal at PA 10/PA 41 does not have a protected left turn phase, traffic is often stranded beyond the stop bar

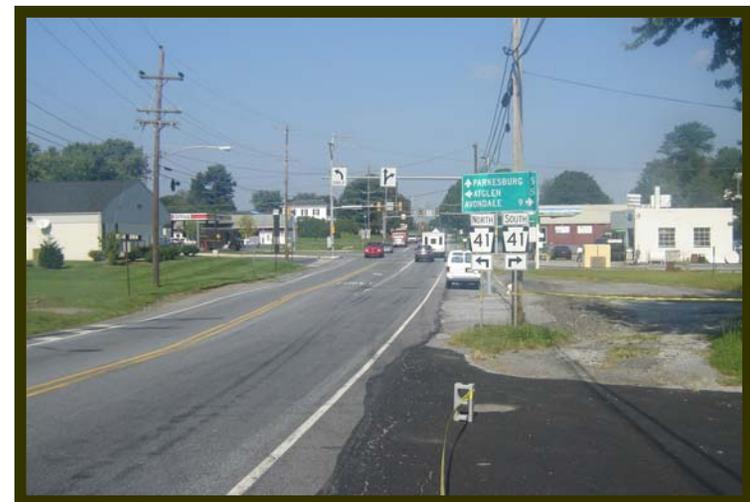
PA 10/PA 41 northbound intersection approach

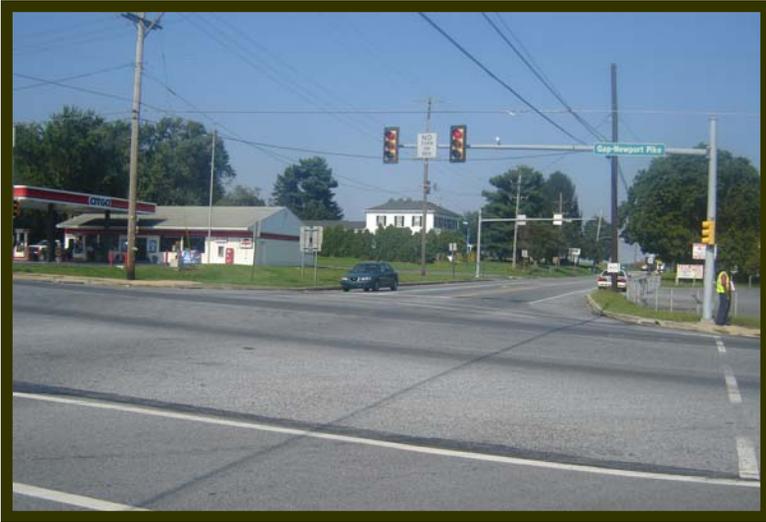
The stop bar for the PA 10/PA 41 intersection southbound approach is too close to the intersection

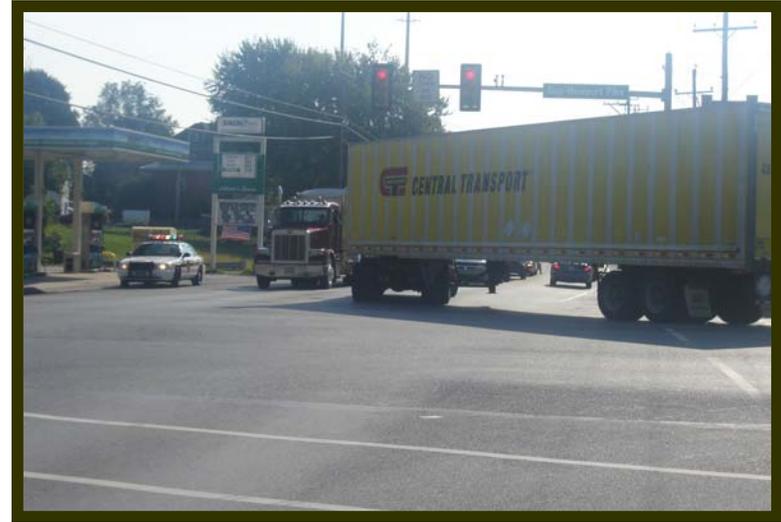
Truck making a right turn on to PA10 southbound from eastbound PA 41

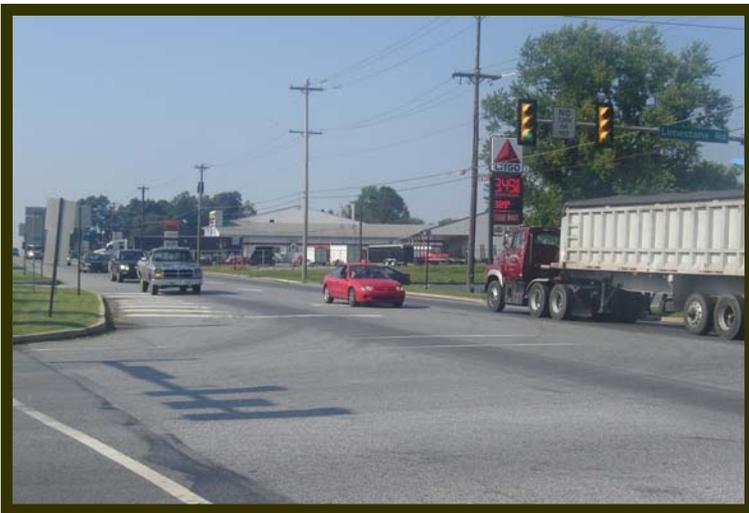
Pavement markings are faded at the PA 10/PA 41 intersection

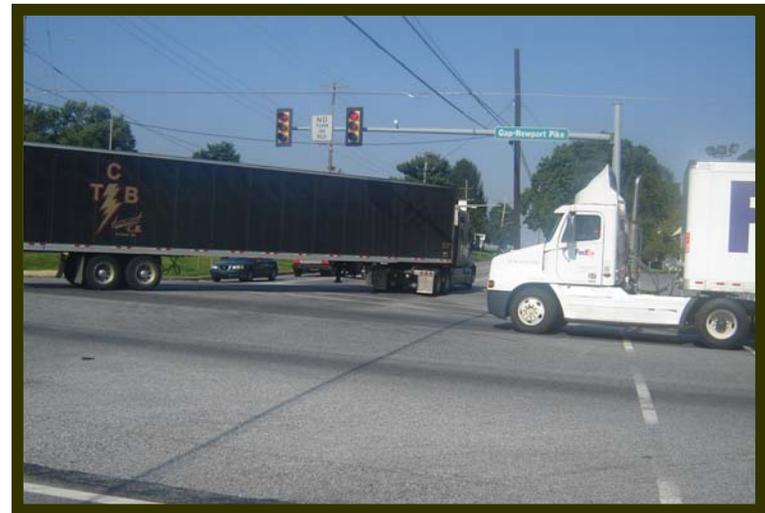
Truck making a left turn on to PA10 northbound from eastbound PA 41

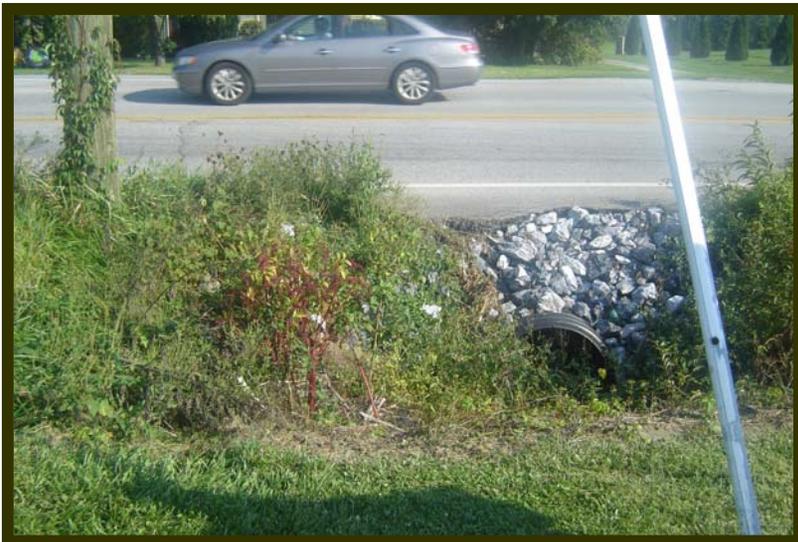
Unprotected drain on the southbound side of PA 10 opposite Gum Tree Road

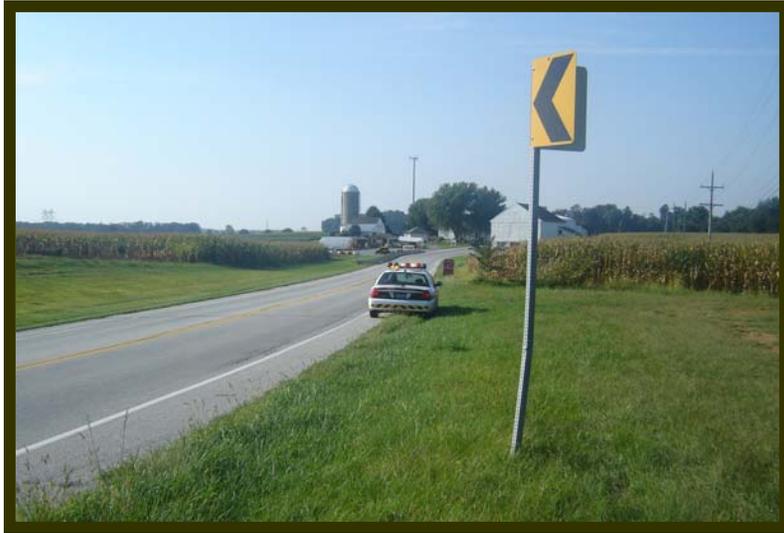
Traffic was observed speeding southbound around the curve north of Friendship Church Road

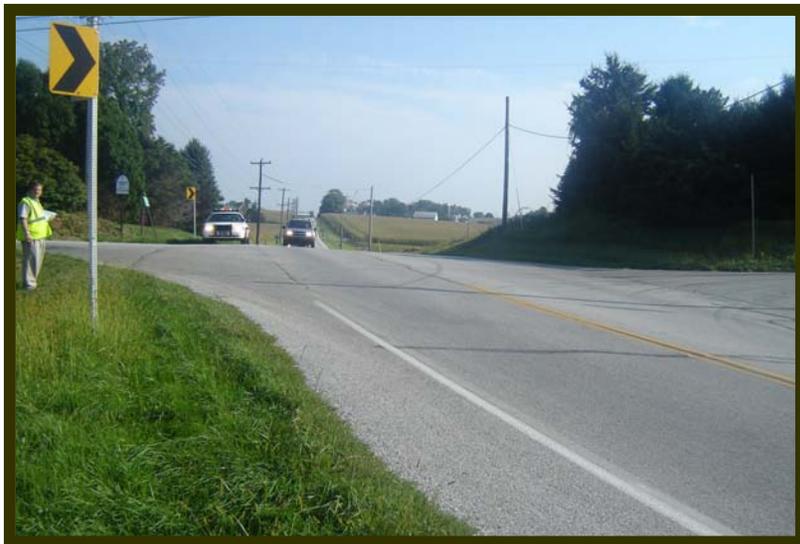
Friendship Church Road is in a curve on PA 10, sight distance is limited to the south due to the undulating roadway

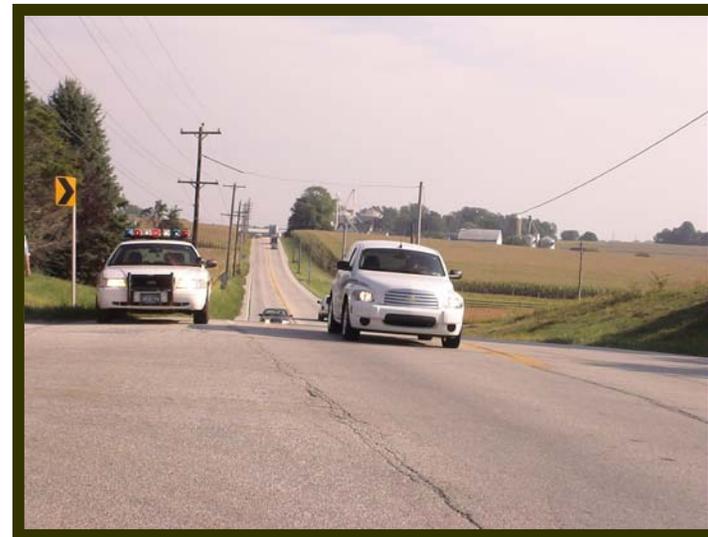
At Friendship Church Road, some vehicles are not visible due to the geometry of the roadway
